U.S. Fire Administration/Technical Report Series

Structural Collapse at Dwelling Fire Results in Two Firefighter Fatalities

Stockton, California

USFA-TR-102/February 1997

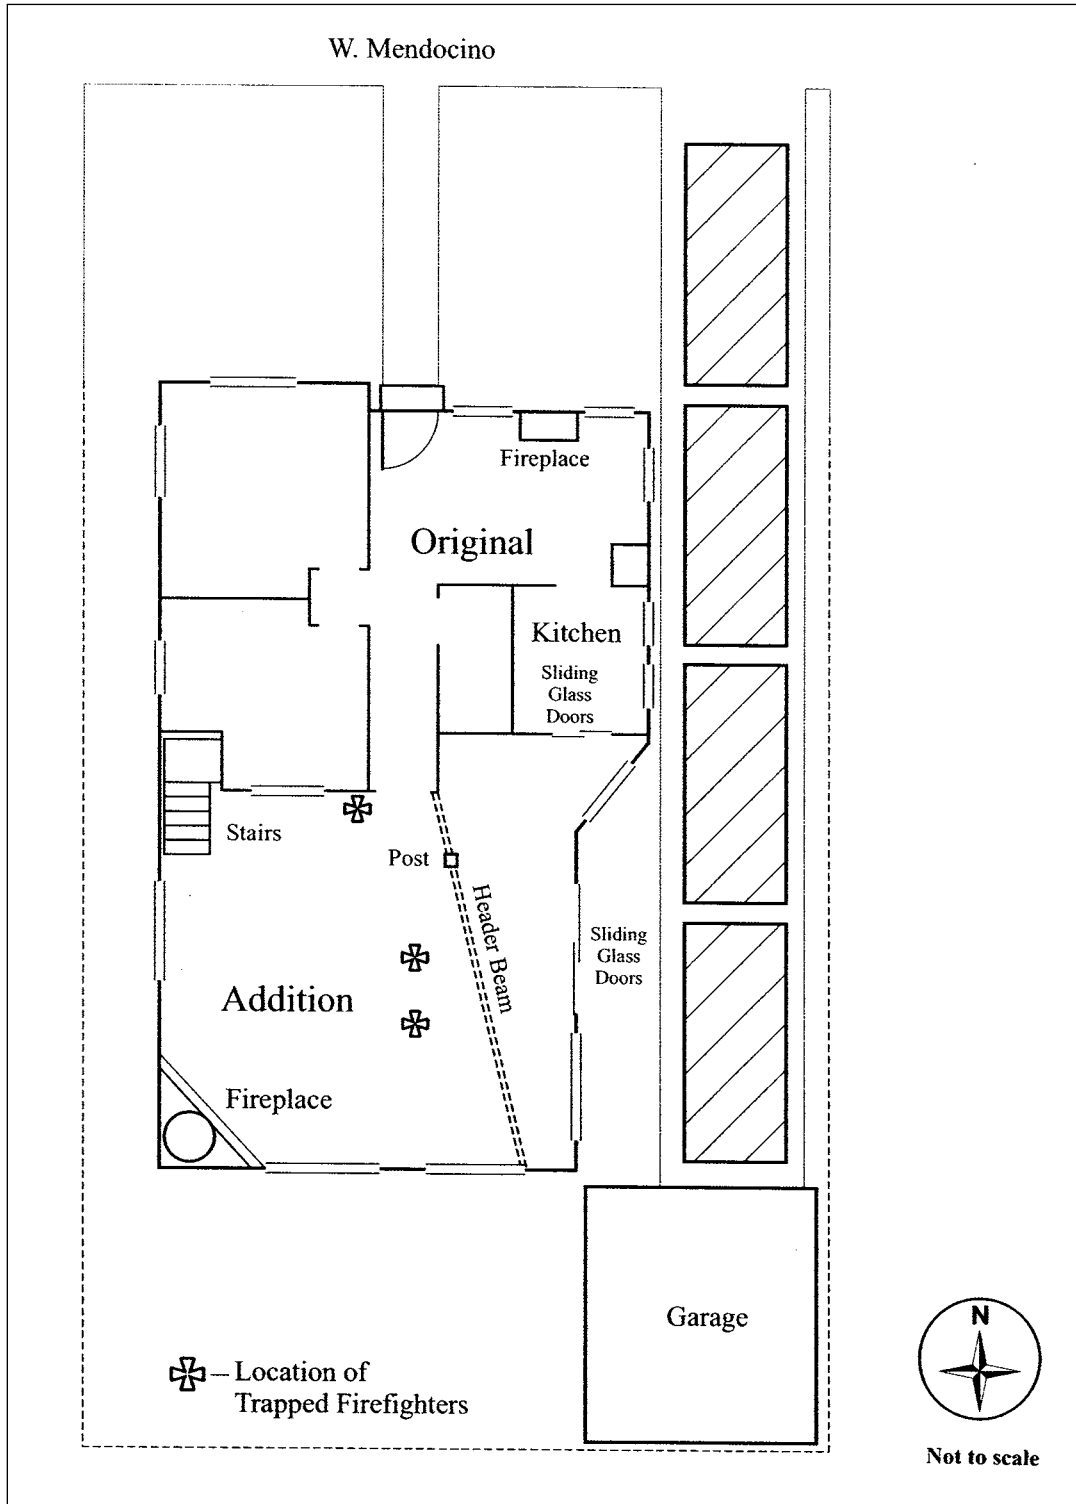
Figure 2: Floor Plan - First Floor

The E6 Captain and one of the firefighters then deployed a standpipe pack to advance a back-up line into the interior. While the other firefighter fed the line from the door, the Captain advanced the 1-3/4 inch line toward the rear of the house. Noting that Engine 9's line had gone to the right, he took the back-up line toward the left side of the house, where fire was visible in the kitchen area. (See Figure 2)

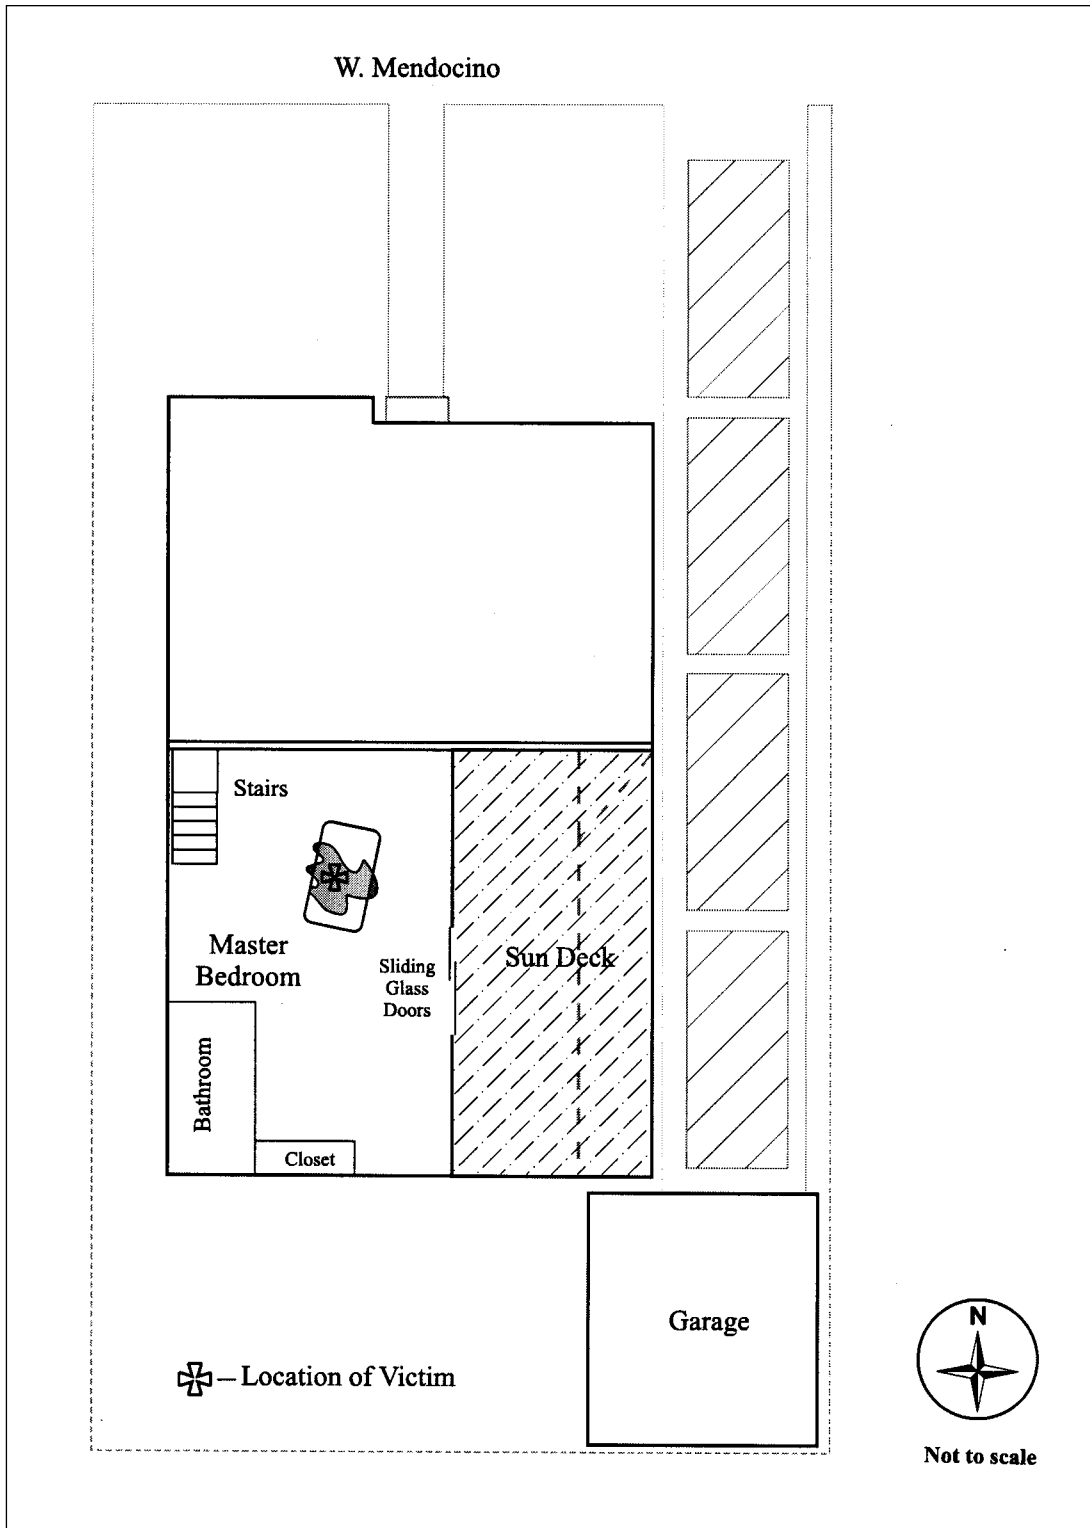
Figure 3: Floor Plan - Second Floor

Analysis of the structure indicated that the heavy second floor was inadequately supported and vulnerable to the type of catastrophic collapse that occurred. The direct cause of the collapse was attributed to either a failure of the 4 by 6 support post within the room or the failure of the header beam itself.

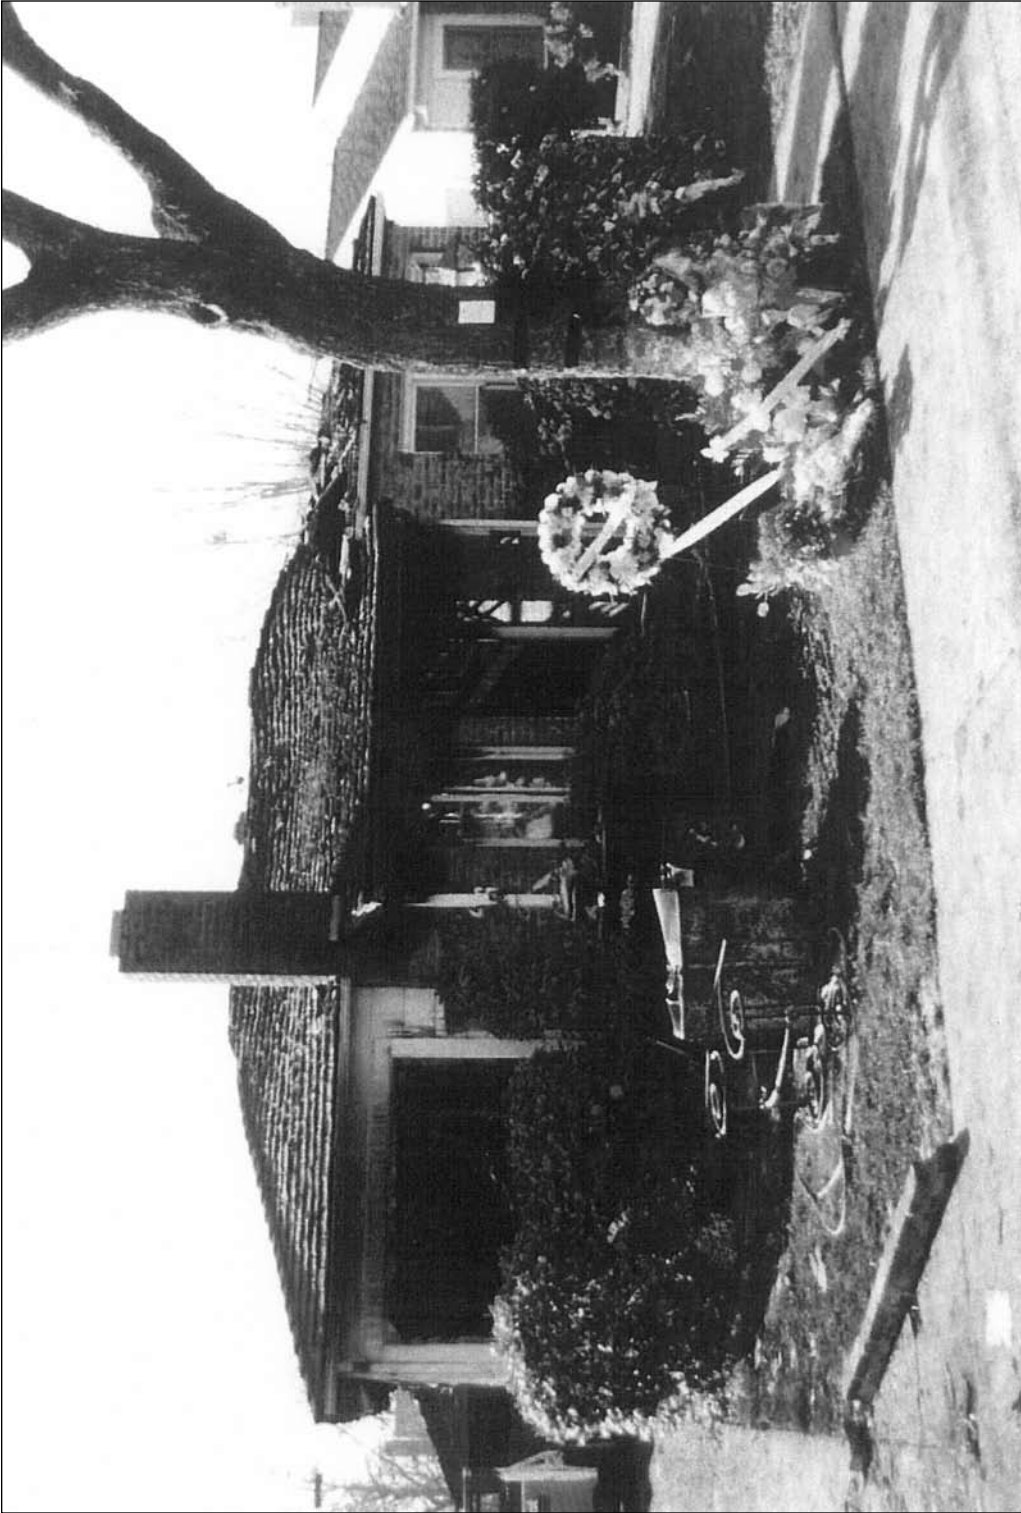
1. View of #25 West Meadows from the street (north) side

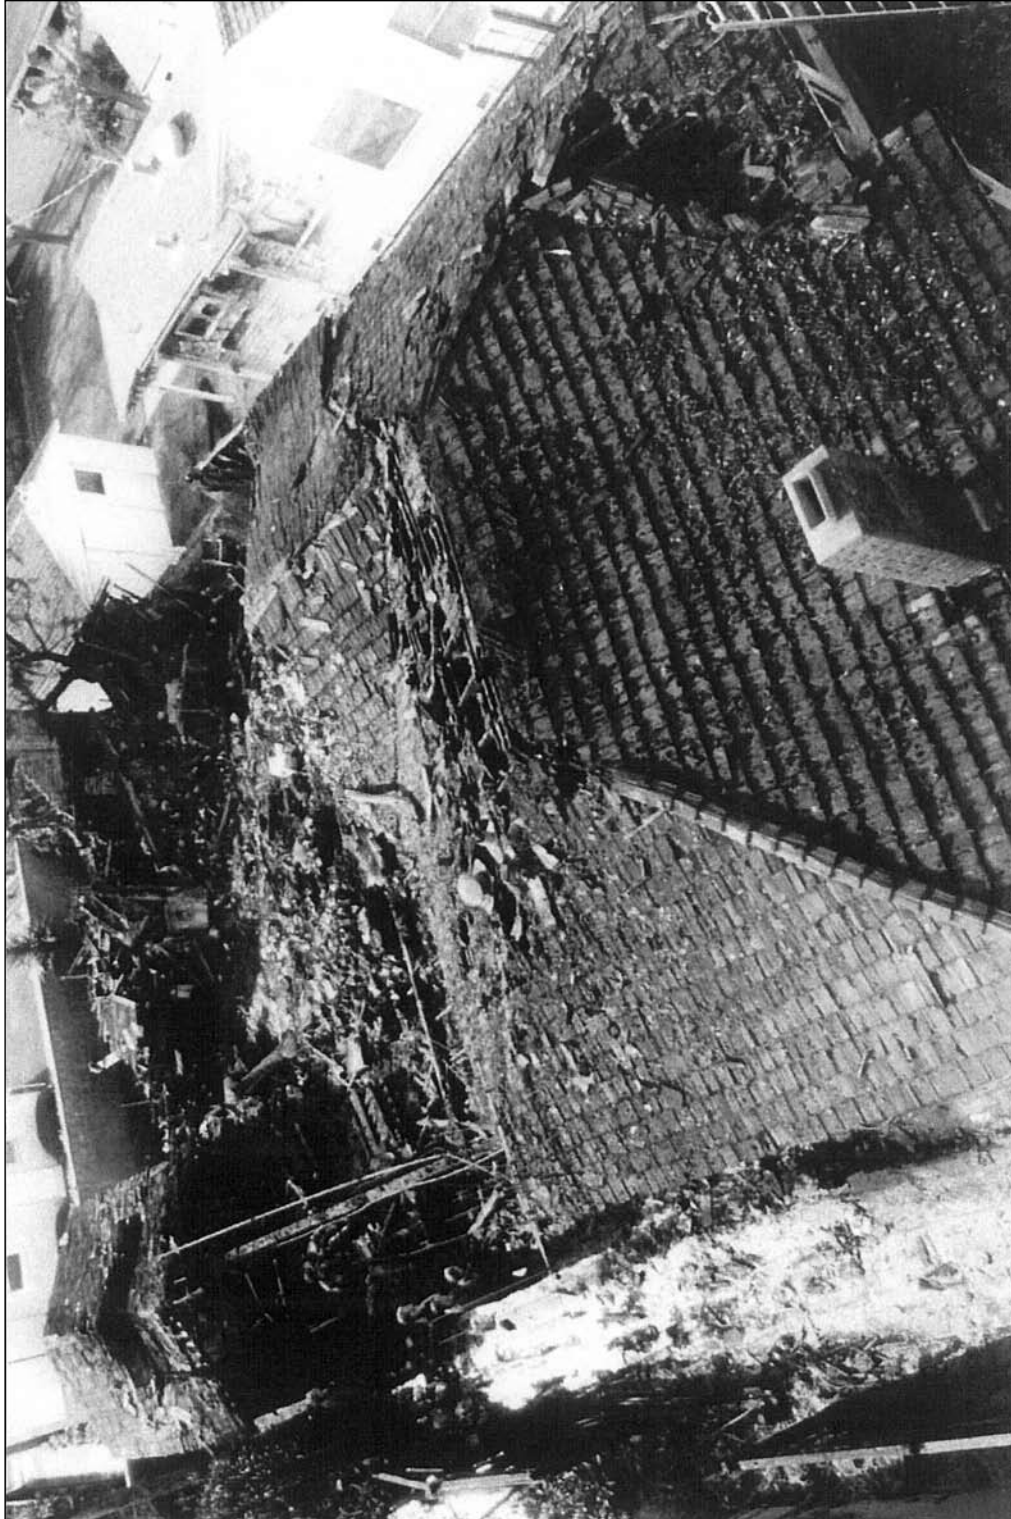
2. Looking south towards rear of house -- note area of second floor collapse

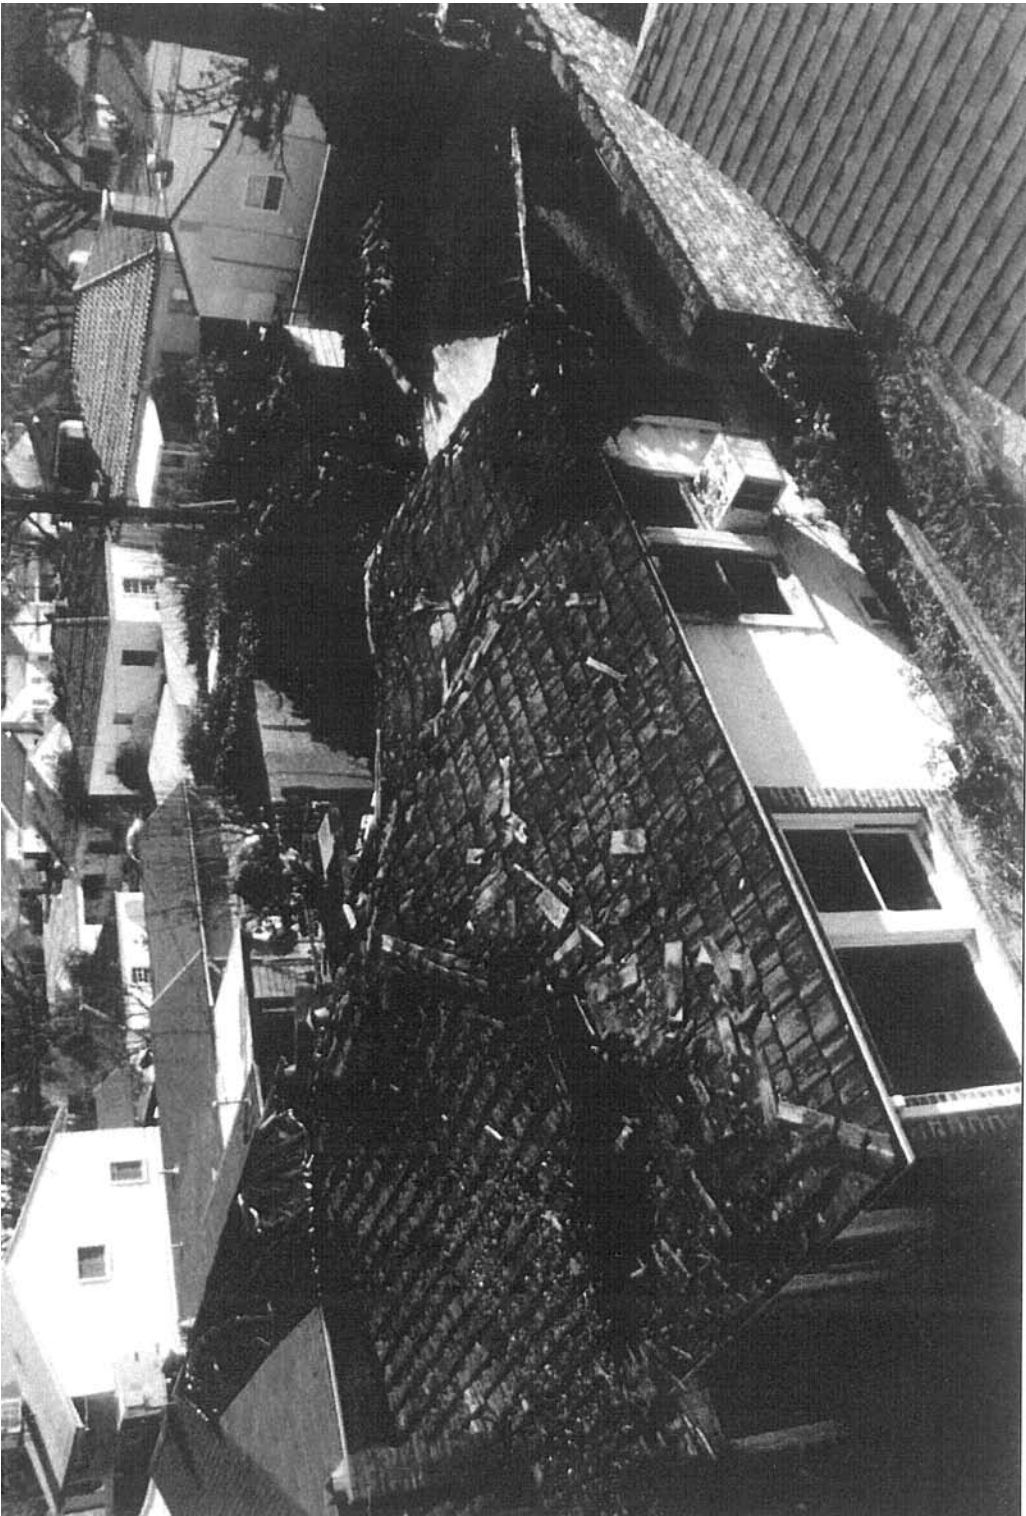
3. Southwest side of house

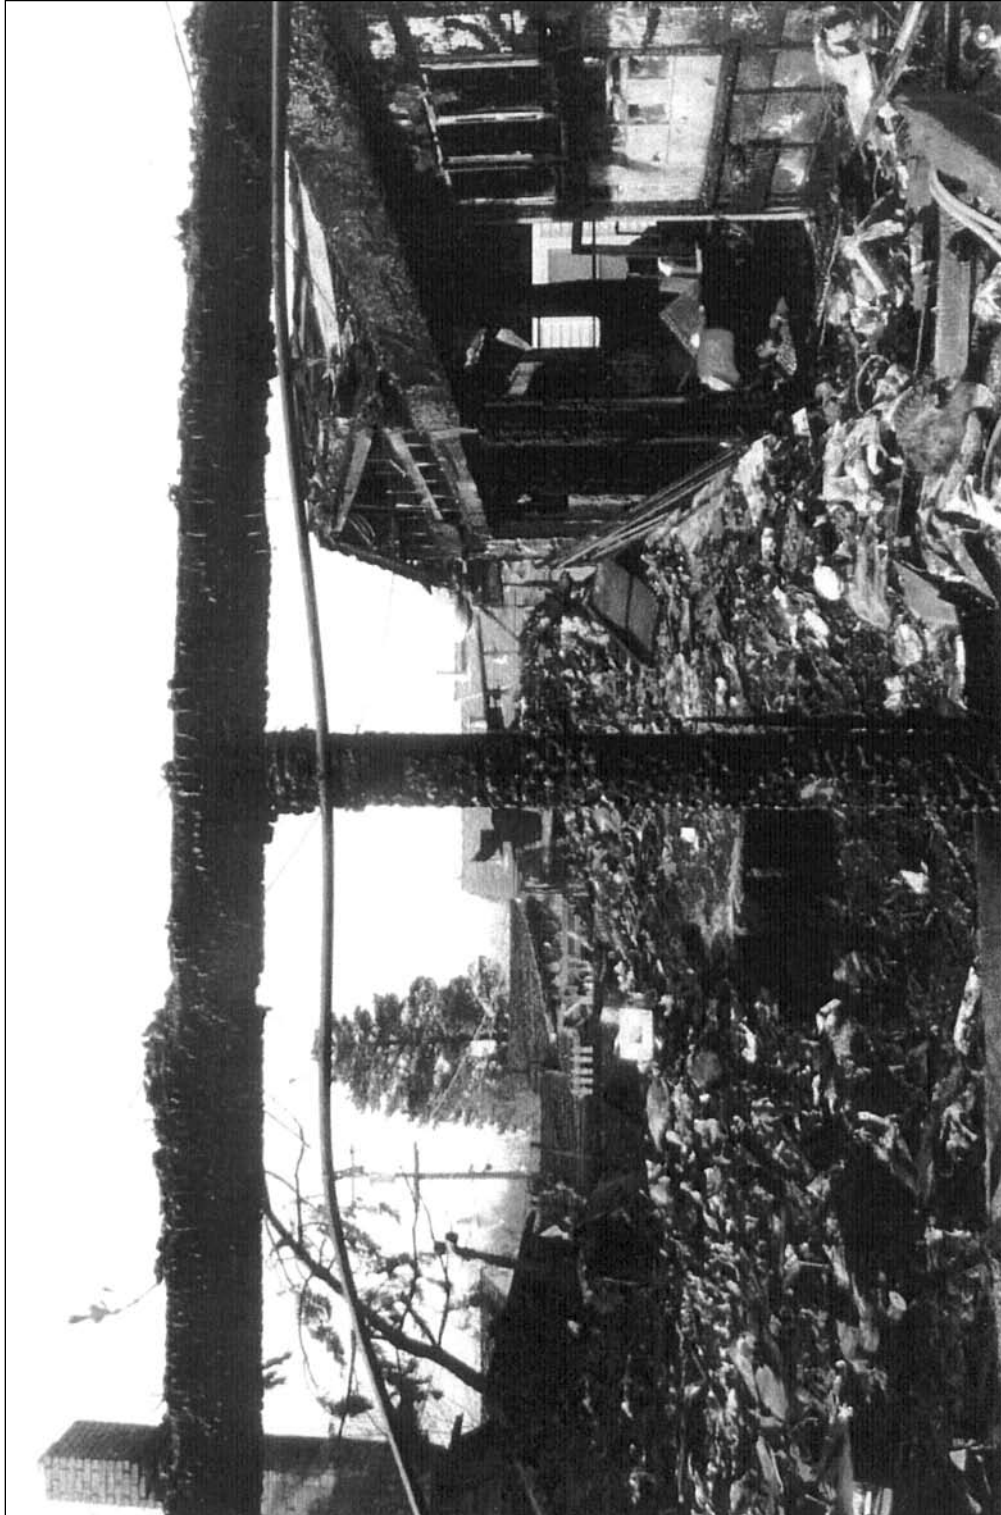
4. Looking southwest, across back room addition, from the driveway.
The original house is on the right side of the photograph.
