Floor Collapse Claims Two Firefighters

Pittston, Pennsylvania

USFA-TR-073/March 1993

Investigated by: J. Gordon Routley

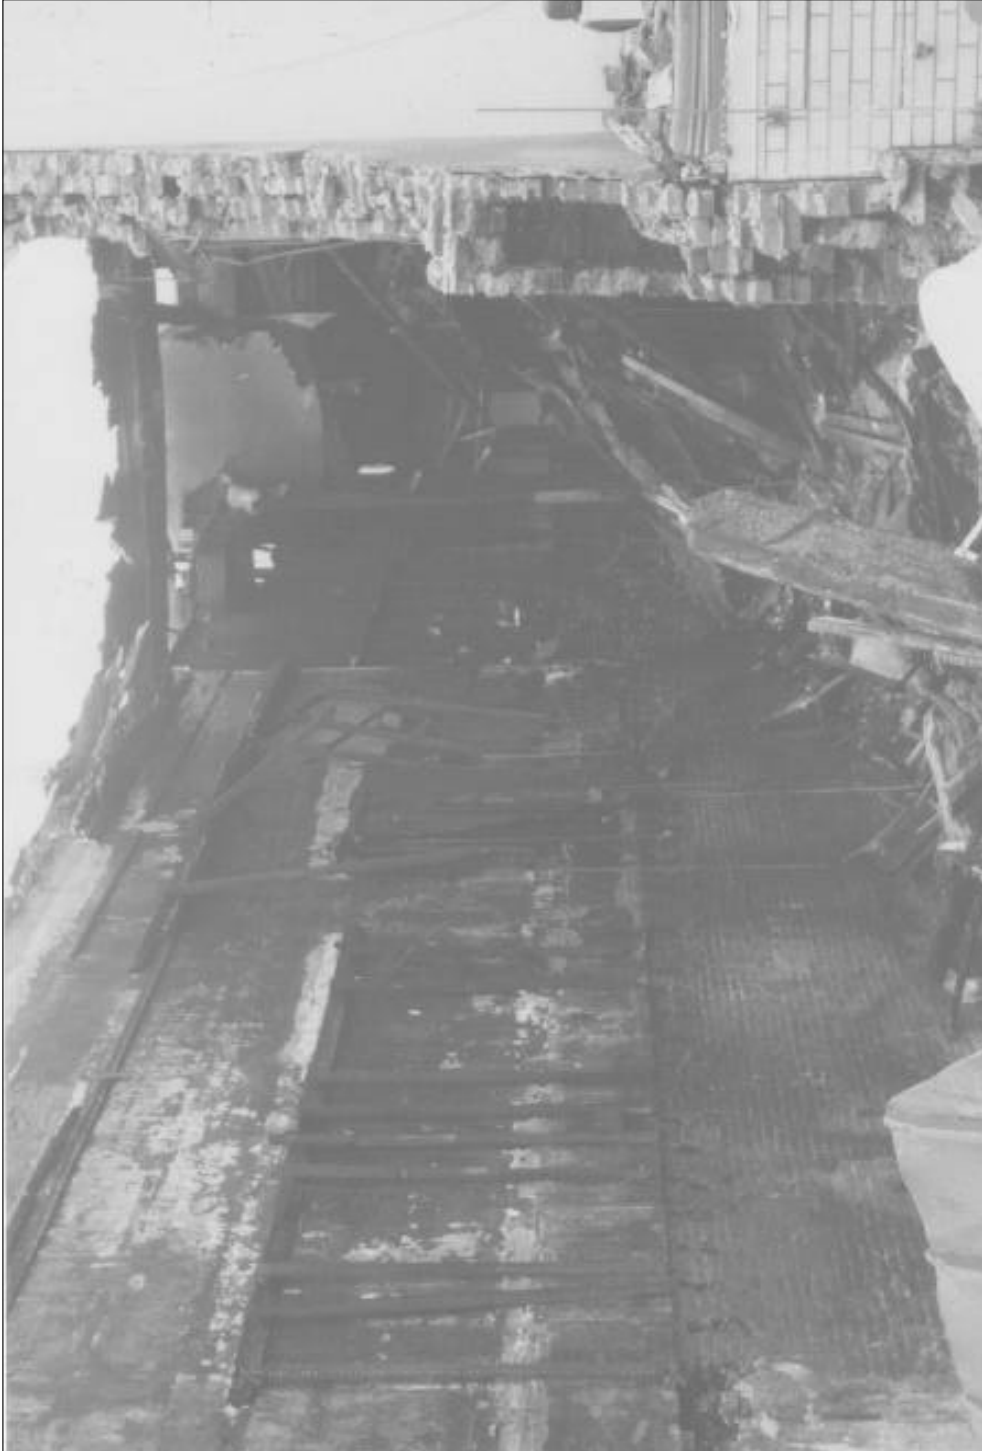
The fire may have smoldered undetected for hours. The vacant area had an opening to an old chimney flue or vent stack in the exterior wall, which may have allowed the smoke to escape during the early stages of the fire. The downtown area was sparsely populated due to the snowfall that had started on the previous day, and even if someone had seen smoke coming from the stack it would have looked like smoke coming from a chimney.

Photo by Ty Dickerson
Void in brick wall (foreground) was a flue from a heating unit (previously removed) that may have allowed smoke from the basement to vent to the outside in the early stages of the fire.

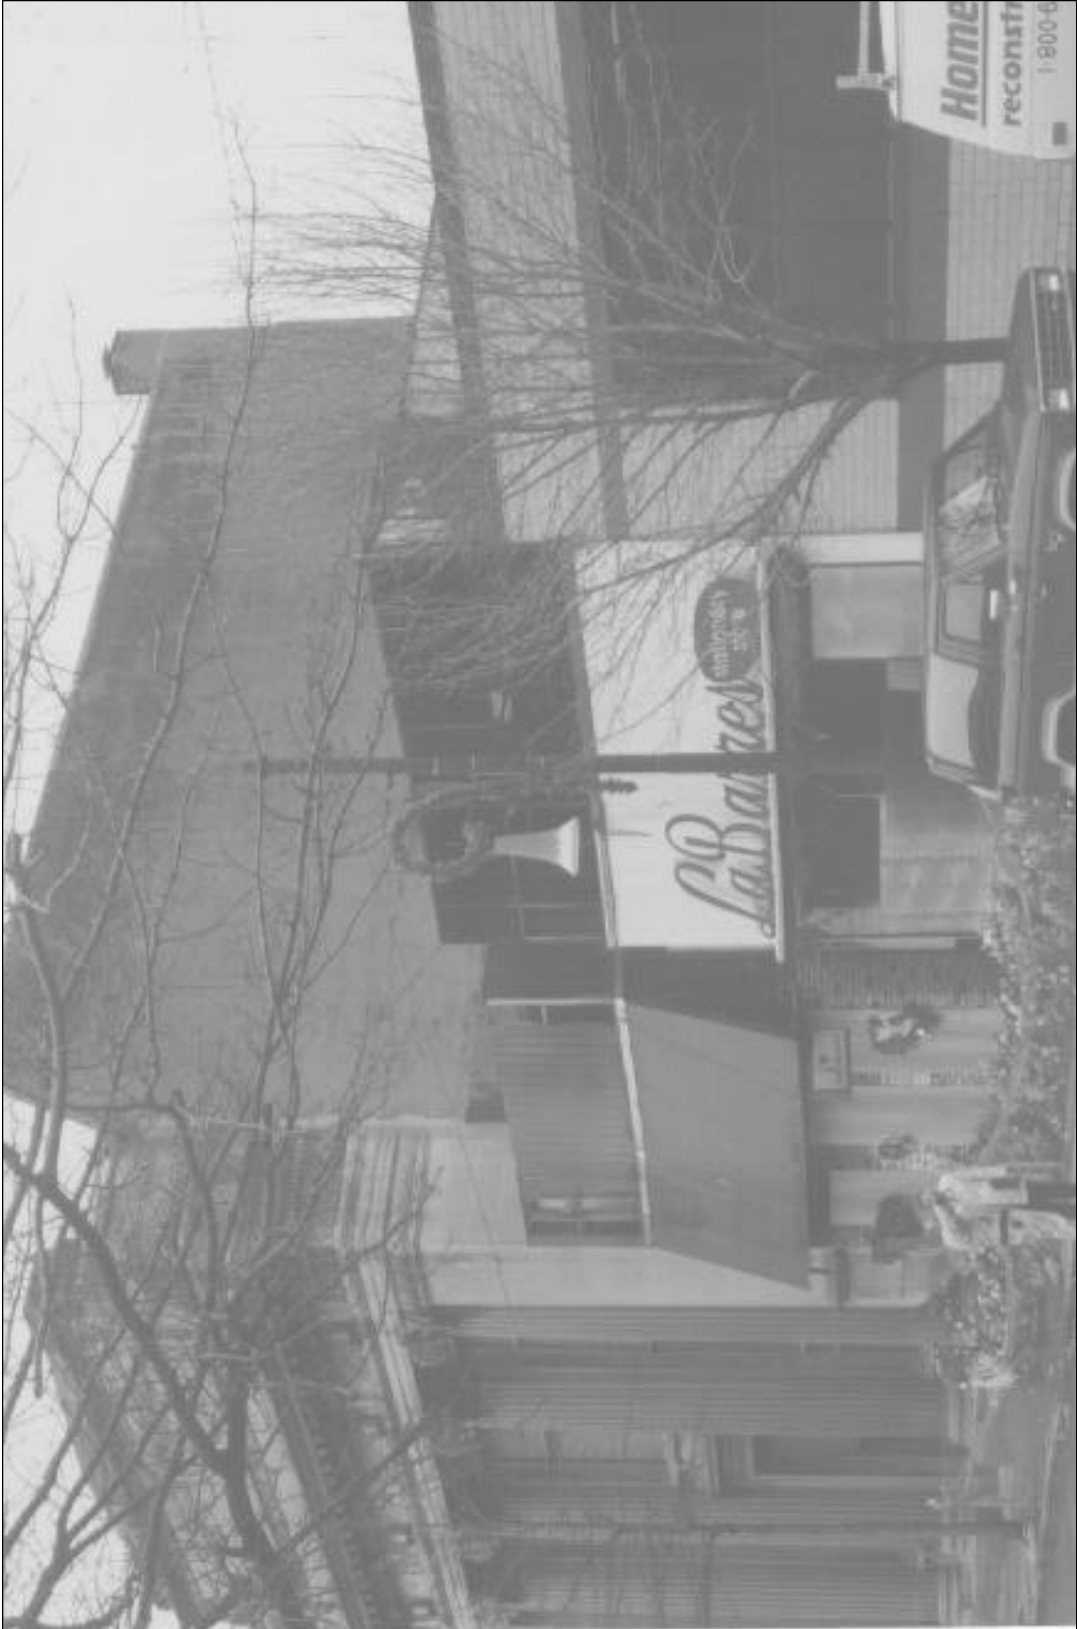
The outline of the upper floors of the original structures is visible in the wall separating the fire buildings from the exposed bank building (background). The void space above the entrances to the two buildings is also visible. The condition on arrival was smoke coming from this space.

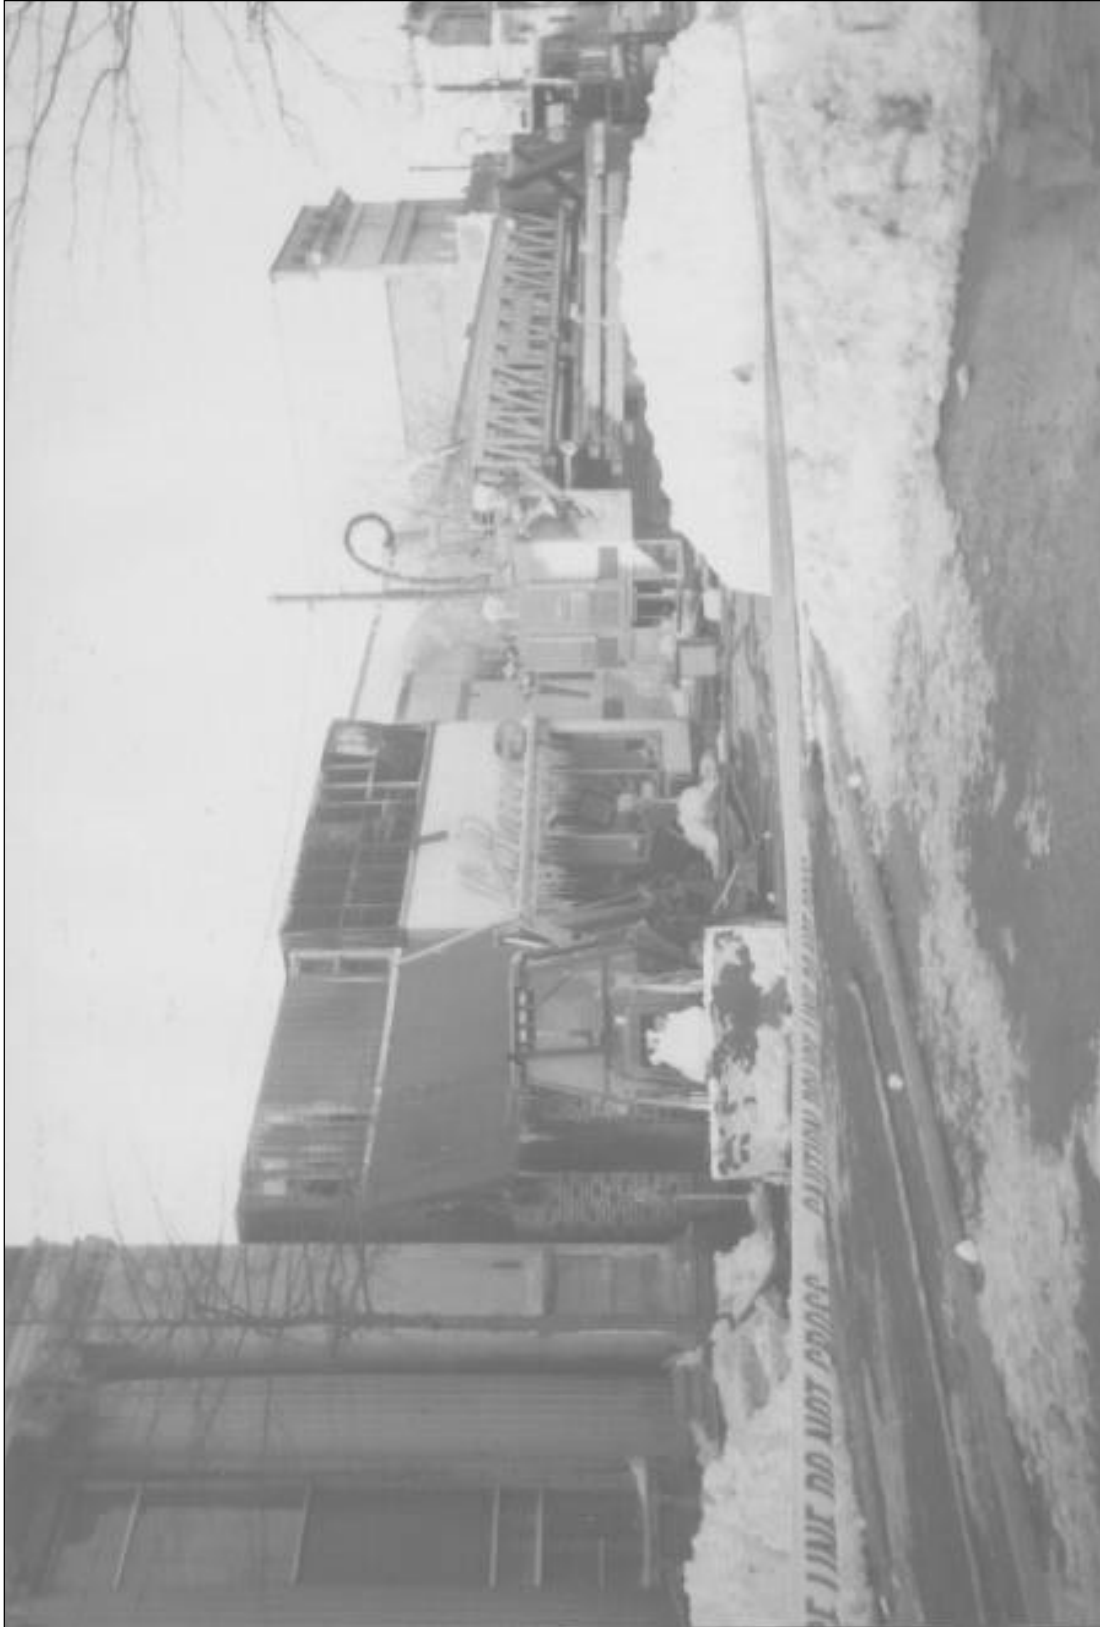
Approximately 16 hours after the fire, a backhoe is in front of the occupancy of fire origin to open an access to the coal bin under the sidewalk and provide access to the basement.
