Forest Service

FY 2007

Aviation Safety Summary

Prepared by the
National Aviation Safety Center
Boise, ID

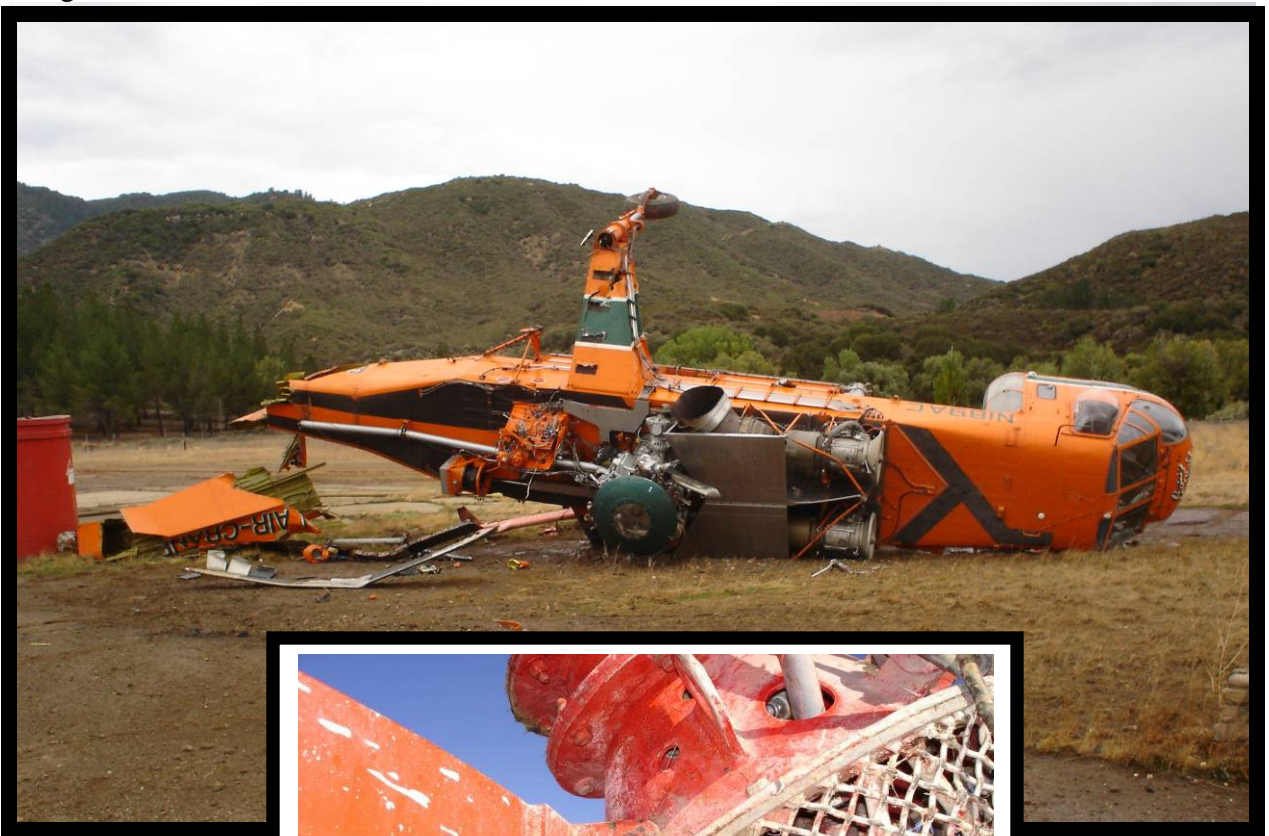
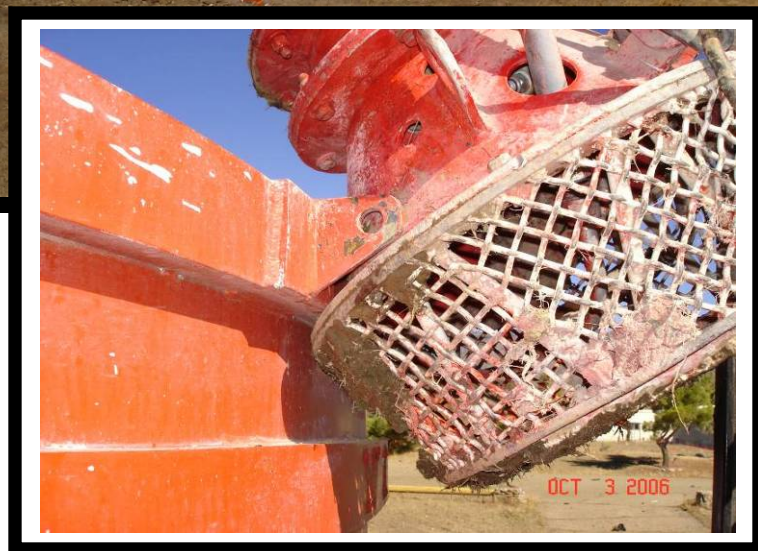
The dip tank exterior was encircled by two support rings, which went around the top perimeter of the tank. The support rings had 90-degree lips. Two lifting eyes, spaced 180 degrees apart, were welded to these support rings. The snorkel installation was through supplemental type certificate. The snorkel tip contained a screen to prevent foreign object ingestion. This screen had a 90-degree upper lip. Scrape marks were evident on the upper ring of the tank moving toward one of the lifting eyes. Investigators also noted damage to the snorkel tip and area of the lifting eye on the tank.

According to a USFS regional aviation safety manager, normal procedures following a caught snorkel are to slowly maneuver the helicopter until the snag becomes free. At the time of the accident, there were no widely distributed USFS published procedures on pilot actions following a snagged snorkel condition.

The National Transportation Safety Board determines the probable cause(s) of this accident as follows: The pilot-in-command's improper remedial action, which resulted in a loss of helicopter control. Contributing factors were the retardant tank and snorkel designs.

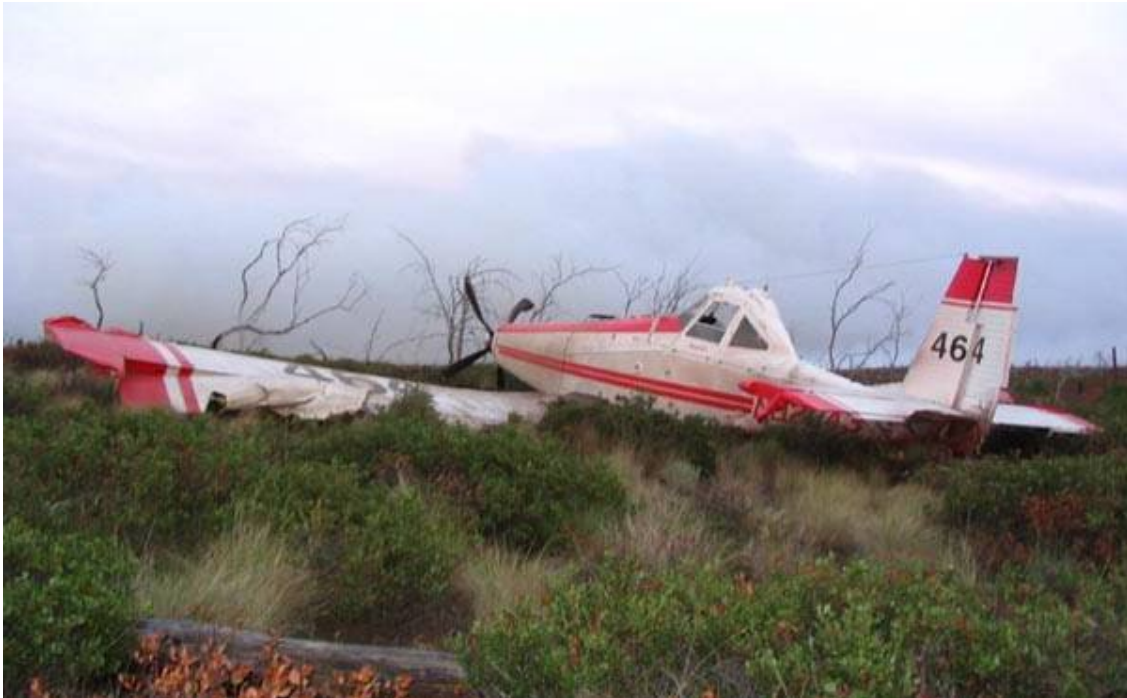
NTSB Identification: **LAX07TA208**
R-6, Malheur NF
Aircraft: WSK PZL Mielec M-18A, registration: N92043
Injuries: 1 Minor.

On July 7, 2007, about 1916 Pacific daylight time, a Msk Pzl Mielec, M 18A (a.k.a. "Dromader"), N92043, experienced a total loss of engine power while maneuvering about 20 miles northwest of Burns, Oregon. The airplane was substantially damaged during the pilot's forced landing in a rough, vegetation-covered, open field. During the accident flight, the single engine air tanker (SEAT) was under the operational control of the U.S. Department of the Interior (DOI). Visual meteorological conditions prevailed at the time of the public-use fire suppression flight, and a company flight plan had been filed. The airline transport pilot sustained minor injuries. The DOI operated the airplane under a "call-when-needed" contract with New Frontier Aviation, Fort Benton, Montana. The purpose of the flight was for the pilot to disperse 500 gallons of fire retardant chemical on the Egley Complex Fire in the Malheur National Forest, near Burns. The airplane was operated with a restricted category Federal Aviation Administration (FAA) airworthiness certificate under the provisions of 14 CFR Part 91. The flight originated from Burns about 1903.

According to the pilot, the engine stopped operating while he was overflying the intended retardant drop zone at 1,500 feet above ground level. The pilot attempted to restart the engine, but he was not successful. Thereafter, he dumped the retardant load, made a distress radio call, and forced landed. The airplane came to rest in an upright attitude.

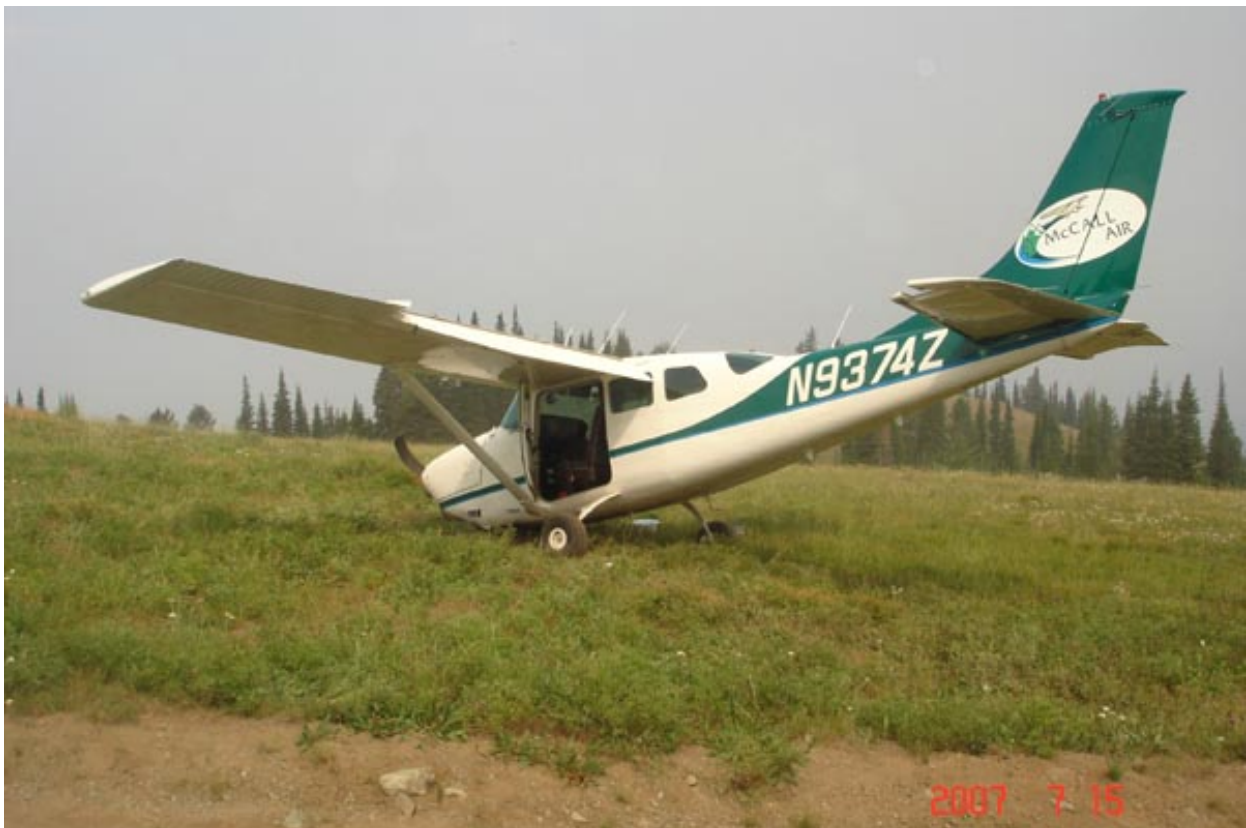
NTSB Identification: **SEA07TA203**
R-4, Payette NF
Aircraft: Cessna TU206G, registration: N9374Z
Injuries: 2 Uninjured.

On July 14, 2007, at approximately 0915 mountain daylight time, a Cessna TU206G, N9374Z, was substantially damaged during a forced landing attempt on Horse Mountain, near New Meadows, Idaho. The commercial pilot and his passenger were not injured. The airplane was being operated under contract to the United States Department of Agriculture, Forest Service (USFS) by Wilderness Aircraft II LLC of McCall, Idaho, as a public use flight. The purpose of the flight was to conduct airborne fire reconnaissance. Visual meteorological conditions prevailed. A company flight plan had been filed; the flight had originated from McCall, Idaho, at 0813.

The National Transportation Safety Board determines the probable cause(s) of this accident as follows: The loss of engine power due to the loss of engine oil pressure following the oil pump's drive shaft failure for an undetermined reason. Contributing factors were the lack of suitable terrain for a forced landing and the rough/uneven terrain.

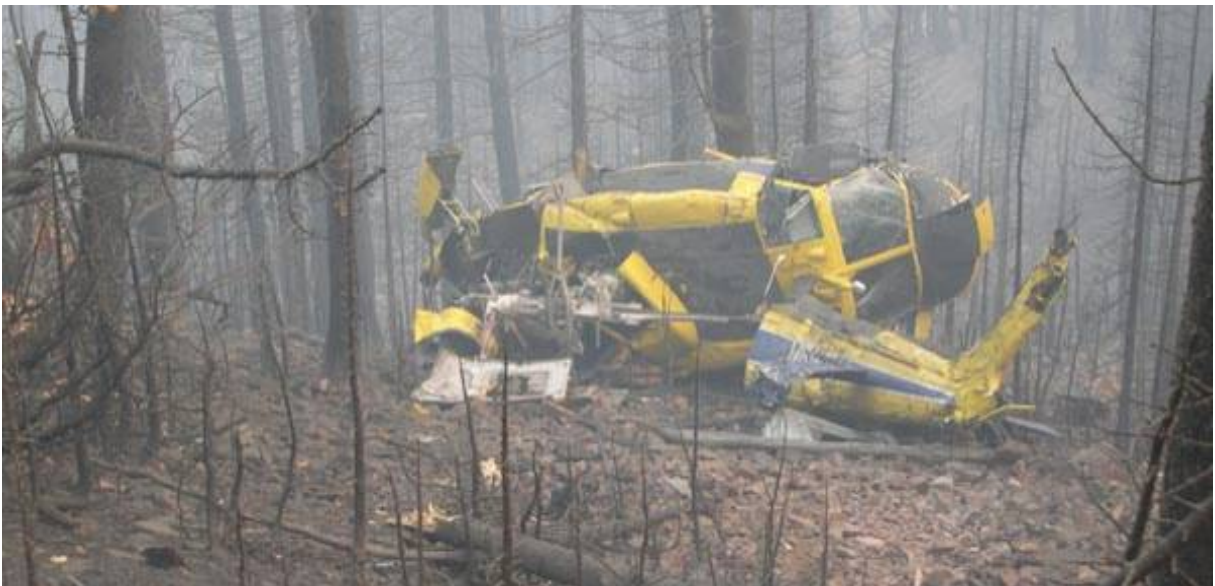
NTSB Identification: **SEA07TA202**
R-1, Lewis & Clark NF
Aircraft: Bell UH-1H, registration: N667HP
Injuries: 1 Minor.

On July 16, 2007, at 0910 mountain daylight time, a Bell UH-1H helicopter, N667HP, sustained substantial damage when it impacted terrain following a loss of control while departing a remote landing zone near Benchmark, Montana. The commercial pilot, the sole occupant, sustained minor injuries. The helicopter was registered to Leading Edge Aviation LLC of Clarkston, Washington, and under the operational control of the United States Forest Service (USFS). Visual meteorological conditions prevailed and a company flight plan was filed for the local public use flight. The purpose of the flight was to carry an external load in support of fighting the Ahorn fire on the Bob Marshal Wilderness Area within the Lewis and Clark National Forest.

According to information provided by USFS personnel, the pilot flew the helicopter from the Benchmark Helibase departing with a visibility of 5 miles under moderate smoky conditions. While en route to the landing zone, the visibility deteriorated and the pilot reported difficulty seeing the landing zone. The pilot successfully landed at the landing zone without incident and set down a load of supplies. The ground crew then attached a load of firefighting equipment that was to be returned to the Helibase. As the pilot transitioned to forward flight to depart from the landing zone, the visibility dropped, and he reportedly lost all visual reference. The helicopter settled into trees and impacted the ground, coming to rest on its right side. In the area of the landing zone at the time of the accident, the visibility was reported to be fluctuating between 1/4 to 1 mile due to smoke.

The National Transportation Safety Board determines the probable cause(s) of this accident as follows: Dense smoke/haze which restricted the pilot's visibility and the pilot's failure to maintain aircraft control during the emergency descent resulting in impact with terrain.

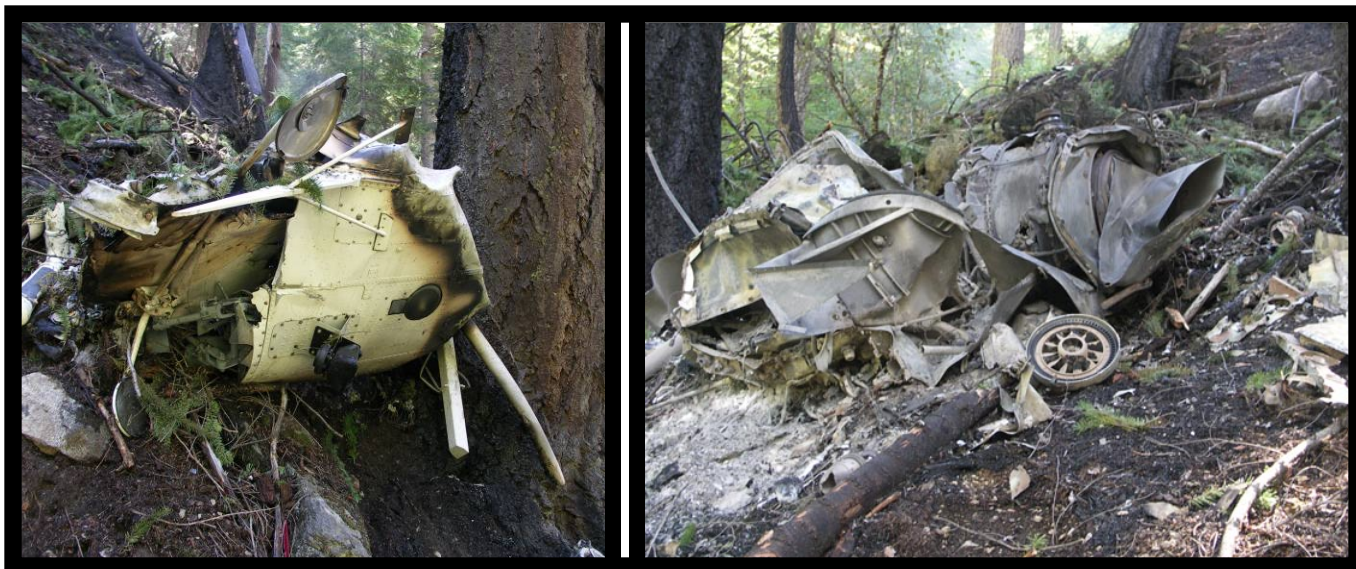
NTSB Identification: **LAX07TA227**
R-5, Klamath NF
Aircraft: Bell 205 A1++, registration: N205BR
Injuries: 1 Fatal.

On July 23, 2007, about 1100 Pacific daylight time, a Bell 205 A1++, N205BR, impacted trees during a long line mission in support of the Norcross Incident about 1/4 mile southeast of the Happy Camp Airport (36S), Happy Camp, California. The United States Forest Service (USFS) operated the helicopter under the provisions of 14 CFR Part 133 as a long line operation to drop off water blivets for ground crews in the area. The helicopter was destroyed after impacting the heavily forested area, and a post-impact fire consumed the cabin area. The certificated airline transport (ATP) helicopter pilot, the sole occupant, was fatally injured. Visual meteorological conditions prevailed for the local public-use firefighting flight, and a USFS flight plan had been activated.

According to USFS investigators, the helicopter was outfitted with a 150-foot-long long line; the tree that the helicopter struck was about 165 feet tall. The main rotor struck the top 15 feet of the tree. There were no obvious mechanical malfunctions noted with the engine. The investigation is on going, with a planned reconstruction of the airframe and examination of the engine following recovery of the helicopter.

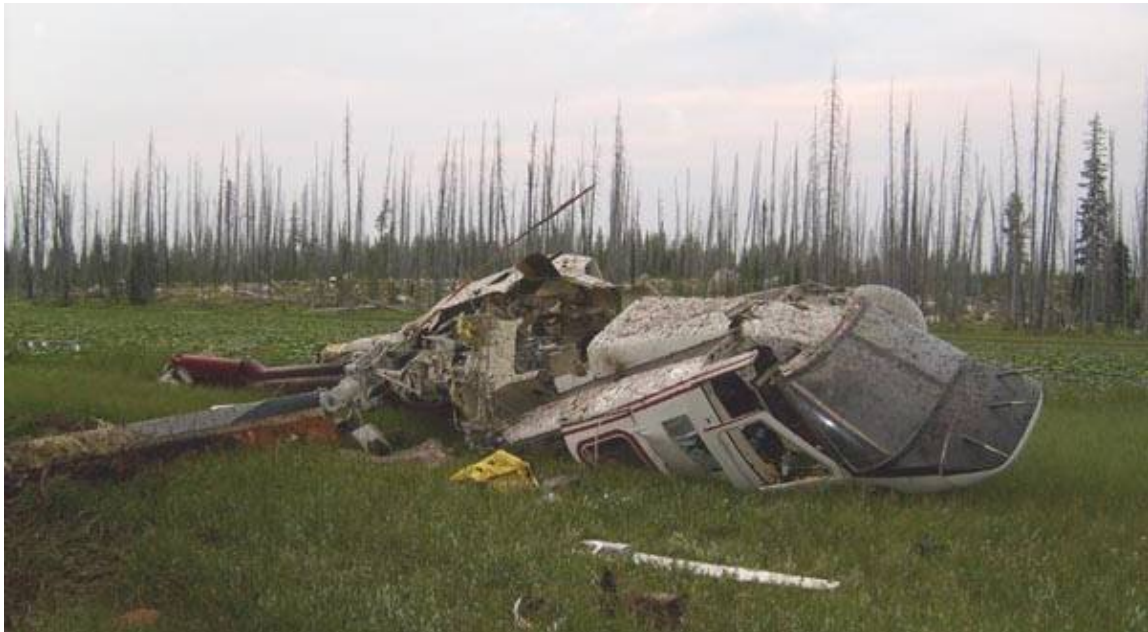
NTSB Identification: **SEA07TA214**
R-4, Payette NF
Aircraft: Bell 214ST, registration: N724HT
Injuries: 1 Serious, 1 Minor.

On July 25, 2007, at 1947 mountain daylight time, a Bell 214ST helicopter, N724HT, sustained substantial damage when it impacted terrain following a loss of control while conducting long-line operations in a remote area 22 miles northeast of McCall, Idaho. The airline transport pilot (ATP) sustained serious injuries and the passenger/crew chief, sustained minor injuries. The helicopter was registered to US Leaseco, Inc of Baltimore, Maryland, and under the operational control of the United States Forest Service (USFS). Visual meteorological conditions prevailed and a flight plan was filed for the local public use flight. The purpose of the flight was to conduct external load operations in support of the Loon fire.

Examination of the helicopter revealed no mechanical anomalies with the engine or airframe.

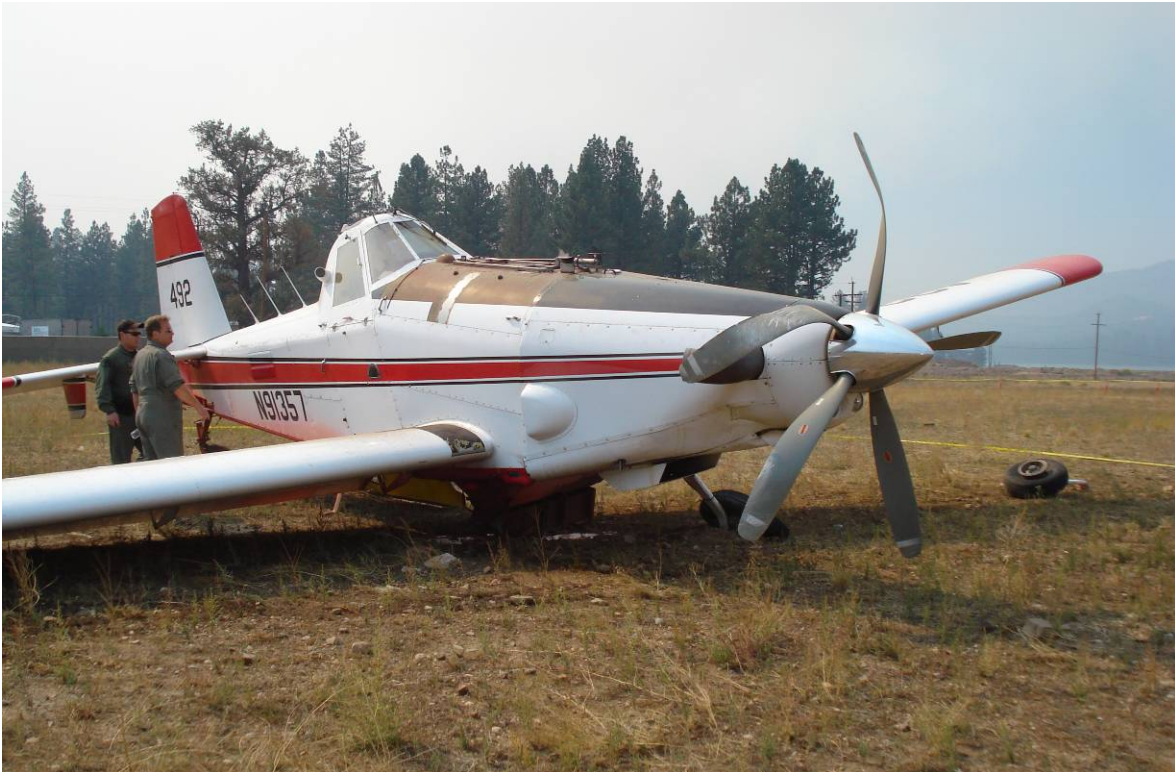
NTSB Identification: **LAX07TA277**
San Bernardino NF
Aircraft: Air Tractor AT-802A, registration: N91357
Injuries: 1 Uninjured.

On September 17, 2007, about 1310 Pacific daylight time, an Air Tractor AT-802A, N91357, collided with terrain during a forced landing following a loss of engine power near Big Bear City, California. The USDA Forest Service operated the airplane under the provisions of 14 CFR Part 91 as a public-use aerial application flight. The airplane sustained substantial damage. The commercial pilot, the sole occupant, was not injured. Visual meteorological conditions prevailed for the firefighting mission, and a company VFR flight plan had been filed.

According to the pilot, he had just reloaded the airplane with fire retardant, taken off, and was on his way to the drop zone when he observed the engine chip indicator light had illuminated. He released the load, and made a forced landing in an open field. During the landing rollout, the airplane impacted a berm. When it came down again, it slid sideways, and the landing gear separated.

Recovery personnel reported metal debris in the exhaust stack.

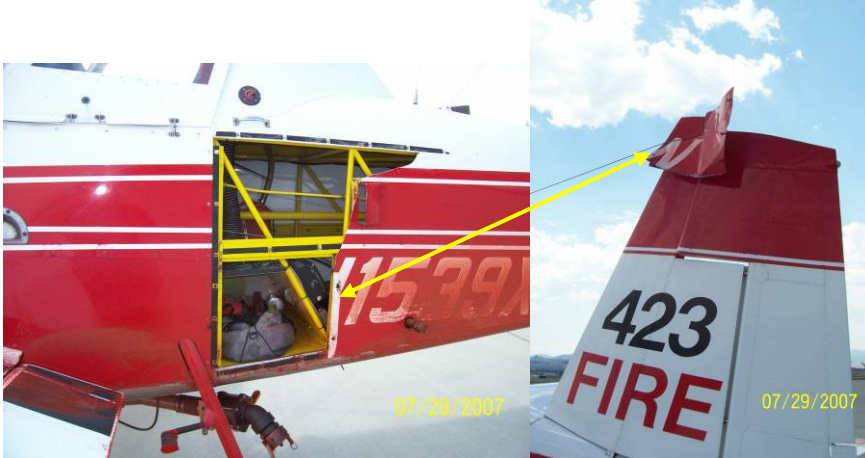
- ❖ 7/29/2007 Air Tractor 502A, Helena NF
 - Cargo door came off in flight and stuck between the rudder and cable.
