**REPORT ON ALTERNATIVE MEASURES TO ADDRESS CRACKS  
IN THE MONUMENT AT THE TOMB OF THE UNKNOWNNS AT  
ARLINGTON NATIONAL CEMETERY, VIRGINIA**

Appendix A  
1990 Drawings of the Tomb Monument

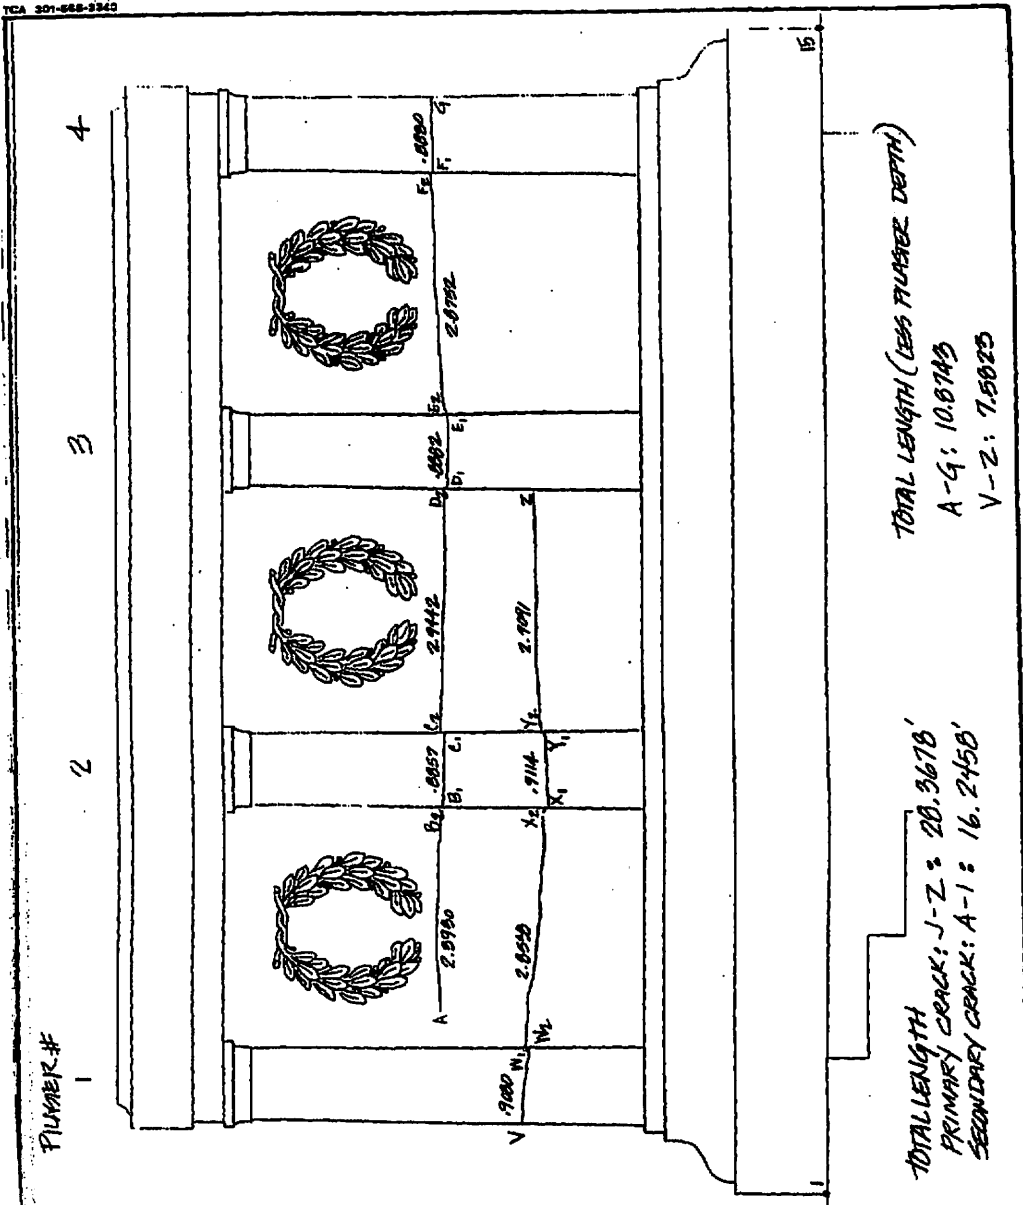
V-1  
 SHEET NO.

TOTAL LENGTH  
 PRIMARY CRACK: J-Z = 20.3678'  
 SECONDARY CRACK: A-I = 16.2458'

**TOMB OF THE UNKNOWN SOLDIER  
 SOUTH ELEVATION  
 Crack Length Measurements**

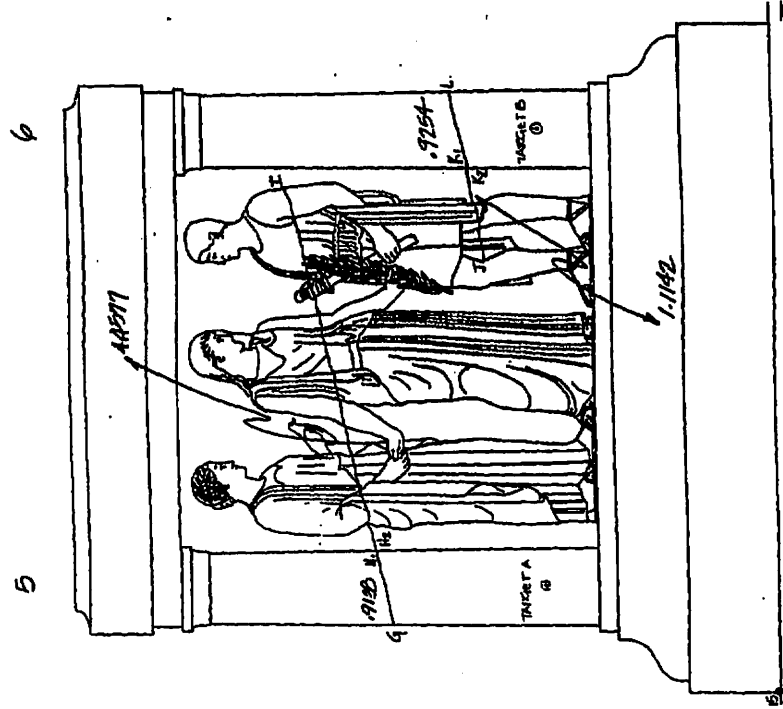
V-2  
 SHEET NO.

**TOMB OF THE UNKNOWN SOLDIER  
 EAST ELEVATION  
 Crack Length Measurements**

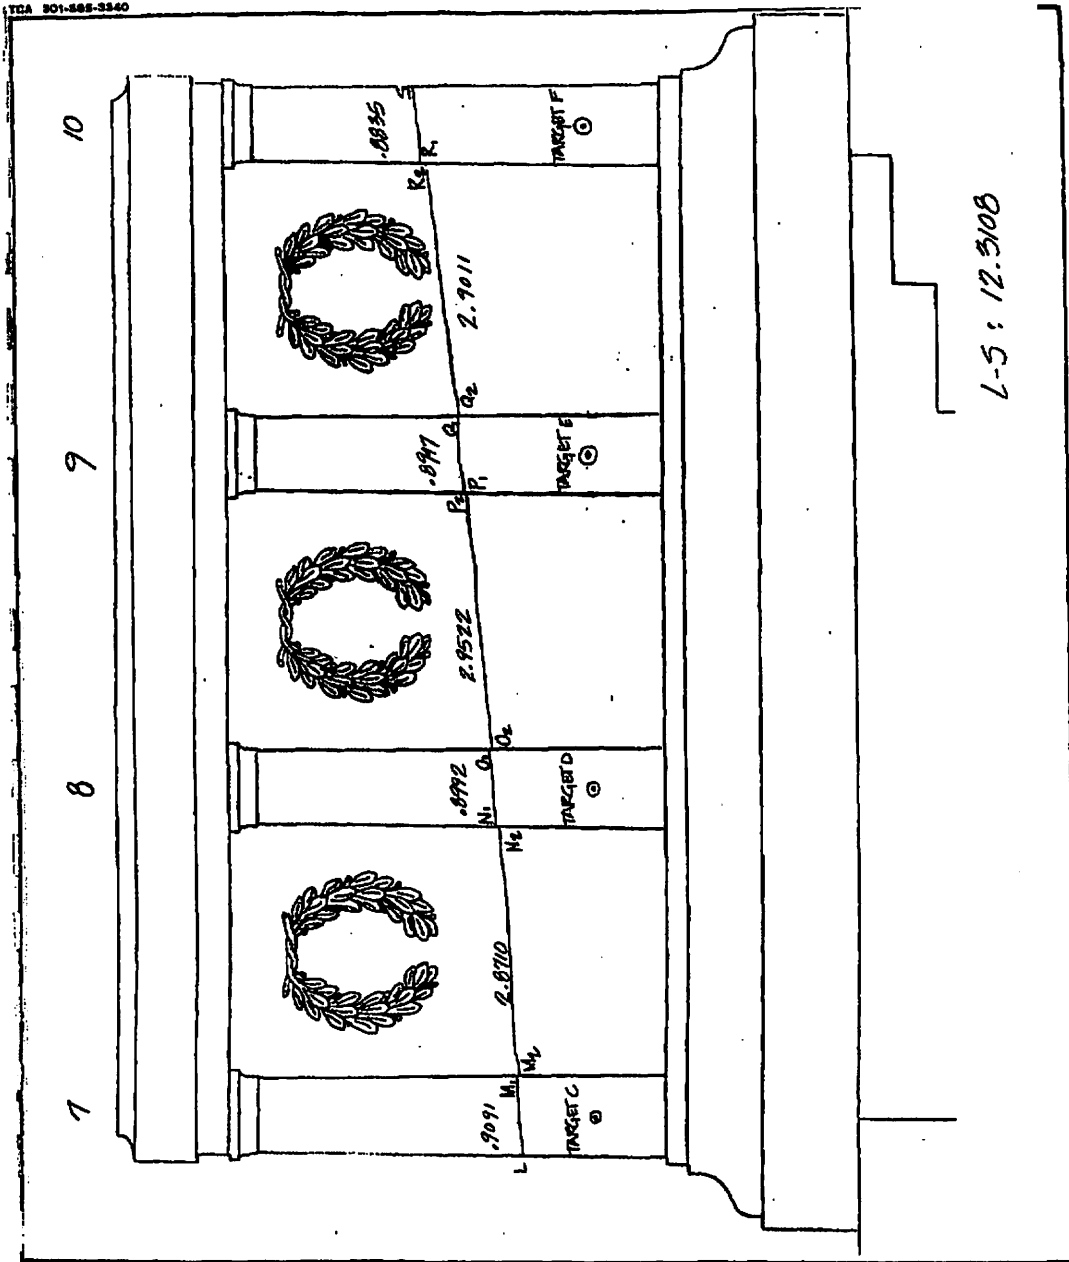
V-3  
SHEET NO.

**TOMB OF THE UNKNOWN SOLDIER  
NORTH ELEVATION  
Crack Length Measurements**

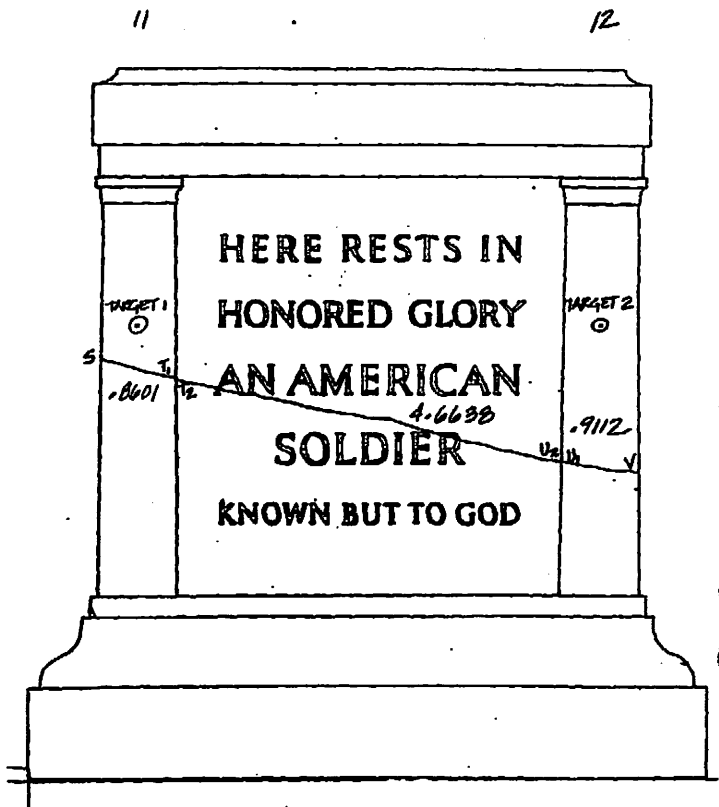
TOMB OF THE UNKNOWN SOLDIER  
WEST ELEVATION  
Crack Length Measurements
