**REHABILITATION OF DAMAGED FLOOD CONTROL WORKS
LEHIGH RIVER WEISSPORT FLOOD PROTECTION PROJECT
CARBON COUNTY, PENNSYLVANIA**

DRAFT ENVIRONMENTAL ASSESSMENT

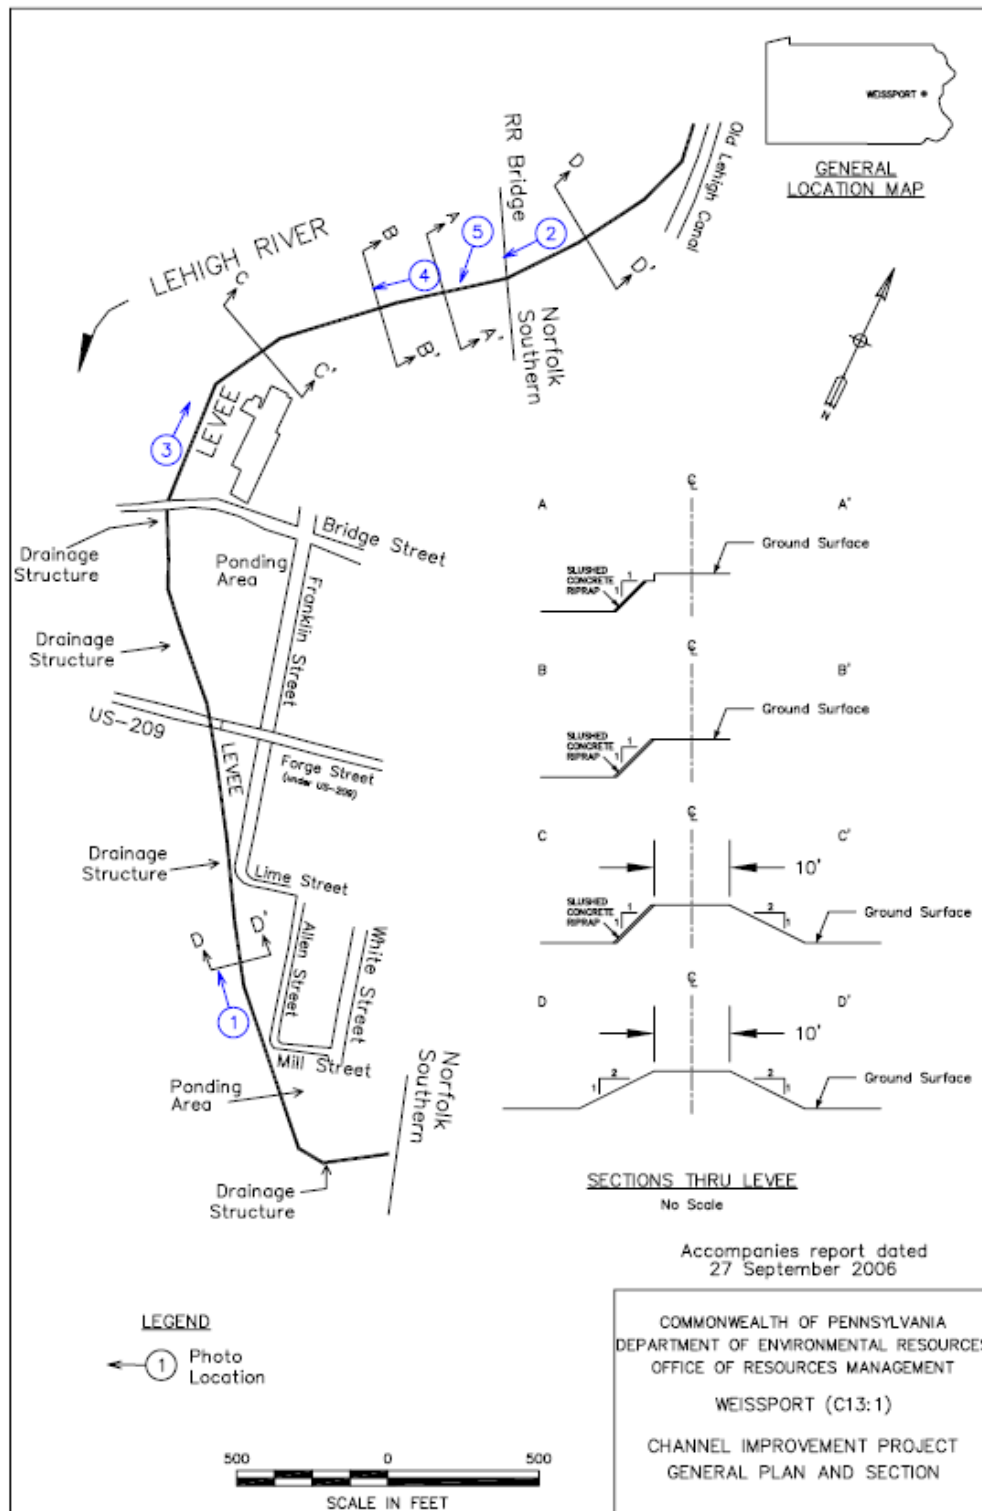
Figure 3-1: Weissport Repair along the Lehigh River: numbers refer to photographs in the Appendix.

Repairs to the damaged portions of the river bank riprap and concrete facing in damaged areas were discussed in Section 2.4. Figure 3-1 depicts the repair locations proposed along the banks of the Lehigh River. An aerial photograph of the proposed sections of the flood control structure is provided in the Appendix.

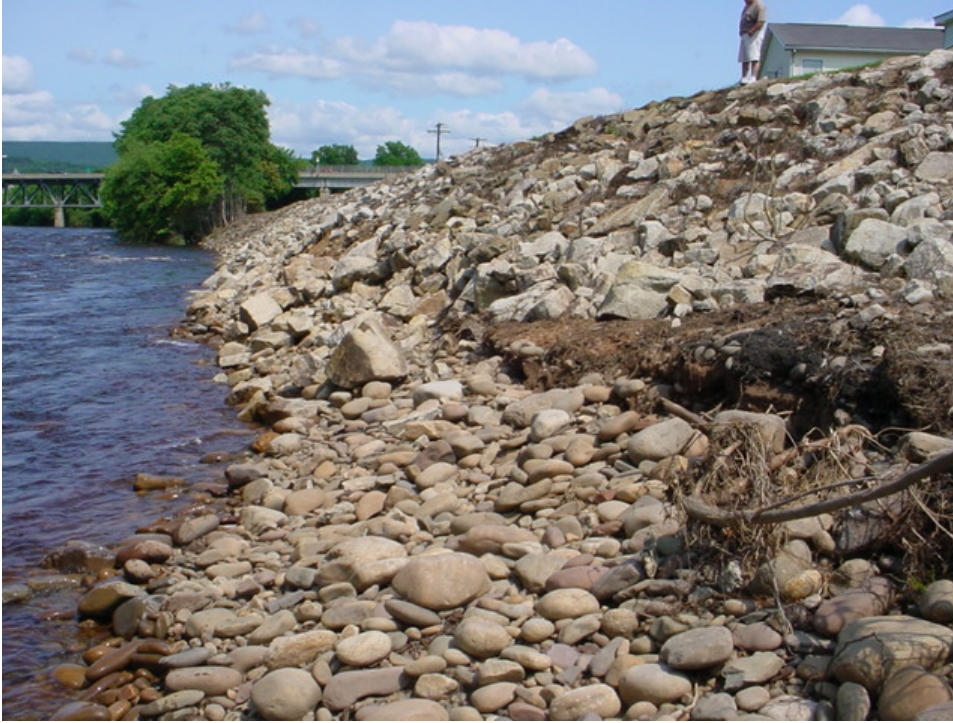
Photo 1. [7 July 2006] Area of loss or sloughing of riprap adjacent to the Borough Hall.

The first area is located in the vicinity of Borough Hall along Allen Street and is approximately 180 feet long by 10 feet wide by 10 feet in height (Photo 1 in the Appendix). It is recommended that two 10-foot transition zones be included (at each end). Similar to the original design, 12-inch riprap will be used with 6-inch blanket layers. A “V” shaped toe 5 feet wide and 3 feet deep will be repaired for the entire length. The existing riprap will be temporarily removed while the damaged area is excavated and graded for the placement of geotextile and riprap. Dewatering of the area will be required during construction.

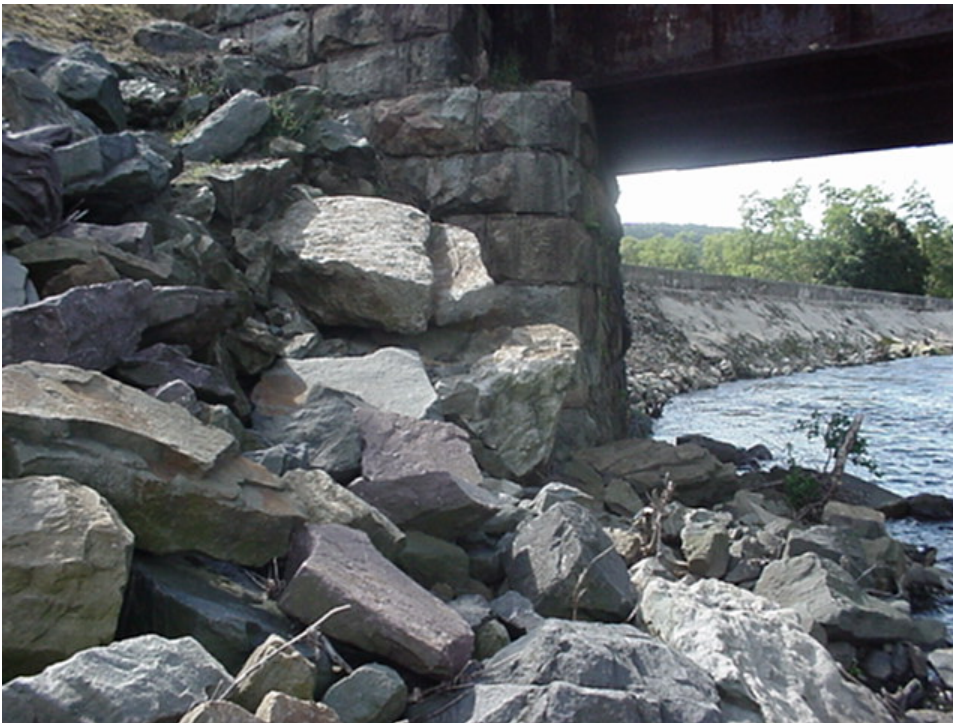
Photo 2. [21 September 2006] Area of loss of riprap immediately upstream of the Railroad Bridge.

The second area is located upstream of the railroad bridge and is approximately 15 feet long by 15 feet wide by 10 feet in height (Photo 2 in the Appendix). Two 10-foot transitional zones will be constructed on each end of the damaged area. It is recommended that the existing dislodged riprap be removed to excavate prior to placing a new layer of 35-inch riprap with geotextile layer underneath. Existing riprap may be reused, where appropriate. The repair work will require dewatering. Upstream (150 to 285 feet) of the bridge (Photo 3 in the Appendix), material that had existed prior to the storm along the exterior toe of the levee had eroded. The toe of the concrete facing, however, was not exposed along this reach.

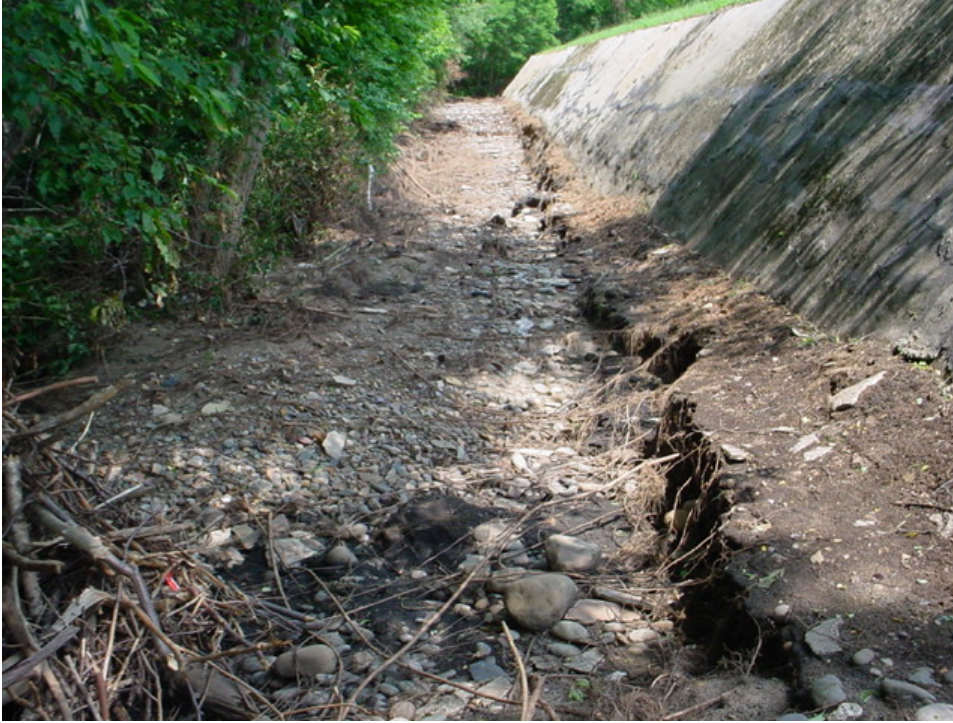
Photo 3. [7 July 2006] Area of erosion of material at the exterior toe of the concrete-faced portion of the levee.

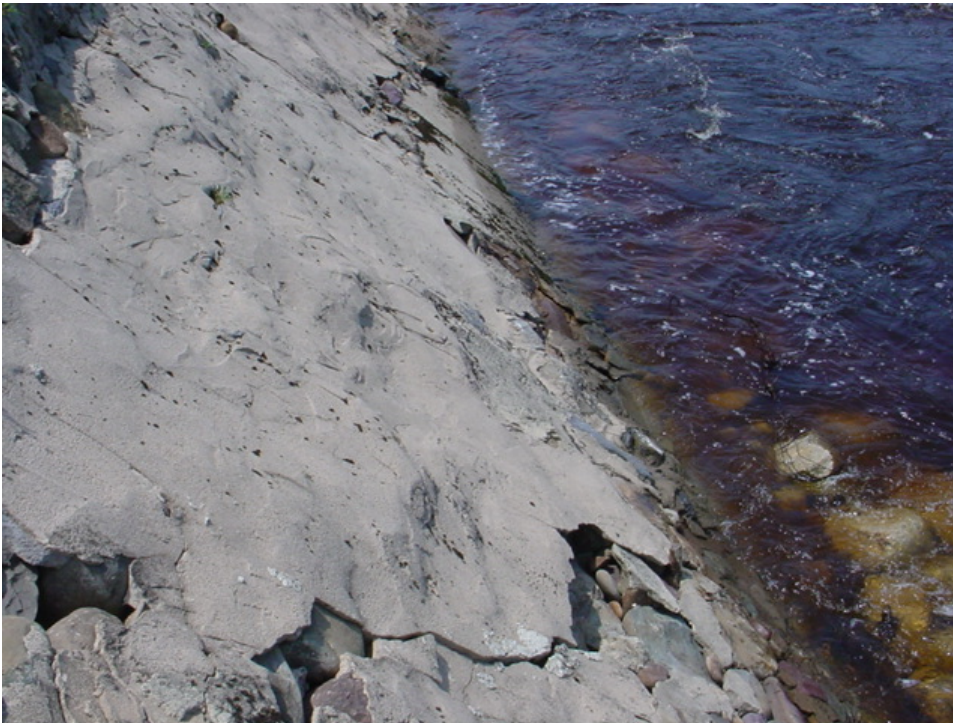
Photo 4. [7 July 2006] Area of deterioration of the concrete facing.

The third area is located south of the railroad bridge and is approximately 200 feet long by 15 feet wide (Photos 4 and 5 in the Appendix). The damaged area exhibits cracking and spalling in grouted riprap. The recommended repair will require the removal of old concrete and 12-inch riprap placed and grouted. Approximately 50 feet of the existing toe at various locations will require riprap replacement. The design toe is “V” shaped 12 feet wide by 3 feet deep. Work on the toe will require dewatering.

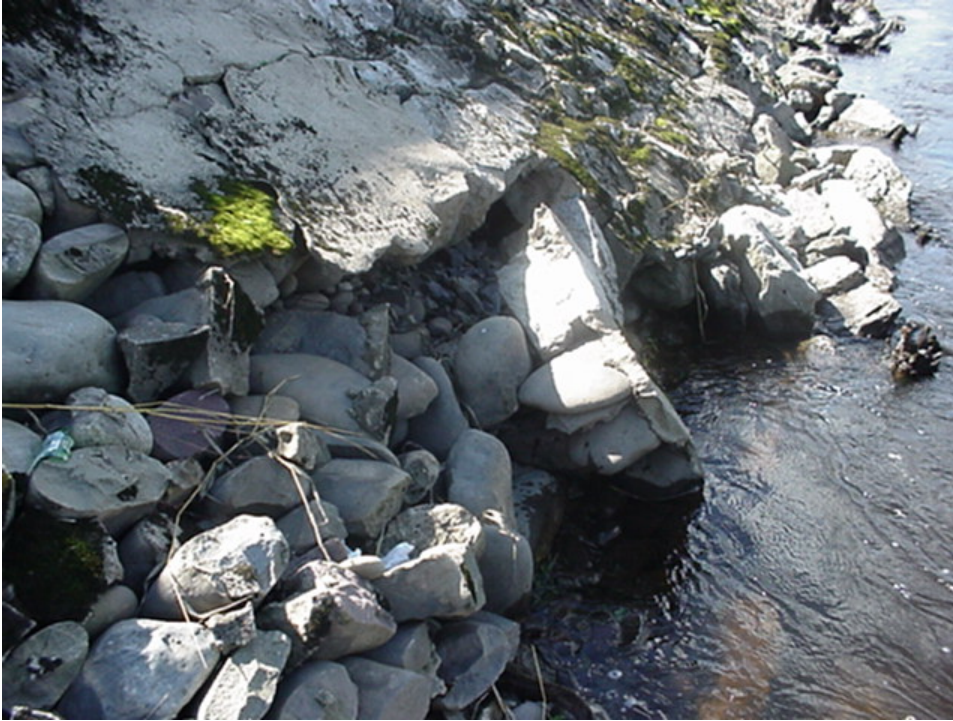
c. The concrete facing appeared to have been damaged in the reach from the railroad bridge downstream to the first change in levee alignment. (This coincides with the end of the levee section that has a parapet wall.) The damage consisted of cracking and spalling in several locations (see Photo 4), and loss of riprap near the toe of the levee in a few locations (see Photo 5).

Photo 5. [21 September 2006] Loss of riprap at the toe of the levee below the concrete facing.
