1992 Reservoir Drawdown Test

Lower Granite and Little Goose Dams

Appendix T

Evaluation of 100 Percent Spill on
Fish Passage Conditions at Lower Granite Dam

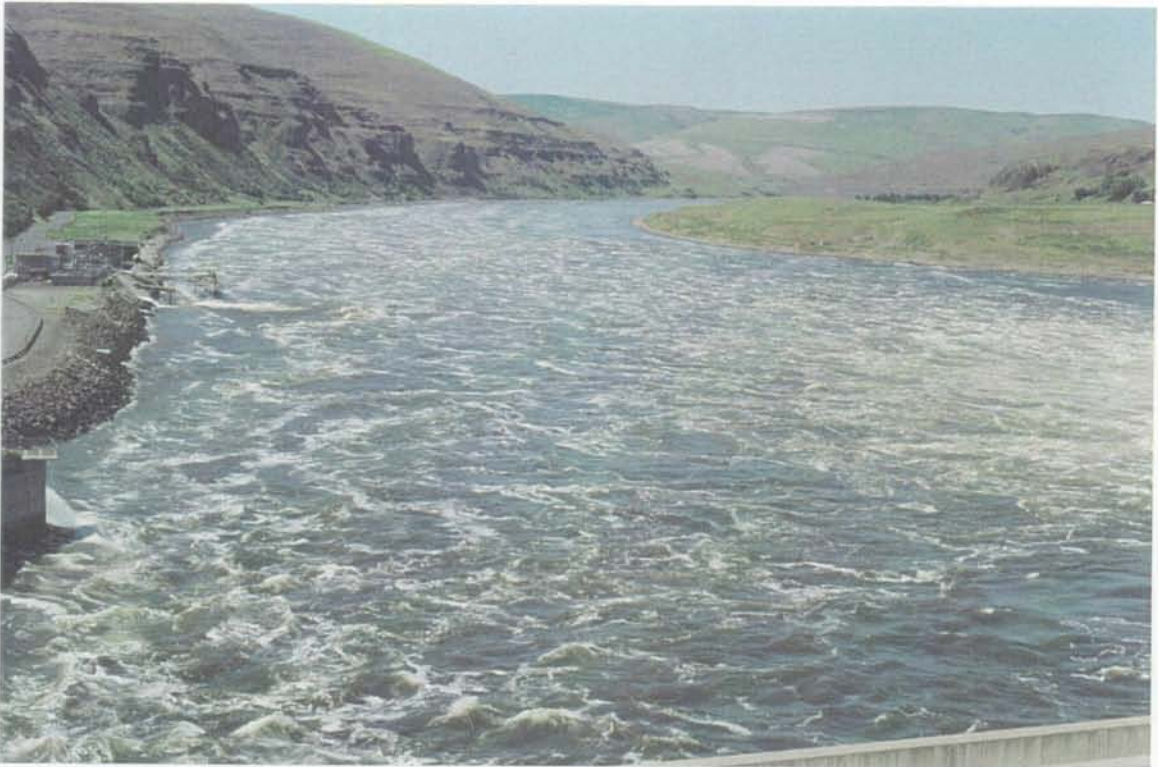
Figure 4a. Tailrace of Lower Granite, south-angled spill pattern; 100,000 cfs over spillway and no-powerhouse discharge. Turbulence in front of the powerhouse.

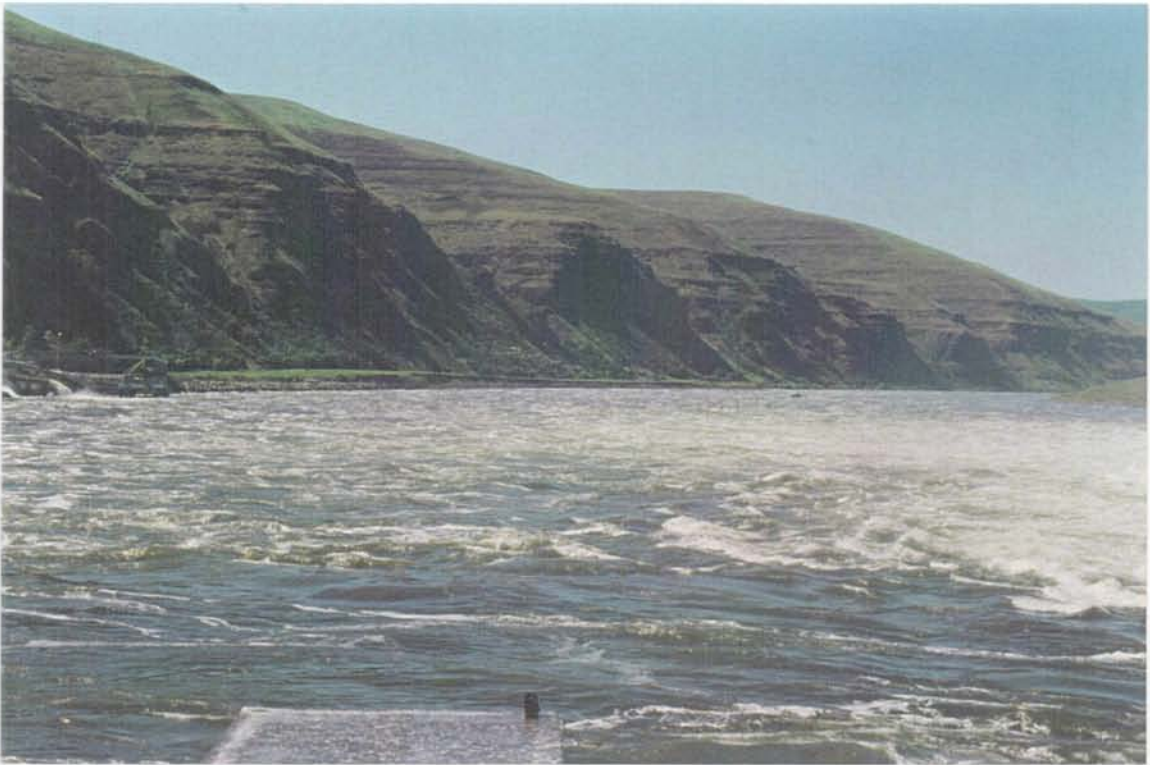
Figure 4b. Looking downstream from Lower Granite Dam powerhouse tailrace deck. Crowned spill pattern. Flows formed eddy in front of the powerhouse

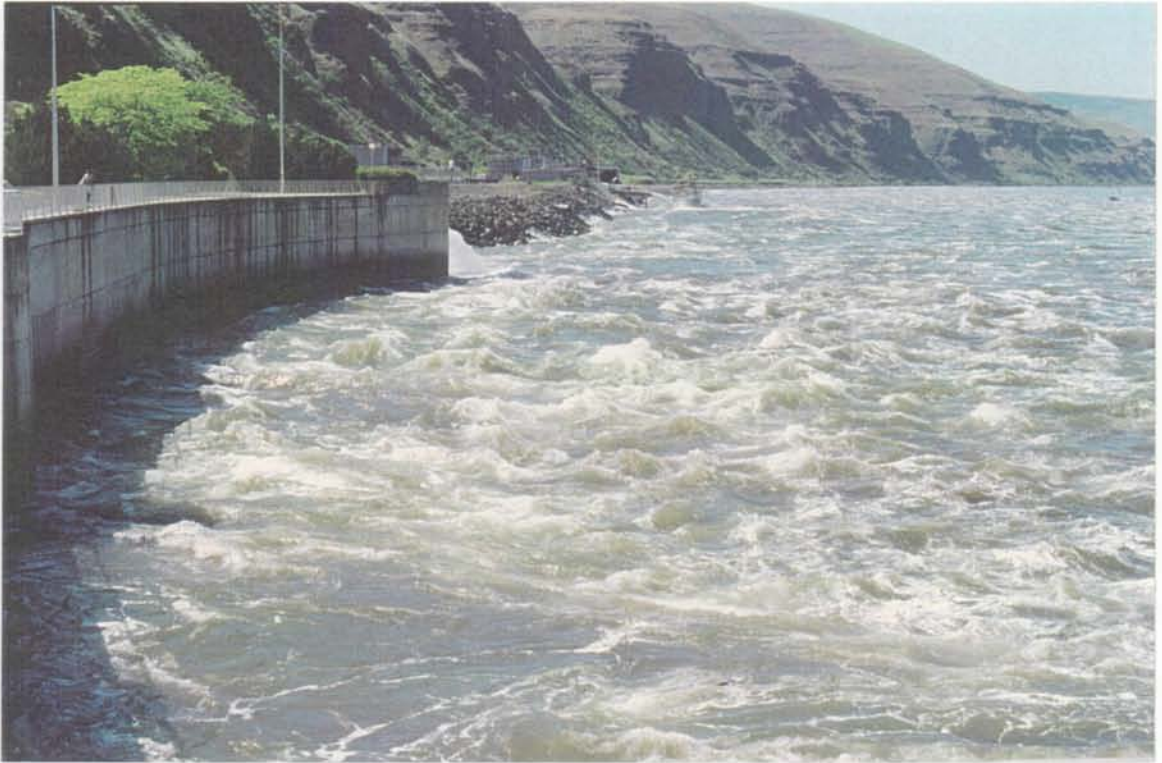
Figure 4c. Lower Granite tailrace, taken from tailrace deck, north-angled spill pattern. Turbulence in the area of the south shore fish collection channel entrances.

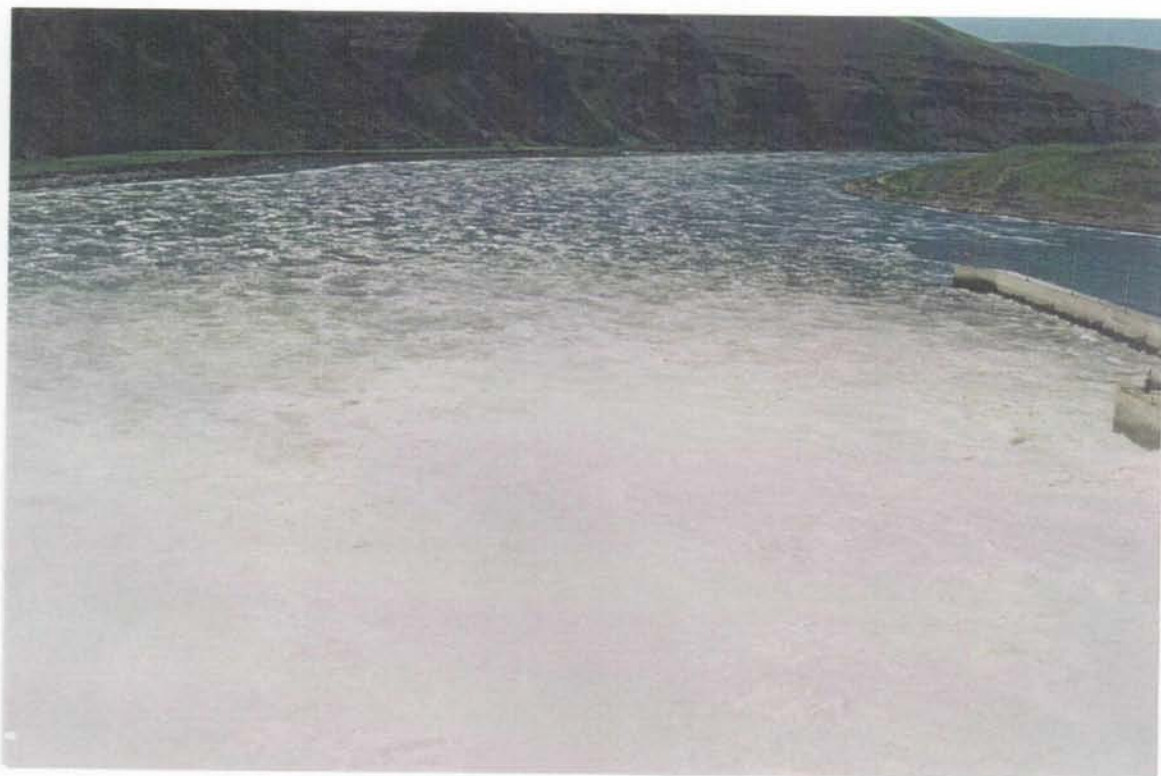
Figure 4d. Lower Granite tailrace, taken from the top of the dam. North-angled spill pattern.

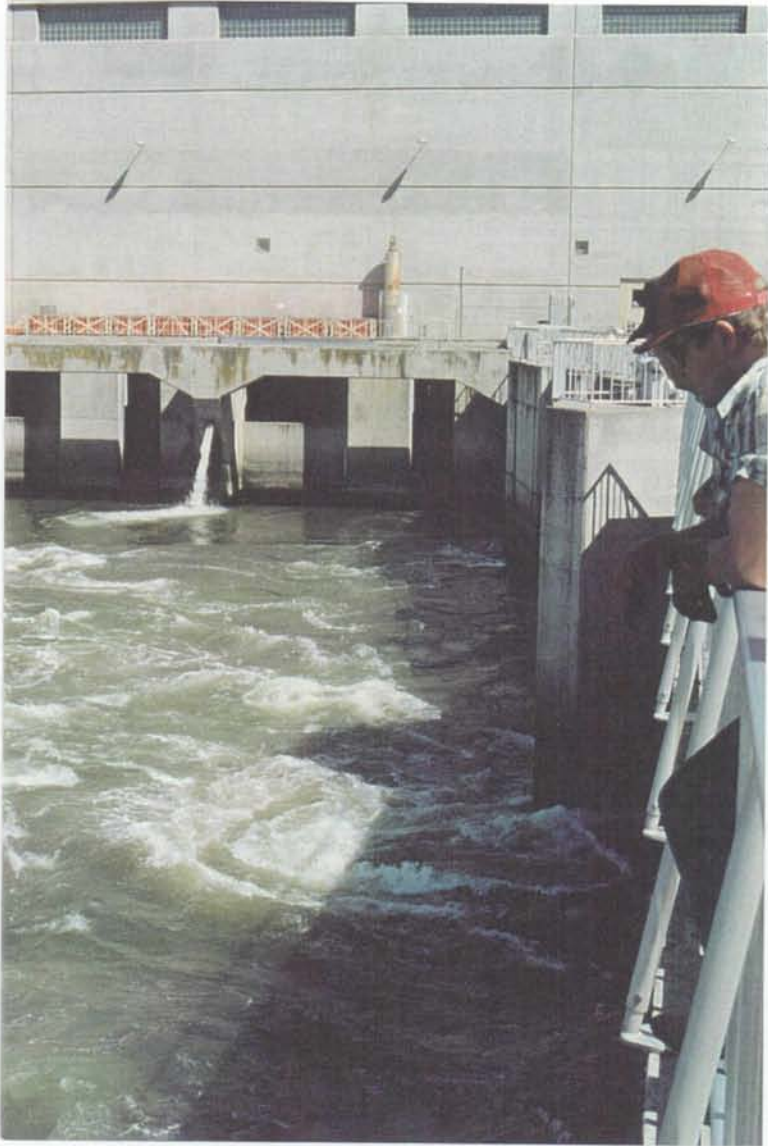
Figure 4e. South shore and floating orifice gate No. 1 entrance conditions. Flow pattern has reversed from upstream to downstream.

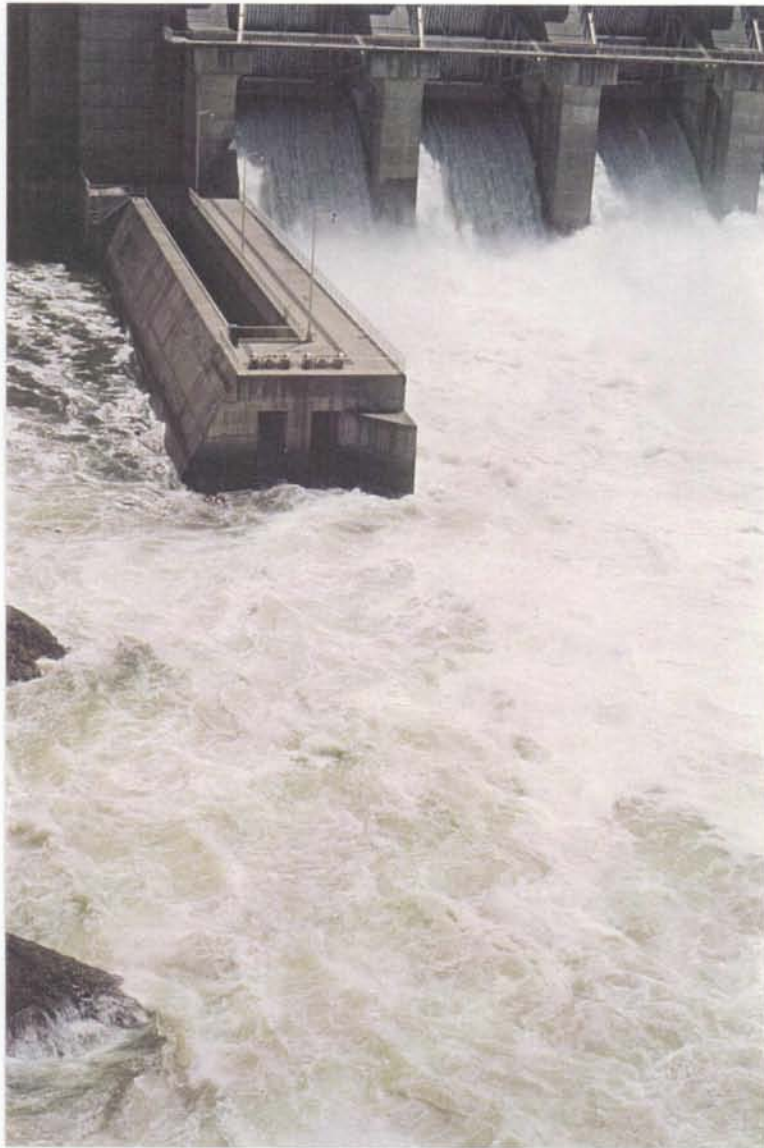
Figure 4f. North shore entrance conditions.
Highly turbulent, masking flow from entrances.

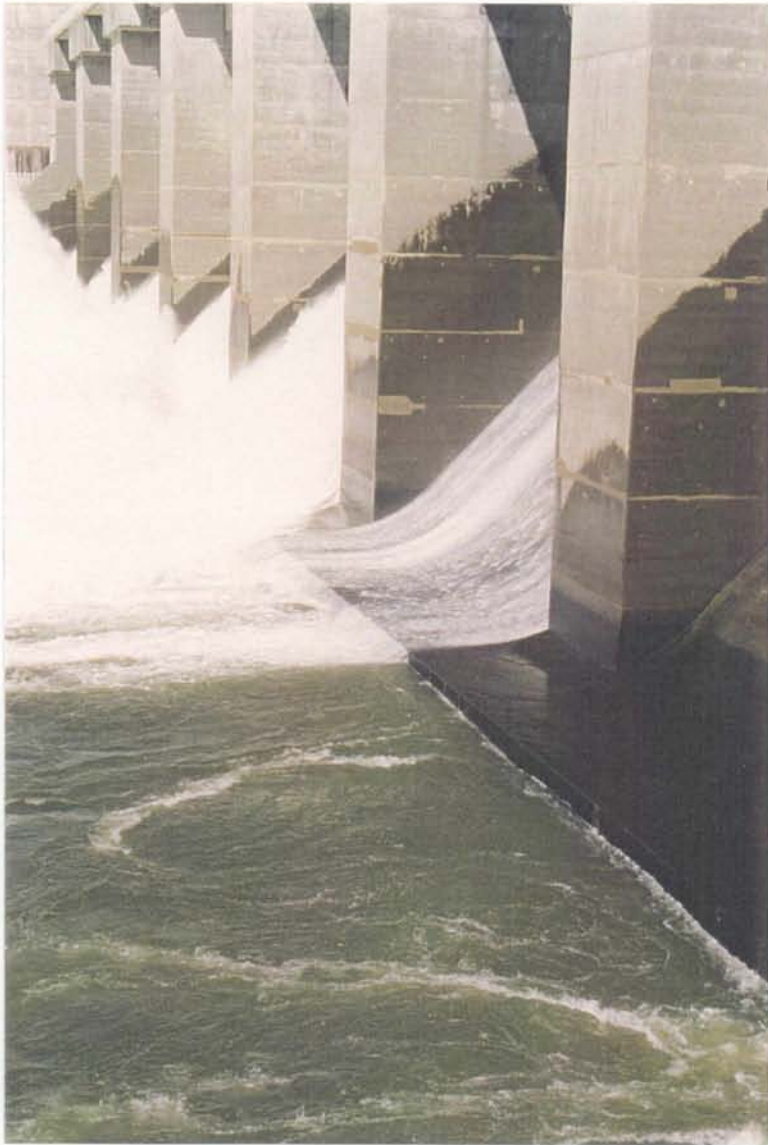
A reduction in depth of the stilling basin is expected to reduce dissolved gas levels, but this may be counteracted by a loss of spillway deflector (flip-lip) effectiveness. It appeared that under reduced tailrace conditions caused by no powerhouse discharge, the flip-lips were ineffective, resulting in an increase in dissolved gas levels over what would be expected if the flip-lips were effective. The flip-lips were designed to operate at tailwater elevations existing under high flow conditions, which are not present when the entire river discharge is passing over the spillway. (It is important to note that estimates of juvenile fish spillway mortality were obtained with functioning spillway deflectors. Mortality under changed conditions may be significantly higher. Long, et al., indicated 27.5 percent mortality in bays without flip-lips, which may be more representative of conditions that will exist under reduced tailwater levels.) The lack of less-saturated powerhouse flows for mixing with spillway flows will also result in slower dissipation of high dissolved gas levels.

Figure 4g. Spillway deflector as spill was shut off.

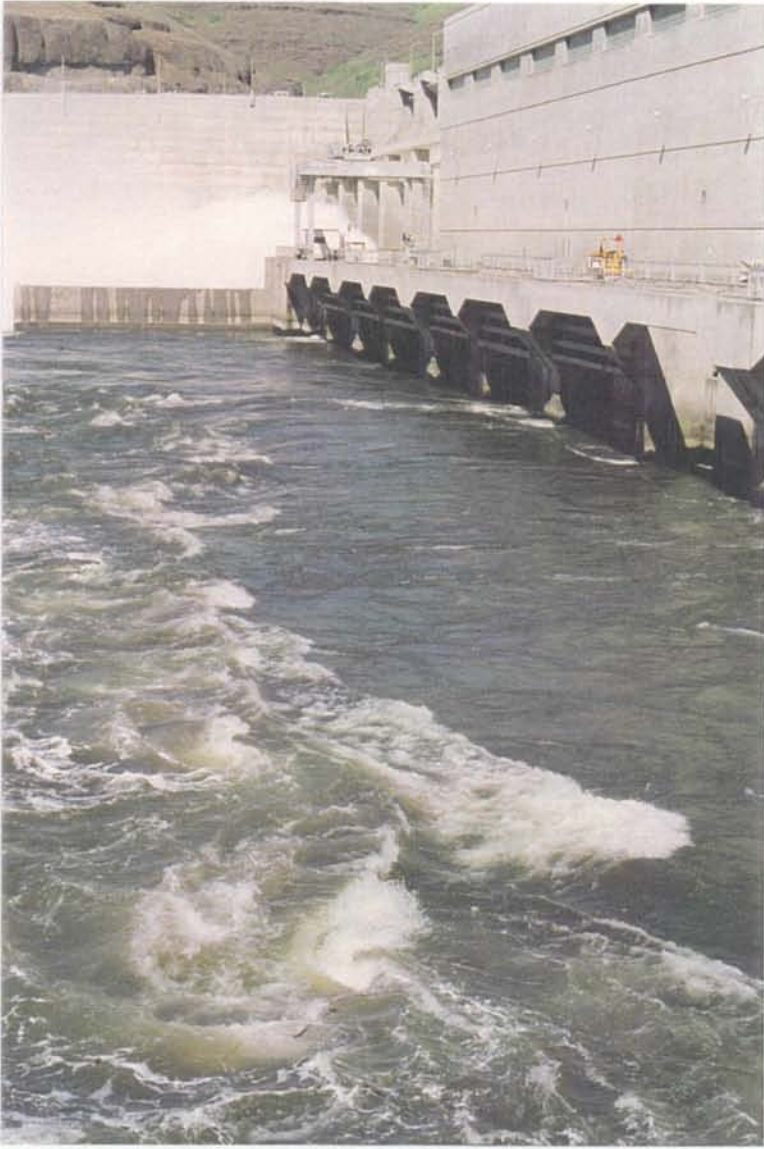
eddy flow formed a series of standing waves in front of the first five powerhouse units, and continued north to the southern edge of the spill. Considerable turbulence was observed in front of the north shore entrance, becoming worse as the spill pattern shifted from the south to the north-angled.

Figure 4h. Standing waves in front of powerhouse.

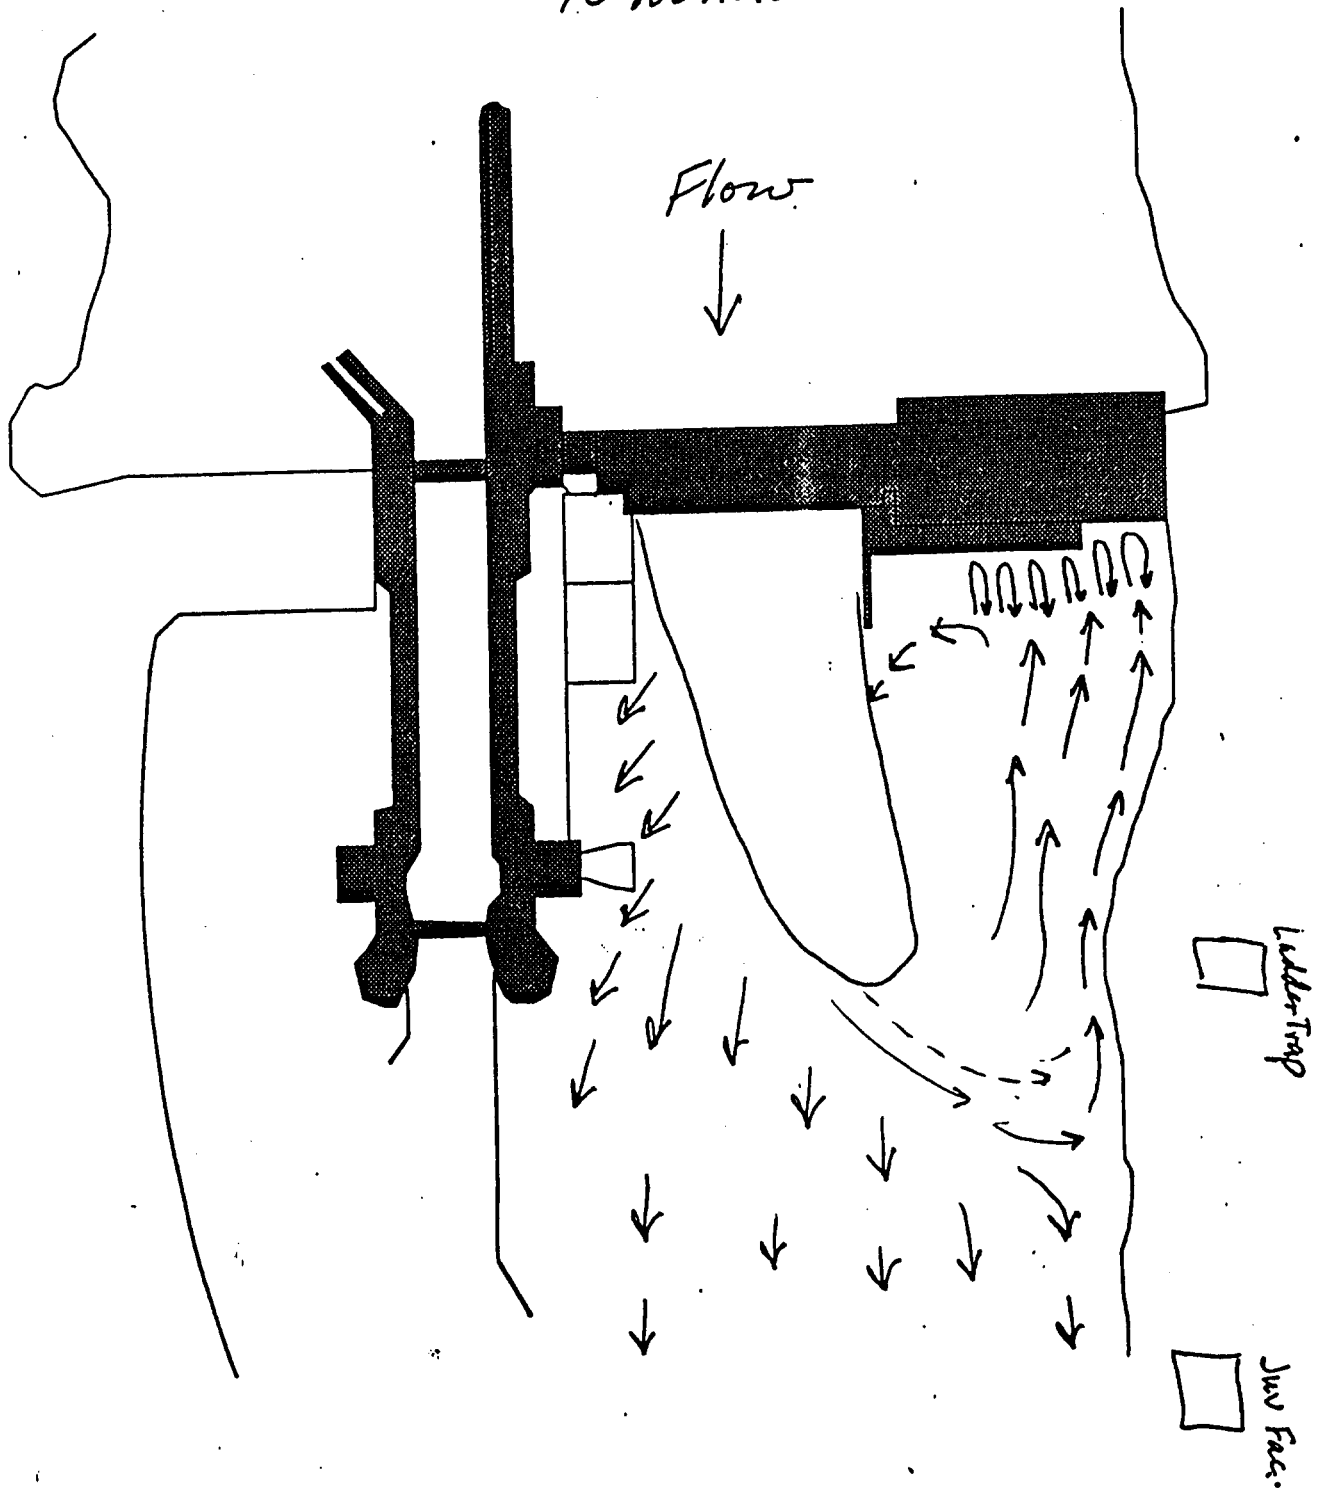
1 June 91 Pattern 1, Angled to powerhouse
~ 100KCF3

Pattern 1, was an angled pattern with the highest flow on the powerhouse side of the spillway. With this pattern, a large part of the flow moved toward the south shore and formed a backeddy midway between the ladder trap and the juvenile facility (see diagram). The backeddy ran along the south shore and then formed a large toproll when it reached the powerhouse. The backeddy flow then moved north along the powerhouse and joined the south edge of the spill. The south-shore entrances to the fishway would probably be ineffective because the backeddy would lead the fish away from the entrances rather than to them, as is normally the case when there is discharge from the powerhouse. The toproll extended along the powerhouse in front of most of the floating orifice openings and would make them less effective, in my judgement, than when there is discharge from all six turbines. The two north powerhouse entrances (NPE1 and NPE2) were the most usable, if the fish could get to the vicinity of the openings. To get to the north powerhouse entrances, the fish would have to move upstream along the south edge of the spill, but north of the backeddy. The fishway entrance north of the spillway would not be very effective because of turbulent waters along the side of the lock downstream from the fishway. I was hoping that the north entrance would still be usable with the spill angled away to the south, but such did not appear to be the case.

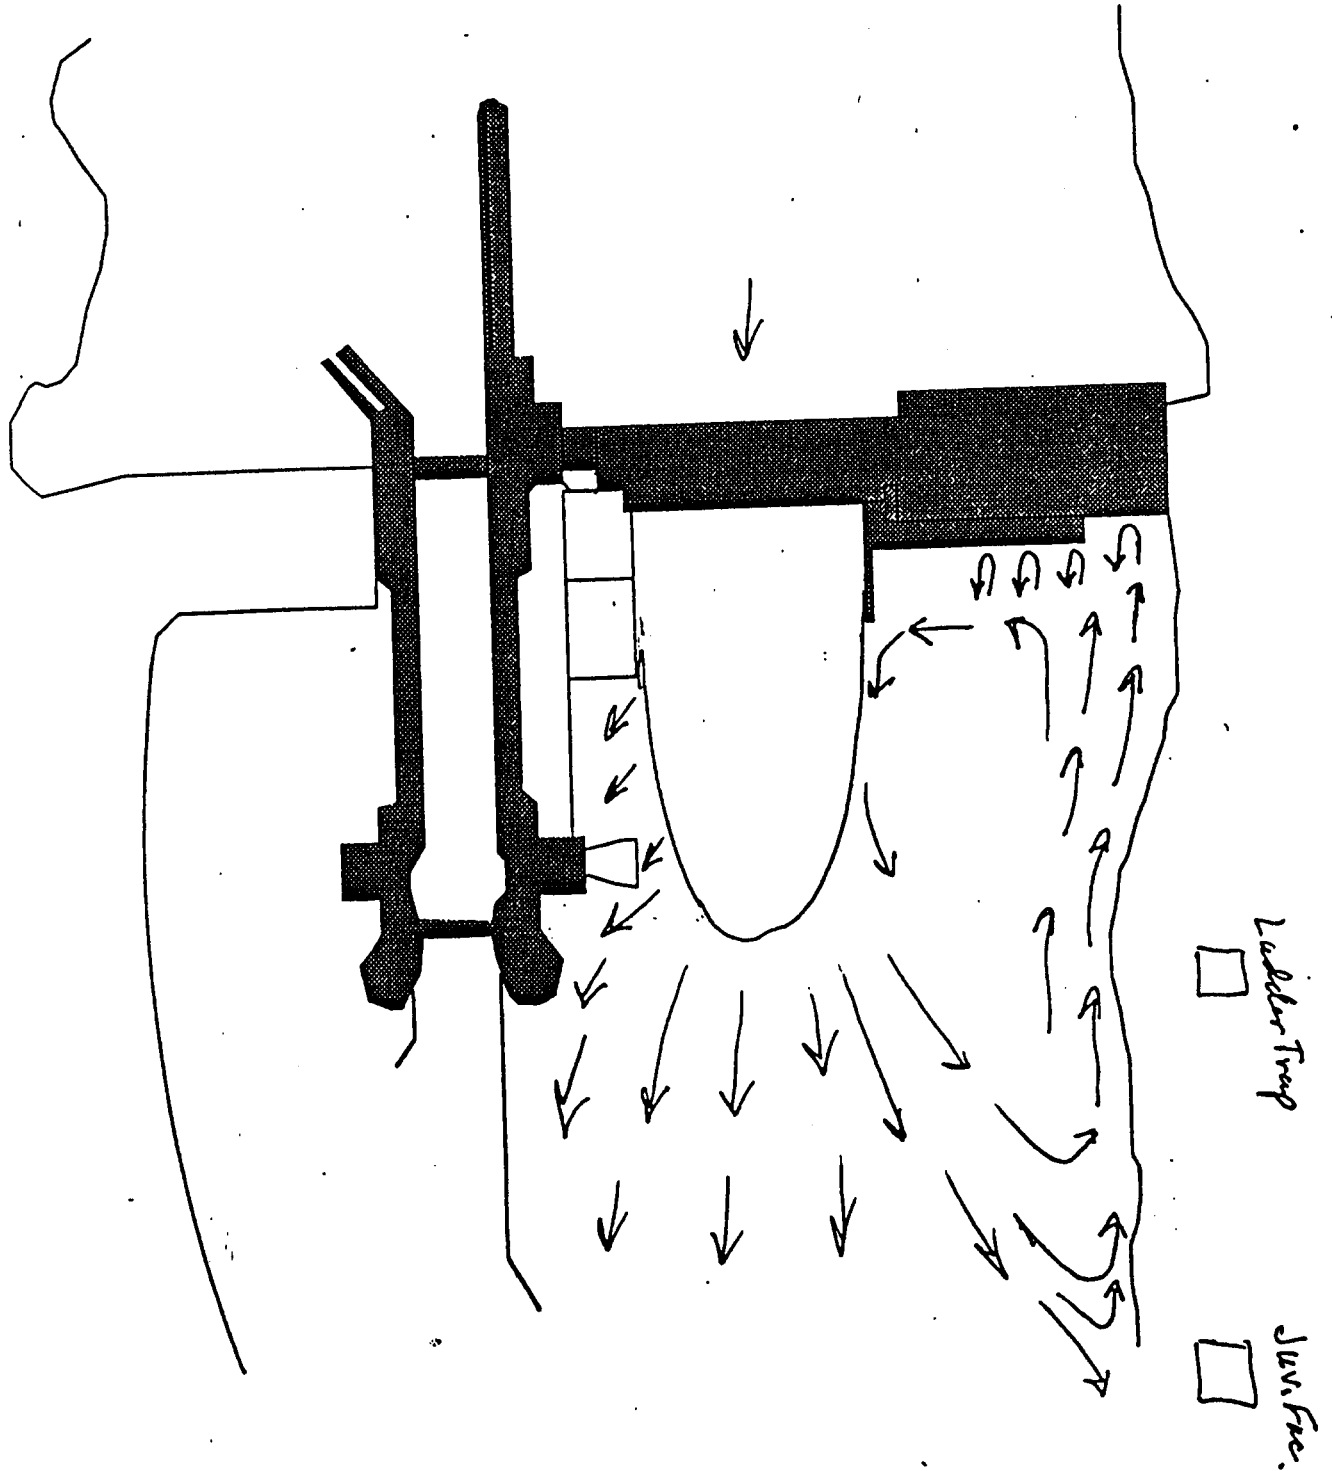
1 June 91, Pattern 2, Crowned in center
~ 100 KCFS

Pattern 2, was a crowned pattern with most of the water spilled through the center spillbays. The primary changes in flow patterns downstream from the dam were: (1) less flow toward the south shore, (2) the backeddy starting point shifted downstream to the juvenile facility, and (3) the turbulence downstream from the north entrance increased (see diagram). The north powerhouse entrances were the only

entrances that appeared usable, if fish could find their way to that vicinity.

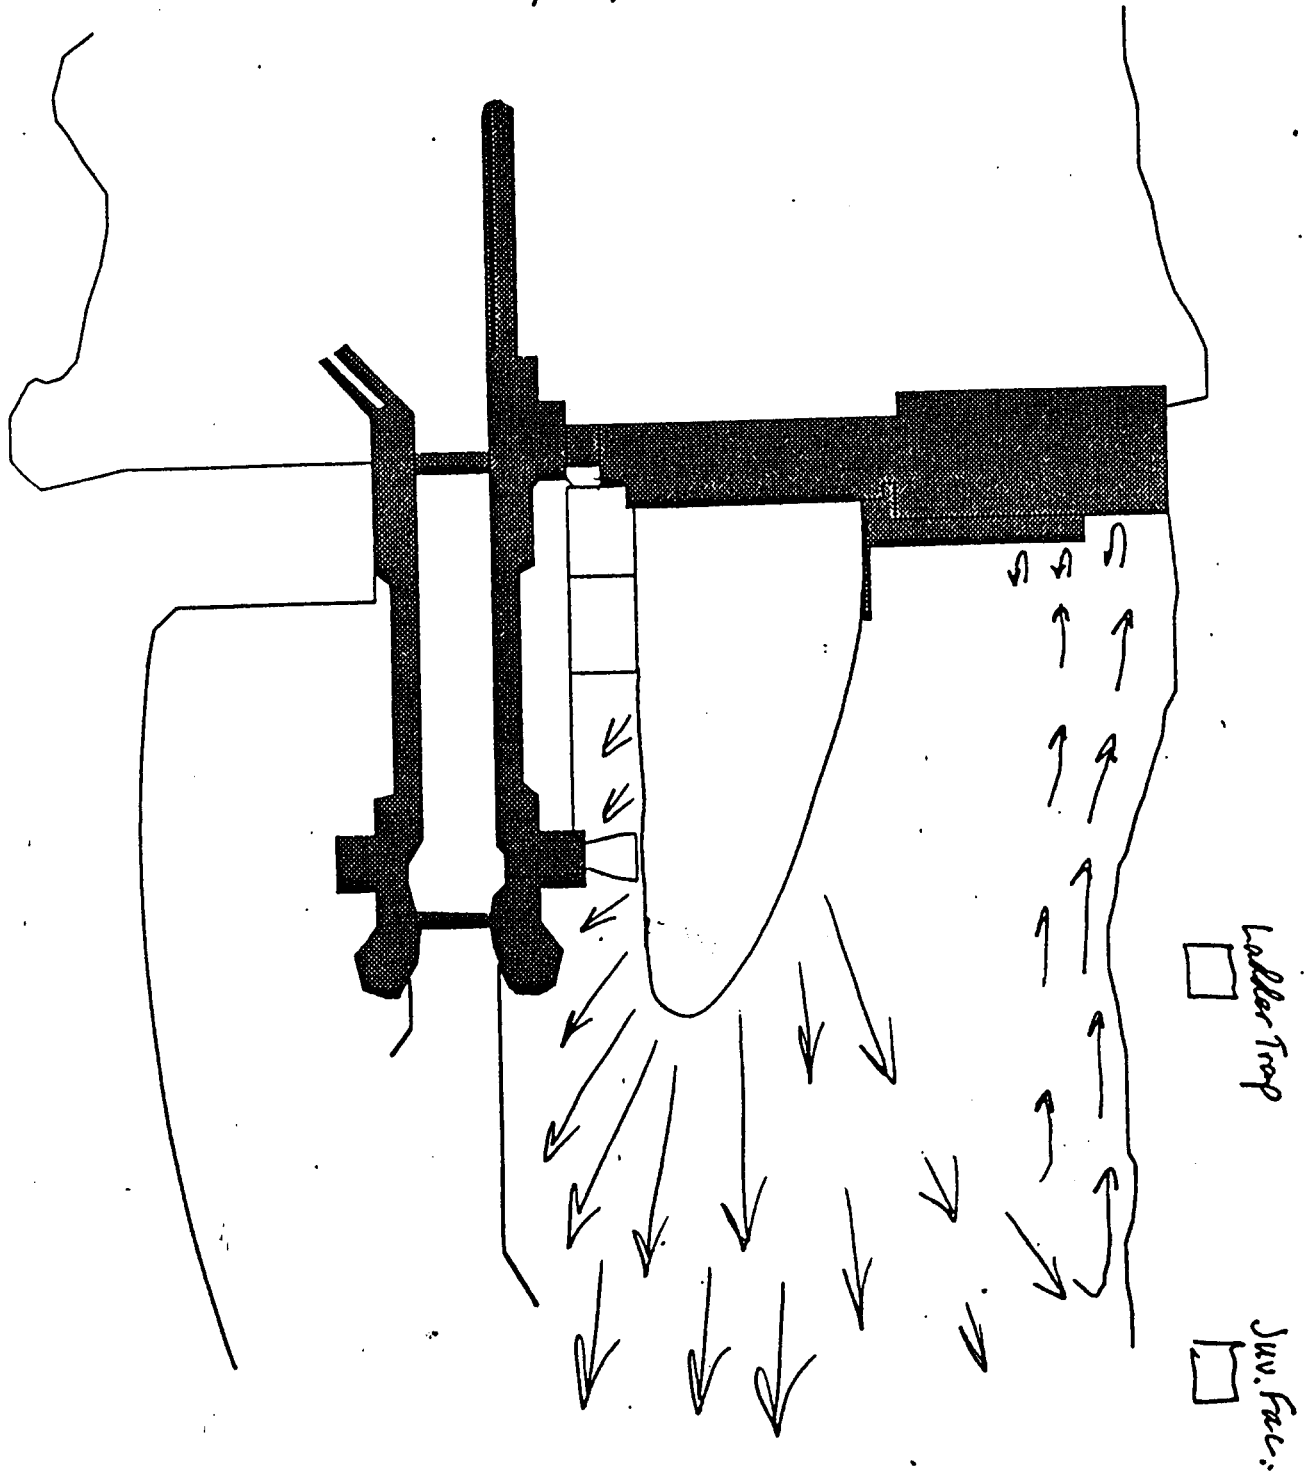
1 June 91, Pattern 3, Angled to lock
~ 100 KCFS

Pattern 3, was an angled pattern with most of the water passed through the north spillbays (see diagram). This pattern resulted in more turbulence along the lock, less flow in the backeddy along the south shore, and more favorable conditions at the north powerhouse entrances. The south entrances to the fishway were still not usable because of reversed flows.
