Powerhouse Major Rehabilitation Program

Ice Harbor Lock & Dam
Snake River, WA

March 1997

SUBJECT: Evaluation Report for Major Rehabilitation of Generating Units 1-6 at Ice Harbor Lock and Dam Powerhouse dated March 1997, Advance Copies

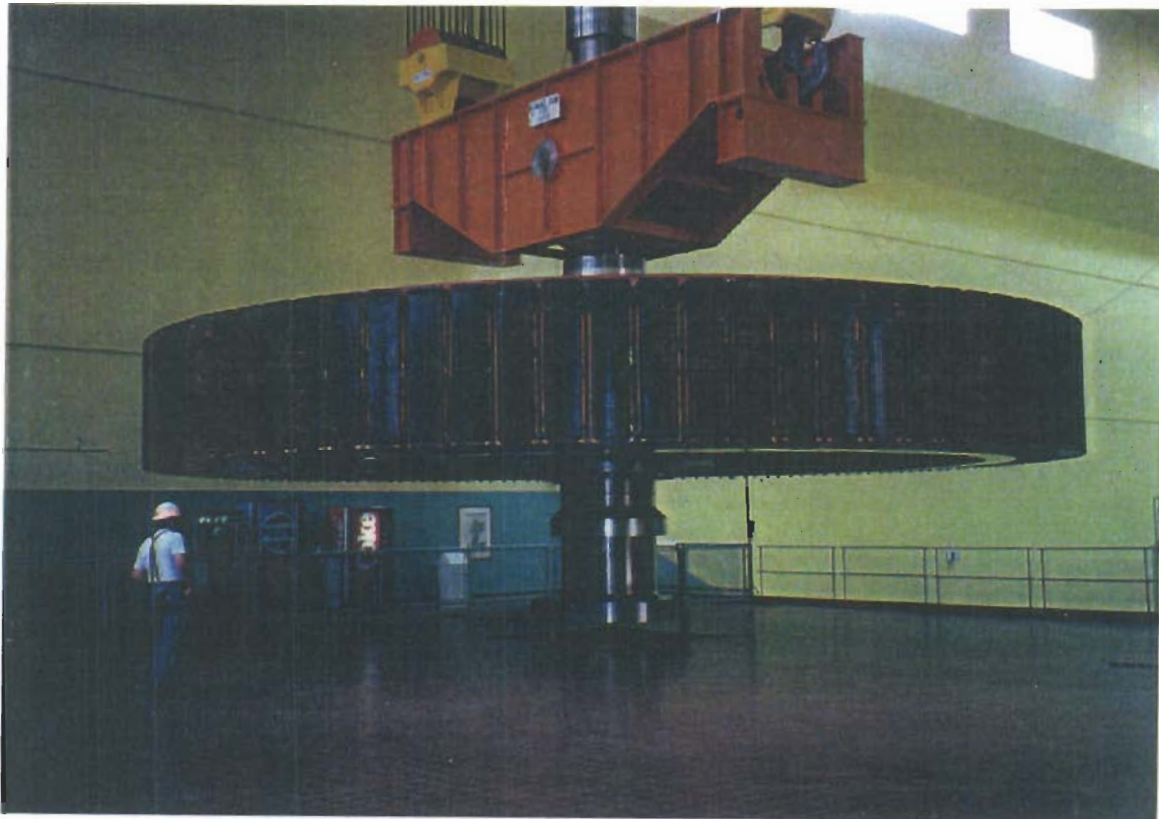
Figure 3-3
Generator Rotor From Unit 5

Generator rotor from unit 5 awaiting completion of repairs of the stator.

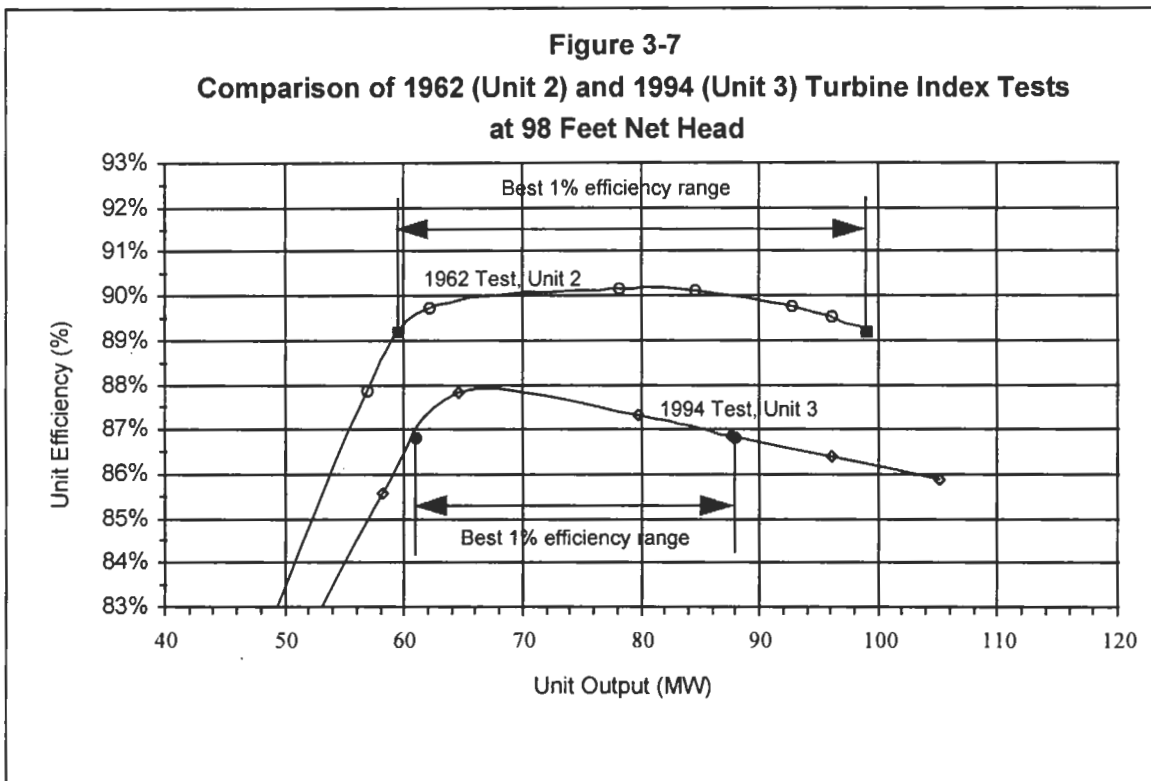
As shown in figure 3-7, the upper curve (1962 Index test on unit 2) shows a maximum unit efficiency of about 90.2 percent. Because of concerns about endangered fish, the units must be operated to within 1 percent of maximum efficiency during the fish passage period. (There is a general consensus among the fishery community that the requirement to operate within the maximum 1-percent efficiency was arbitrary and not based on scientific-based data.) The operating band for the 1962 curve allows generating between 59.5 MW and 99.0 MW, a fairly broad range that allows considerable flexibility in adjusting to system load changes.

The lower curve (1994 test on unit 3) shows that maximum unit efficiency has dropped to approximately 87.9 percent. Also, the shape of the performance curve is more peaked and, therefore, the allowable operating range is narrowed (61.0 MW to 88.0 MW). With this narrower range, the amount of generation capacity available has been reduced from 99.0 MW to 88 MW per unit, a total reduction of 33 MW for units 1 through 3 at the rated head.

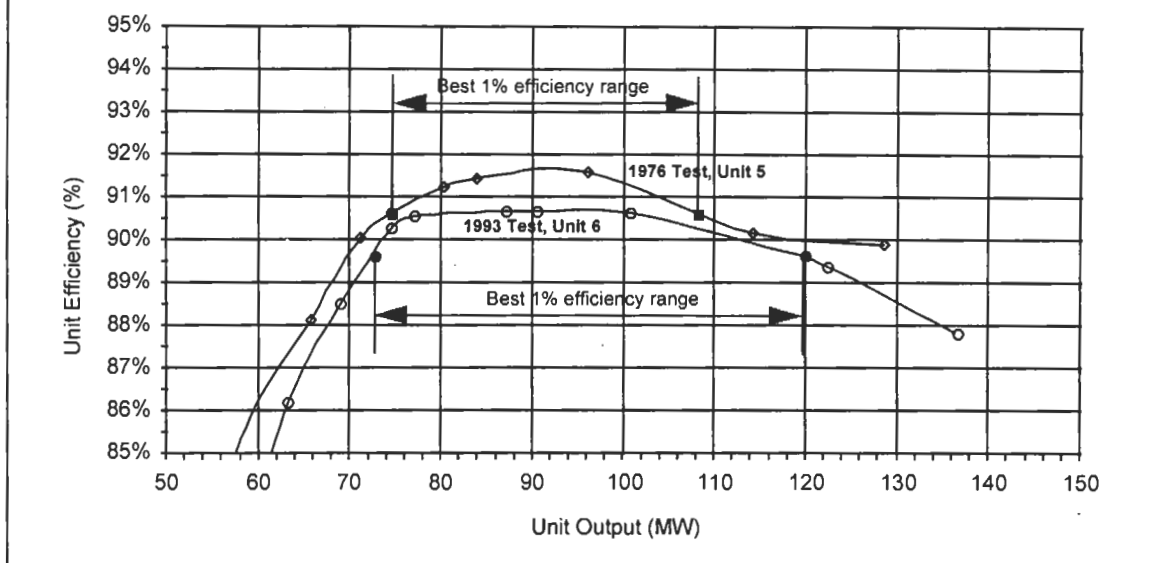
**Figure 3-8.
Comparison of 1976 (Unit 5) and 1993 (Unit 6) Turbine Index Tests
at 98 Feet Net Head**

The turbine efficiencies of units 1 through 3 and units 4 through 6 have deteriorated by about 2.4 and 1.1 percent, respectively, since they were first put into service. The primary cause of reduced turbine efficiency is wear and tear and roughened wetted surfaces. Smoother wetted surfaces will increase efficiency, and will also enhance fish survival.

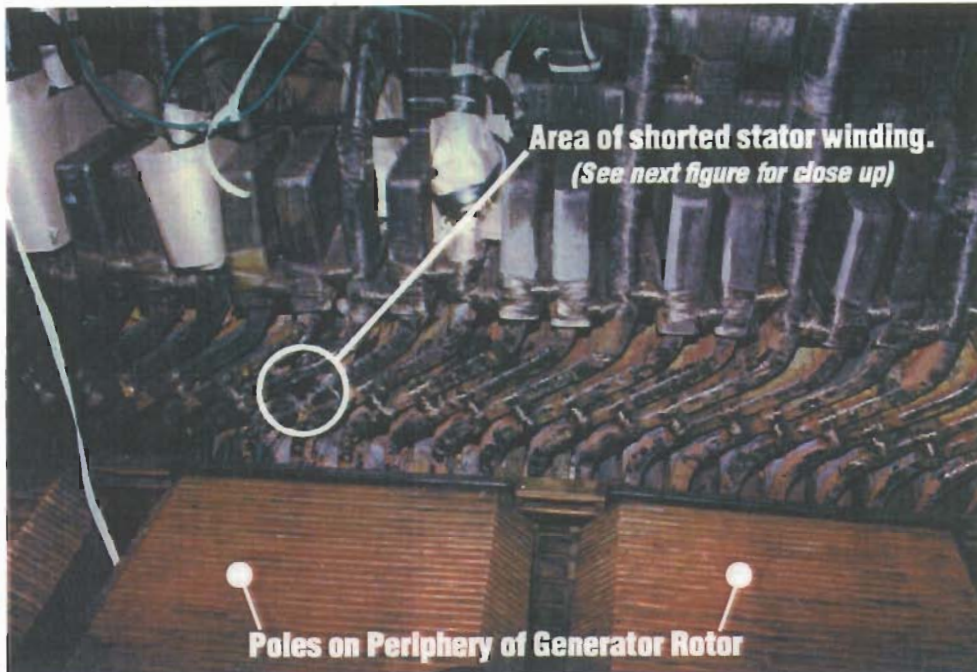
Figure 4-1. Stator Winding Failure, Unit 5 (November 1995)

Figure 4-1 shows a stator winding failure on unit 5, which is typical for units 4 through 6. A close-up view of the shorted stator winding is shown on figure 4-2. Note the blown-out section of the stator coil, which must be replaced. Figure 4-3 shows the typical worn-through area of the stator insulation prior to shorting and failure. Also note the white powder on the coils, which is the result of abrasion from movement between loose lashings (ties that connect coils together for stability purposes as pointed out in figure 4-3) and insulated coils as a result of vibration and thermal cycling.

In May 1994, a stator coil on unit 5 shorted out and failed. A close-up view of the circled area is shown on the following figure.

Under the Without-Project Condition, also referred to as the base condition, when an individual stator coil fails, a number of courses can be taken depending on the extent of damage determined by diagnostic testing. Current practice is to leave the rotor in place when possible, and repair the damaged coil(s). This can be accomplished only if the damage to the iron lamination is at, or near, the surface. Access to the coils can be gained by the removal of strategic rotor poles opposite the shorted coil. This practice, however, provides only limited access. If numerous coils must be replaced, or if damage to the iron lamination is much below the surface, removal of the rotor is required in order to allow unstacking of the iron laminations for repair and replacement.

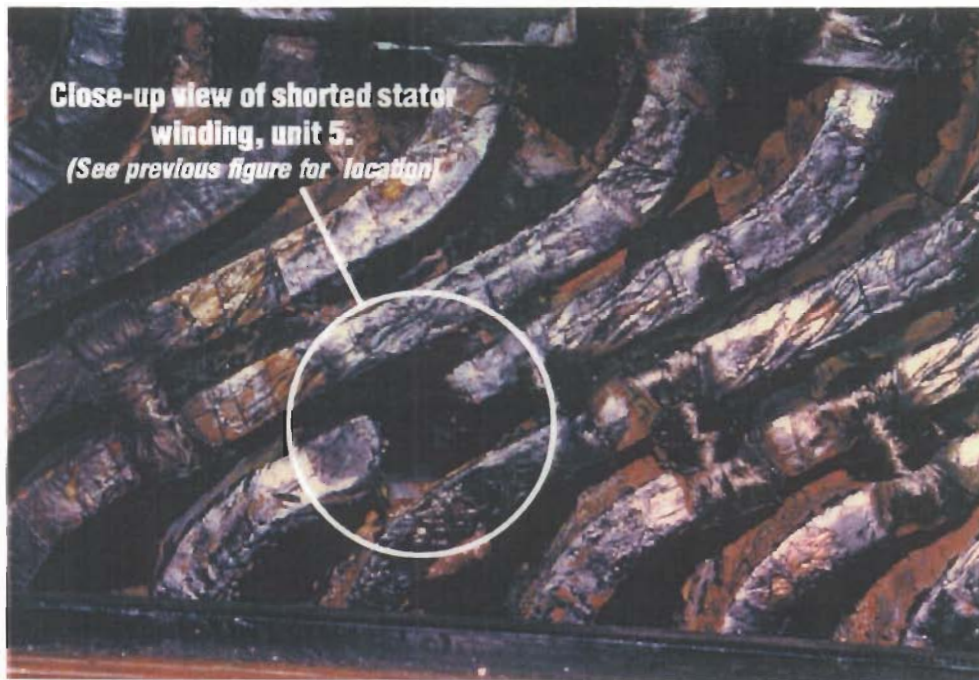
Figure 4-2. Stator Winding Failure Close-Up , Unit 5 (November 1995)

Close-up view of the failed stator coil as shown on the previous figure.

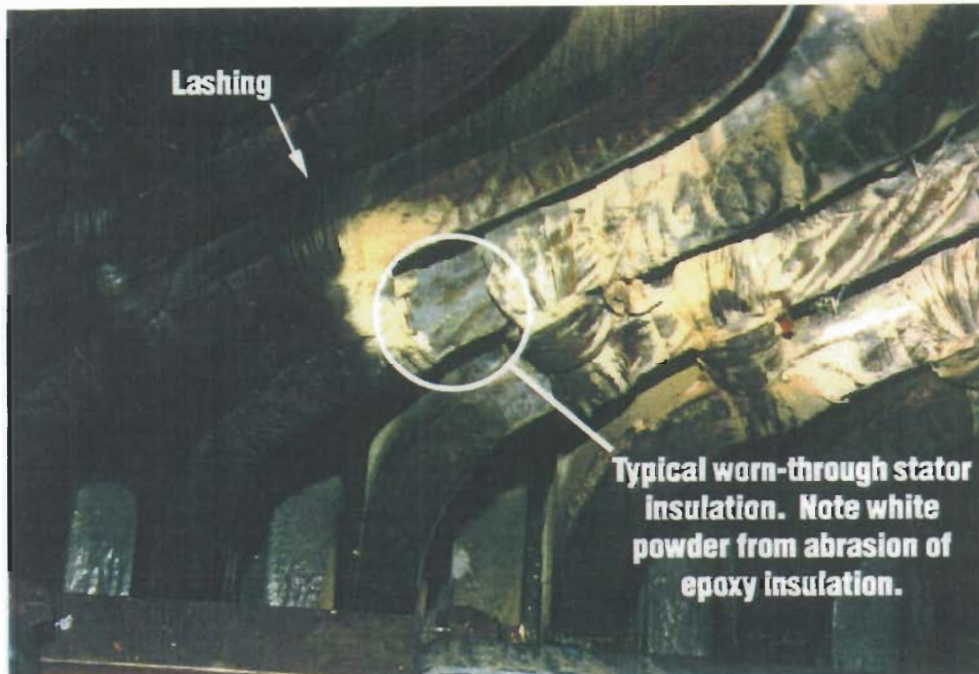
Figure 4-3
Exposed Stator Winding, Unit 5 (January 1996)

*Typical worn-through stator insulation exposing the coil.
Note the white powder resulting from abrasion of epoxy insulation.*

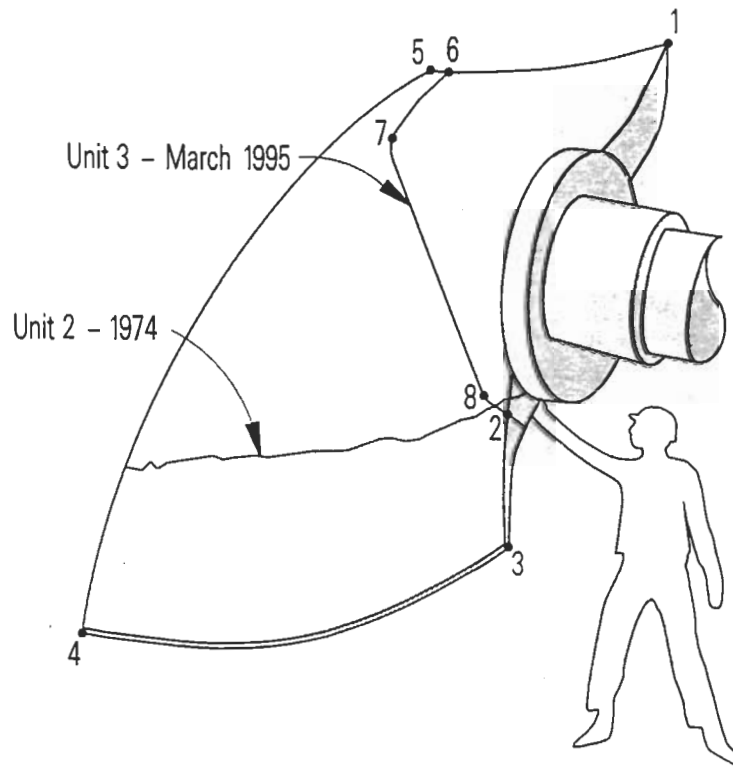
Figure 4-4
Location Of Turbine Blade Breaks

Figure 4-4 shows the approximate location of the turbine blade breaks on units 2 and 3. The edges of the blades, defined by numbers 1, 5, 4, and 3 are typically lined with stainless steel to resist cavitation.

Turbine blade segments have broken off on two different occasions. The numbers (1 through 8) are used for orientation purposes in figures 4-5 and 4-6, relative to unit 3.

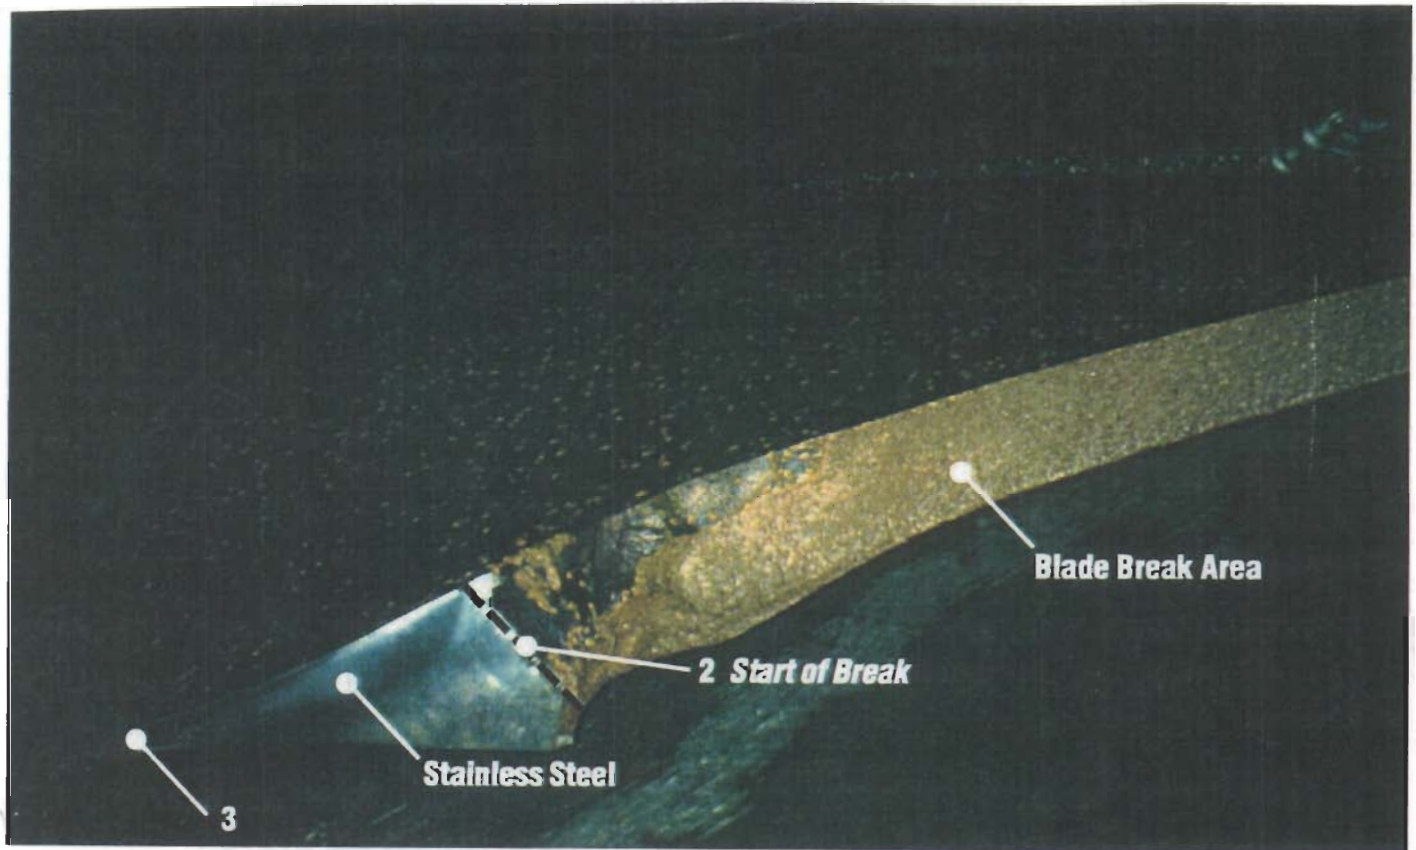
Figure 4-6. View of Broken Edge of Blade From Unit 3, July 1995

View looking into the broken edge of the blade, as shown on figure 4-5. The broken edge of the blade is the brown area. The bright portion in the lower left is the stainless steel edge between numbers 2 and 3. The dark areas along the break (to the immediate right of the stainless steel) are a previously welded area that has failed.

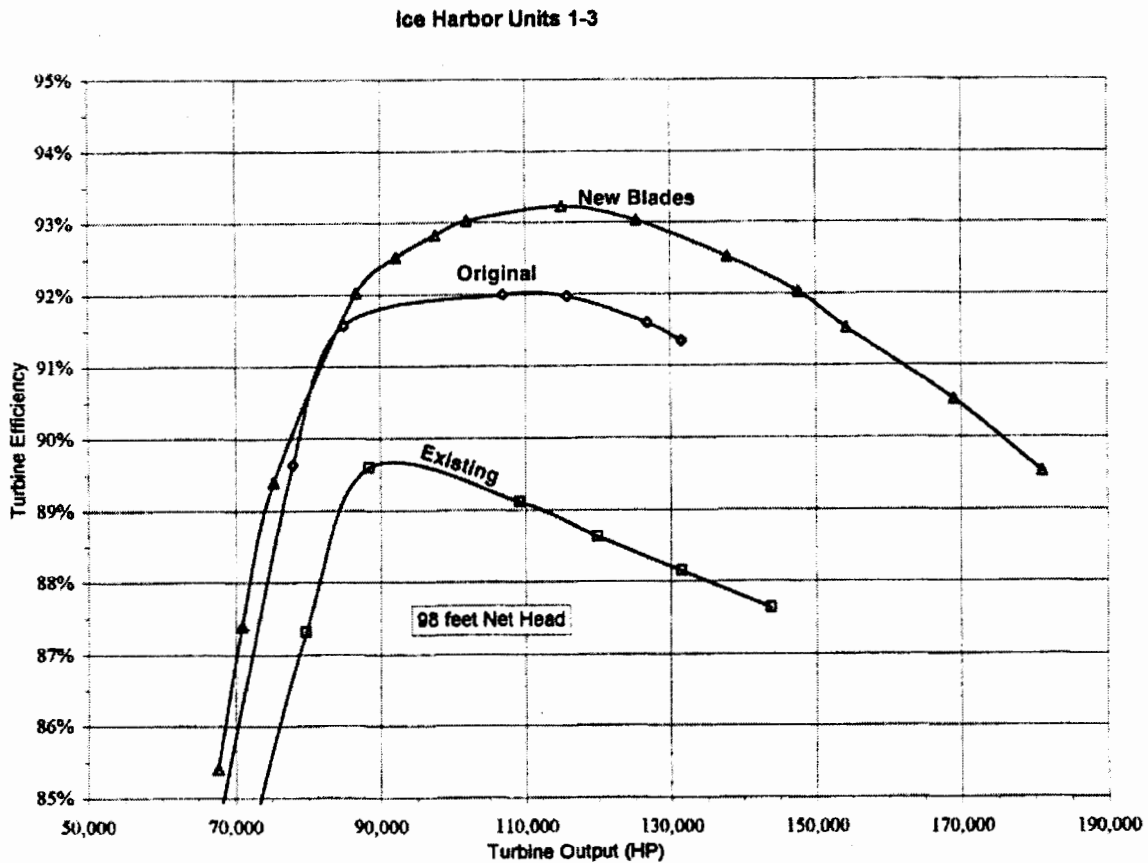
Figure 4-7
Comparison of Performance on Units 1 through 3

The new blades curve is based upon an existing model from a turbine manufacturer. No special emphasis was placed upon its flatness. A "flatter" curve is achievable, and emphasis will be placed on such a characteristic in the procurement contract.

The action to fully restore lost turbine reliability and efficiency with minimum expense is replacement of the existing turbine blades. Refurbishment of the blades was not considered as a viable measure, because of the blade breakage problem. Figure 4-7 compares turbine efficiency of the current and original turbine blades on units 1 through 3 to that which would be achieved by replacing the blades. More detailed information is included in appendix H, *Governor Sensitivity Analysis, and Turbine Engineering and Reliability Analysis.*

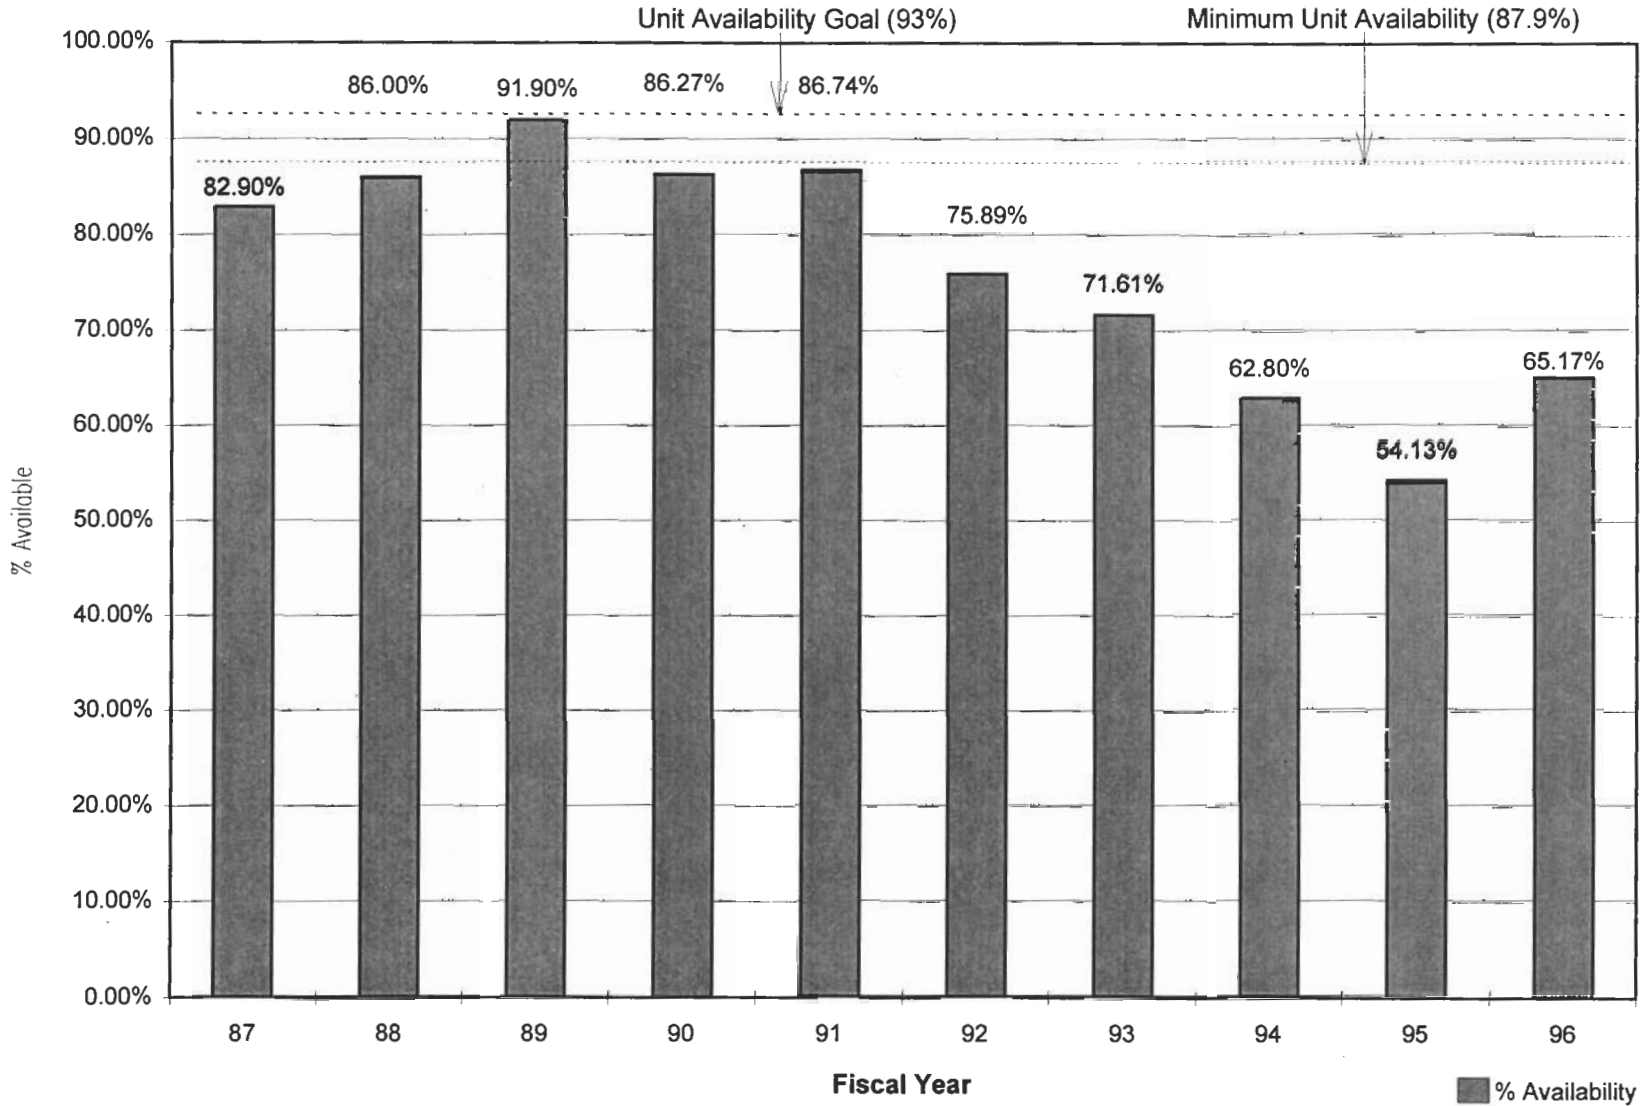
FIGURE 4-9 ICE HARBOR HISTORICAL POWERHOUSE UNIT AVAILABILITY

The declines in power plant availability noted on the graph are the results of unit failures due to deferred maintenance on generator and turbine components caused by insufficient funding and manpower. The unit availability goal of 93 percent has not been met since sometime before 1985. The data shows a steadily-declining trend, with 1991 values around 86 percent, to a low of 54 percent in 1995.

Unless the generator windings and turbine blades are replaced, availability will continue to drop. The impact on the system grid is dependent on the time and length of each outage. In general, the impact could include the necessity to purchase power at premium costs, increased risk of system voltage instability during peak loads, and an inability to meet customer demand for energy during peak load times. In the extreme case, voltage instability and inability to meet customer demand can lead to brownouts or blackouts similar to what happened on 3 July 1996 and 10 August 1996 throughout the western states.
