# Posttraffic Testing at the National Airport Pavement Test Facility: Test Item MFC

September 2001

DOT/FAA/AR-TN01/49

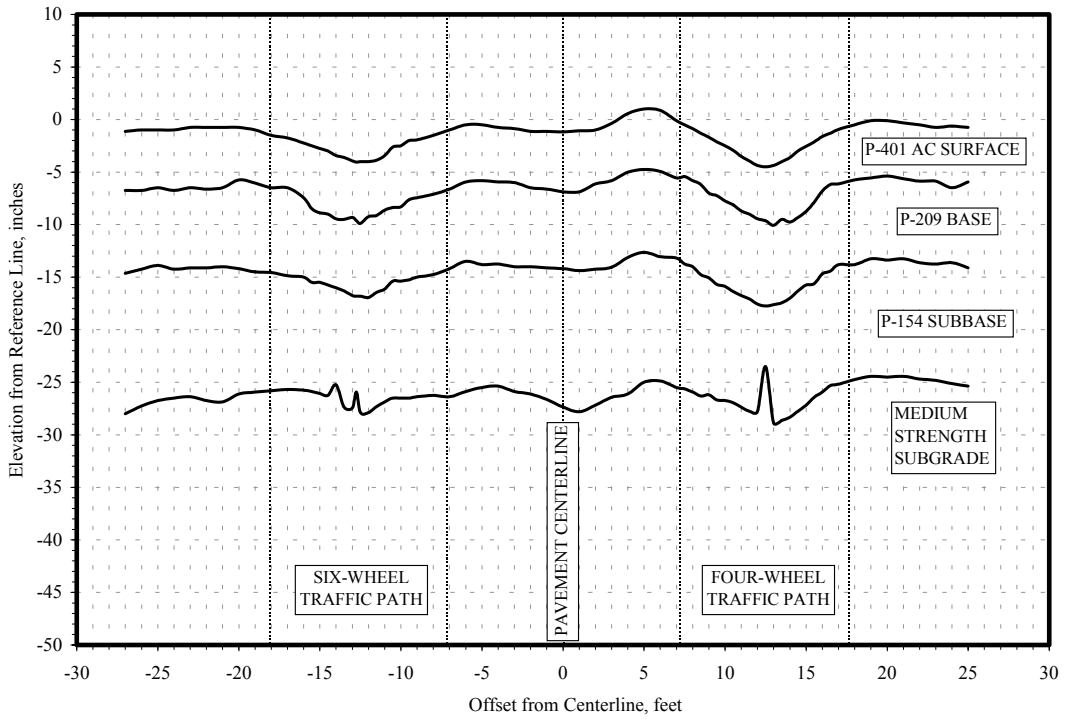
FIGURE 4a. PAVEMENT LAYER PROFILE MEASUREMENTS IN THE MFC TRENCH (WEST FACE)

Figures 4a and 4b show the pavement layer profile measurements on the west face and the east face of the trench respectively. The subgrade intrusion into the P-154 base in the six-wheel traffic path and in the four-wheel traffic path is clearly visible in the figures.

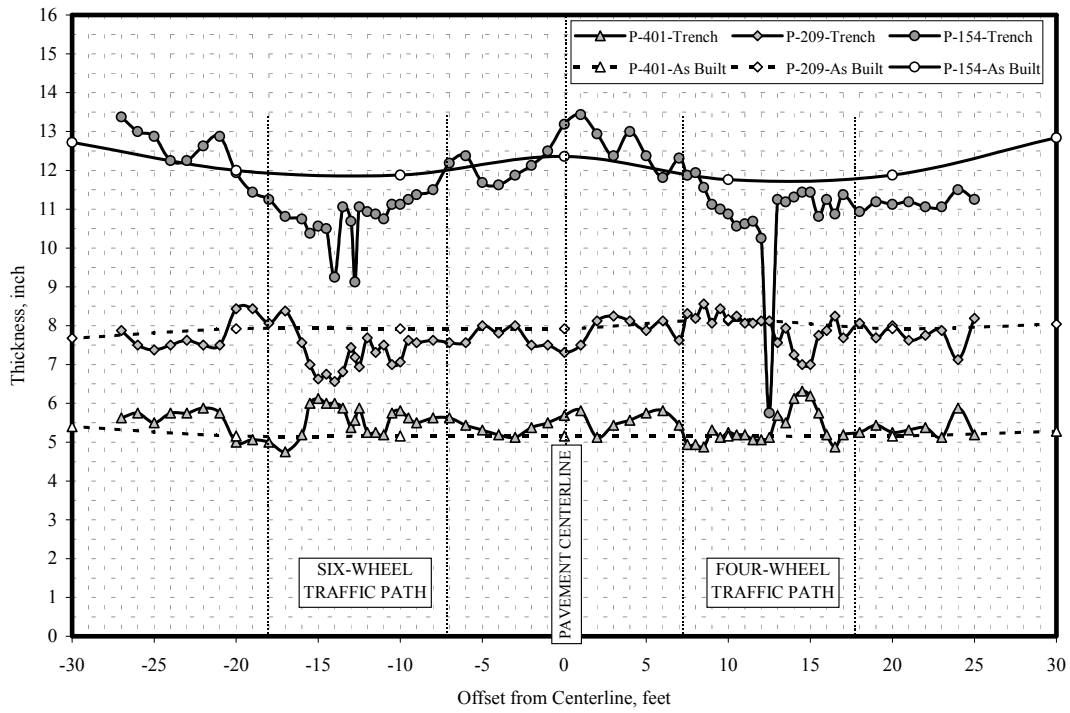
FIGURE 5a. PAVEMENT LAYER THICKNESSES IN THE MFC TRENCH (WEST FACE)

Figures 5a and 5b show the comparison between the as-built and the trench pavement layer thicknesses across the pavement in the transverse direction. The layer thickness measurements were made at 5-foot (1.52-m) intervals during the construction (as-built thickness), whereas in the trench, measurements were made at 1-foot (0.3-m) intervals outside the wheel paths, and at 6-inch (0.15-m) intervals inside the wheel path. Reduction in thickness of the P-154 layer in the wheel tracks is observed. The thickness of the P-154 layer increased in the upheaval area.

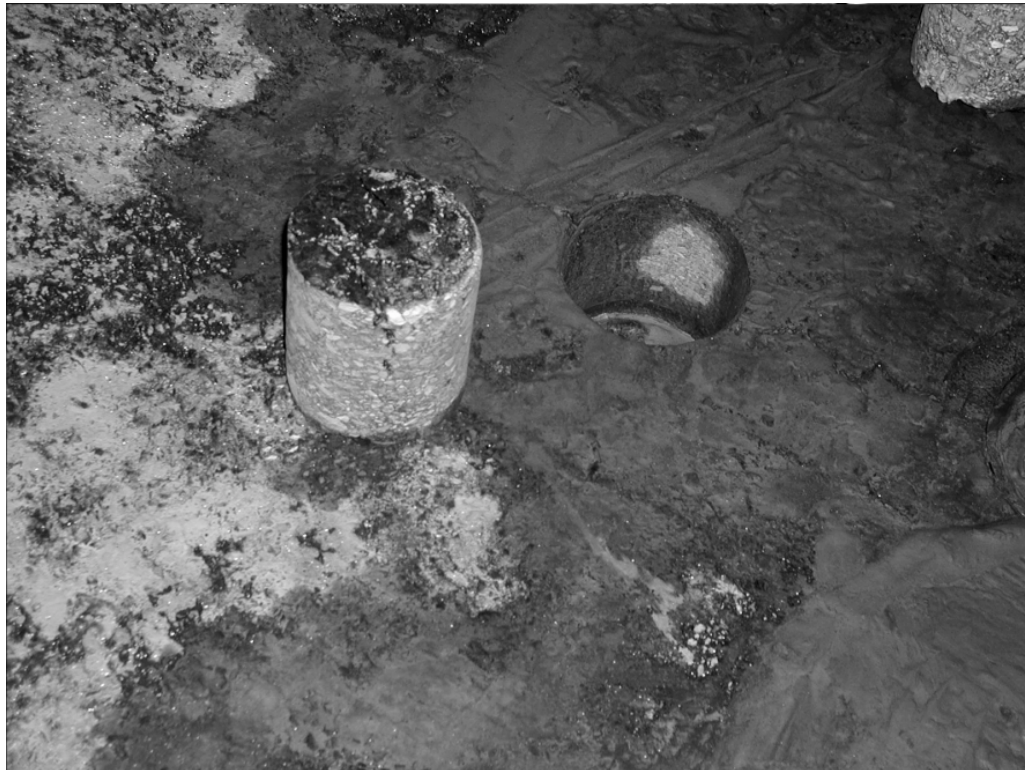
Nineteen cores were extracted. Table 2 summarizes the thickness measurements on the P-401 cores. A careful examination of these cores showed that all the cracks (except in one core from the four-wheel traffic path) initiated from the top. The maximum crack depth was 2.5 inches (63.5 mm). Only one core was cracked in the bottom lift. Delamination between the two P-401 layers was observed on the four-wheel traffic path cores. Only two cores from the six-wheel traffic path showed delamination. The P-401 core thickness varied from 4.8 inches (122 mm) to 5.6 inches (142 mm). Figure 6 gives the statistical summary of thickness measurements. Figure 7 shows a P-401 core with a crack.

FIGURE 7. P-401 CORE SHOWING CRACK LOCATION

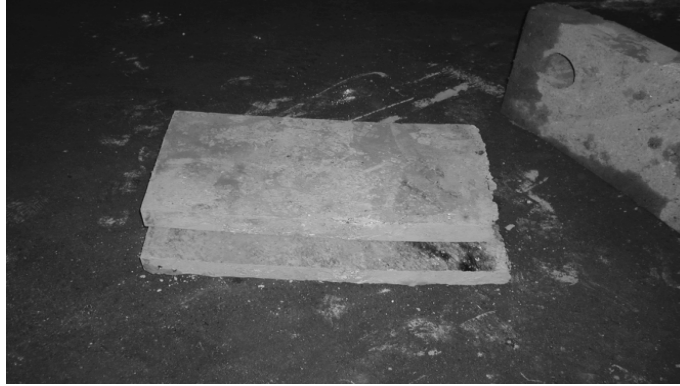
Figure 8 is a photograph showing evidence of delamination in the P-401 layer. A thin layer of dust was observed between the two lifts that could have been the cause of delamination. The P-401 layer was removed using a backhoe (figure 9). During the removal, the two lifts of the P-401 layer in the four-wheel traffic path separated easily (delamination). Figure 10 shows the P-401 layer at the location of maximum rutting (center of the six-wheel traffic path). No signs of rutting in the P-401 layer were observed. Portions of chunk samples (from AC removed with a backhoe or other equipment) and cores were stored for future testing.

FIGURE 8. P-401 SURFACE EXHIBITING DELAMINATION

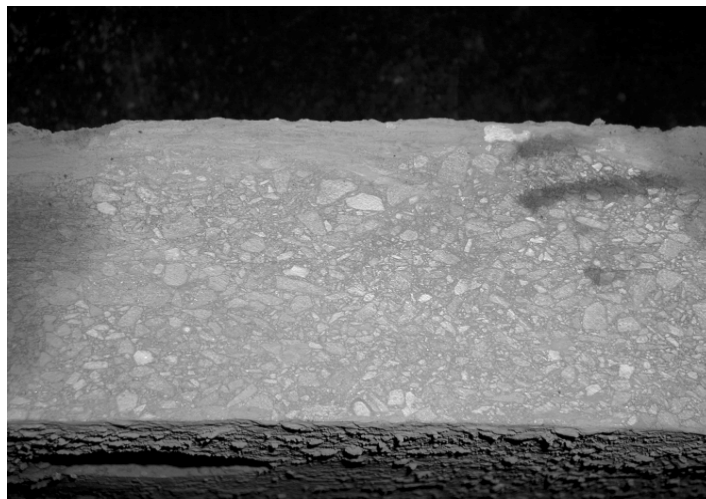
FIGURE 10. P-401 FROM MAXIMUM RUTTING LOCATION  
IN SIX-WHEEL TRAFFIC PATH

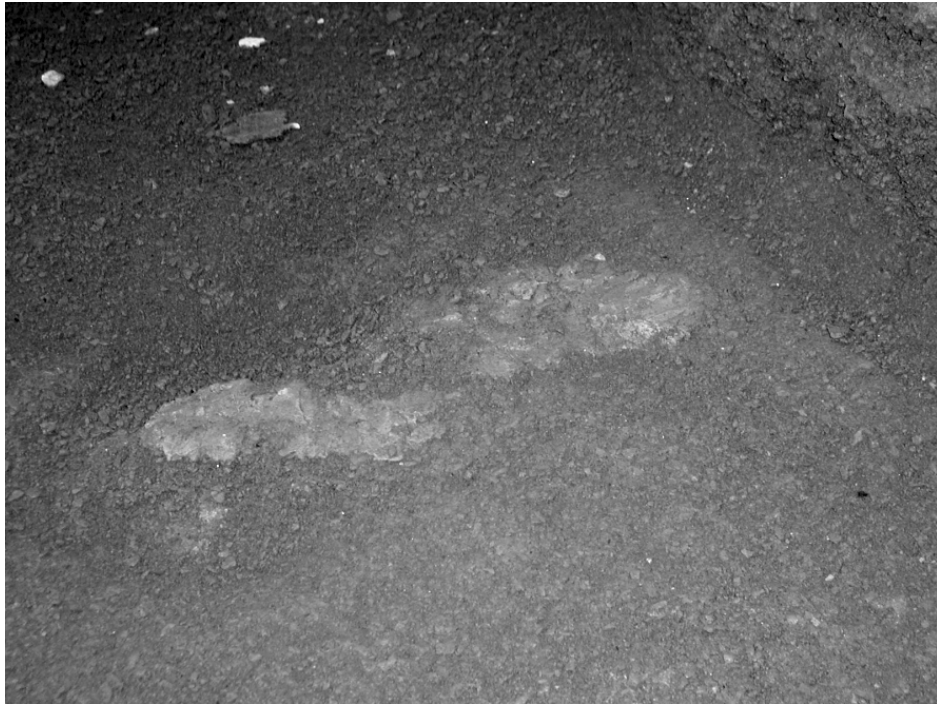
After completing the tests in the P-154 test pits, the base and subbase were completely excavated using a backhoe. Near the interface, material was hand excavated using shovels. Evidence of clay subgrade penetrating upward into the P-154 subbase was observed (figure 20) at the location of maximum rutting in the four-wheel traffic path (south side). Excavation was continued with careful hand digging near the location of penetration. Subgrade penetration was observed for the whole width of the trench, but of varying extent, as shown in figure 21. The maximum depth of subgrade penetration into the subbase was approximately 6 inches (152 mm) (figure 22). Figure 23 shows the lateral movement of the subbase material originating at the subbase/subgrade interface. The P-154 subbase layer is crushed stone (unbound granular material). When the tensile stress in the unbound granular layer due to applied load exceeds the residual compressive stress (developed due to initial compaction and preloading), lateral movement in the unbound granular layer may take place. This phenomenon was observed in the south side four-wheel traffic path at the location of maximum rutting. About a 2-inch (51-mm) subgrade penetration into the P-154 layer was observed in the center of the six-wheel traffic path (north side) in two places (figure 24). Subgrade penetration into base/subbase has also been observed in past full-scale airport pavement tests [1 and 2].

FIGURE 20. CLAY SUBGRADE PENETRATING INTO P-154 SUBBASE ON THE SOUTH SIDE (FOUR-WHEEL TRAFFIC PATH)

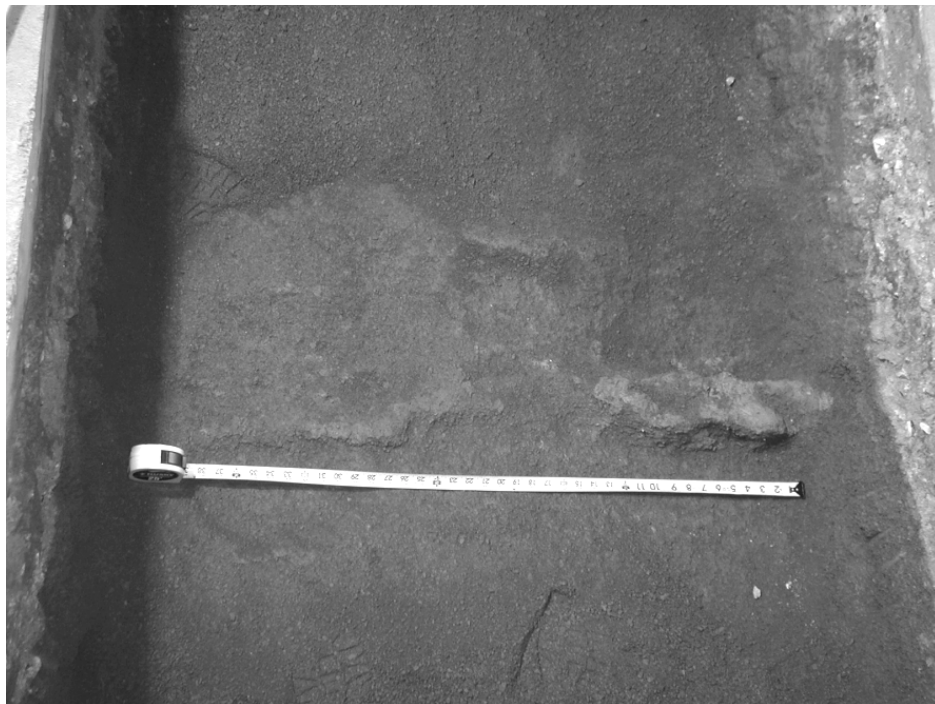
FIGURE 21. SUBGRADE PENETRATING INTO P-154 SUBBASE FOR THE ENTIRE TRENCH WIDTH ON THE SOUTH SIDE (FOUR-WHEEL TRAFFIC PATH)

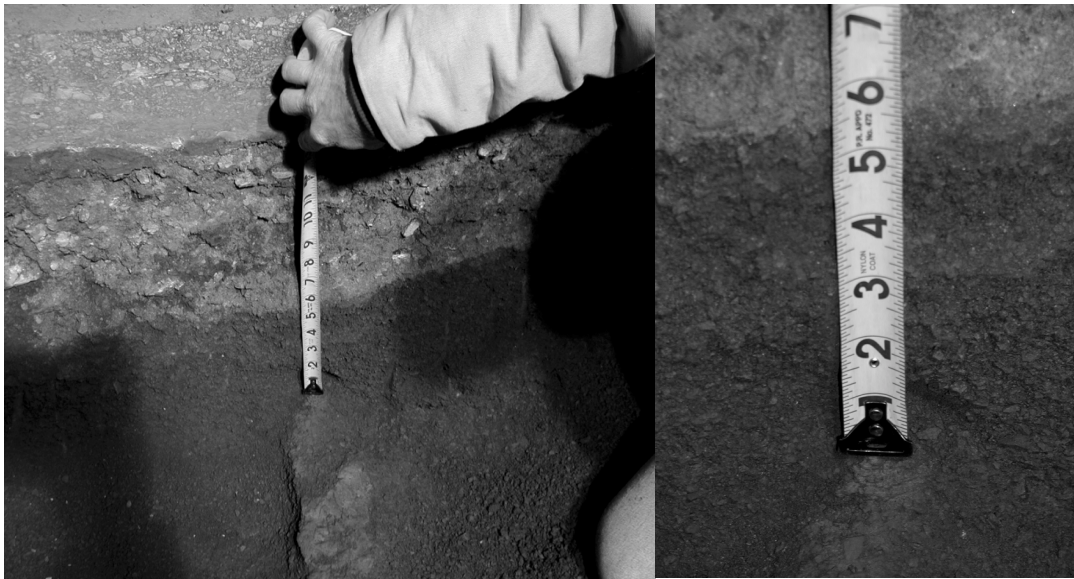
FIGURE 22. SUBGRADE PENETRATION INTO THE P-154 LAYER

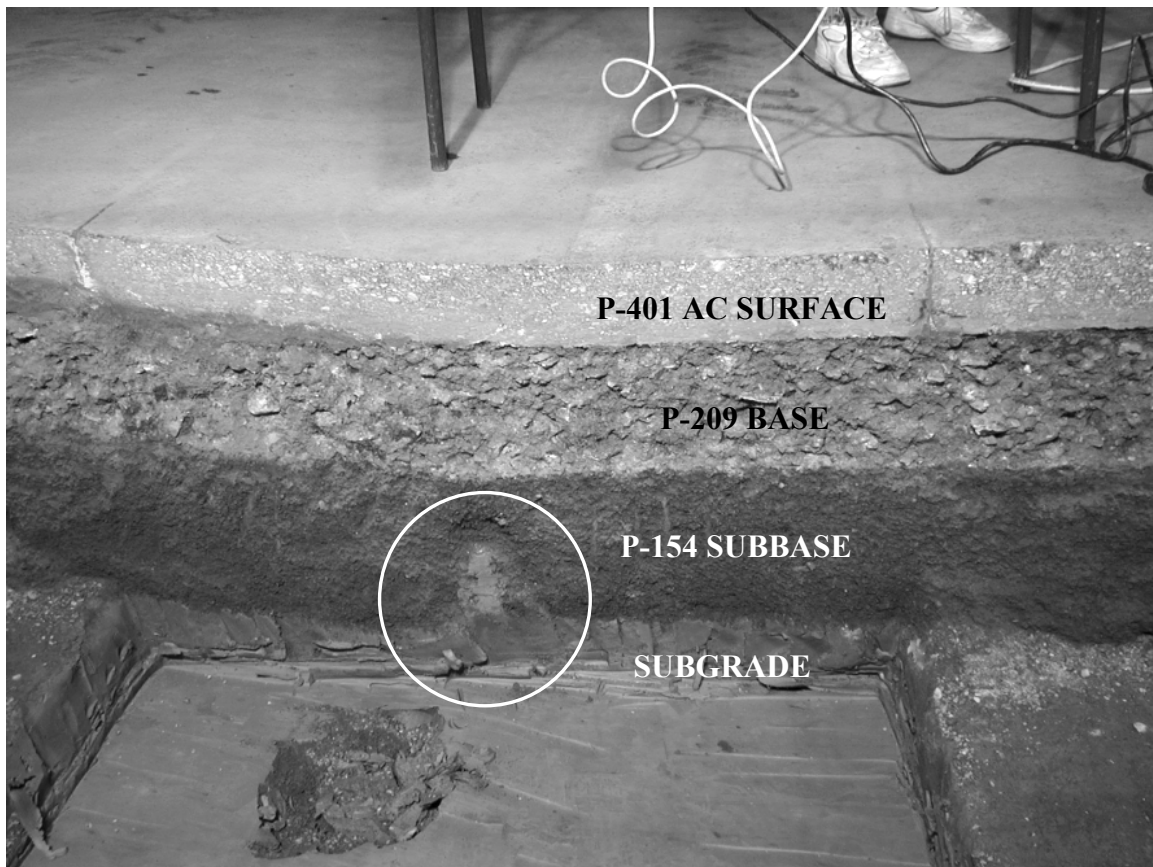
After the completion of testing, the trench walls were cleaned to clearly expose the layer interfaces. Measurements of the pavement layer interface profiles were made relative to a horizontal string line to quantify the contribution of each component layer to the total pavement rutting and upheaval, see figures 3 and 4. Subgrade intrusion into the P-154 base at two locations in the six-wheel traffic path and one location in the four-wheel traffic path was observed. Reduction in thickness of the P-154 in the wheel tracks was observed. Thickness of the P-154 layer increased in the upheaval area. Rutting was primarily contributed by the subgrade and the P-154 subbase. Shear flow, because of shear failure in the subgrade, contributed to the upheaval.

FIGURE 23. LATERAL MOVEMENT IN P-154 SUBBASE ORIGINATING AT THE SUBBASE/SUBGRADE INTERFACE IN FOUR-WHEEL TRAFFIC PATH

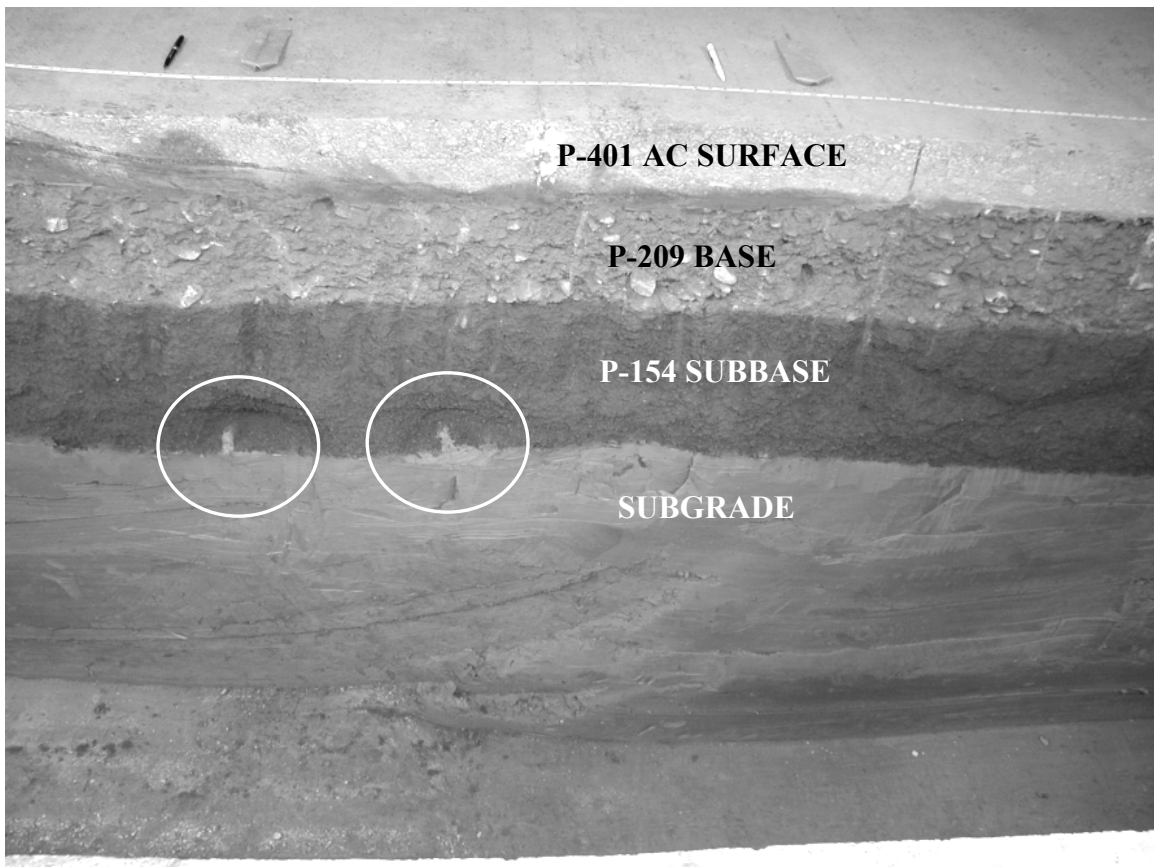
FIGURE 24. LATERAL MOVEMENT IN P-154 SUBBASE ORIGINATING AT THE SUBBASE/SUBGRADE INTERFACE IN SIX-WHEEL TRAFFIC PATH
