# Appendix D Project Map and Typical Cross Section

## **Appendix E Descriptions of Crossings**

In 2001 and 2004, BLM and Forest Service resource specialists monitored and evaluated the Furnace Creek Road and surrounding area. As the alternatives for the project were formulated, attention was focused on the areas where the road either crosses the creek or is in the same channel. Eventually, 14 areas of concern were identified and the alternatives were designed to address the problems at the crossings. The photographs were taken in July 2004, with the exception of the pre-gate photo of crossing #8 (this photo was taken in fall 2001). Appendix E provides photographs and descriptions of all 14 crossings.

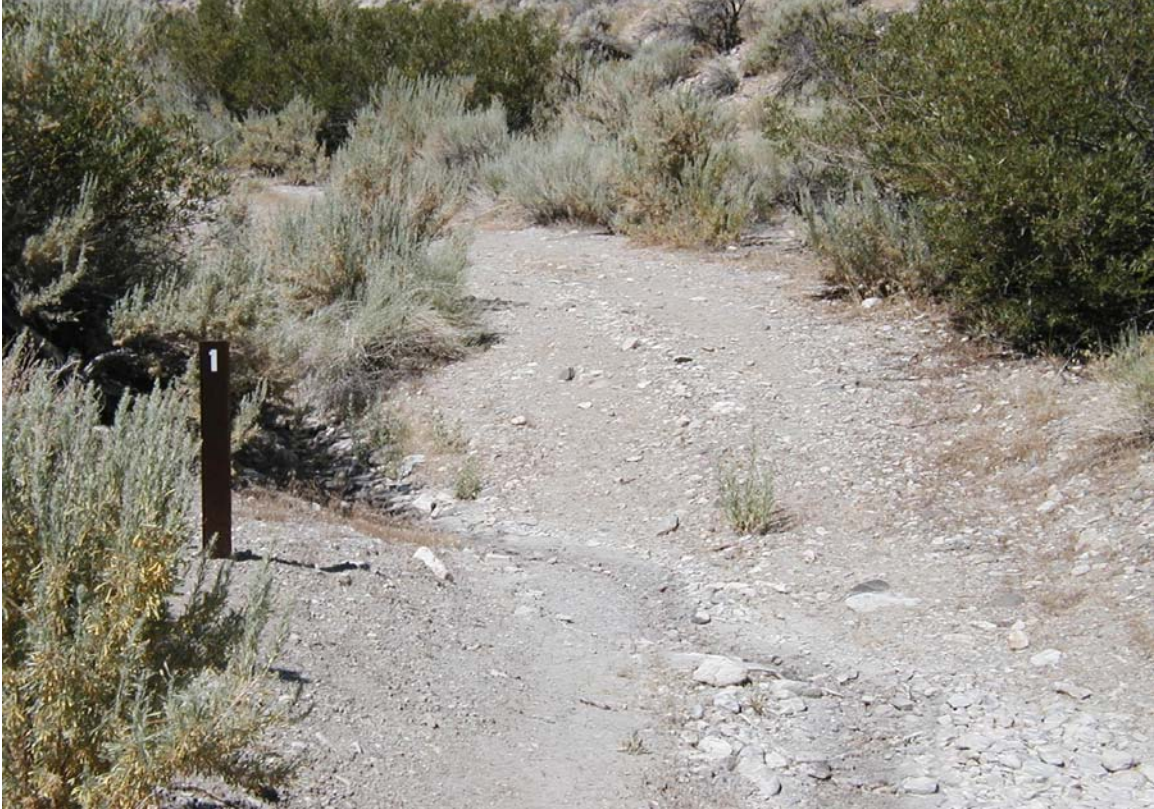
## Crossing 1 - 140 feet from BLM Gate Elevation 5600'

Crossing is 5' across

Dry crossing

Stream channel condition same above and below crossing

No noticeable impacts

No corrective measures proposed

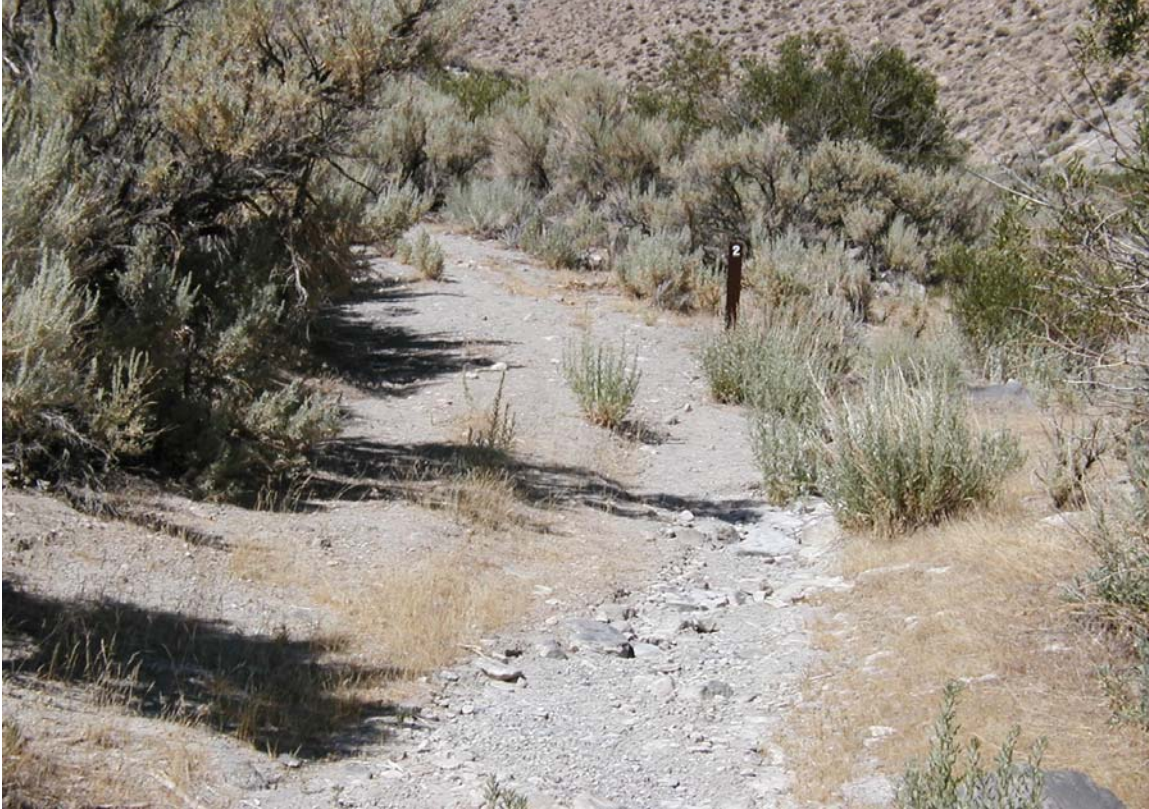
## Crossing 2 - 400 feet from BLM Gate Elevation 5610'

Crossing is 10' across

Dry crossing

Stream channel condition same above and below crossing

No noticeable impacts

No corrective measures proposed

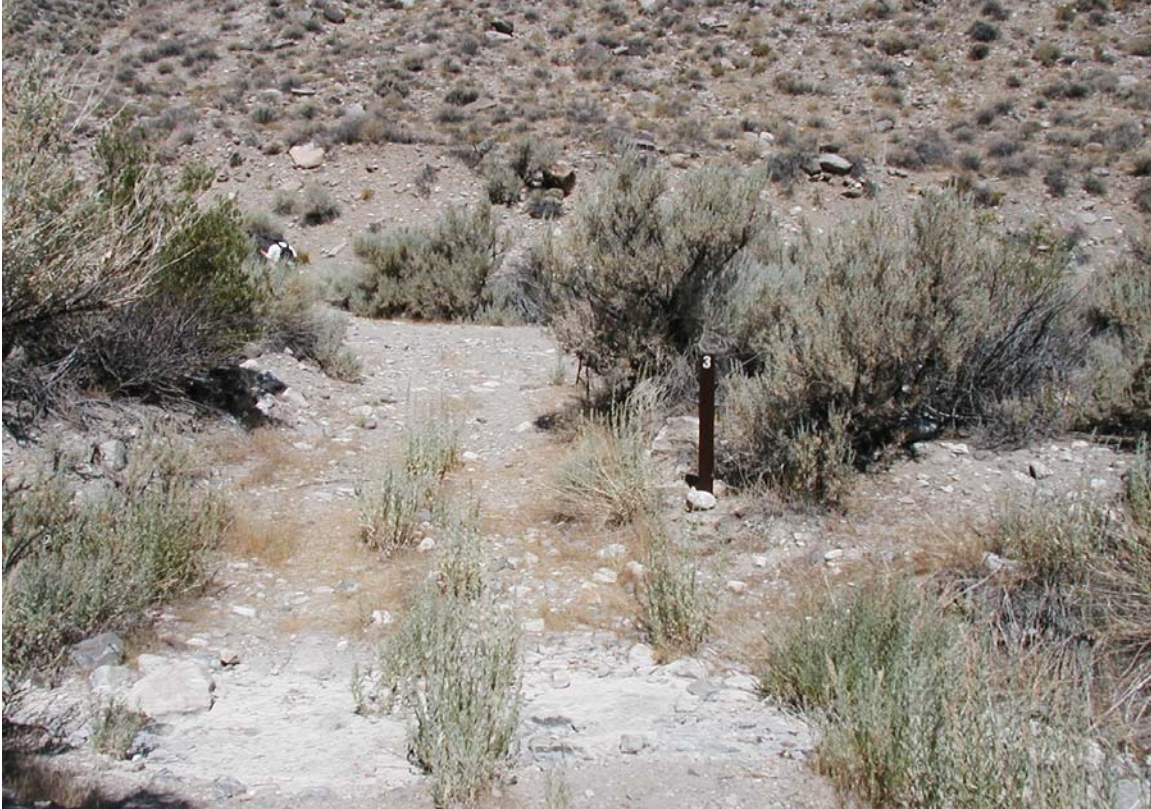
## Crossing 3 - .20 mile from BLM Gate Elevation 5650'

Crossing is 5' across

Dry crossing

Stream channel condition mostly the same above and below crossing

Headcut above crossing

No corrective measures proposed

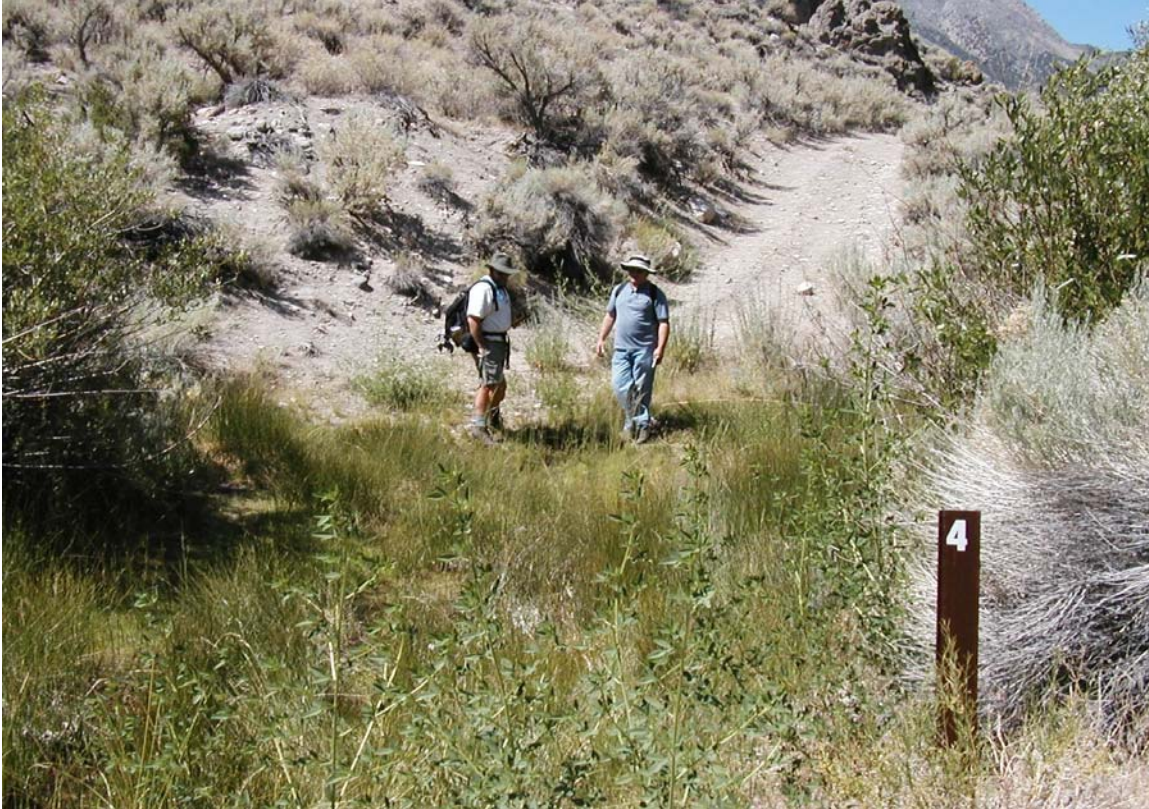
## Crossing 4 - .40 mile from BLM Gate Elevation 5750'

Crossing is 40' wide

Wet crossing at time picture was taken; dry by August

Some loss/trampling of riparian vegetation

Channel widening/some sediment in channel

Small spring in channel eating into the slope

Some corrective measures are proposed

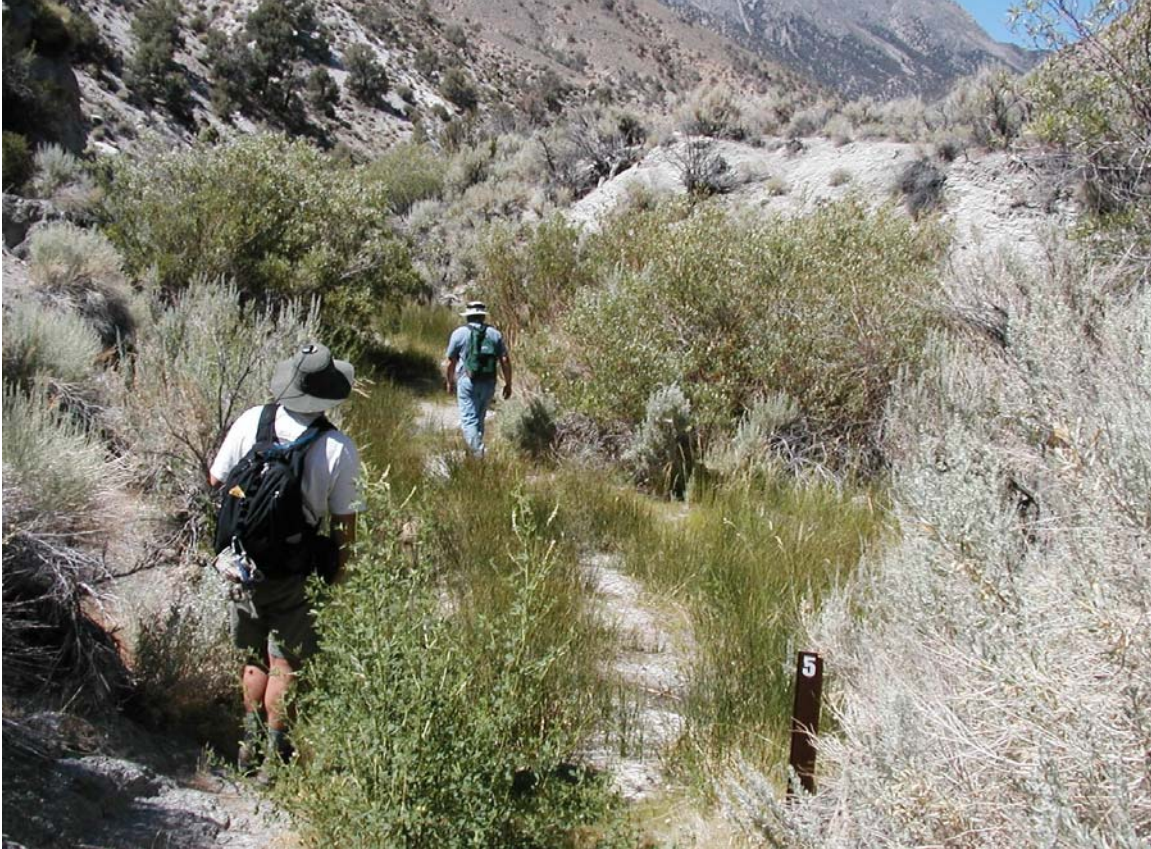
## Crossing 5 - .45 mile from BLM Gate Elevation 5760'

Crossing is 145' long

Wet crossing with road and stream in the same channel; crossing dry by August

Some erosion, large headcut

Loss of riparian vegetation

Road has captured the stream and altered the normal flow of the stream

Stream bed is scoured as a result of the crossing

Some corrective measures are proposed

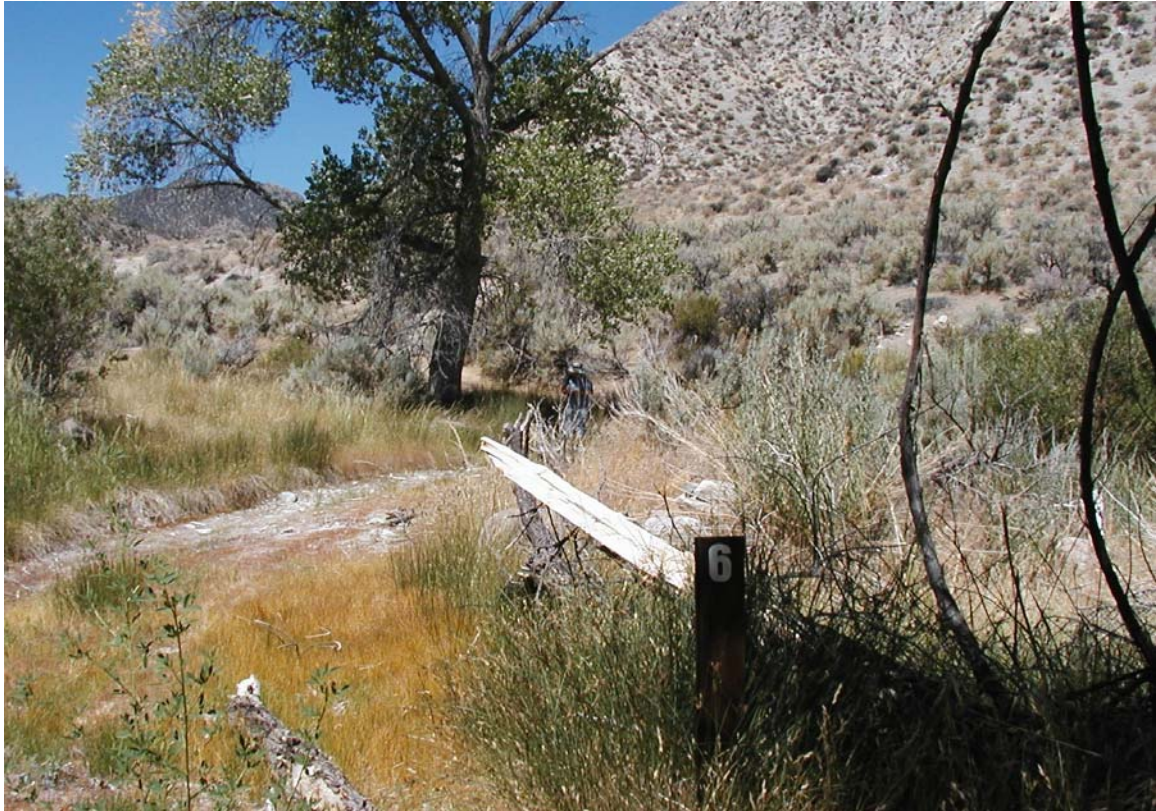
## Crossing 6 - .70 mile from BLM Gate Elevation 5845'

Crossing is 1-2' with approximately 60' of impact

Crossing dry

Minor headcut

Flow regime altered by road

Water ponds during peak runoff

Some corrective measures are proposed

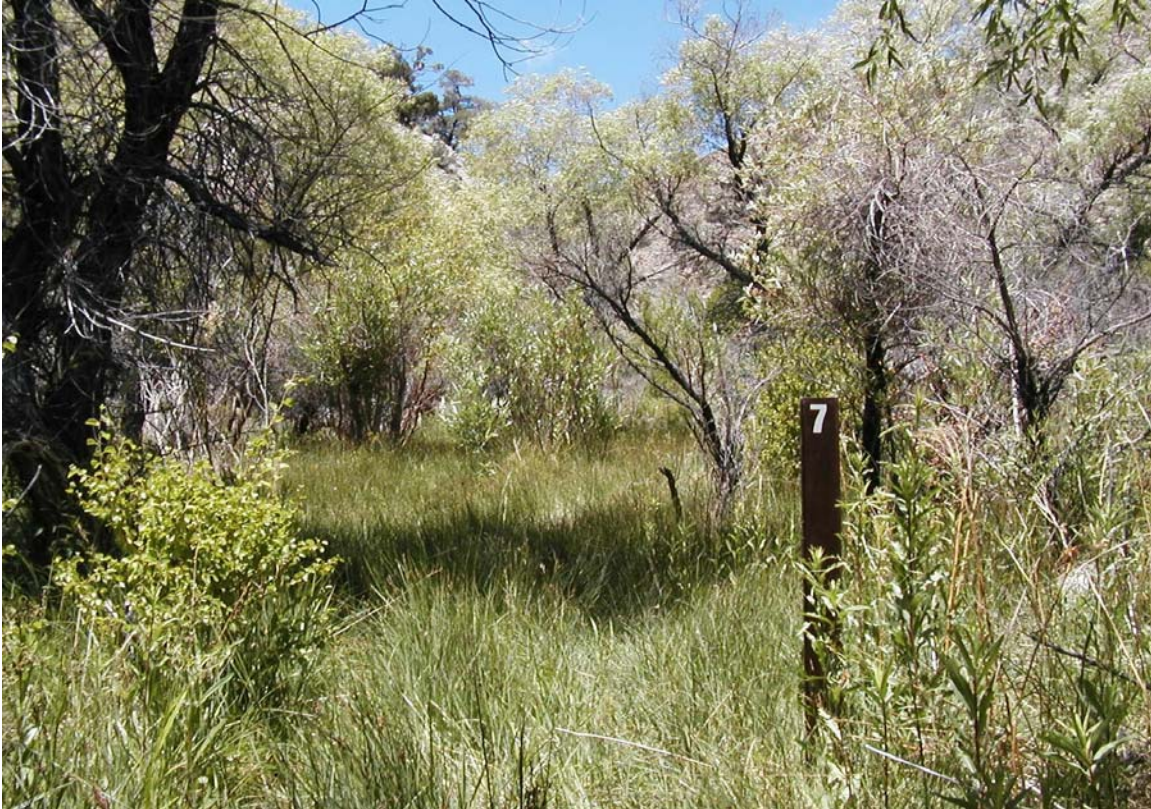
## Crossing 7 - 1.40 miles from BLM Gate Elevation 6180'

Crossing is approximately 60' wide

Wet crossing; vegetation loss

Road and stream in same channel

Road is channelizing water flow; interfering with normal flow regime

Evidence of road ruts

Some corrective measures are proposed, including realignment

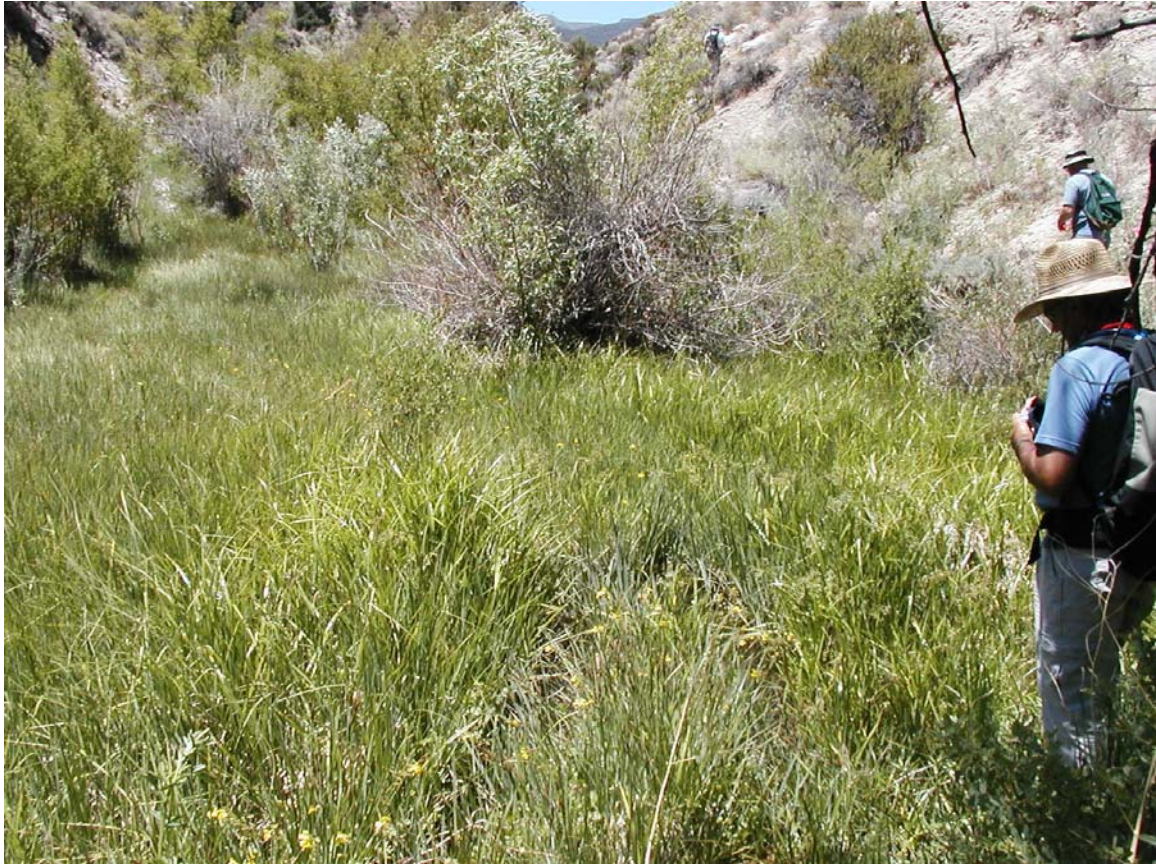
## Crossing 8 - 1.50 mile from BLM Gate Elevation 6200'

Crossing 120' long

Wet crossing; vegetation loss

Road and stream in same channel

Road is channelizing water flow; interfering with normal flow regime

Evidence of road ruts

Some corrective measures are proposed, including realignment

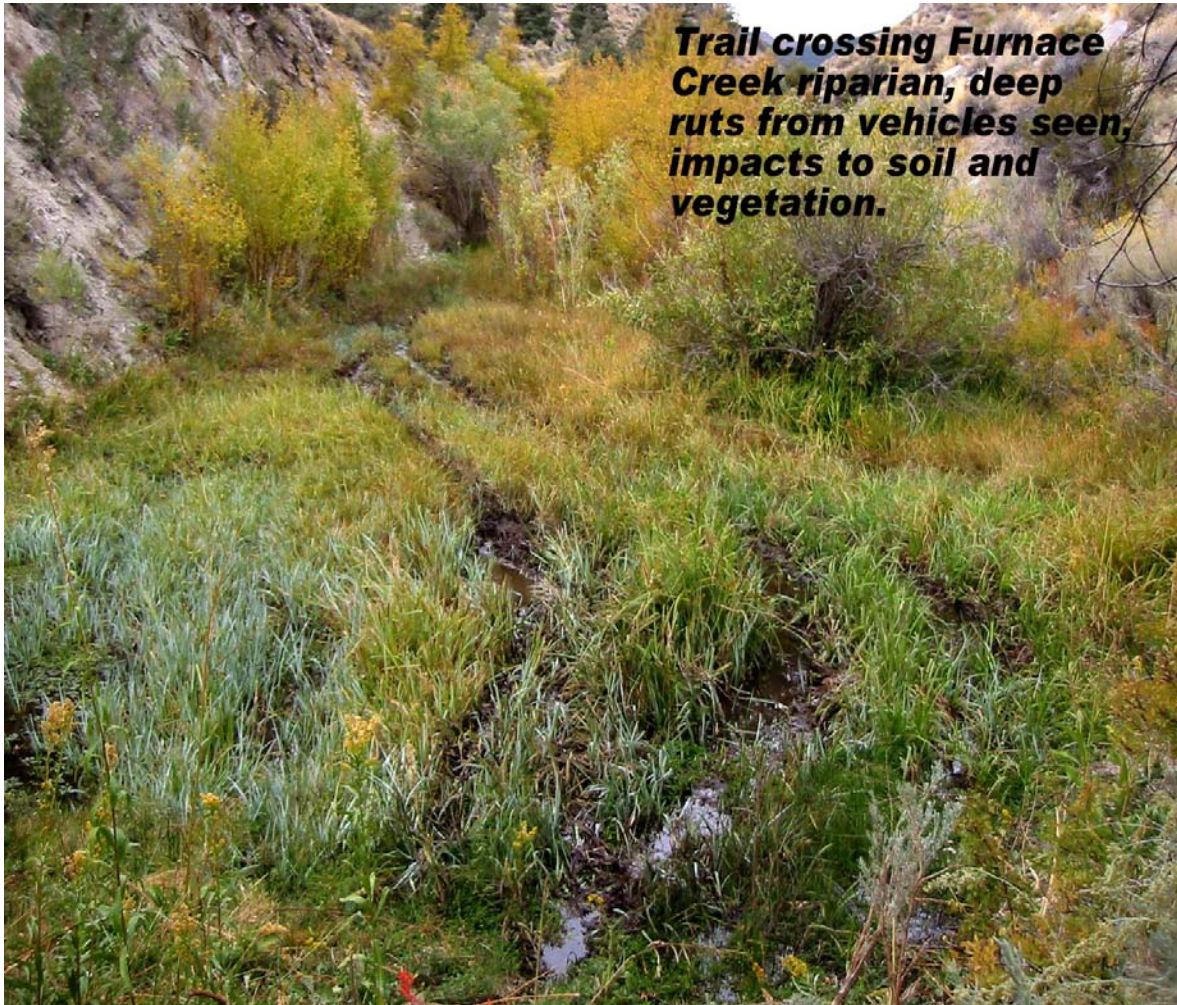
## Crossing 8

\*\*Photograph taken fall 2001, before the interim closure was in place. Ruts that were very obvious in this photo are not so obvious in the photo of Crossing #8 taken in July 2004.

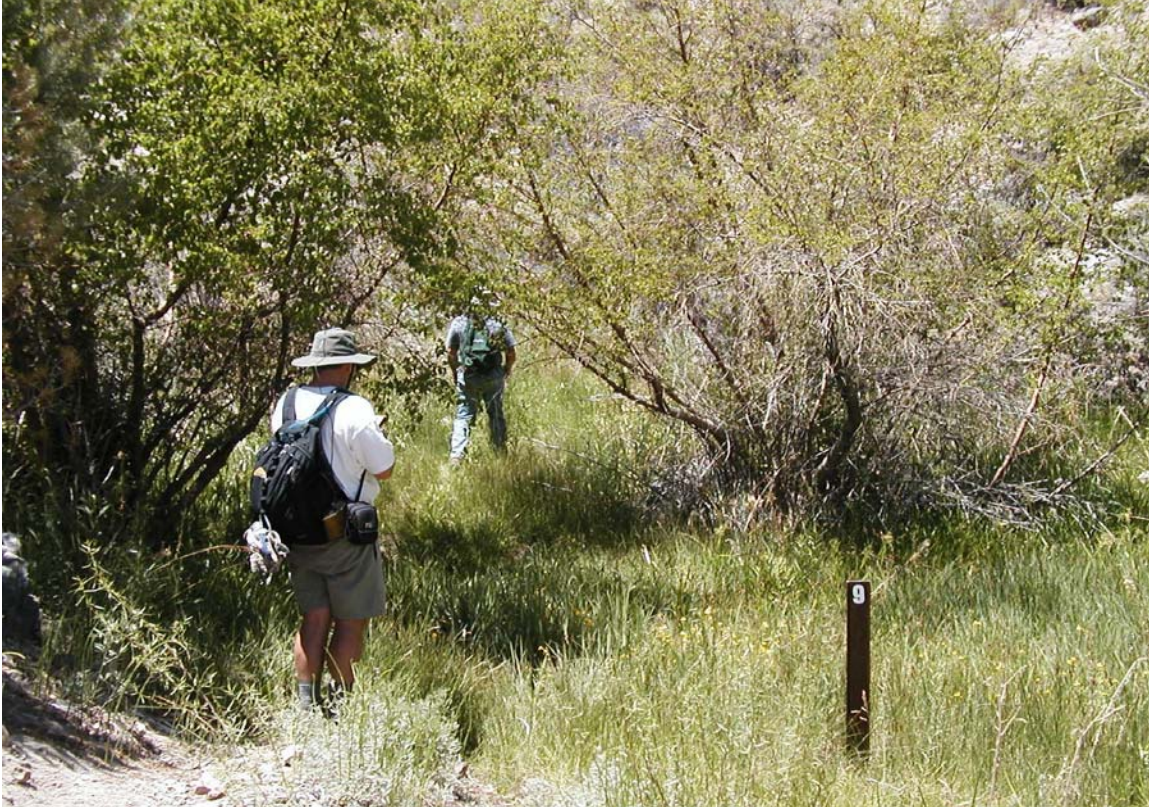
## Crossing 9 - 1.60 miles from BLM Gate Elevation 6260'

Crossing is 20' wide

Wet crossing

Evidence of road ruts

Channel looks natural above and below the channel

Some corrective measures are proposed

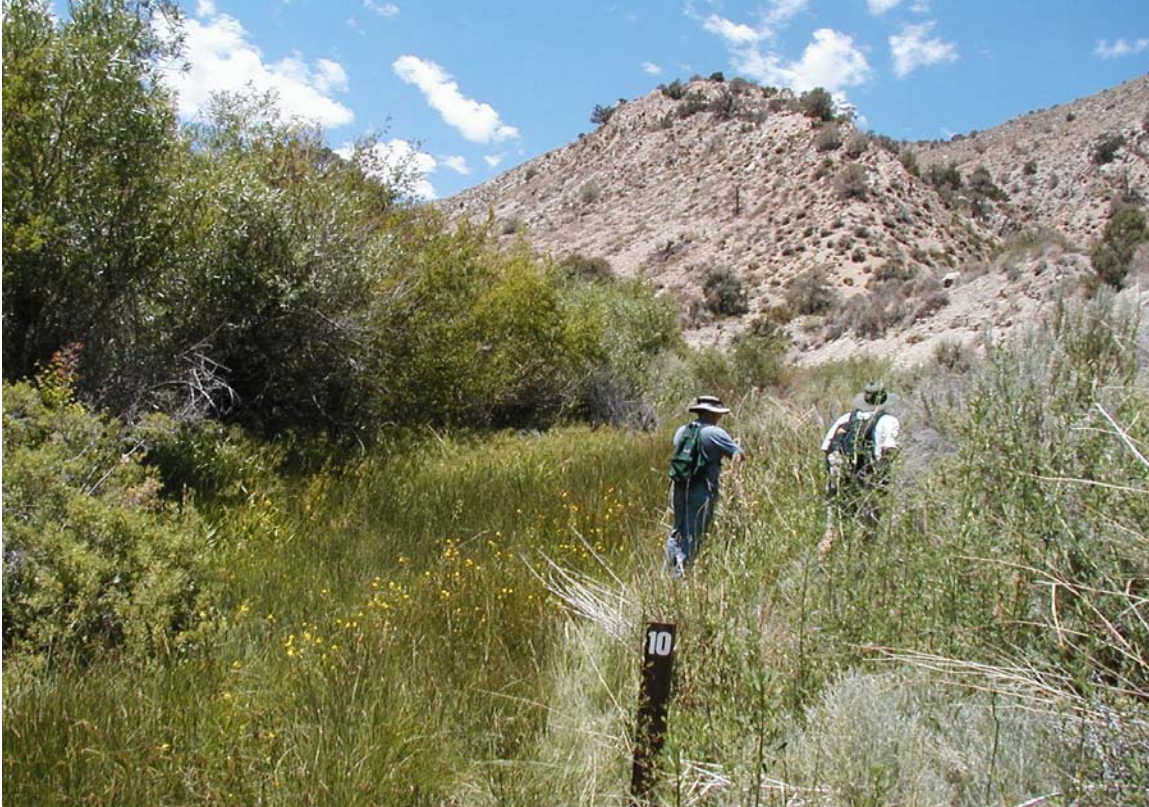
## Crossing 10 - 1.70 miles from BLM gate Elevation 6320'

Crossing is 90' long

Wet crossing; vegetation loss

Road and stream in same channel

Road is channelizing water flow; interfering with normal flow regime

Evidence of road ruts

Some corrective measures are proposed, including realignment

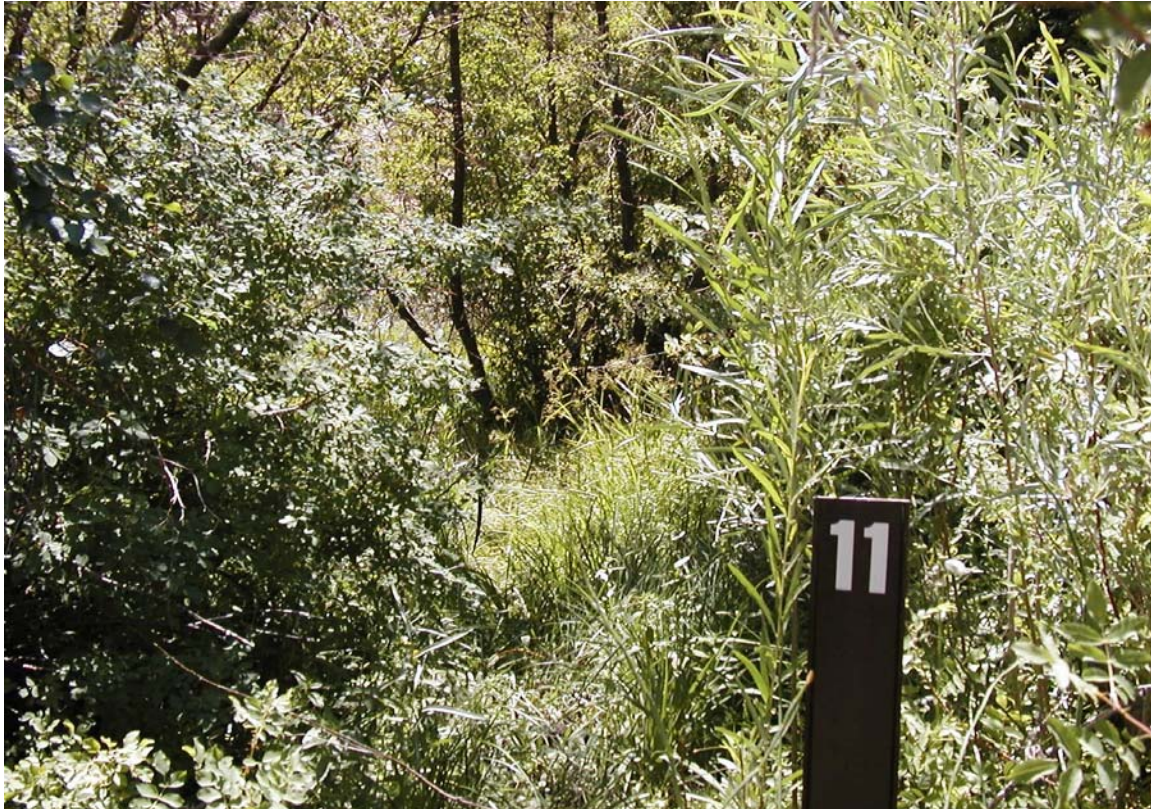
## Crossing 11 - 1.80 mile from BLM Gate Elevation 6385'

Crossing is 50' long

Wet crossing

Evidence of road ruts, scouring, and loss of vegetation

Road interfering with normal flow regime

Some corrective measures are proposed, including realignment

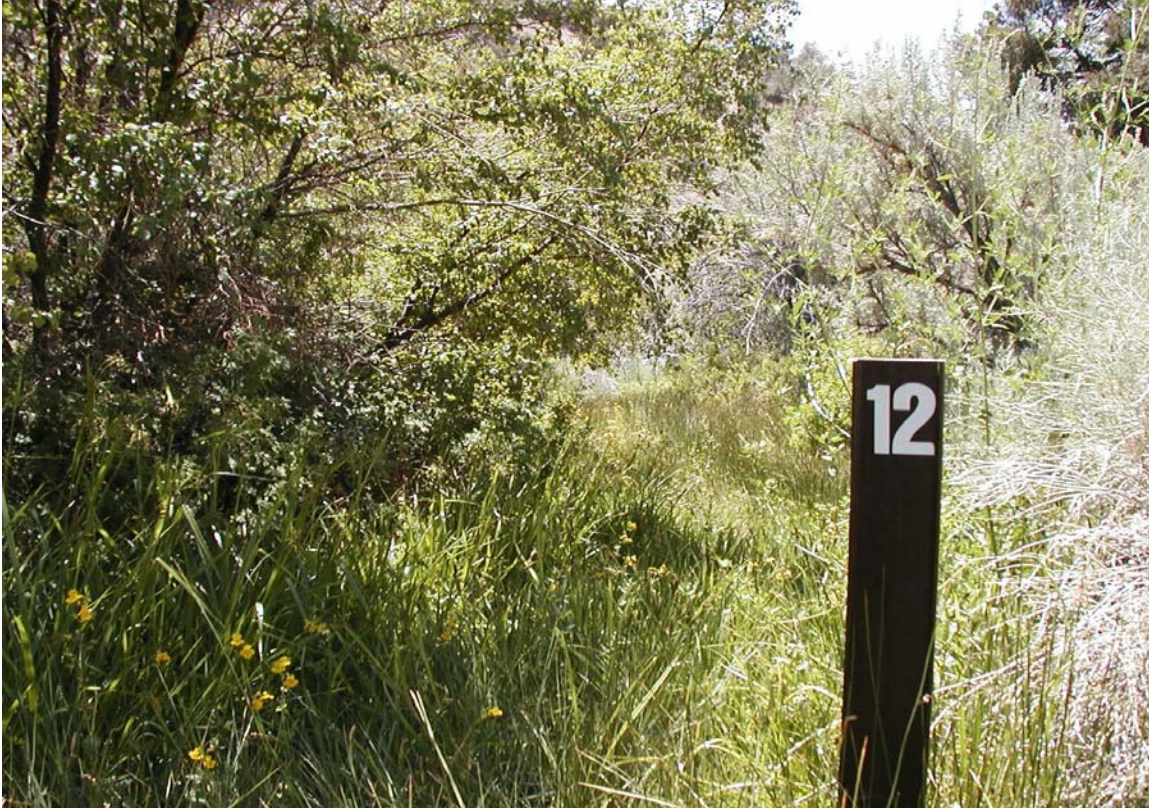
## Crossing 12 - 1.90 miles from BLM Gate Elevation 6430'

Crossing is 178' long

Wet crossing

Stream/road is in the same channel

Normal stream flow regime is altered

Evidence of road ruts

Some corrective measures are proposed, including realignment

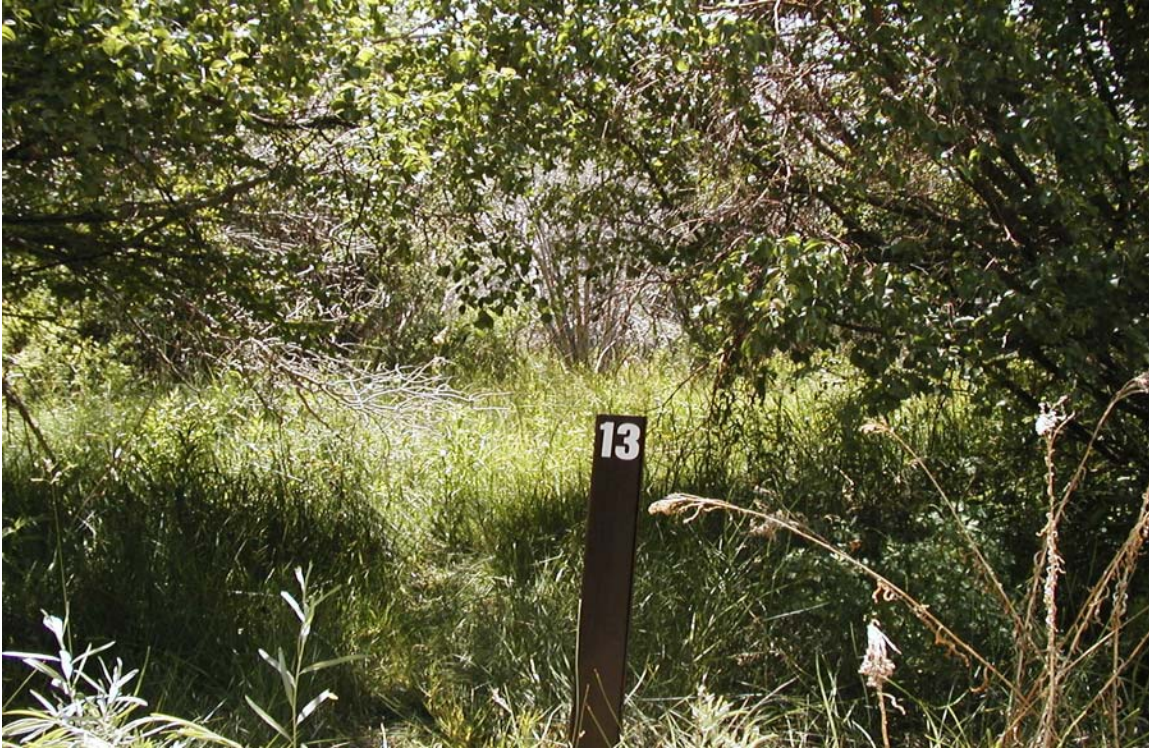
## Crossing 13 - 2.00 mile from BLM Gate Elevation 6460'

Crossing is 630' long

Stream/road is in the same channel

Normal stream flow regime is altered

Evidence of road ruts

Some corrective measures are proposed, including realignment

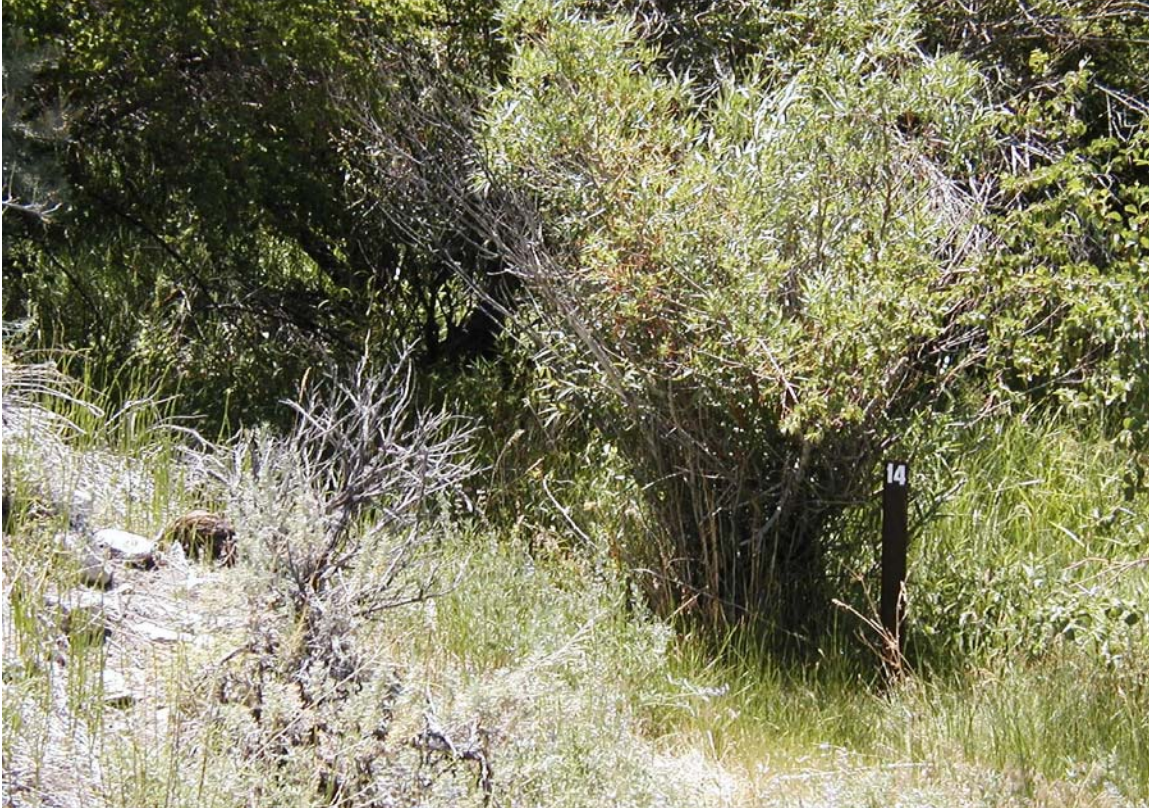
## Crossing 14 - 2.30 mile from BLM Gate Elevation 6665'

Crossing is 35' across

Wet crossing

Evidence of road ruts

Some corrective measures are proposed
