Significant Radioactive Leak at Sellafield due to Operational Complacency

The Office of Environment, Safety and Health is issuing this Environment, Safety and Health Bulletin to provide information about a serious process leak at British Nuclear Group's Thermal Oxide Reprocessing Plant (THORP) in Sellafield, England. Investigators determined that this leak was exacerbated by operators' failure to monitor process indicators.

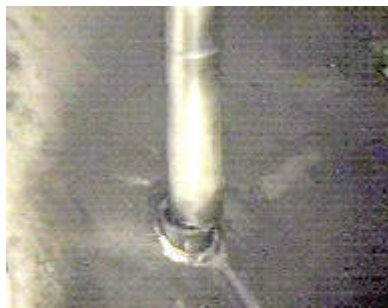
On April 20, 2005, a camera inspection of a feed clarification cell at THORP revealed that 83,000 liters of dissolver solution had leaked from a broken pipe (Figure 1) into the cell sump. The highly radioactive dissolver solution, consisting of approximately 19 metric tons of uranium, plutonium and fission products dissolved in nitric acid, was entirely contained within the stainless steel-lined cell. No personnel were injured as a result of this incident. However, the cleanup costs for this event are expected to exceed \$500 million, and the THORP facility faces a lengthy shutdown (possibly even permanent closure).

Figure 1. Failed Pipe Nozzle on Accountability Vessel

The Board of Inquiry that investigated the incident identified design flaws associated with the accountability vessels that led to fatigue failure of the feed pipe. More seriously, the Board also identified multiple conduct-of-operations failures resulting in the failure to detect a persistent leak for 9 months. The Board characterized these failures as a culture of operational complacency. The Board Report can be accessed at http://www.eh.doe.gov/II/BNFL_THORP_BOI-070705.pdf. The findings from the Board's report are summarized below.

Investigators believe the feed pipe failed because of fatigue stresses induced by excessive vessel movement. This is supported by operator observations of excess vessel vibration and in video footage showing significant movement of the vessel during agitation and emptying cycles.

- Off-normal operating conditions are appropriately identified and acted upon.
- Equipment design issues are independently evaluated.

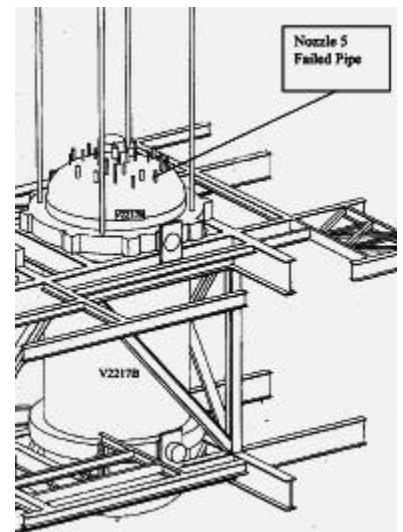
The accountability vessels are suspended from the cell roof to enable operators to weigh the vessel and determine material balances. The vessels are supported by four rods that pass through the roof to a weighing mechanism (Figure 2). The vessels are normally operated in the suspended position, but they can be lowered onto a steel frame to establish data points or to perform calibrations.

The original design of these vessels required restraint blocks to prevent lateral movement of the

Figure 2. Accountability Vessel Assembly

vessels. The design was changed to delete these restraint blocks, but it appears that the effect of this design change on piping stresses was not evaluated.
