Modification of Visual Approach Slope Indicator Baffles at Pearson Field Airpark, Vancouver, WA

June 2007

DOT/FAA/AR-TN07/12

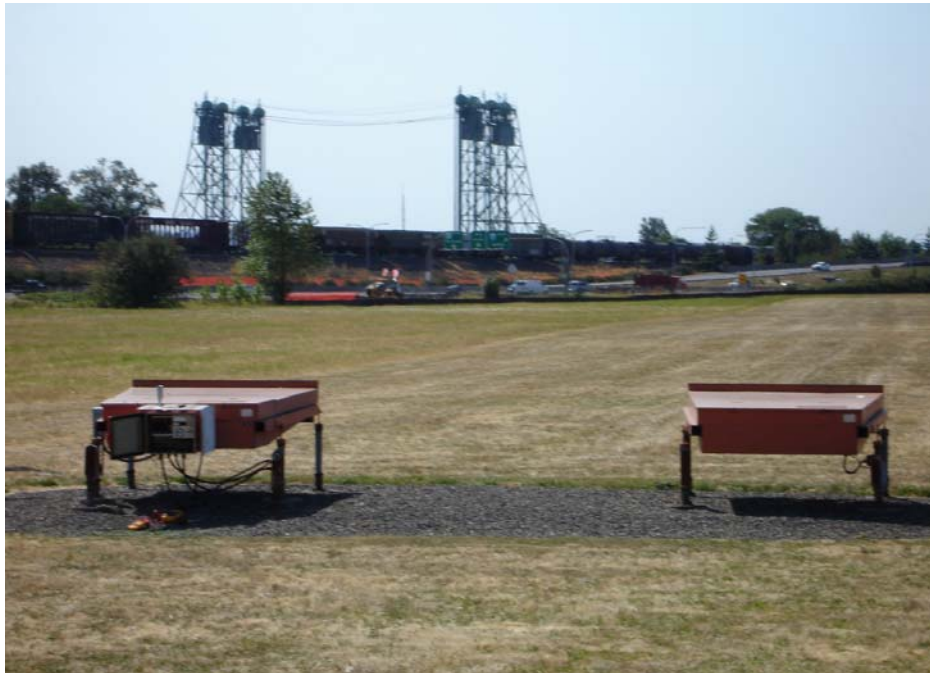
In the situation at Pearson's runway 8 VASI system, portions of the on glide path signal intersected with the northern-most vertical supports of the Interstate I-5 bridge connecting OR and WA over the Columbia River (see figure B-1 in appendix B). The FAA Flight Inspection Operations Group failed the VASI system on July 12, 2005, citing the potentially dangerous situation that the VASI signal created by overlapping the bridge obstruction. At that point, the VASI units were placed out of service. It is interesting to note that the VASI at VUO had been baffled many years ago, but over the last 25 years since the units were installed, the units became misaligned.

Figure B-1. Interstate I-5 Bridge Forming Obstruction

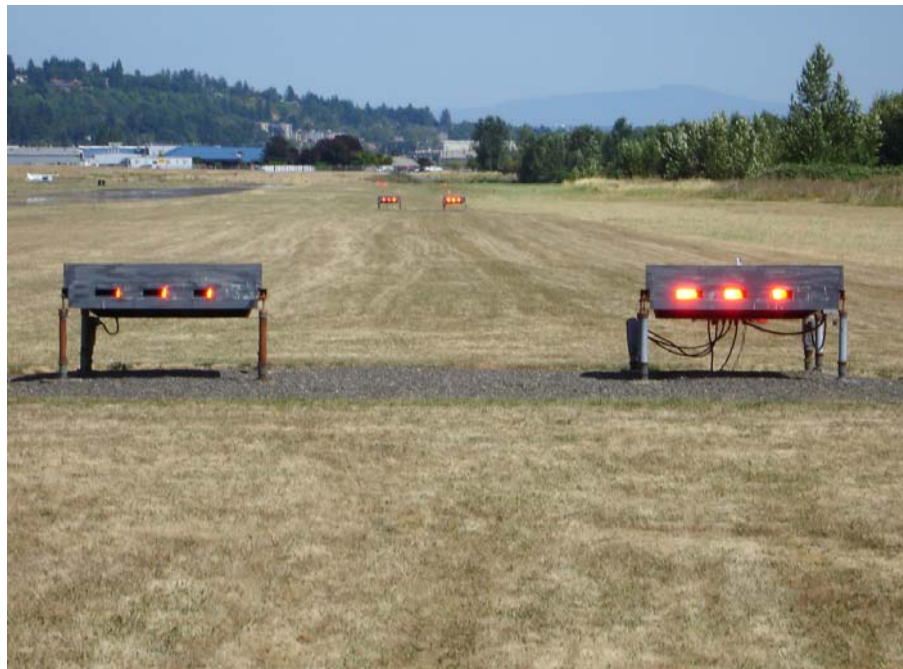
offset distances between the baffles varied with each unit. Furthermore, the inner baffles were attached using rivets to the sectional supports of the ceiling of the boxes, and were left in a hanging position without any support on the bottom. The inner baffles were constructed of 1/16-in.-thick aluminum. Over time, this type of material does have a tendency to warp and twist, and can contribute to the problem with the light being visible beyond the obstruction. It was determined, however, that the twisting and nonsymmetrical positioning of the baffles was not the cause of the problem at Pearson.

Figure B-2. The VASI Units Before Modification

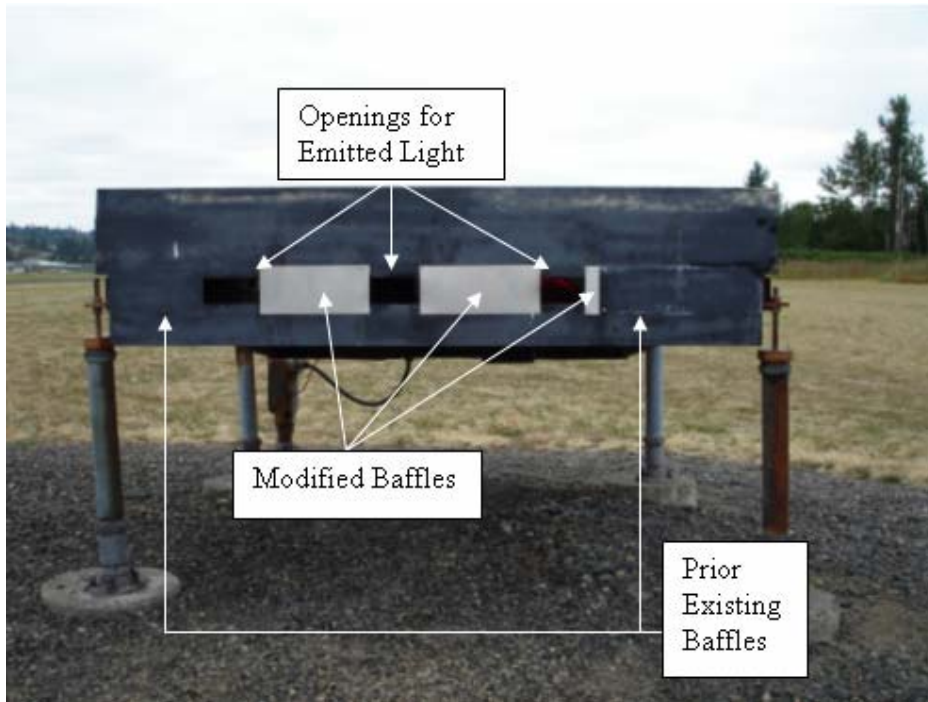
The outer baffles of a VASI unit are designed to restrict the angle of light laterally across the final approach area, and can be adjusted by increasing or decreasing the overall horizontal width of each outer baffle (see figure B-6 in appendix B). These outer baffles are also made of aluminum, and are approximately 6 in. high (enough to cover the 4-in. opening in the front of the VASI unit), and vary in width depending on their purpose. In the situation at Pearson, it was determined that the horizontal lengths of the outer baffles were the only elements of the system that needed modification to restrict the lateral coverage of the VASI signal.

Figure B-6. Front View of a Modified VASI Unit

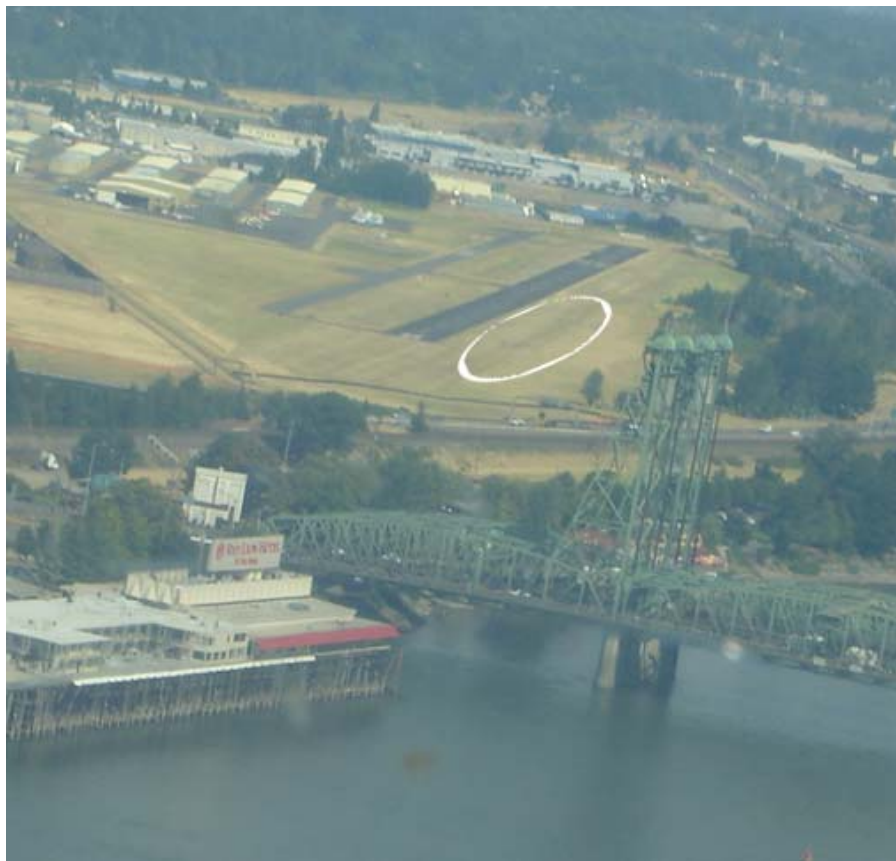
After the units were satisfactorily baffled, a Cessna 172 was used to conduct airborne flight evaluations of the VASI units. A series of approaches to runway 8 were flown from about 6 mi out, over the Columbia River, along the right-most limits of the usable VASI signal. The flight evaluations revealed that the baffle modifications made to the VASI units were successfully blocking light along the baffled line path. Visible light from the units was detected at distances greater than 3 nautical miles along the runway centerline. During each approach, the pilot flew the aircraft towards the VASI units, wavering left and right of the baffled lines, to evaluate the point at which the VASI signal was visible (see figure B-7 in appendix B) and not visible (see figure B-8 in appendix B).

Figure B-8. Flight Evaluation Right of Baffled Line—VASI Signal not Visible
