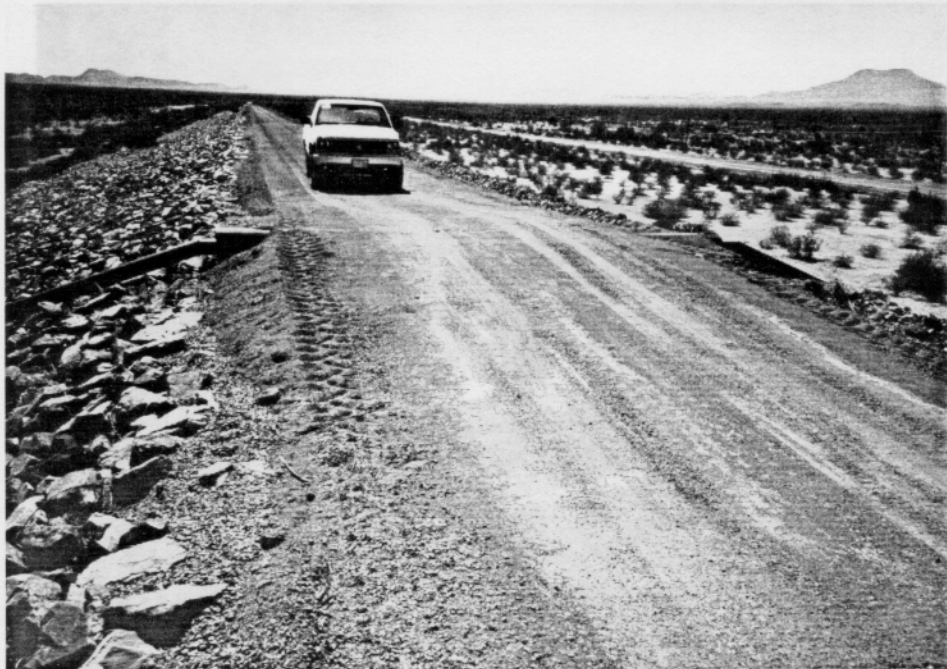
Photo No. 2-01. Pipeline Crossing over Dam Embankment.

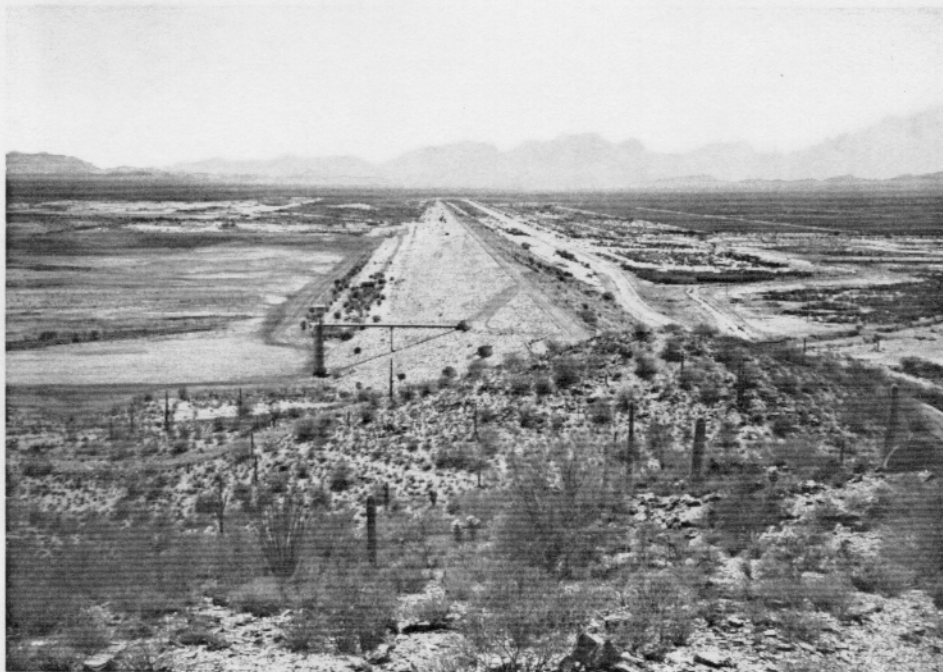
Photo 2-02. Upstream Face of the Tat Momolikot Dam Embankment (looking west from the overlook area).

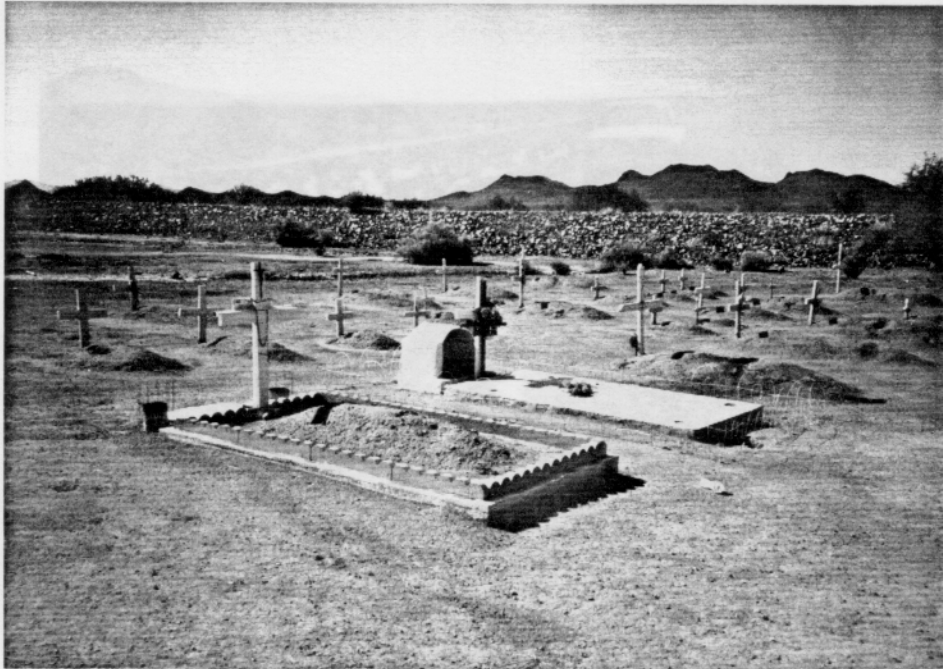
Photo 2-03. Tat Momolikot Cemetery and Dike
(beyond the white crosses).

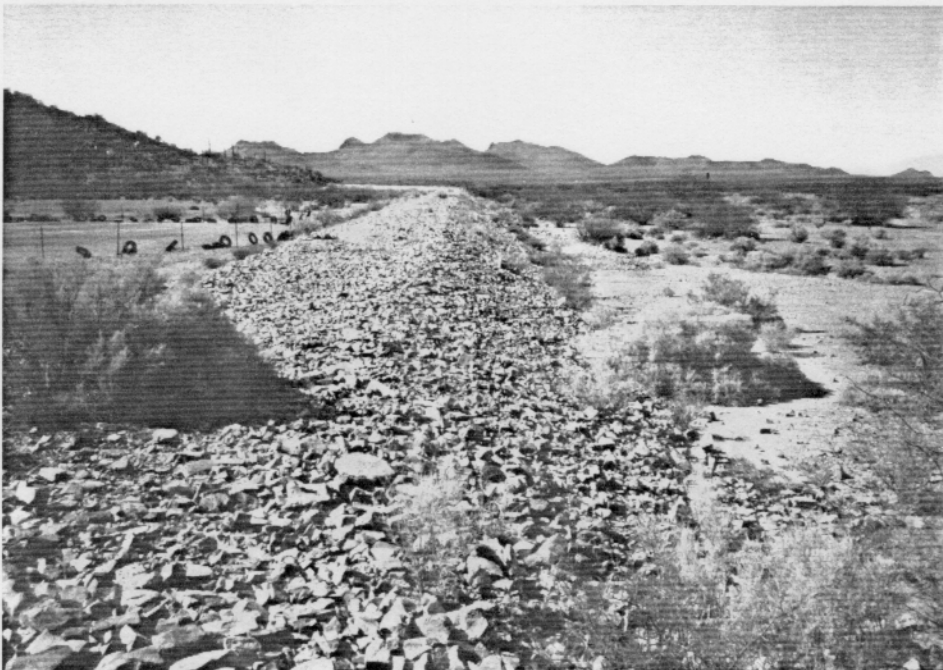
Photo 2-04. Tat Momolikot Village Dike
(looking north along the east village dike).

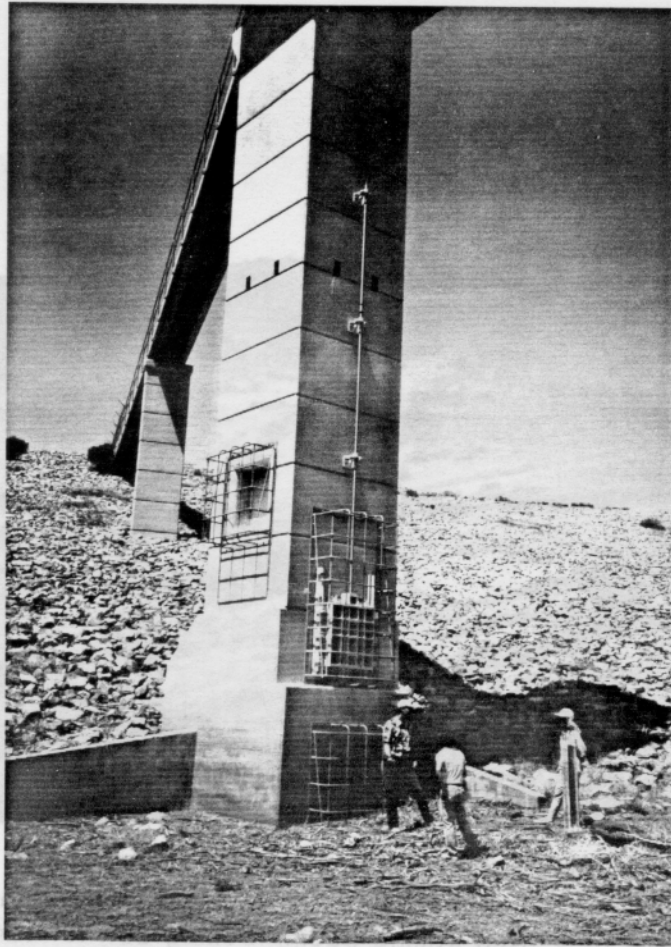
Photo 2-05. Conservation Outlet Works Intake Tower (view from upstream, within reservoir).

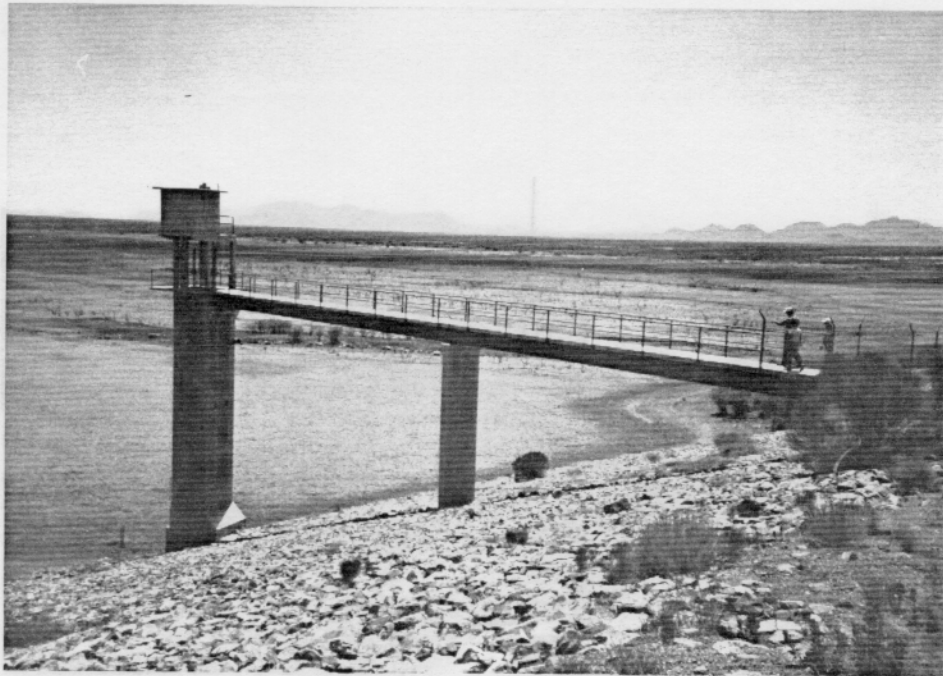
Photo 2-06. Conservation Outlet Works Intake Tower and Access Bridge (looking southwest from the main dam embankment).

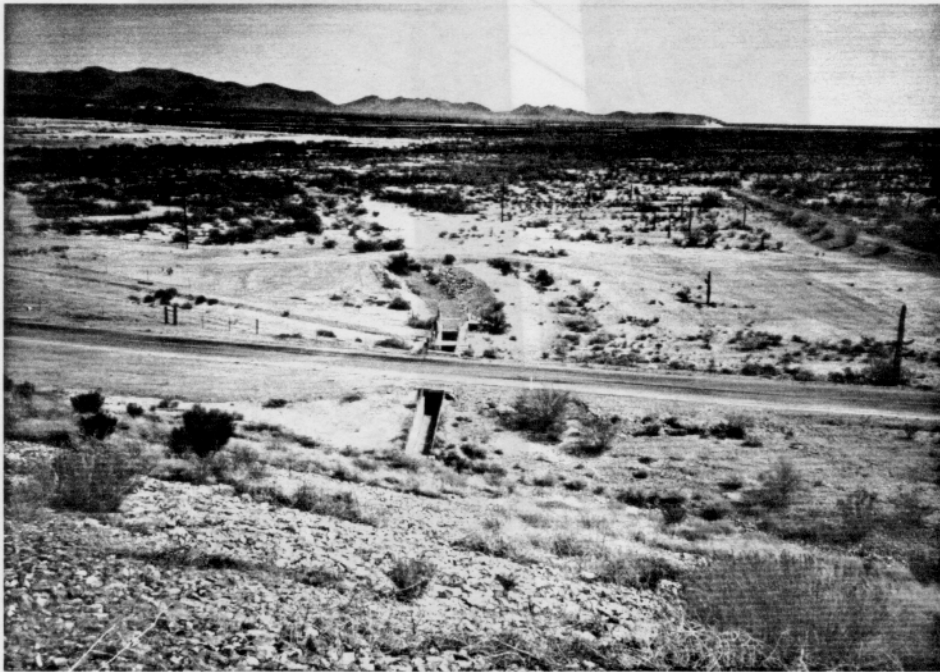
Photo 2-07. Conservation Outlet Works Outlet Channel, Stilling Basin (foreground center), and Vaiva Vo Irrigation Project Canal (left from stilling basin; looking downstream from the main dam embankment).

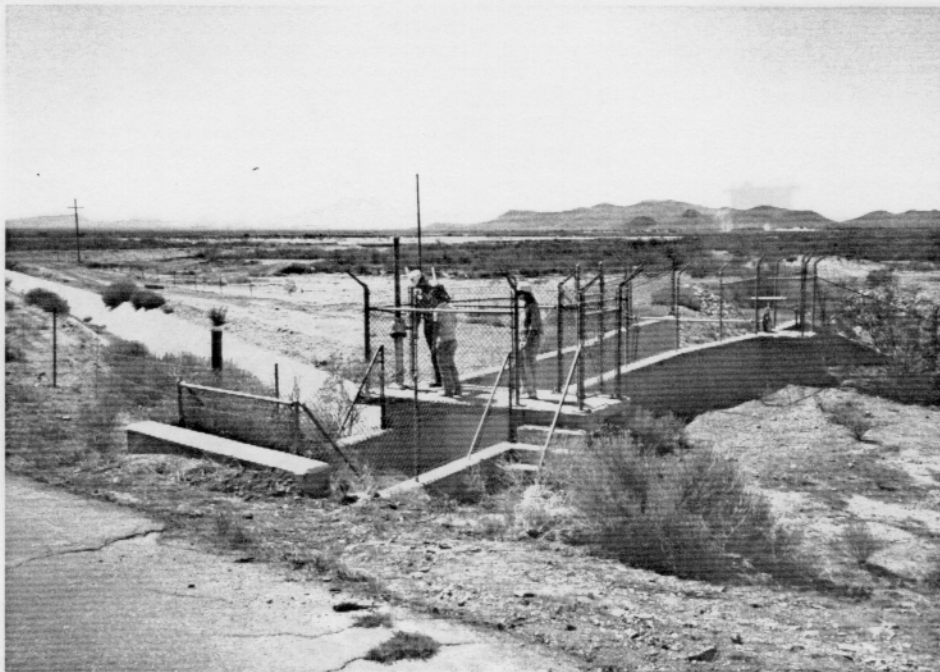
Photo 2-08. Conservation Outlet Works Stilling Basin and Vaiva Vo Irrigation Project Canal (background left; looking northwest from the road).

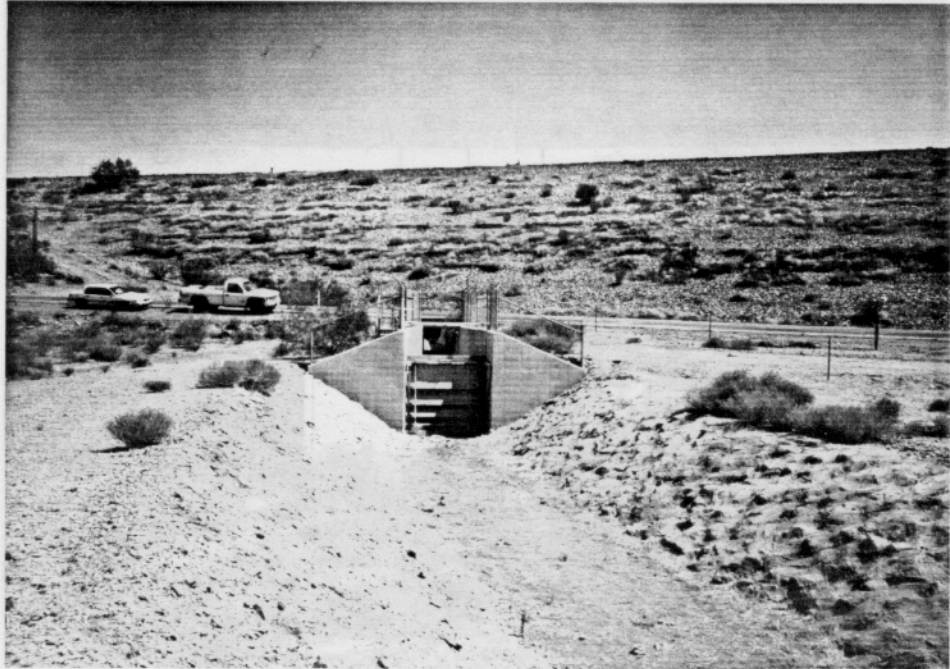
Photo 2-09. Conservation Outlet Works Radial Gate at the Downstream End of the Stilling Basin (view from outlet channel, looking upstream).

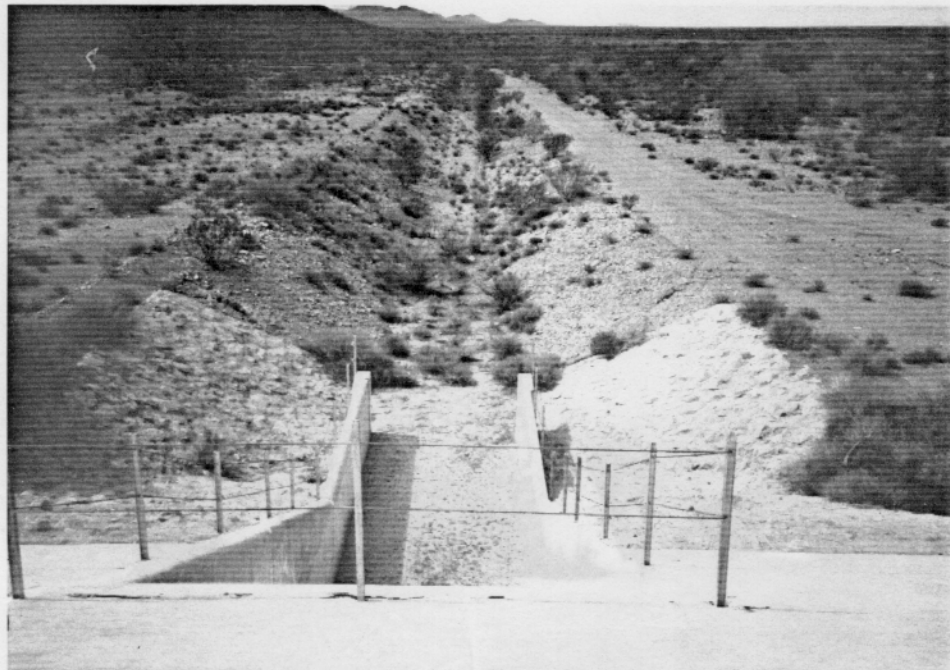
Photo 2-10. Flood Control Outlet Works Approach Channel (view from spillway embankment, looking upstream).

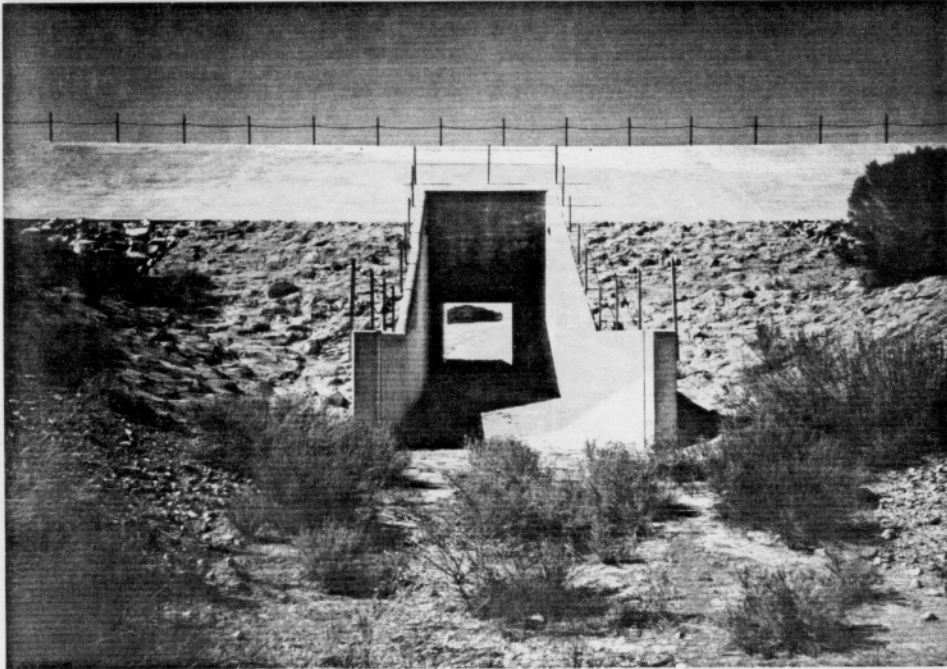
Photo 2-11. Flood Control Outlet Works Conduit
(view from approach channel, looking downstream).

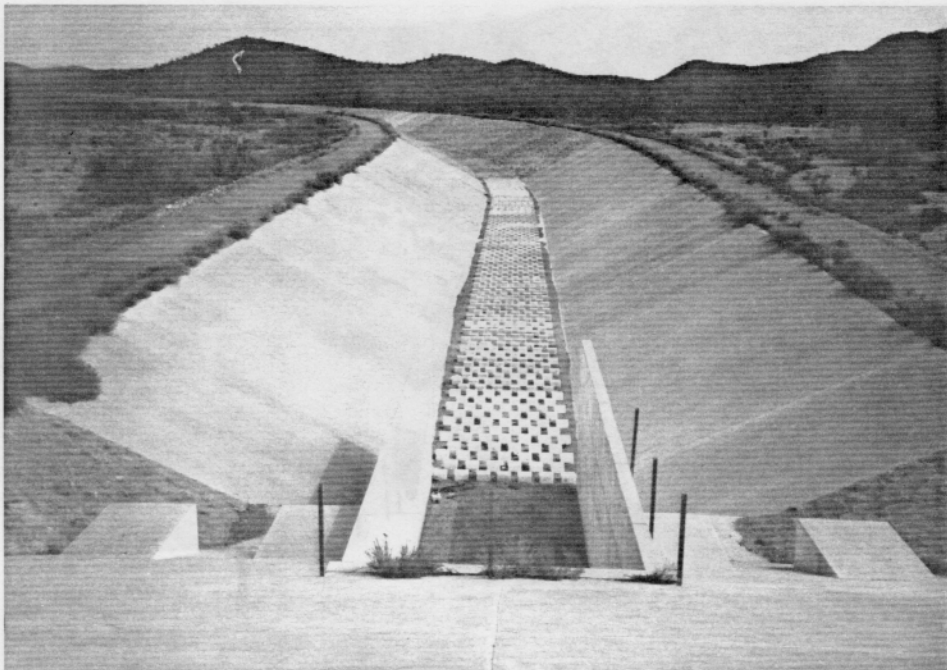
Photo 2-12. Flood Control Outlet Works Outlet Channel
(view from spillway embankment, looking downstream).

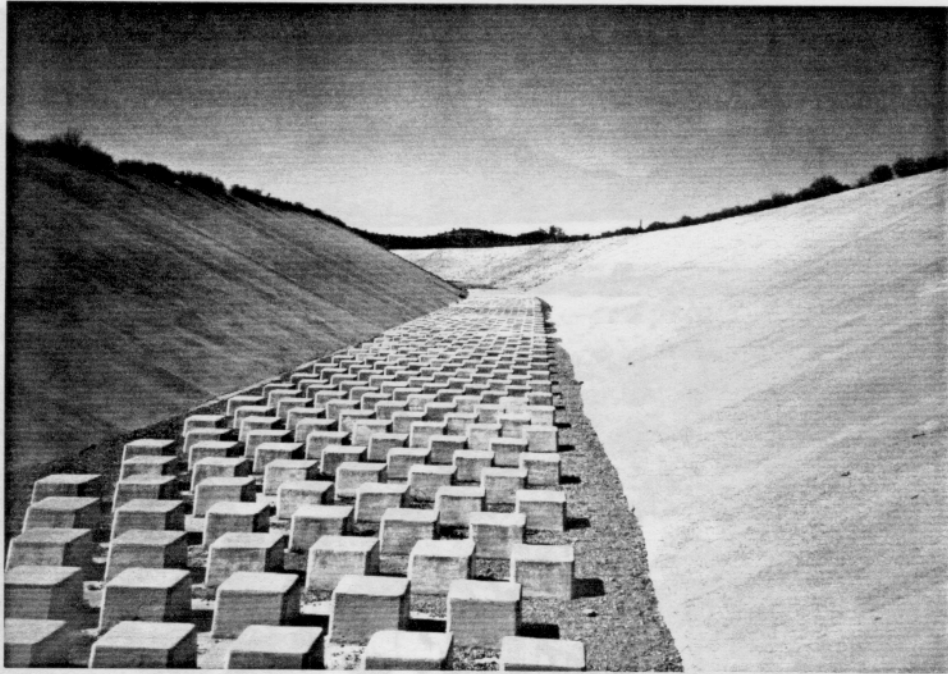
Photo 2-13. Flood Control Outlet Works Outlet Channel
(looking downstream at baffle blocks from within channel).

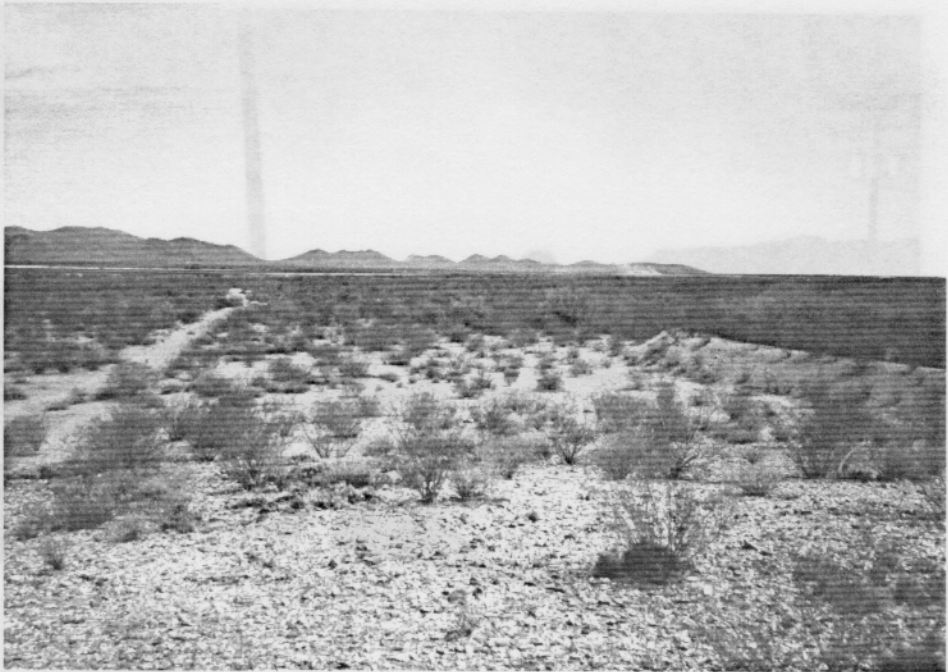
Photo 2-14. Flood Control Outlet Works Outlet Channel
at the Downstream End of the Single Unlined West Levee
(looking northwest toward Santa Rosa Wash).

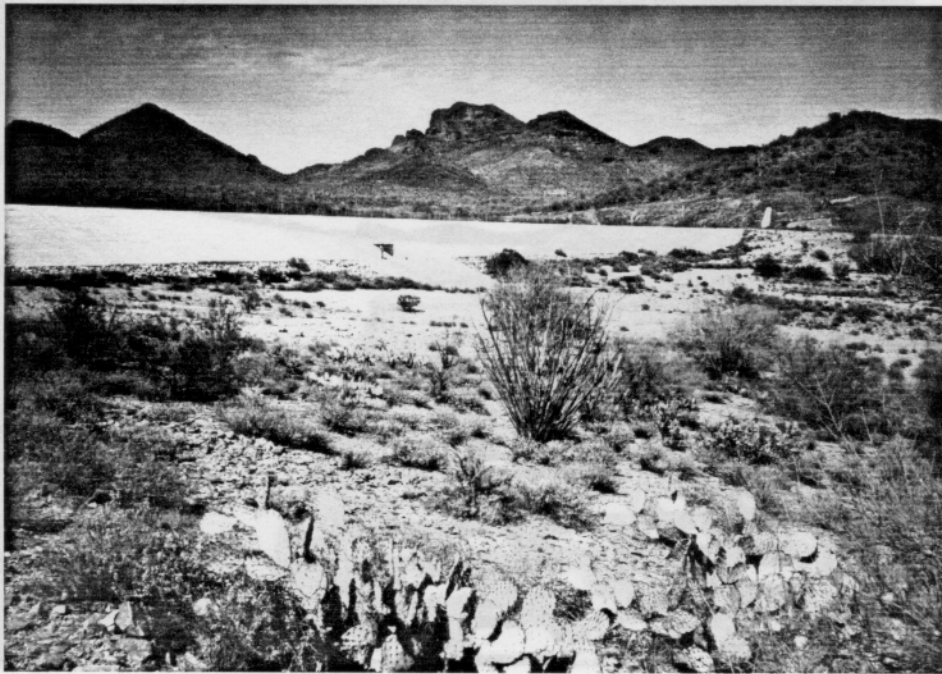
Photo 2-15. Upstream Slope of Spillway (view toward northeast).

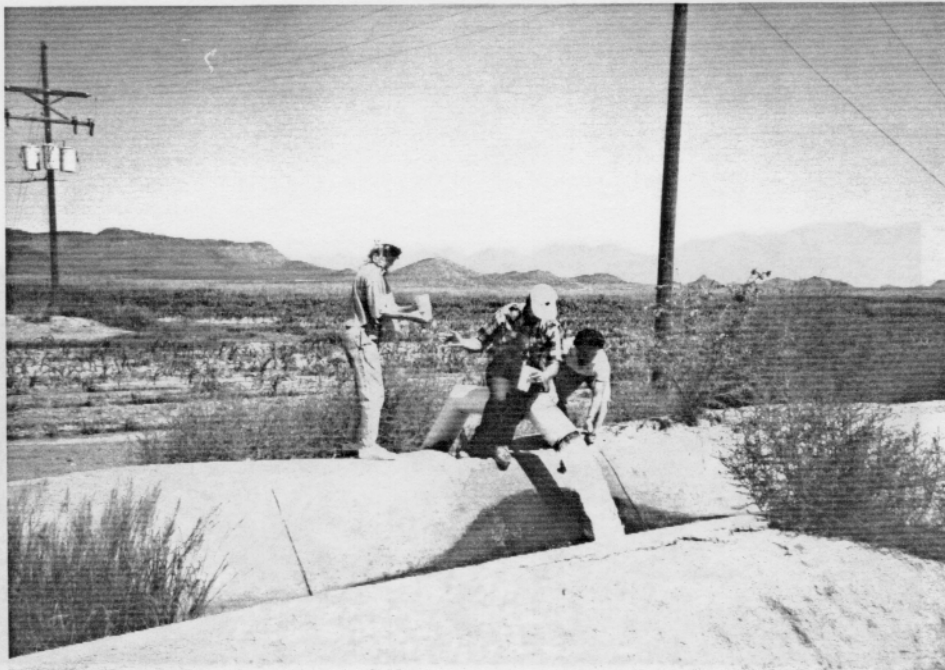
Photo 2-16. Water being pumped into an irrigation canal from a well on the Tonoho O'odham Farm.
