US Army Corps  
Of Engineers  
Nashville District

## Briefing Outline

This is the basic outline of the Wolf Creek briefing.

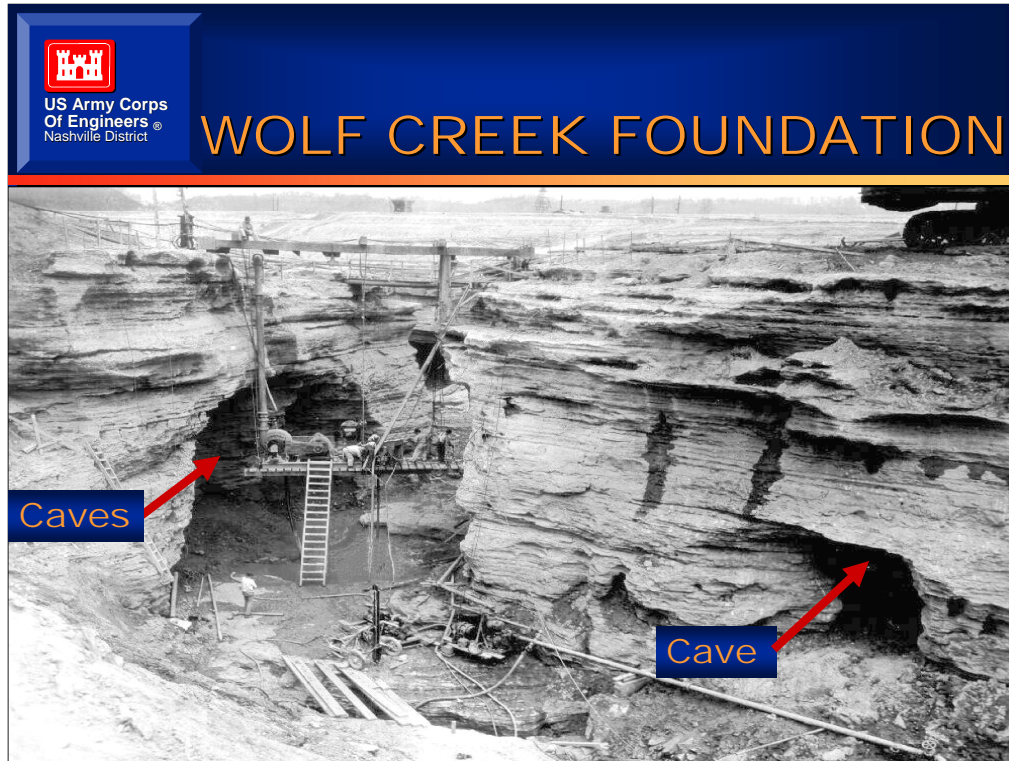
This photo was taken during construction showing conditions that were exposed by the cut-off trench. Many things depicted by this photograph do not meet current construction standards for dam foundation treatment.

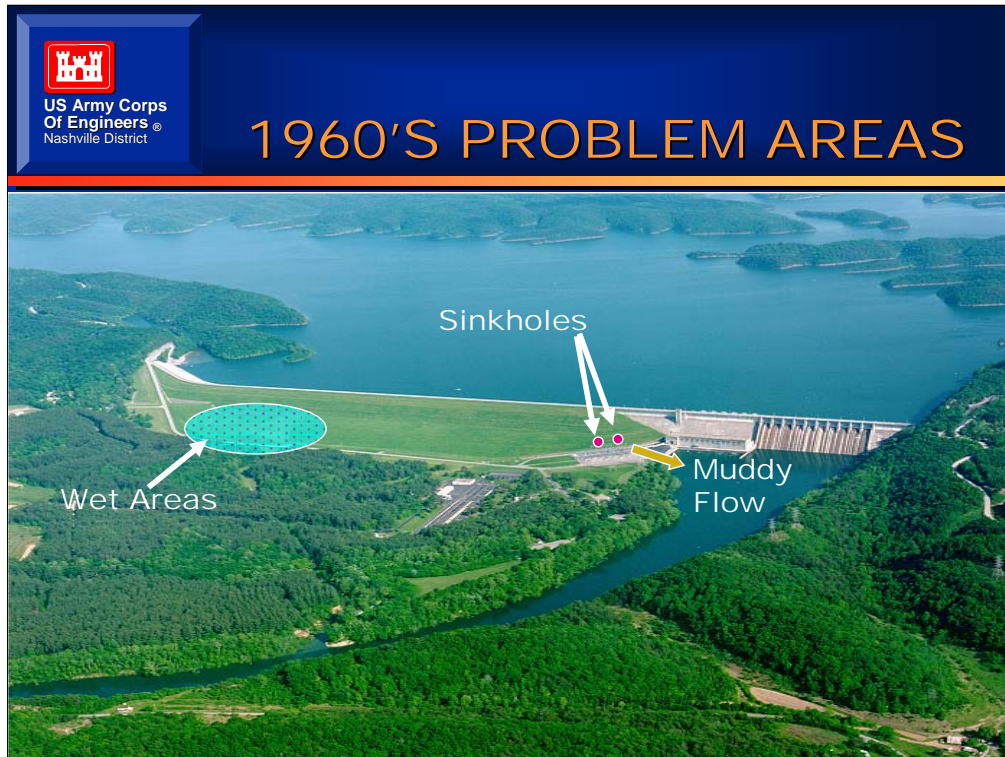
In the 1960s Wolf Creek started exhibiting signs of distress that grew progressively worse until muddy flows and sinkholes triggered an emergency remedial action in 1968 and '69.

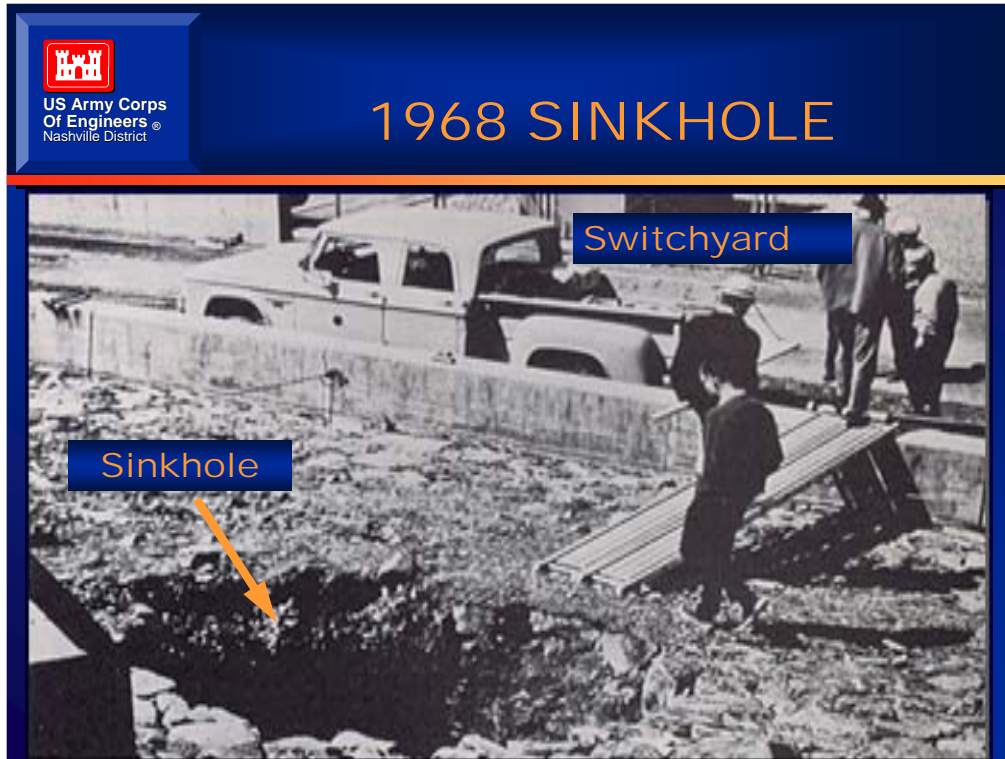
This is what happened at Wolf Creek back in the late 60's

This is a photo of one of the 1968 sinkholes. It was about 13 feet in diameter at the surface and extended to top of rock about 40 feet below the surface.

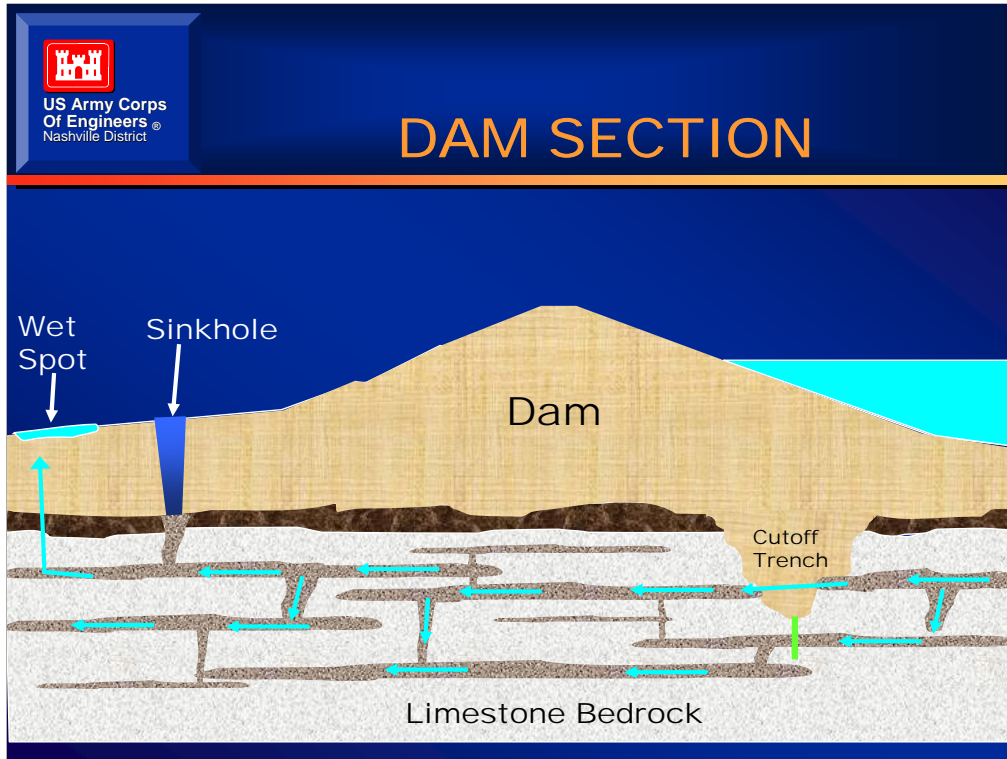
Cross section of the dam showing the presence of sink hole in relation to foundation rock.

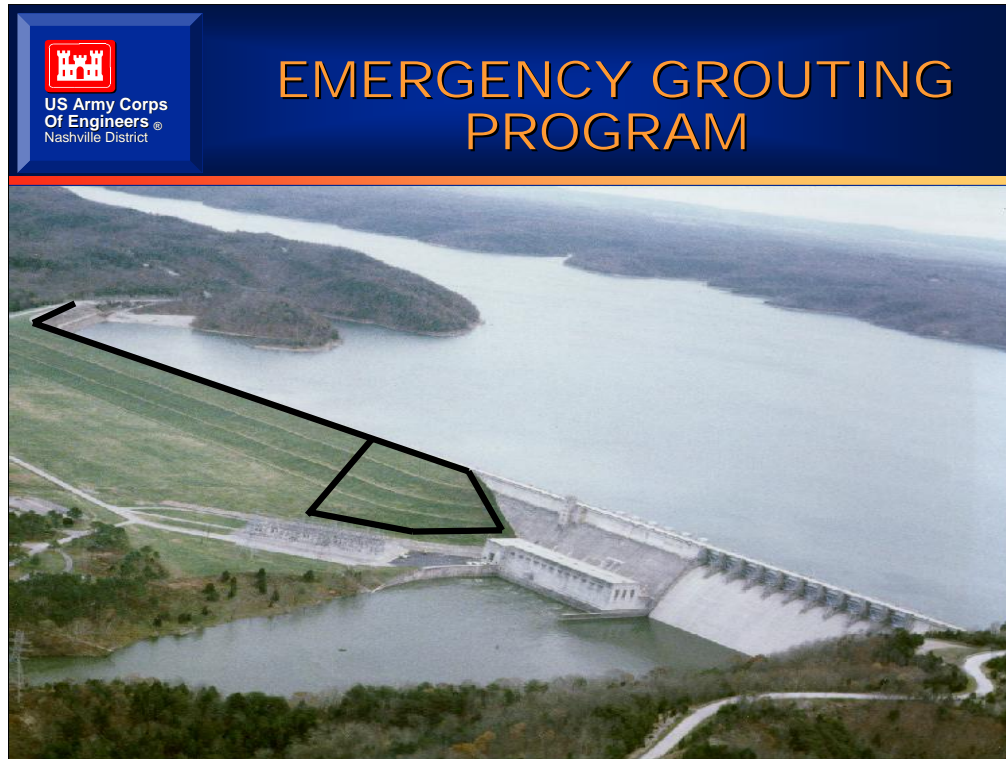
Following the sinkholes, detailed studies and emergency drilling, grouting, and instrumentation program were begun. The Pool was lowered to elevation 680 for about 8 months.

Initial grouting program concentrated in area of embankment/concrete tie-in. Completed in June 1970. Nearly 300,000 ft<sup>3</sup> grout solids injected. To put that in perspective, enough to pave a road 6 inches thick, 20 feet wide, and 5.5 miles long Pz levels reduced, muddy flows stopped Generally credited with preventing failure Additional grouting extended along crest to right abutment between 1970 and 1975

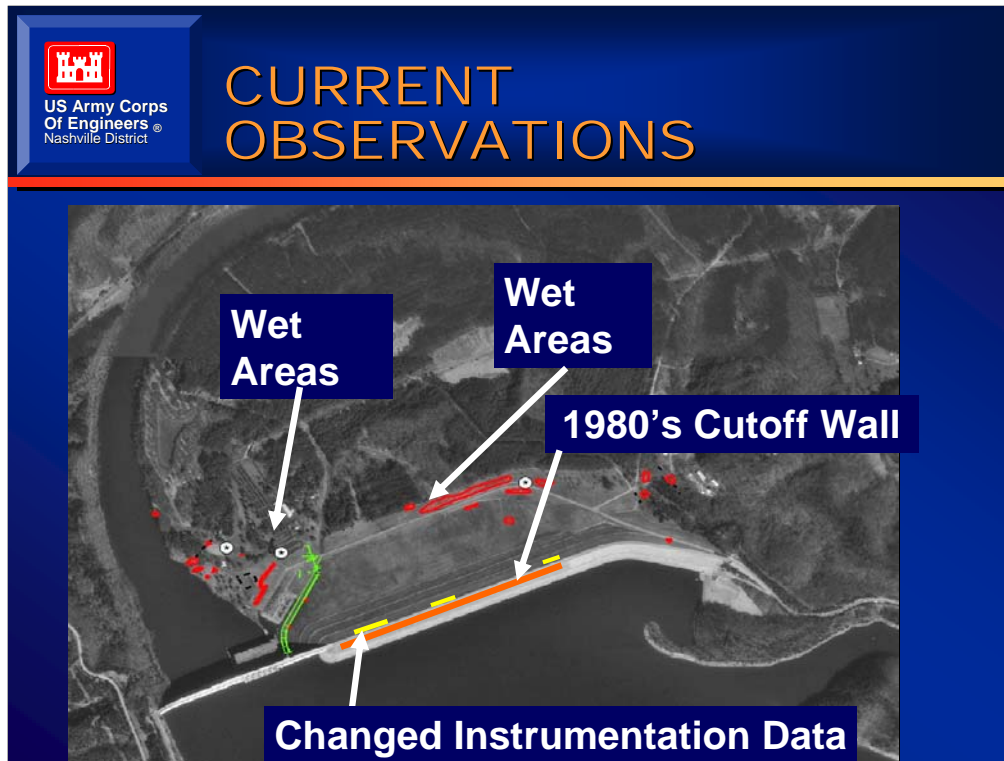
This aerial view shows the present distribution of distress indicators. These have advanced to the point where a major rehabilitation of the project is justified. A new cutoff wall is planned to accomplish this.

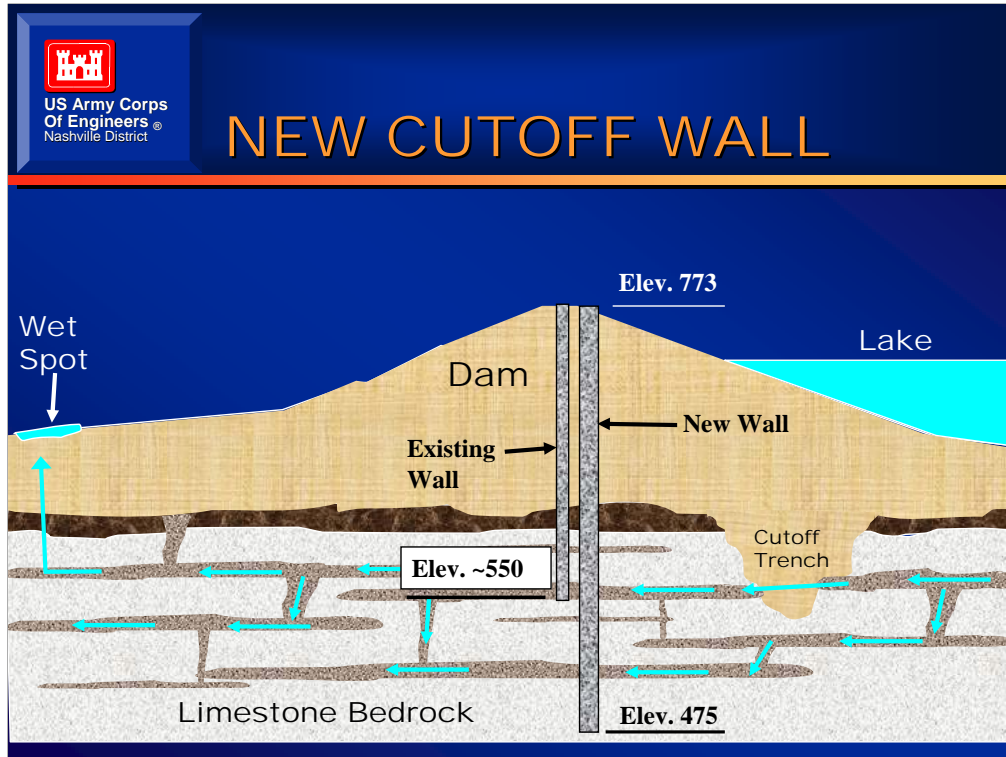
A cross section of the dam showing the location of the old and new cut-off walls. The old wall was a pioneering construction effort. The technology for installing these walls has advanced considerably in the past 25 years. The new wall will be superior to the old wall.
