# COLUMBIA

## ACCIDENT INVESTIGATION BOARD

REPORT VOLUME I  
AUGUST 2003

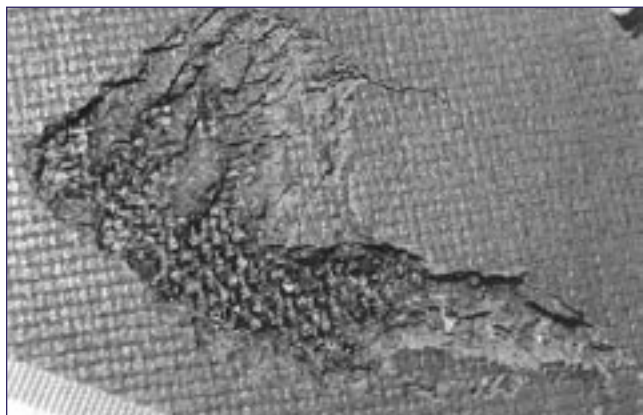
Figure 3.3-2. Damage on the outer surface of RCC panel 10-right from *Atlantis* after STS-45.

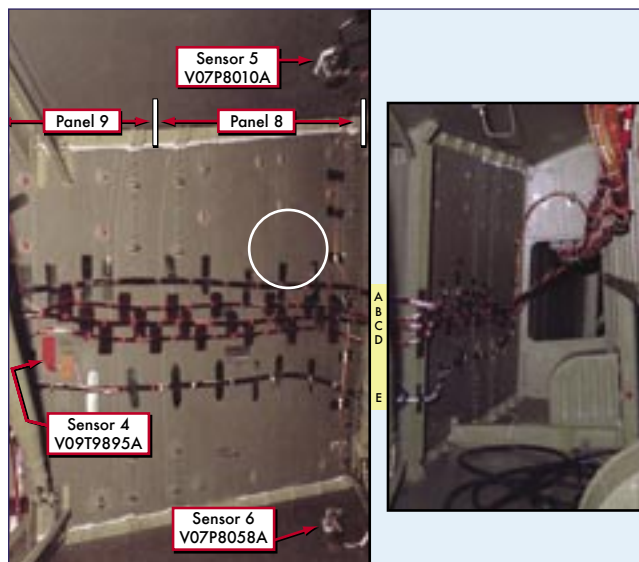
Figure 3.6-8. The left photo above shows the wiring runs on the backside of the wing leading edge behind RCC panel 8 – the circle marks the most likely area where the burn through of the wing leading edge spar initially occurred at EI+487 seconds. The right photo shows the wire bundles as they continue forward behind RCC panels 7 and 6. The major cable bundles in the upper right of the right photo carried the majority of the sensor data inside the wing. As these bundles were burned, controllers on the ground began seeing off-nominal sensor indications.

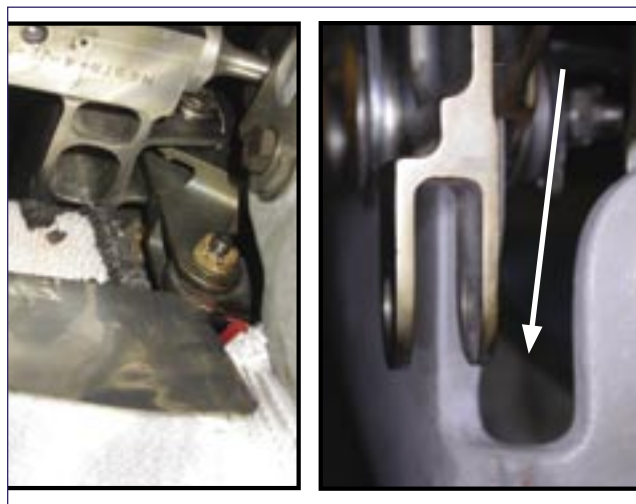
*Figure 3.7-2. Each RCC panel has a U-shaped slot (see arrow) in the back of the panel. Once superheated air entered the breach in RCC panel 8, some of that superheated air went through this slot and caused substantial damage to the Thermal Protection System tiles behind this area.*

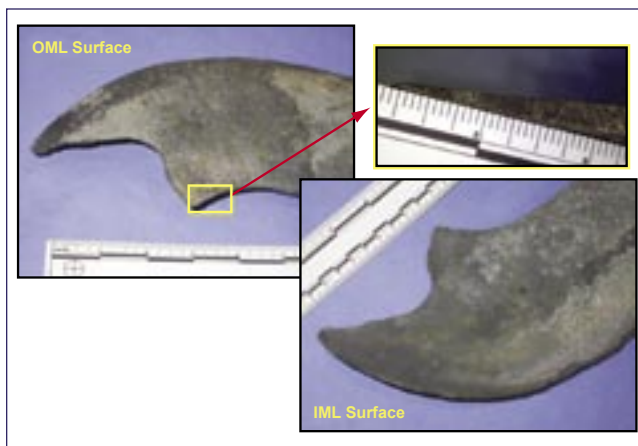
Figure 3.7-4. The outboard rib of panel 8 and the inboard rib of panel 9 showed signs of extreme heating and erosion. RCC erosion of this magnitude was not observed in any other location on the Orbiter.

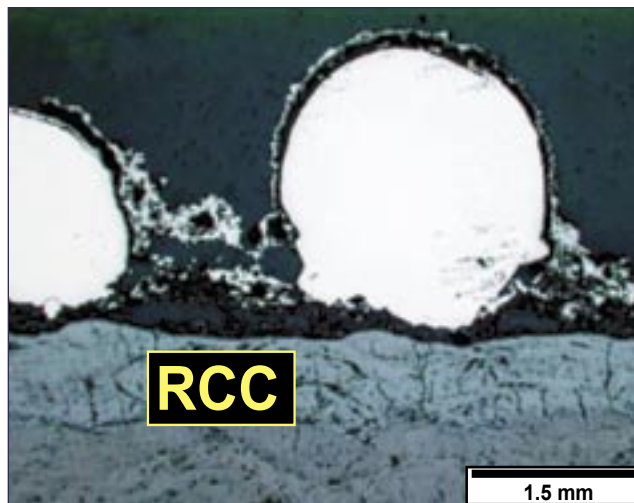
*Figure 3.7-8. Spheroids of Inconel 718 and Cerachrome were deposited directly on the surface of RCC panel 8-left. This slag deposit pattern was not seen on any other RCC panels.*
