Part One

The Accident

Part One of the report of the Columbia Accident Investigation Board is organized into four chapters. In order to set the background for further discussion, Chapter 1 relates the history of the Space Shuttle Program before the *Challenger* accident. The events leading to the original approval of the Space Shuttle Program are recounted, as well as an examination of some of the promises made in order to gain that approval. In retrospect, many of these promises could never have been achieved. Chapter 2 documents the final flight of *Columbia*. As a straightforward record of the event, it contains no findings or recommendations. Chapter 3 reviews five analytical paths – aerodynamic, thermodynamic, sensor data timeline, debris reconstruction, and imaging evidence – to show that all five independently arrive at the same conclusion. Chapter 4 describes the investigation into other possible physical factors that might have contributed to the accident, but were subsequently dismissed as possible causes.

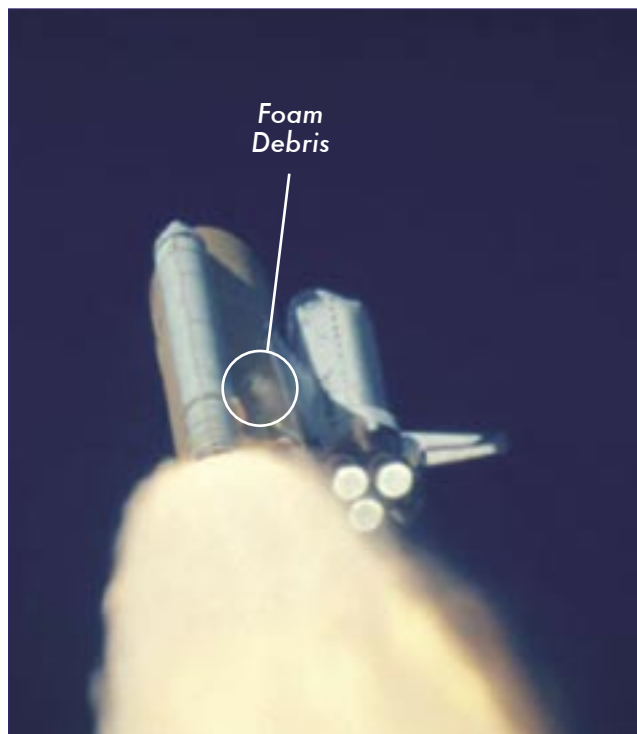
Figure 2.3-2. A shower of foam debris after the impact on *Columbia's* left wing. The event was not observed in real time.

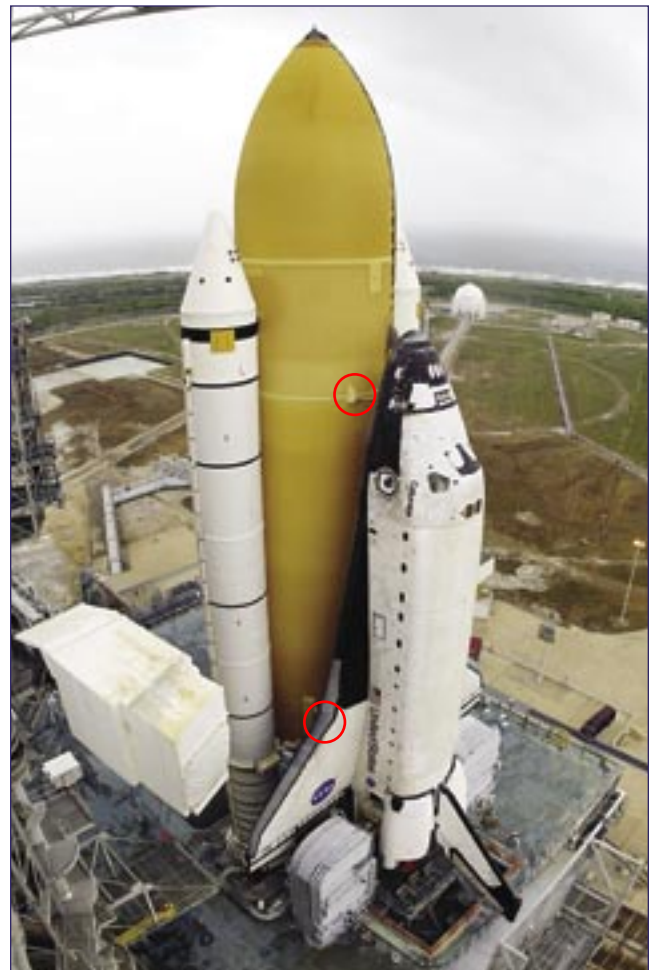
Figure 3.1-1. Columbia sitting at Launch Complex 39-A. The upper circle shows the left bipod (-Y) ramp on the forward attach point, while the lower circle is around RCC panel 8-left.

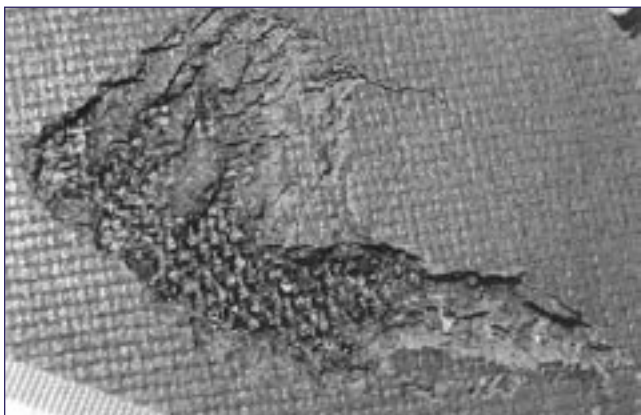
Figure 3.3-2. Damage on the outer surface of RCC panel 10-right from *Atlantis* after STS-45.

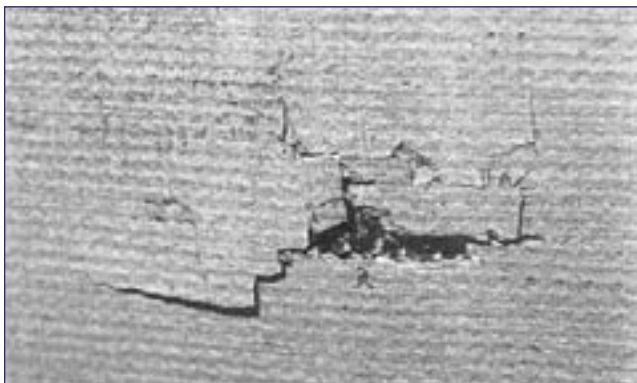
Figure 3.3-3. Damage on the inner surface of RCC panel 10-right from *Atlantis* after STS-45.

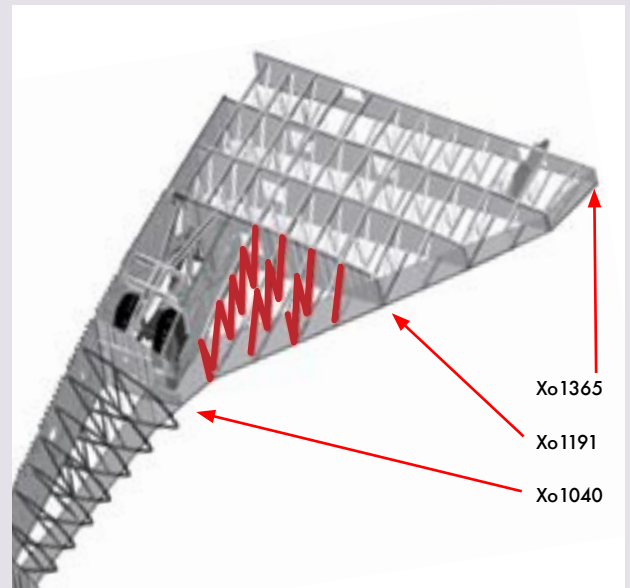
The major internal support structures in the mid-wing are constructed from aluminum alloy. Since aluminum melts at 1,200 degrees Fahrenheit, it is likely these truss tubes in the mid-wing were destroyed and wing structural integrity was lost.

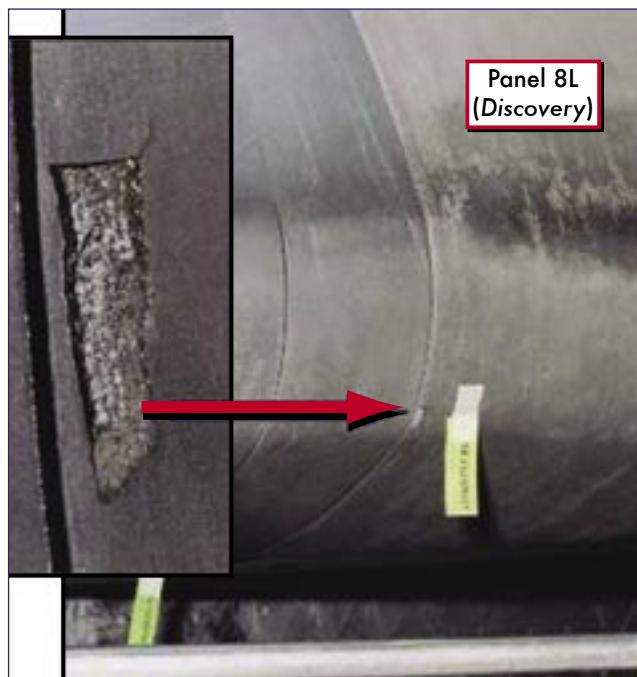
Figure 3.3-5. RCC panel 8-left from *Discovery* had to be scrapped after STS-103 because of the damage shown here.

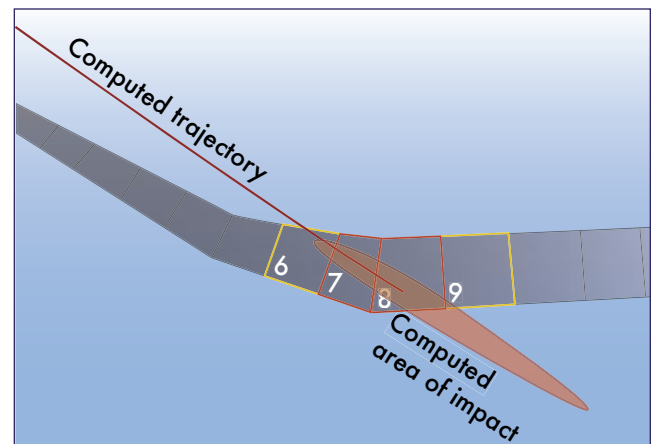
Figure 3.4-3: The best estimate of the site of impact by the center of the foam.

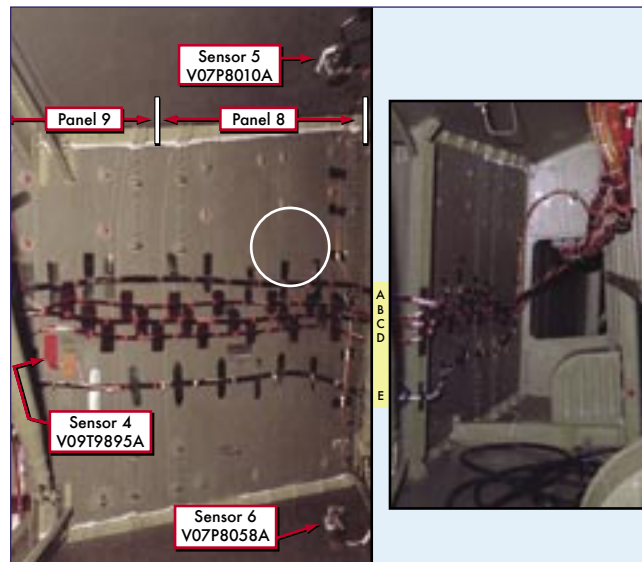
Figure 3.6-8. The left photo above shows the wiring runs on the backside of the wing leading edge behind RCC panel 8 – the circle marks the most likely area where the burn through of the wing leading edge spar initially occurred at EI+487 seconds. The right photo shows the wire bundles as they continue forward behind RCC panels 7 and 6. The major cable bundles in the upper right of the right photo carried the majority of the sensor data inside the wing. As these bundles were burned, controllers on the ground began seeing off-nominal sensor indications.

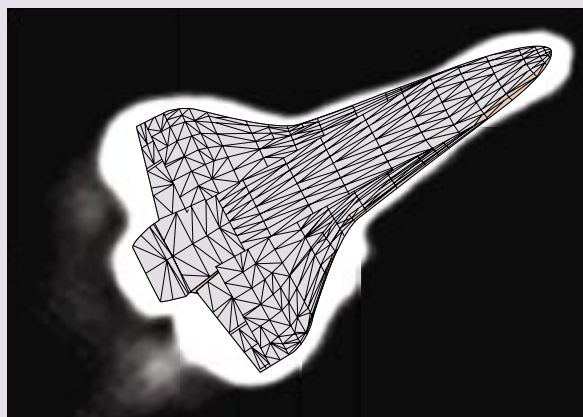
The image shows an unusual condition on the left wing, a leading-edge disturbance that might indicate damage. Several analysts concluded that the distortion evident in the image likely came from the modification and interaction of shock waves due to the damaged leading edge. The overall appearance of the leading-edge damage at this point on the trajectory is consistent with the scenario.

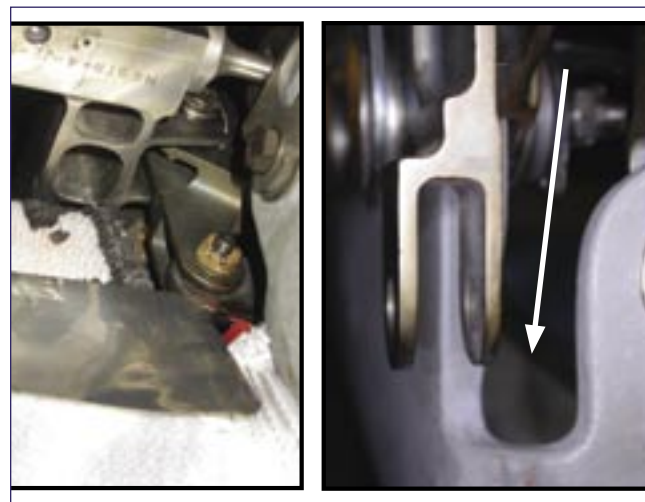
Figure 3.7-2. Each RCC panel has a U-shaped slot (see arrow) in the back of the panel. Once superheated air entered the breach in RCC panel 8, some of that superheated air went through this slot and caused substantial damage to the Thermal Protection System tiles behind this area.

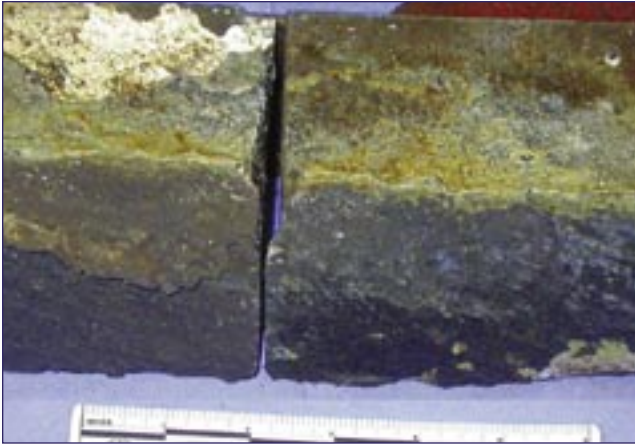
Figure 3.7-3. Superheated airflow caused erosion in tiles around the RCC panel 8 and 9 interface. The tiles shown are from behind the area where the superheated air exited from the slot in Figure 3.7-2. These tiles showed much greater thermal damage than other tiles in this area and chemical analysis showed the presence of metals only found in wing leading edge components.

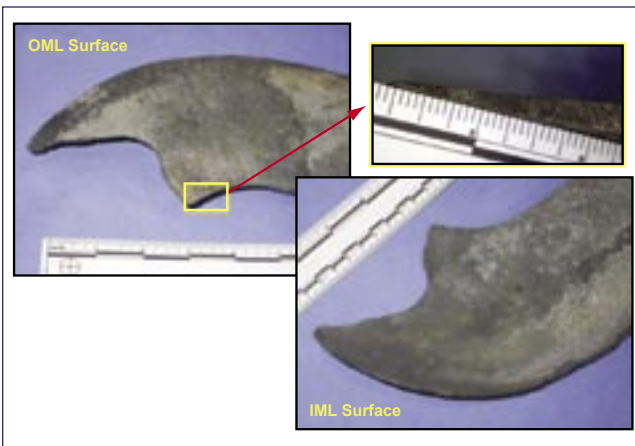
Figure 3.7-4. The outboard rib of panel 8 and the inboard rib of panel 9 showed signs of extreme heating and erosion. RCC erosion of this magnitude was not observed in any other location on the Orbiter.

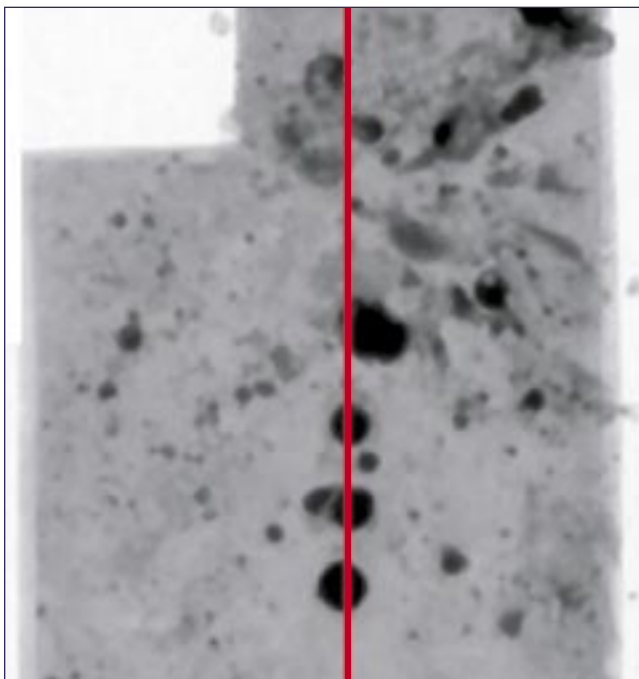
Figure 3.7-7. X-ray analysis of RCC panel 8-left showed a bottom-to-top pattern of slag deposits.

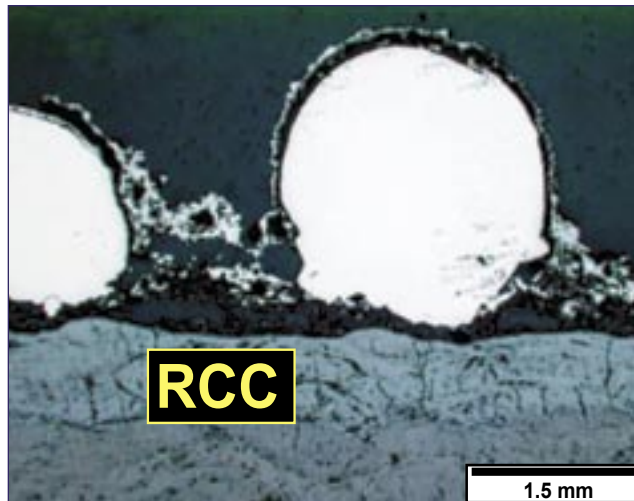
Figure 3.7-8. Spheroids of Inconel 718 and Cerachrome were deposited directly on the surface of RCC panel 8-left. This slag deposit pattern was not seen on any other RCC panels.

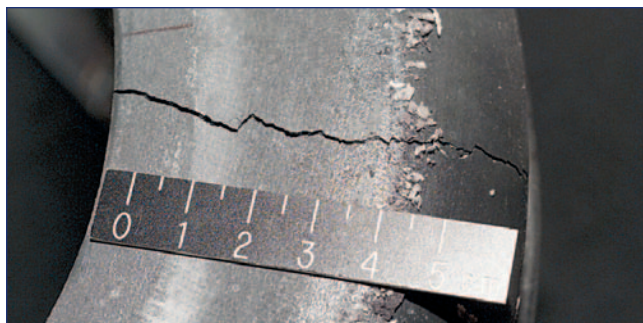
Figure 3.8-6. A 5.5-inch crack on the outboard portion of RCC Panel 6 during testing.

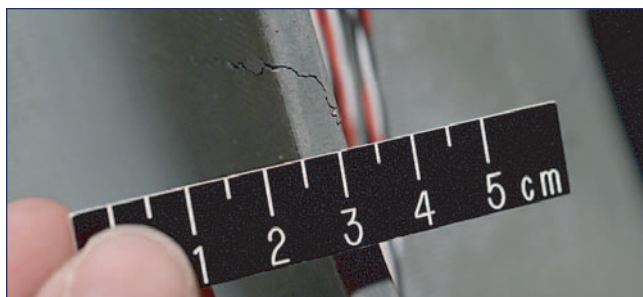
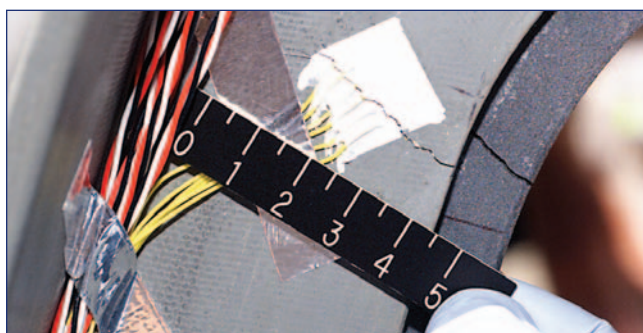
Figure 3.8-7. Two views of the crack in the T-seal between RCC Panels 6 and 7.

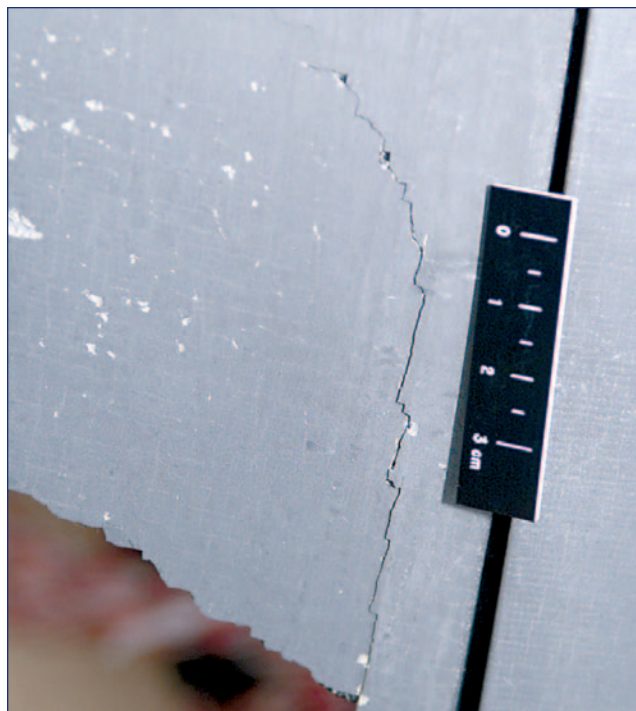
Figure 3.8-10. Numerous cracks were also noted in RCC Panel 8.

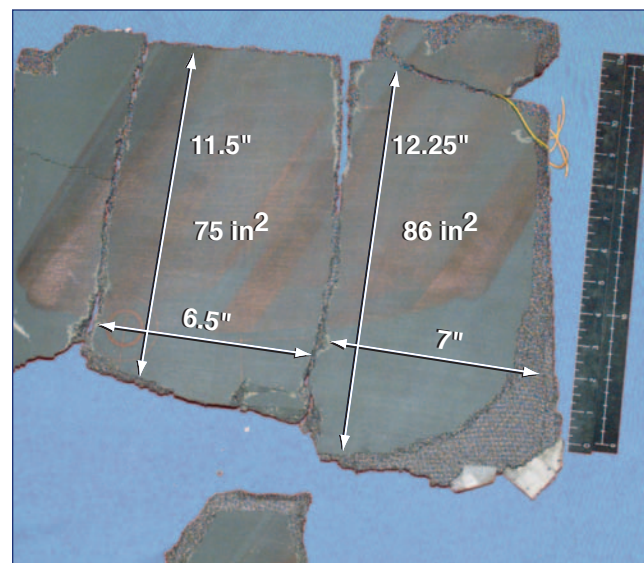
Figure 3.8-11. Three large pieces of debris from the panel face sheet were lodged within the hollow area behind the RCC panel.

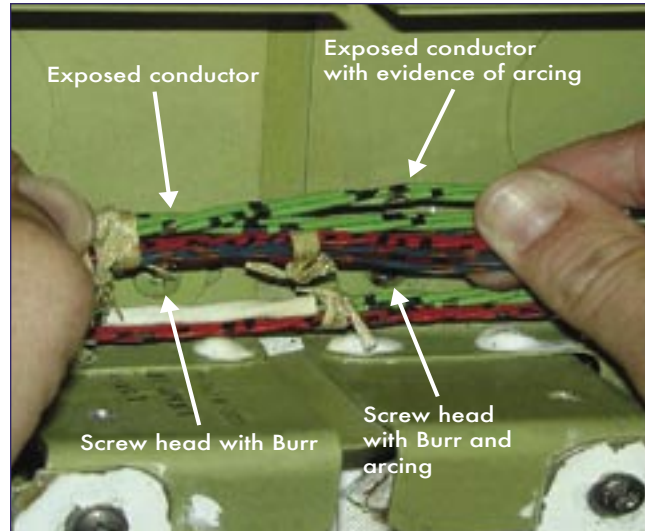
Figure 4.2-2. Arc tracking damage in Kapton wiring.
