Type A Accident Investigation Report

THE JULY 27, 2007
TANK 241-S-102 WASTE SPILL
AT
THE HANFORD TANK FARMS

Volume 2

September 2007

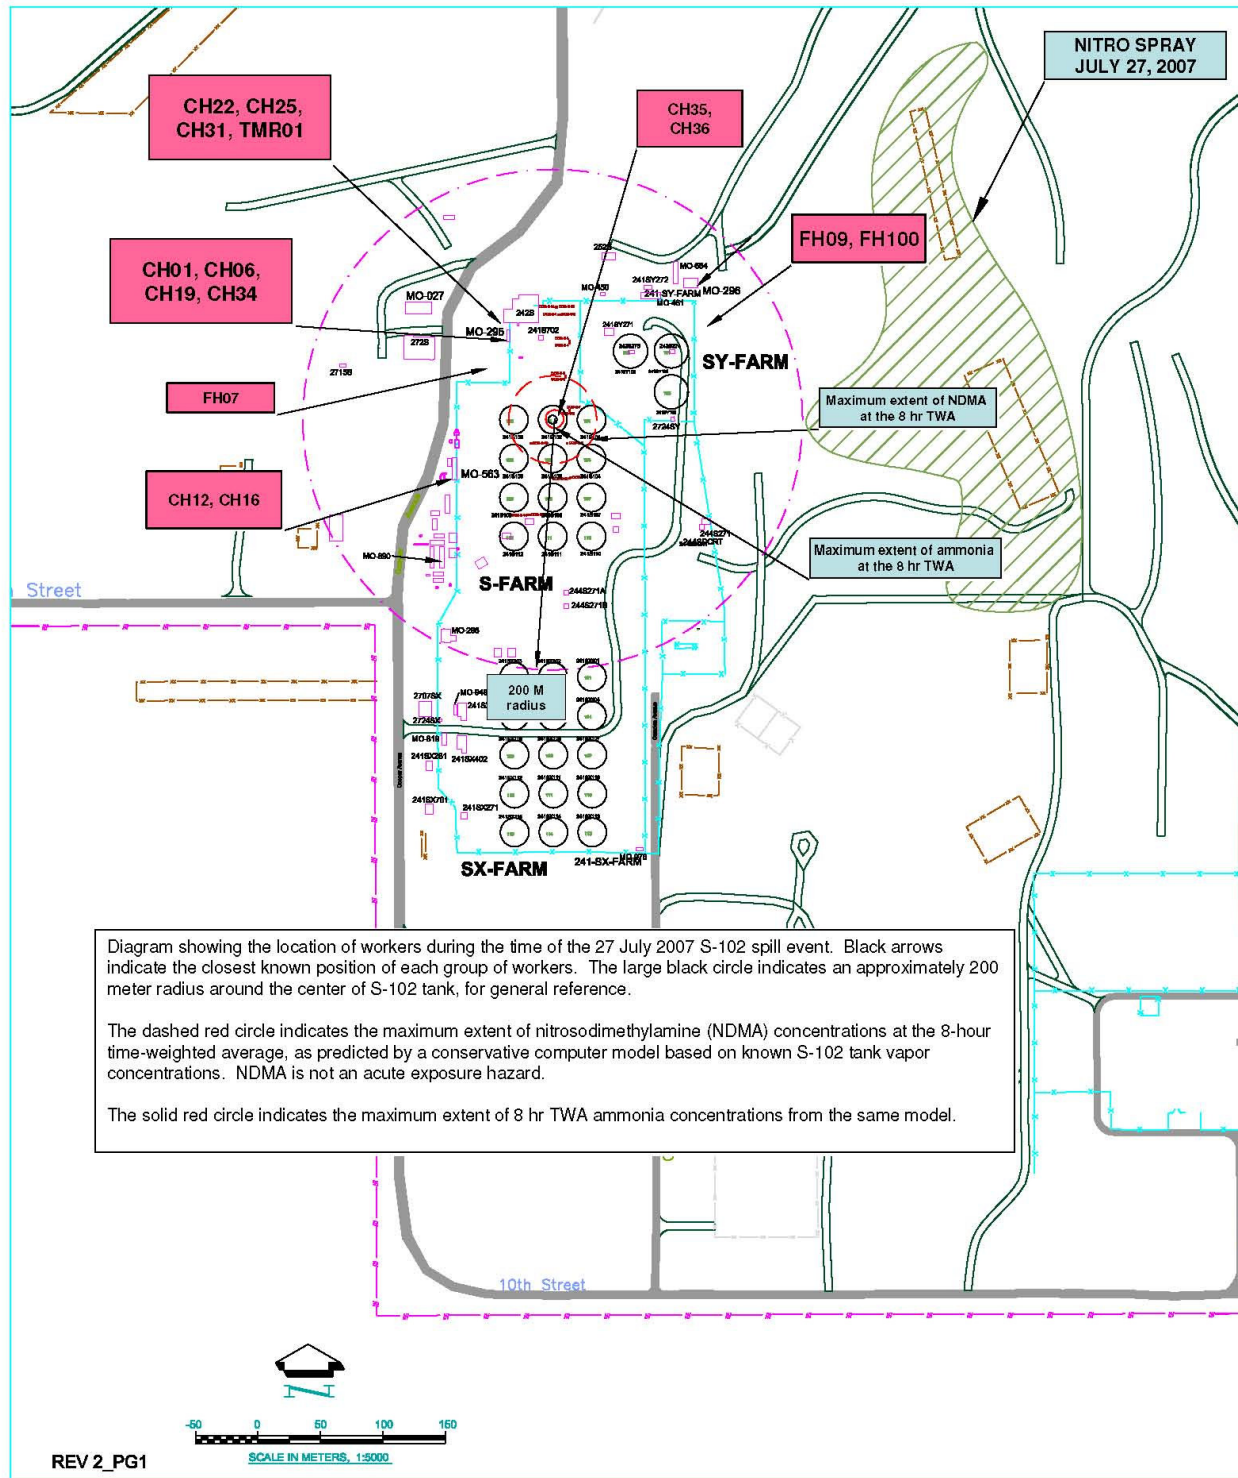
**S-102 Tank Spill Exposure
July 27, 2007
Figure 1 of 2**

On July 27, Fluor Hanford (FH) employees began applying approximately 2,400 gallons of herbicide. The application occurred from 7:30 A.M. to approximately 10:00 A.M., north and east of the tank farm (see figures 1 and 2). The Material Safety Data Sheets for the two herbicides, anti-foam agent, and methylated seed oil indicate they may be skin, eye, and respiratory irritants, and cause gastrointestinal symptoms on ingestion (see Table 4). The FH worker coordinating the spray team access and routing reported no adverse effects from the herbicide application activities.

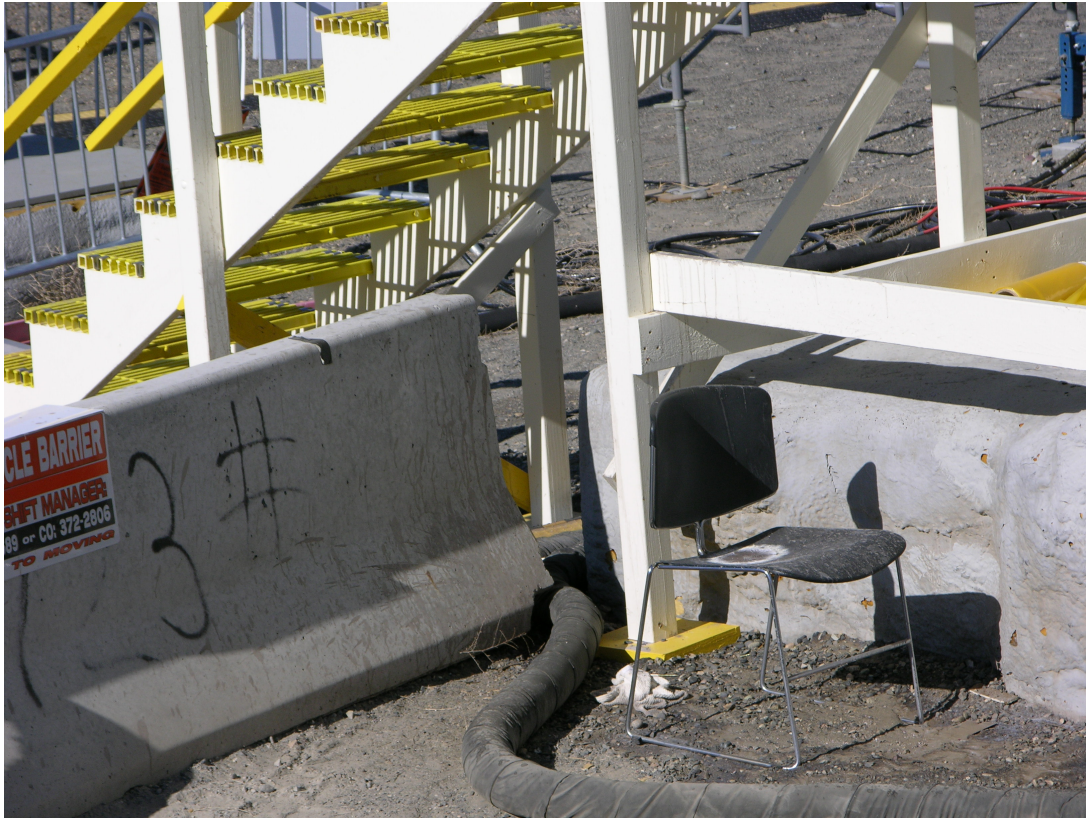
On July 27, 2007, before a contamination fixative was applied to minimize airborne dispersal, photographs were taken of the pump head and surrounding areas. When these were compared with photographs of these areas from Wednesday, July 25, 2007, the indications of the physical areas affected by the liquid release and of solids dispersal from the release point could be clearly seen.

These indications included splatter on the stairs and framework on the north side of the pump head and on a concrete vehicle barrier (primarily on its south face) that was located northwest of the pump head, approximately 15 feet away; wetted ground around the pump head area; and what appeared to be granular solids that were entrained in the liquid release. The release appeared to have originated in the 1½-inch dilution water supply hose at a location near a gap between a concrete vehicle barrier and the pump pit wall. The splatter range, pattern, and volume indications support this as the release point, and seem to suggest that the release was initially at a higher pressure, consistent with a depressurizing volume. The photographs also suggest this point of release by a puddle that collected in a cavity that was formed by the dilution water supply hose where it touched the pump pit wall on its northeast and northwest corners.

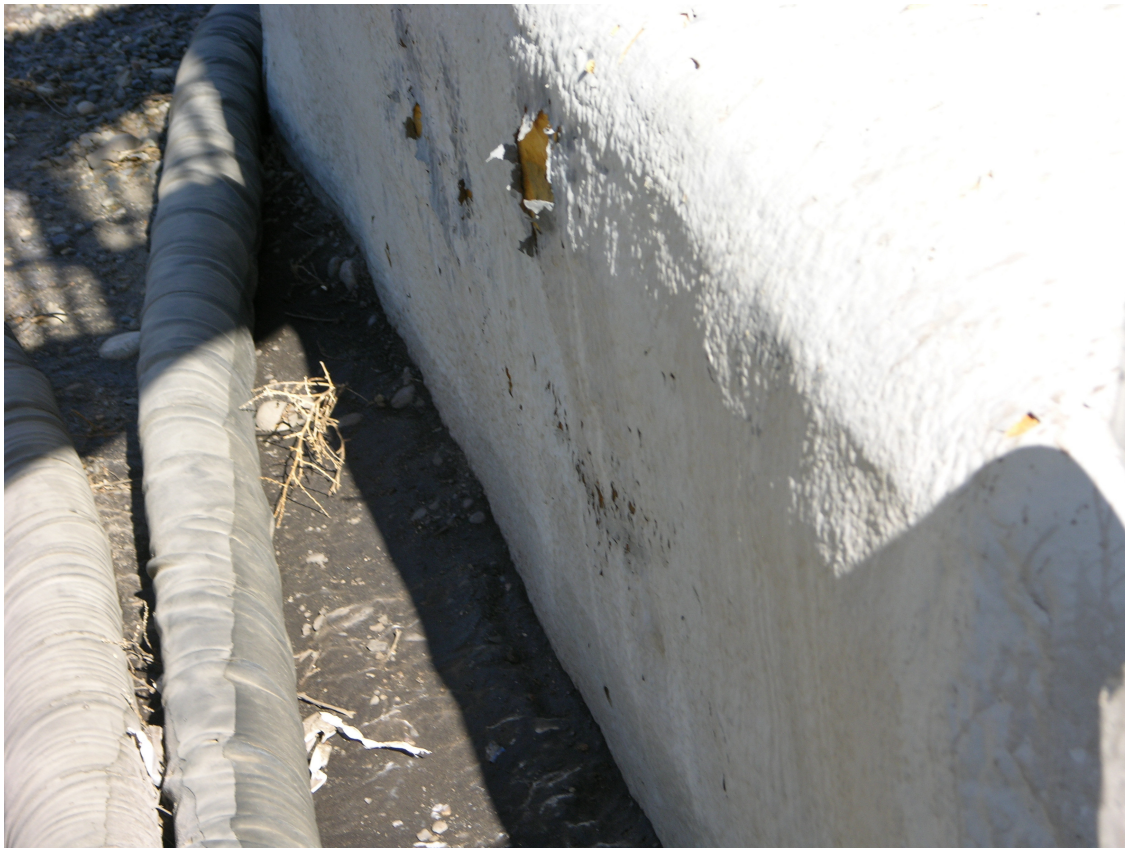
The photographs clearly show a "bathtub ring" on the inside of this cavity several inches deep along the top of the hose and on the north face of the pump pit wall. If the leak had been from any other location downhill from this location, this puddle could not have formed.
