Defective MSA Hood Stitching

Site/Facility: Hanford T Plant

Reference: 2006-RL-HNF-0046

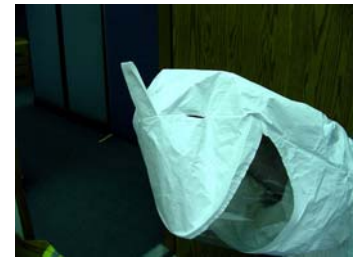
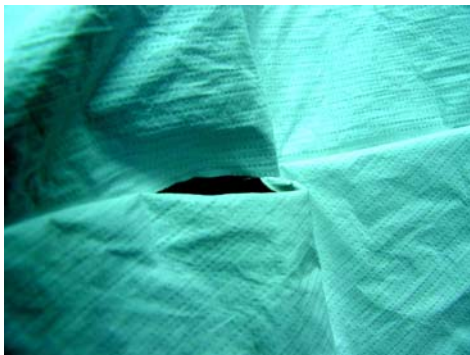
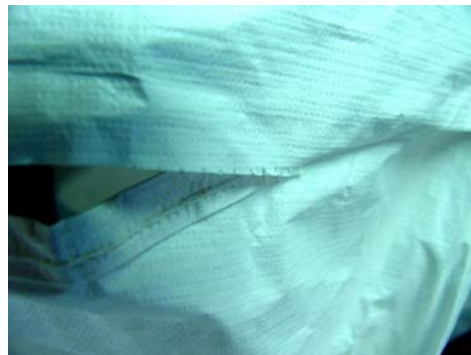
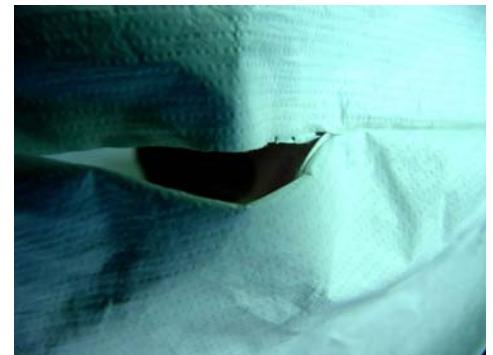
In October 2006, T Plant personnel discovered three MSA hoods with seam problems with two that have not been fully sewn and another that about two stitches may have been pulled apart or missed. The two seams not fully sewn are about 2 inches down the left side from the top tab. The hoods have a date on the tag that reads 6/06, which means they were manufactured in June 2006. The manufacturer who makes these for MSA stated that about 2,000 of them were made in June. The hoods are being returned to the manufacturer for evaluation. At this time, we are not aware of how many of these hoods may have a problem, but evidence has shown this to be a very small number, as the manufacturer stated that less than two dozen or about 1 percent were affected.

Below are photographs of the defective MSA hoods identified by T Plant personnel.

Important Point:	<ul style="list-style-type: none"> • Users of MSA hoods should be aware of the potential manufacturing problem and should always perform thorough pre-use inspections. • Special focus should be placed on inspection of seams in MSA hoods to determine if they are defective.
Contributor:	<ul style="list-style-type: none"> • Manufacturing/Unknown
