APPENDIX

A.
Erosion Hazard Data Sheets
for
Methodology 1: 16 Physical Factors and One Economic
Factor

Erosion Hazard Data Sheets for Methodology 1: 16 Physical Factors and one Economic Factor

Sacramento River, RM 43.3R

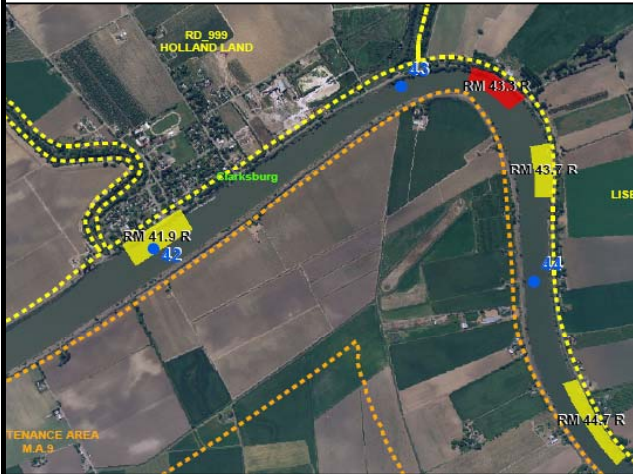
Criteria	Pre-Rock	Post-Rock	Notes
Bank Slope (*2)	4	4	1:1 or less
Berm Width (*2) - Estimated	5	5	no berm
Length of erosion	4	4	1060 ft
Location of erosion	5	5	toe and underwater, bank (still eroding underwater and at the toe with the rock)
Bank Stability	4	2	vertical sections, greater than half height (still some vertical sections with rock, but not as tall)
Radius of Curvature (R_c/w)	3	3	$R/w = 2.4$ (Ayres calculation)
Site Relative to Bend	5	5	outside of a less than 90 degree bend
Geomorph	0	0	no migration expected
Vegetation Cover	2	4	40 to 60 % (with rock, less vegetation, removed what was there and didn't replant, less than 20%)
Tree Hazard	5	5	large leaning trees, visible roots (tree hazards are still present even with the rock)
Soil Type (*2)	3	3	sand
Velocity (*2)	4	4	5.4 ft/s (UNET model)
Wave Action (Wind/Boat)	4	4	heavy waves
Economic Factor (*2)	2	2	farms and small town (Clarksburg)
Human Usage	5	5	daily

Seepage Potential	0	0	no known seepage history
Tidal Fluctuation	3	3	about 3 ft of tidal flux
Erosion Hazard	76	76	Calculate Erosion Hazard

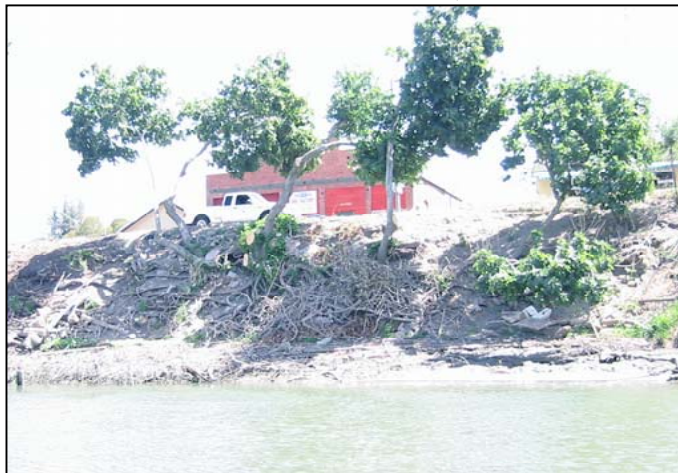
Sacramento River, RM 26.9L

Criteria	Score	Notes
Bank Slope (*2)	5	near vertical to vertical
Berm Width (*2) - Estimated	5	no berm
Length of erosion	2	280 ft
Location of erosion	4	all bank and toe
Bank Stability	4	vertical sections (entire slope), no caves
Radius of Curvature (R_c/w)	0	$R/w = 5.7$ (Ayres calculation)
Site Relative to Bend	2	just downstream of a bend
Geomorph	0	no migration expected
Vegetation Cover	4	less than 20% cover
Tree Hazard	5	trees, roots exposed, and leaning
Soil Type (*2)	3	sand
Velocity (*2)	3	4.9 ft/s (UNET model)
Wave Action (Wind/Boat)	4	heavy wave action
Economic Factor (*2)	2	adjacent to Walnut Grove, population 669 (2000 US Census)
Human Usage	5	Daily
Seepage Potential	0	no known seepage history
Tidal Fluctuation	4	4 ft of tidal flux

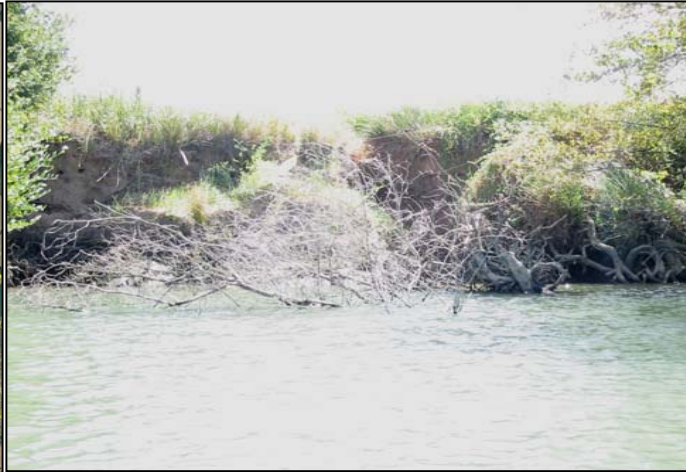
Criteria	Score	Notes
Bank Slope (*2)	5	Vertical slope
Berm Width (*2) - Estimated	3	0 - 20 ft
Length of erosion	4	1400 ft
Location of erosion	5	Bank, toe nad underwater
Bank Stability	5	lots of cave, and vertical sections
Radius of Curvature (R_c/w)	0	$R/w = 5.1$ (Ayres calculation)
Site Relative to Bend	1	straight
Geomorph	0	no migration expected
Vegetation Cover	3	most veg is growing on the tree roots, not in the ground, about 30 %
Tree Hazard	5	Large trees, exposed roots, and leaning
Soil Type (*2)	3	sand
Velocity (*2)	4	5.0 (UNET model)
Wave Action (Wind/Boat)	3	Moderate waves
Economic Factor (*2)	1	Farms
Human Usage	0	rare, no access
Seepage Potential	0	no known history
Tidal Fluctuation	4	4 ft of tidal flux

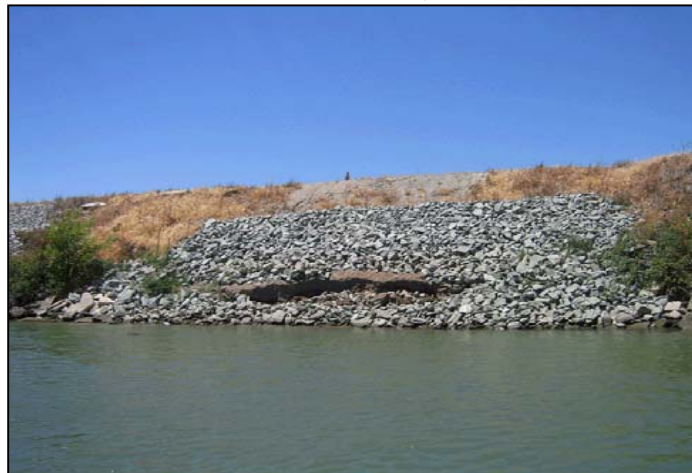
Criteria	Score	Notes
Bank Slope (*2)	4	1:1 slope
Berm Width (*2) - Estimated	5	no berm
Length of erosion	2	430 ft
Location of erosion	2	lower bank
Bank Stability	2	vertical section less than half height, no caves, more rock was placed to fill in large holes from previous year. (photo from 2004)
Radius of Curvature (R_c/w)	0	straight
Site Relative to Bend	1	straight
Geomorph	0	no migration expected
Vegetation Cover	4	less than 20%
Tree Hazard	0	no trees
Soil Type (*2)	3	sands
Velocity (*2)	4	5.6 ft/s (UNET model)
Wave Action (Wind/Boat)	3	Moderate waves
Economic Factor (*2)	1	Farms
Human Usage	3	Monthly
Seepage Potential	0	no know seepage history
Tidal Fluctuation	3	3 ft of tidal flux

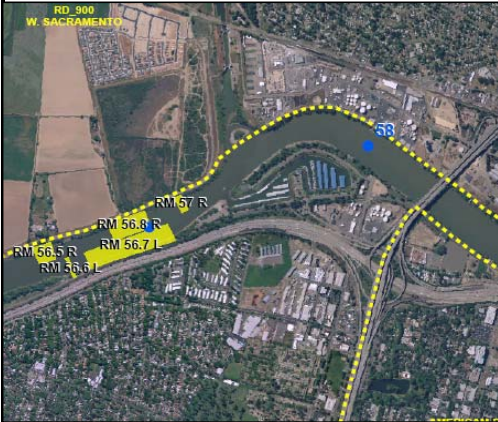
Sacramento River, Rm 56.7L (unrepaired state)

Criteria	Score	Notes
Bank Slope	4	1:1 slope
Berm Width - Estimated	5	no berm
Soil Type	3	sands
Velocity	3	4.5 ft/s (UNET model)
Economic Factor	20	Sacramento
Bank Stability	7	caves, treehazards, and slumping
Erosion Hazard	42	Flow on Inspection Day:

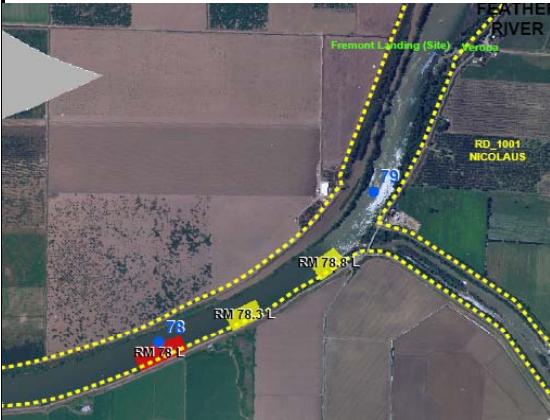
Sacramento River, RM 78L

Criteria	Score	Notes
Bank Slope	3	1.5:1 slope
Berm Width - Estimated	5	no berm
Soil Type	2	clays and silts
Velocity	2	4.2 ft/s (UNET model)
Economic Factor	19	Colusa Basin
Bank Stability	4	slumping
Erosion Hazard	35	Flow on Inspection Day:

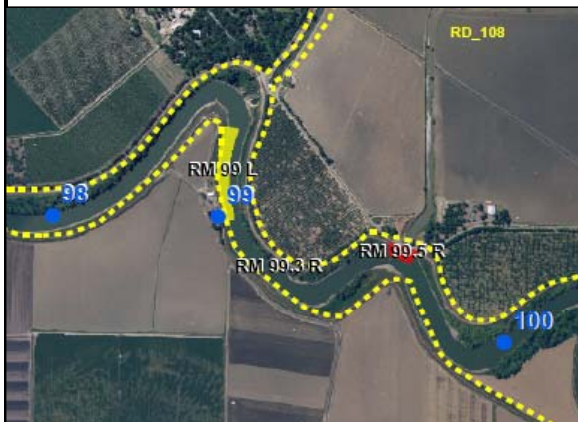
Sacramento River, RM 99.3R

Criteria	Score	Notes
Bank Slope	4	1:1 or less
Berm Width - Estimated	3	5 to 9 ft
Soil Type	2	silty clay
Velocity	3	4.2 ft/s (UNET model) plus eddy currents
Economic Factor	19	Colusa Basin
Bank Stability	4	slumping
Erosion Hazard	35	Flow on Inspection Day:

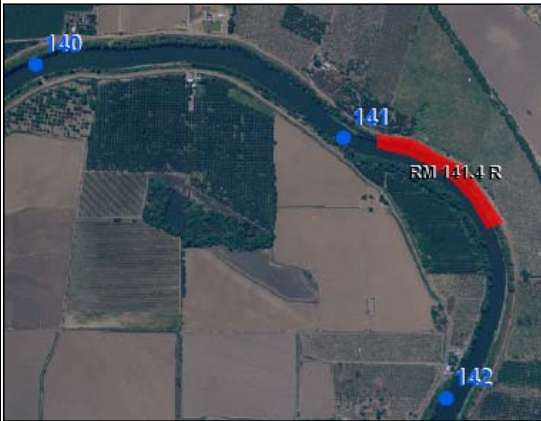
Sacramento River, RM 141.4R

Criteria	Score	Notes
Bank Slope	3	1.5:1 slope
Berm Width - Estimated	2	10 to 12 ft
Soil Type	1	clays
Velocity	2	4.4 ft/s (UNET model)
Economic Factor	19	Colusa Basin
Bank Stability	6	tree hazards, slumping
Erosion Hazard	33	Flow on Inspection Day:

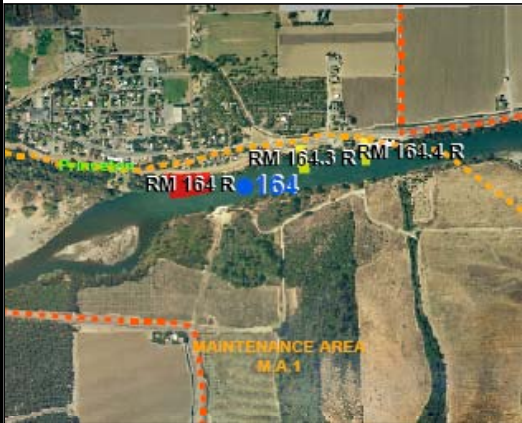
Sacramento River, RM 164R

Criteria	Score	Notes
Bank Slope	4	1:1 slope
Berm Width - Estimated	2	15 ft
Soil Type	2	clays and silts
Velocity	2	4.2 ft/s
Economic Factor	19	Colusa Basin
Bank Stability	4	slumping
Erosion Hazard	33	Flow on Inspection Day:

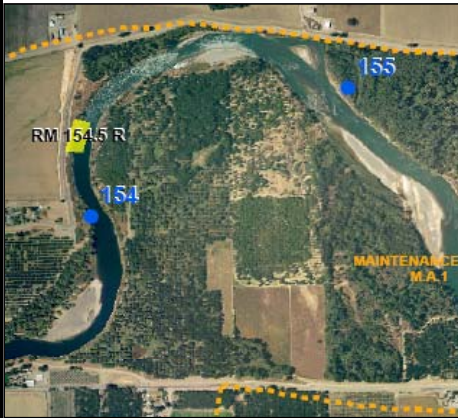
Sacramento River, RM 154.5R

Criteria	Score	Notes
Bank Slope	5	near vertical
Berm Width - Estimated	1	20 to 30 ft
Soil Type	1	clays
Velocity	2	4.2 ft/s (UNET calculation)
Economic Factor	19	Colusa Basin
Bank Stability	4	slumping
Erosion Hazard	32	Flow on Inspection Day:

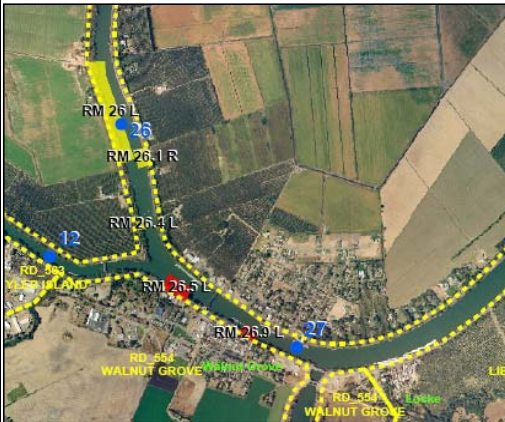
Sacramento River, RM 26.0L

Criteria	Score	Notes
Bank Slope	5	vertical
Berm Width - Estimated	3	0 - 20 ft
Soil Type	3	sand
Velocity	4	5.0 ft/s
Economic Factor	7	Iselton
Bank Stability	7	treehazards, caves, and slumping
Erosion Hazard	29	Flow on Inspection Day:

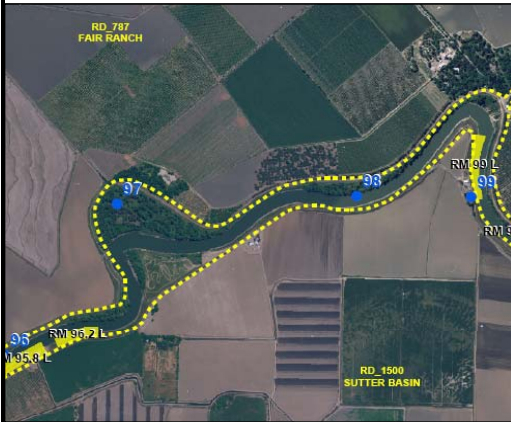
Sacramento River, RM 96.2L

Criteria	Score	Notes
Bank Slope	4	1:1 slope
Berm Width - Estimated	1	25 ft
Soil Type	2	clays and silts
Velocity	2	4.2 ft/s (UNET model)
Economic Factor	14	Sutter Basin
Bank Stability	6	animal holes and slumping
Erosion Hazard	29	Flow on Inspection Day:

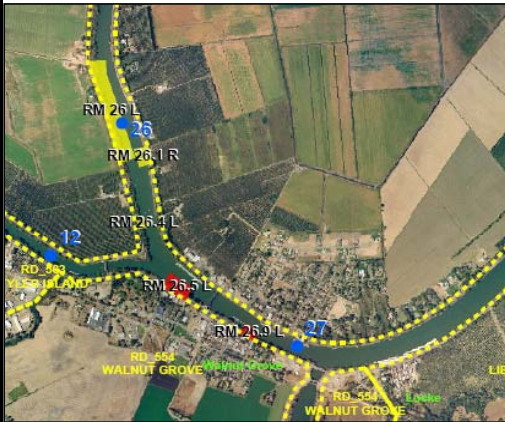
Sacramento River, RM 26.9L

Criteria	Score	Notes
Bank Slope	5	vertical
Berm Width - Estimated	5	no berm
Soil Type	3	sands
Velocity	3	4.9 ft/s (UNET model)
Economic Factor	5	Tyler Island
Bank Stability	7	tree hazards, slumping, tension cracks on road
Erosion Hazard	28	Flow on Inspection Day:

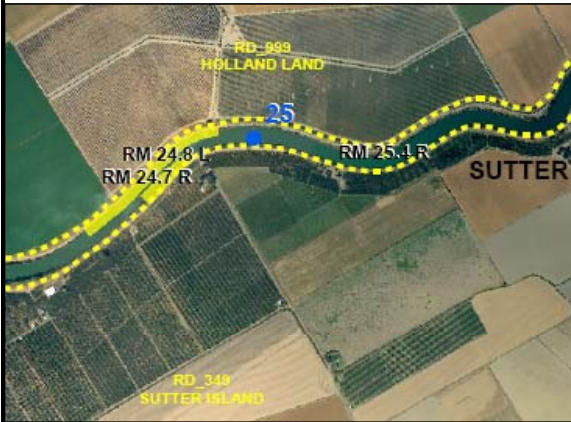
Sutter Slough, RM 25.1R

Criteria	Score	Notes
Bank Slope	3	1.5:1 slope
Berm Width - Estimated	5	no berm
Soil Type	1	clays
Velocity	0	backwater, less than 2 ft/s
Economic Factor	12	Clarksburg
Bank Stability	7	tree hazards, holes, and slumping
Erosion Hazard	28	Flow on Inspection Day:

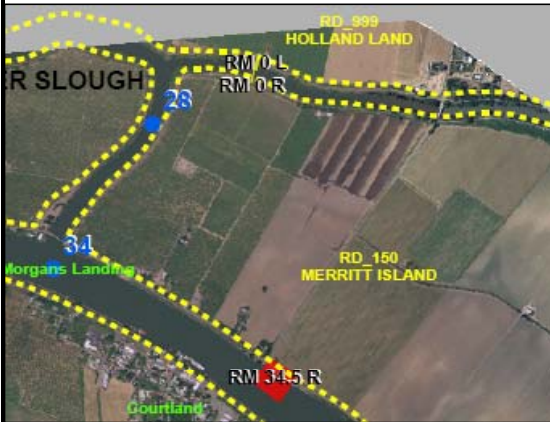
Elk Slough, RM 0.7

Criteria	Score	Notes
Bank Slope	4	1:1 slope
Berm Width - Estimated	5	no berm
Soil Type	1	clays
Velocity	0	backwater, less than 2 ft/s
Economic Factor	12	Clarksburg
Bank Stability	6	tree hazards, slumping
Erosion Hazard	28	Flow on Inspection Day:

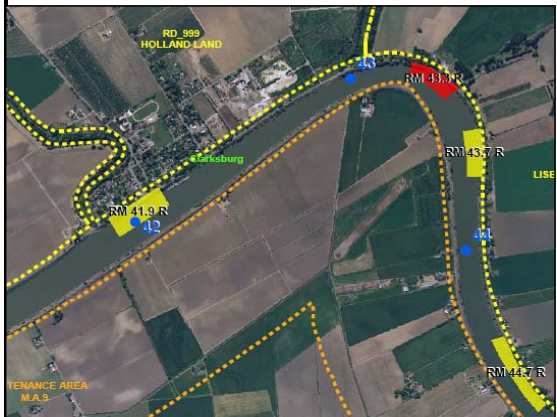
Sacramento River, RM 42.8R

Criteria	Score	Notes
Bank Slope	3	1.5:1 slope
Berm Width - Estimated	5	no berm
Soil Type	3	sand
Velocity	2	4.4 ft/s (UNET model)
Economic Factor	7	Isleton
Bank Stability	6	trees, slumping
Erosion Hazard	26	Flow on Inspection Day:

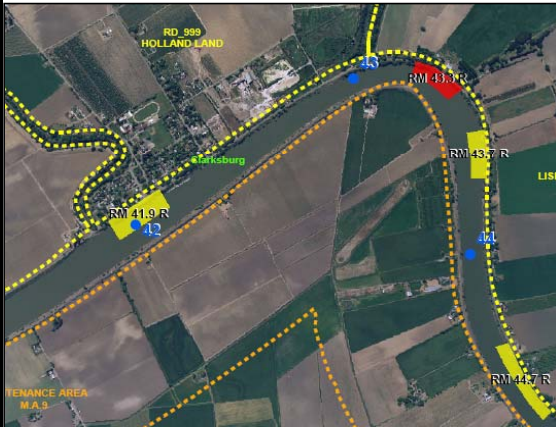
Sacramento River, RM 43.3R

Criteria	Pre-Rock	Post-Rock	Notes
Bank Slope	4	4	1:1 slope (even with added rock)
Berm Width - Estimated	5	5	no berm
Soil Type	3	3	sand
Velocity	4	4	5.4 ft/s (UNET model)
Economic Factor	3	3	Clarksburg Airport
Bank Stability	7	6	tree hazards (still exist even with added rock), caves (filled in with rock), and slumping
Erosion Hazard	26	25	Flow on Inspection Day:

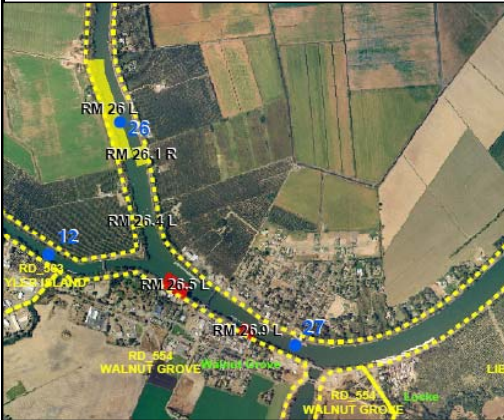
Sacramento River, RM 26.5L

Criteria	Score	Notes
Bank Slope	3	1.5:1 slope
Berm Width - Estimated	5	no berm
Soil Type	3	sands
Velocity	3	4.9 ft/s (UNET model)
Economic Factor	5	Tyler Island
Bank Stability	6	tree hazards, slumping
Erosion Hazard	25	Flow on Inspection Day:

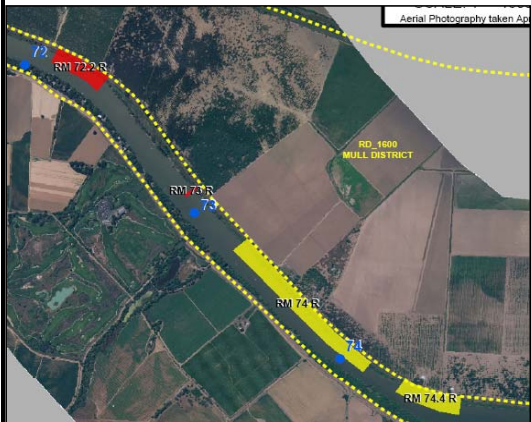
Sacramento River, RM 72.2R

Criteria	Score	Notes
Bank Slope	5	near vertical
Berm Width - Estimated	2	12 - 15 ft
Soil Type	2	silty clay
Velocity	3	4.7 ft/s (UNET model)
Economic Factor	6	Elkhorn
Bank Stability	6	tree hazards and slumping
Erosion Hazard	24	Flow on Inspection Day:

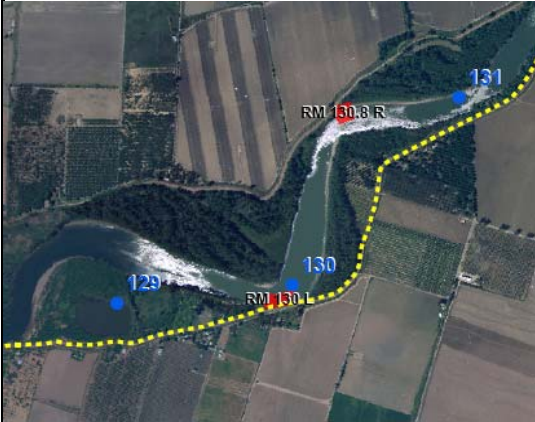
Sacramento River, RM 130L

Criteria	Score	Notes
Bank Slope	3	1.5:1 slope
Berm Width - Estimated	2	10 to 20 ft
Soil Type	1	clay
Velocity	3	4.5 ft/s (UNET model)
Economic Factor	9	Tisdale
Bank Stability	6	tree hazards, slumping
Erosion Hazard	24	Flow on Inspection Day:

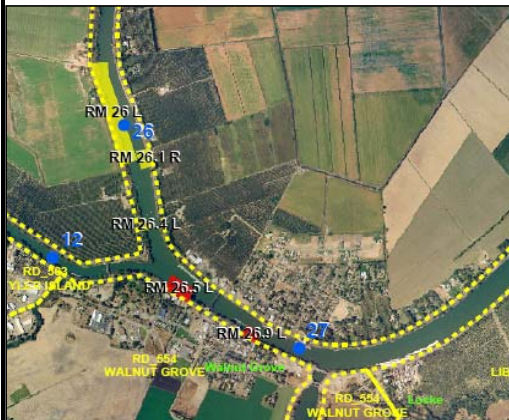
Sacramento River, RM 26.1R

Criteria	Score	Notes
Bank Slope	3	1.5:1 slope
Berm Width - Estimated	5	no berm
Soil Type	3	sand
Velocity	4	5.0 ft/s (UNET model)
Economic Factor	8	Grand Island
Bank Stability	0	no stability issues
Erosion Hazard	23	Flow on Inspection Day:

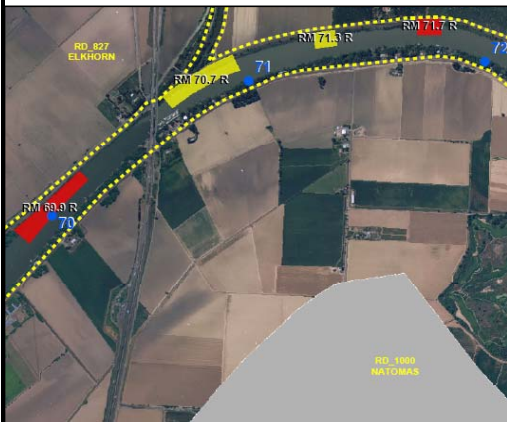
Sacramento River, RM 71-7R

Criteria	Score	Notes
Bank Slope	4	1:1 slope
Berm Width - Estimated	1	20 + feet
Soil Type	2	silts and clays
Velocity	3	4.7 ft/s (UNET model)
Economic Factor	6	Elkhorn
Bank Stability	7	tree hazards, minor slumping, caves
Erosion Hazard	23	Flow on Inspection Day:

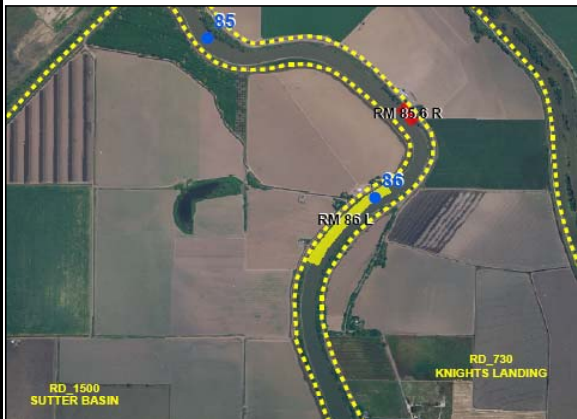
Sacramento River, RM 85.6R

Criteria	Score	Notes
Bank Slope	4	1:1 slope
Berm Width - Estimated	4	1 to 4 ft of berm
Soil Type	2	silts and clays
Velocity	3	4.5 ft/s (UNET model)
Economic Factor	2	Knight's Landing
Bank Stability	7	tree hazards, slumping, seepage, animal burrows
Erosion Hazard	22	Flow on Inspection Day:

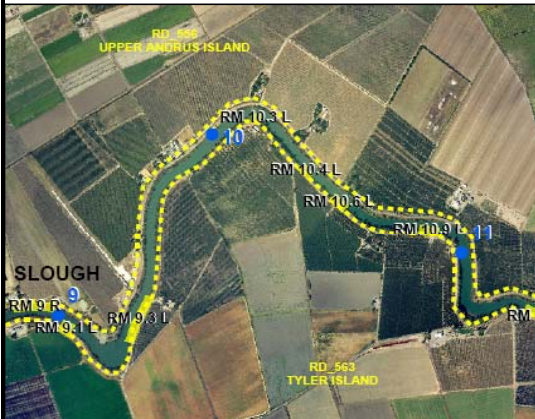
Georgiana Slough, RM 10.3L

Criteria	Score	Notes
Bank Slope	3	1.5:1 slope
Berm Width - Estimated	2	10 - 20 ft of berm
Soil Type	3	sand
Velocity	1	2 - 4 ft/s
Economic Factor	5	Tyler Island
Bank Stability	7	tree hazards, slumping, caves
Erosion Hazard	21	Flow on Inspection Day:

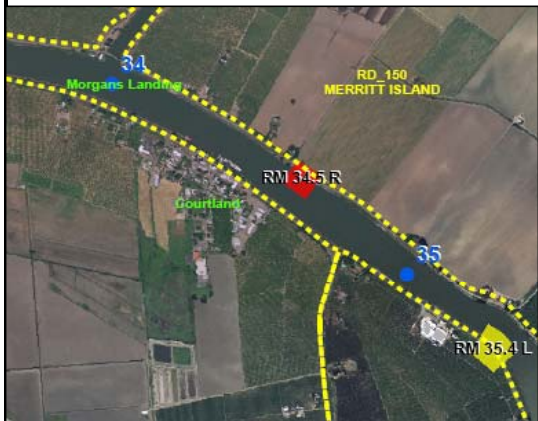
Sacramento River, RM 34.5R

Criteria	Score	Notes
Bank Slope	4	1:1 slope
Berm Width - Estimated	5	no berm
Soil Type	3	sand
Velocity	4	5.6 ft/s (UNET calculation)
Economic Factor	1	Merritt Island
Bank Stability	4	slumping
Erosion Hazard	21	Flow on Inspection Day:

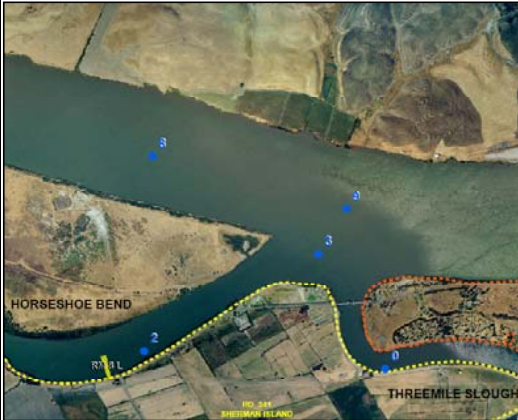
Sacramento River, RM 8L

Criteria	Score	Notes
Bank Slope	5	vertical
Berm Width - Estimated	3	8 - 10 ft (just below levee height)
Soil Type	1	vclay
Velocity	3	4.9 ft/s (UNET model)
Economic Factor	4	Sherman Island
Bank Stability	4	slumping
Erosion Hazard	20	Flow on Inspection Day:

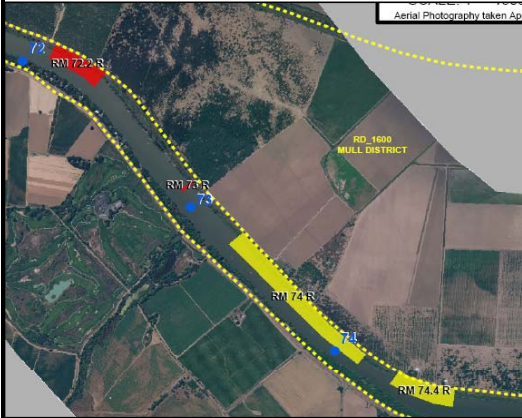
Sacramento River, RM 73R

Criteria	Score	Notes
Bank Slope	3	1.5:1 slope
Berm Width - Estimated	3	5 to 10 ft
Soil Type	2	silts and clays
Velocity	5	4.7 ft/s (UNET model) plus eddy currents
Economic Factor	6	Elkhorn
Bank Stability	0	no stability issues
Erosion Hazard	19	Flow on Inspection Day:

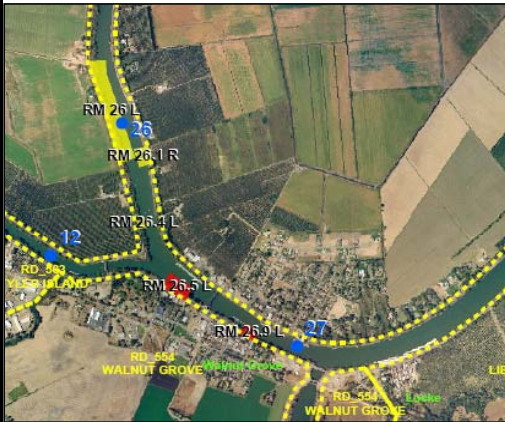
Sacramento River, RM 26.9L

Criteria	Score	Notes
Bank Slope	5	vertical
Berm Width - Estimated	5	no berm
Soil Type	3	sands
Velocity	3	4.9 ft/s (UNET model)
Bank Stability	7	tree hazards, slumping, tension cracks on road
Erosion Hazard	23	Flow on Inspection Day:

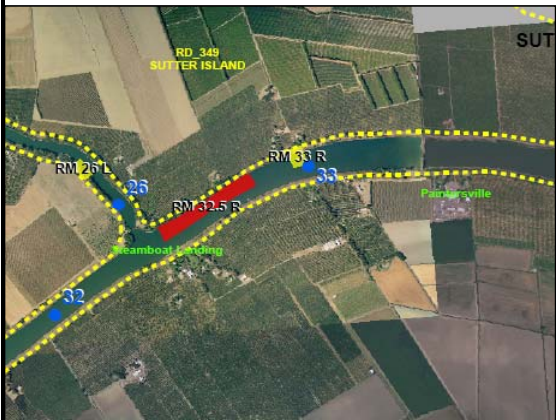
Sacramento River, RM 32.5R

Criteria	Pre-Rock	Post-Rock	Notes
Bank Slope	4	4	1:1 slope (even with added rock)
Berm Width - Estimated	5	5	no berm
Soil Type	3	3	sand
Velocity	4	4	5.4 ft/s (UNET model)
Bank Stability	7	6	tree hazards (still exist even with added rock), caves (filled in with rock), and slumping
Erosion Hazard	23	22	Flow on Inspection Day:
