OPERATING EXPERIENCE SUMMARY

OE SUMMARY 2005-11

1. Supervisory errors result in occupational exposure 1
2. Welder/generator fire results from lack of preventive maintenance ... 3
3. Infrequent performance of high-hazard work contributed to refinery explosion 6
4. Worker seriously injured in fall from tank car 10

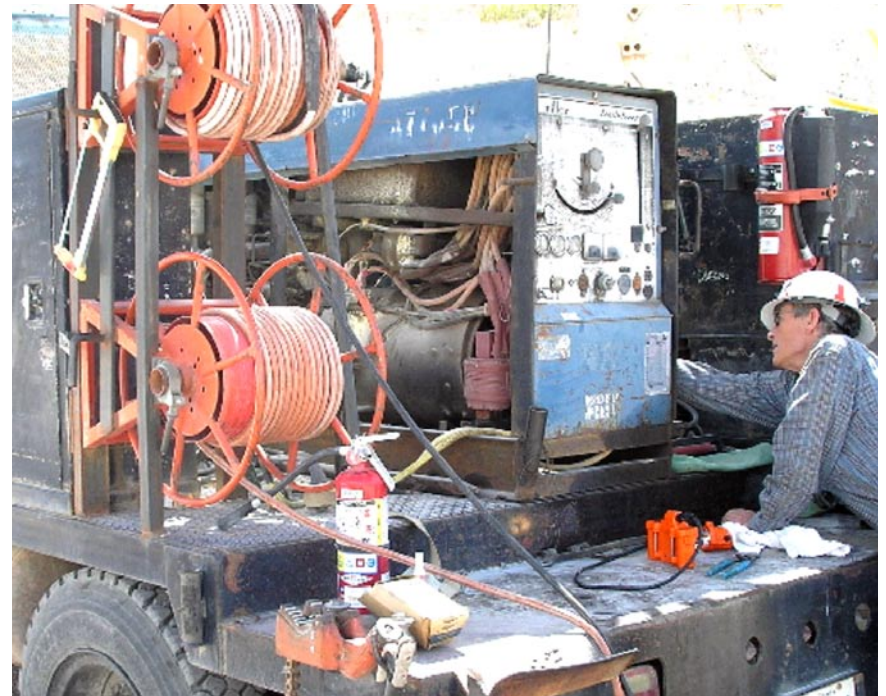
A Bechtel-SAIC Company crew was using the welder/generator to power a drill while working on a mainline track switch. They saw smoke coming from the welder/generator, which was on the back of a mechanic truck (Figure 2-1). One of the crew reported the fire on his radio while another crew member turned off the welder/generator and unplugged the drill. They observed flames through the smoke and quickly extinguished the fire. Pending an investigation of the cause of the equipment failure, the battery cables were disconnected to prevent the welder/generator from being started.

The welder/generator, a Trailblazer model manufactured by Miller, was originally purchased in October 1997. In February 2003, preventive maintenance on welding machines was cancelled. Based on an inspection of the equipment, it appears that an electrical short from damaged low-voltage wires started the fire. The age of the welder/generator and the lack of maintenance were contributing factors.

Figure 2-1. Welder/generator (blue) on bed of mechanic truck

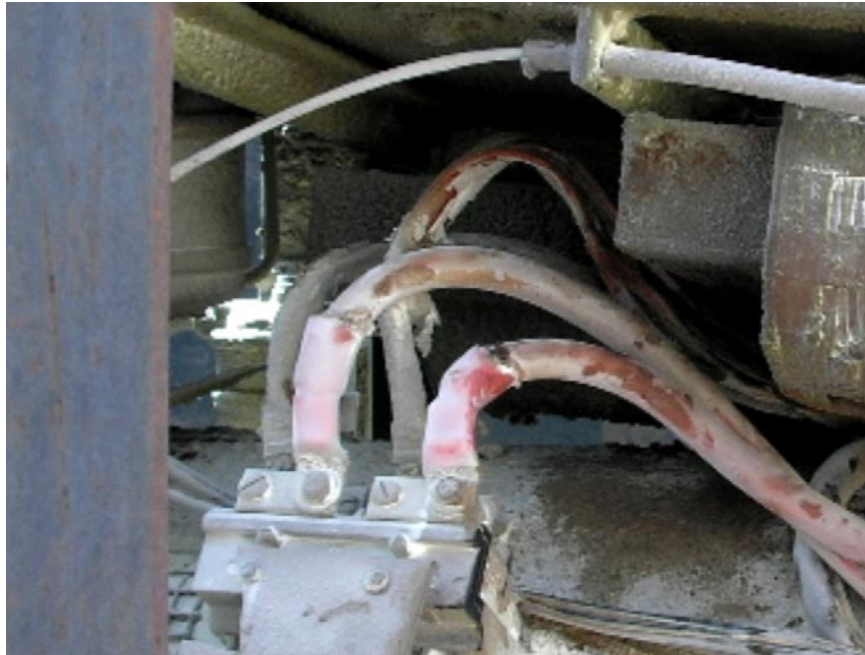
Investigators found several bare, small-gauge wires that appeared to have been abraded through normal use and equipment transportation. The insulation on the heavy-gauge power leads was severely cracked and flaked off when the cable was handled (Figure 2-2). The damage appeared to be from exposure and use over the lifetime of the equipment. It is unlikely that anyone would have discovered the damaged wiring during normal use, which underscores the importance of performing regular maintenance and equipment inspections.

Figure 2-2. Cracked insulation on cables

Investigators also found an excessive buildup of diesel fuel and dust on the welder/generator. The fuel buildup appeared to have come from filling the fuel tank. Fuel on the electrical insulation would have contributed to degradation of the insulation. The accumulation of dust could have caused the buildup of excessive heat in the electrical components.

Paragraphs 5.11 and 6.3.2 of American Welding Society code D1.1, *Structural Welding Code—Steel*, require maintaining welding equipment in good working condition. To meet this requirement, the manufacturer’s maintenance guidelines should be followed. As a corrective action, facility management will

re-establish preventive maintenance programs for all electric arc-welding equipment based on manufacturer recommendations. This effort should be completed in the near term for existing in-service welding equipment and will be applied to new welders added in the future.

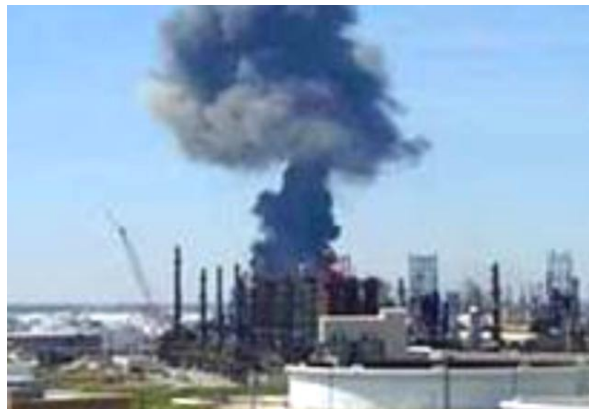
On March 23, 2005, a tremendous explosion (Figure 3-1) occurred at the BP Texas City Refinery, killing 15 workers and injuring more than 100 others on the refinery site. The refinery operator, BP Products North America, Inc., immediately established a team to investigate the cause of this tragedy. The cause is thought to be the ignition of a hydrocarbon vapor cloud that was accidentally released from a fractionating column. Members from the U.S. Chemical Safety and Hazard Investigation Board and OSHA are conducting separate investigations.

Figure 3-1. Photograph of initial explosion

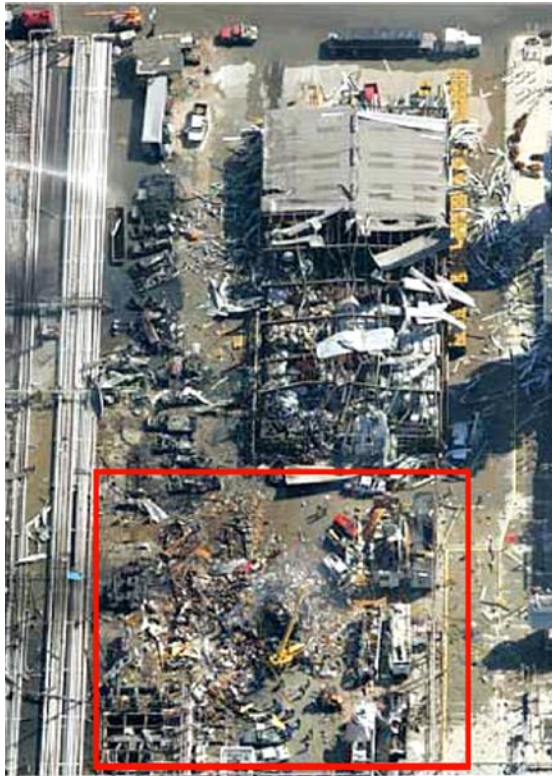
Many of the injured or killed were congregated in or around temporary trailers used to support turnaround work on a nearby ultra-cracker unit. Figure 3-2 is an aerial view showing the destroyed temporary office trailers at the bottom and a heavily damaged catalyst warehouse at the top.

Figure 3-2. Destroyed temporary trailers (red box)

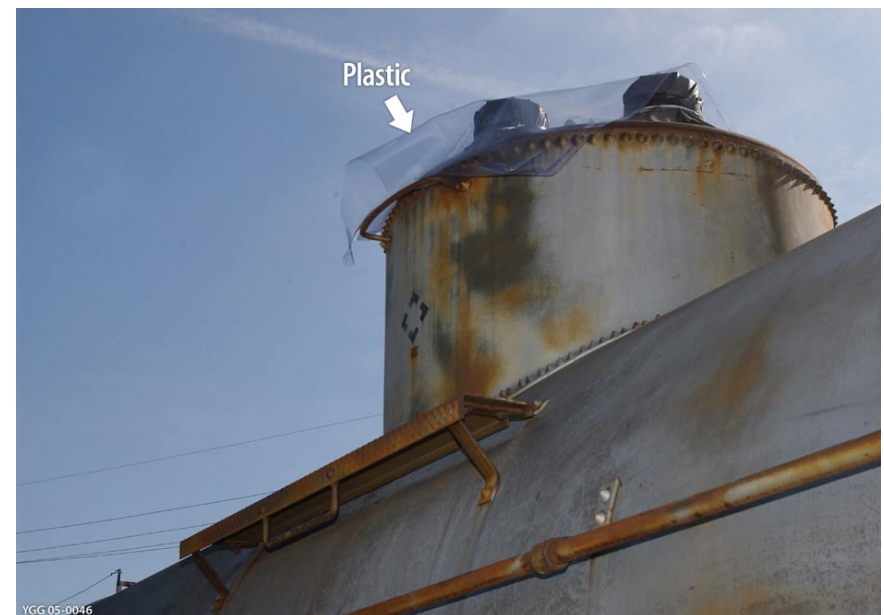
The electrician and his co-worker cut the plastic sheeting on the ground before climbing to the upper platform. The co-worker climbed up to the platform first, and the electrician followed him after placing a segment of rope on the platform for use during their descent. The co-worker placed the plastic over the hatch, as planned, just before the electrician fell (see Figure 4-1).

Figure 4-1. Plastic on rail tank car hatch

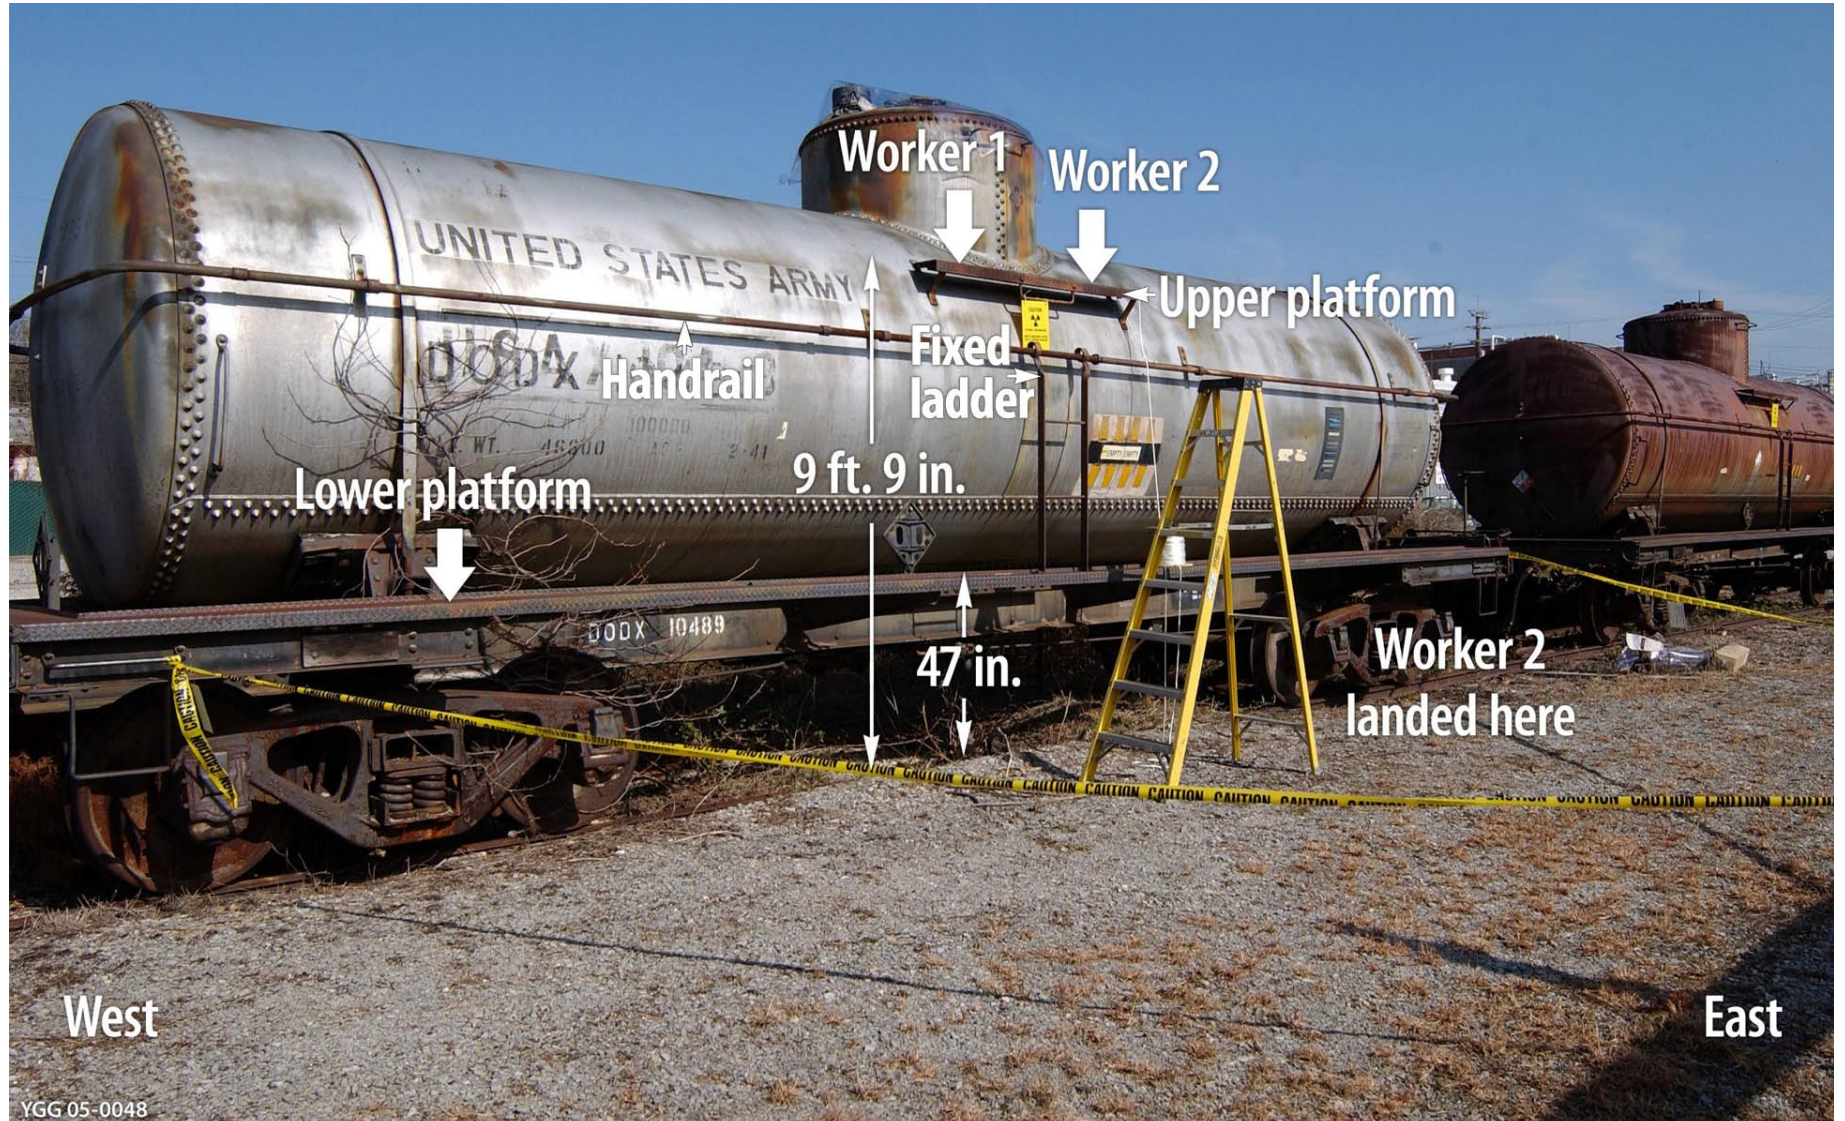
Figure 4-2 shows the tank car following the accident. A stepladder was placed next to the tank car for access to the lower platform, and the car has fixed ladders to access the upper platform. As shown in the figure, there is a handrail around the midpoint of the tank car that provides stability when workers are on the lower platform, as well as a rung at the top of the access hatch. The upper platform also has a climbing rung, which is approximately 10 feet above the ground.

Figure 4-2. Rail tank car accident scene

1. Evaluate whether to continue using the site requirement that permits three-point contact when working on tanker trucks.
2. Require a hierarchy of fall-protection options that includes (a) elimination of the hazard (i.e., work from the ground), (b) use of fixed or portable engineered fall protection, (c) use of PPE, and (d) administrative controls (e.g., procedures).
3. Ensure that procedures and training for elevated work address ladder safety. Topics should include using three points of contact as a control, selecting and using ladders, transitioning on and off ladders, and using dual-purpose equipment (i.e., platforms that also serve as a ladder rung).
