Operating Experience Summary

U.S. Department of Energy
Office of Environment, Safety and Health

OE Summary 2005-14
November 16, 2005

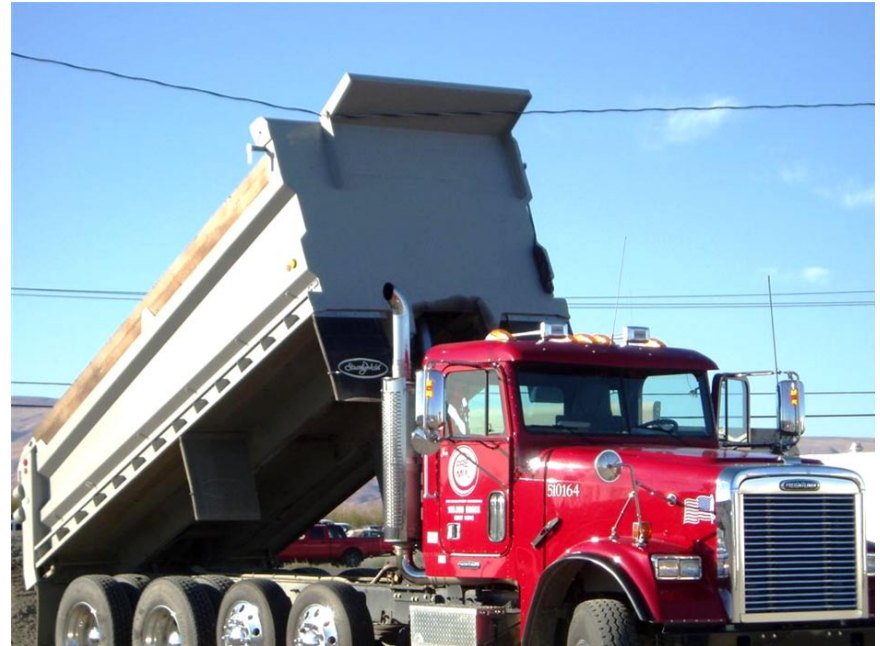
After the first truck departed, the PIC left the work site to determine where the other loads of gravel should be dumped. While he was gone, the second truck arrived. In the absence of the PIC, the second driver communicated with the first driver and was told to dump in the same area. Because the PIC was not at the scene and was unaware of the second truck, the driver received no additional instructions. He dumped his load with the truck facing toward the overhead power line, rather than away from it. An Operations Lead, who was driving by, saw that the raised bed was about to hit the overhead power line and signaled the driver to stop, but the line was hit before the truck stopped. Figure 1-1 shows the raised bed of the truck in contact with the

Figure 1-1. Raised bed in contact with power line

When the driver realized he had hit the power line, he exited the truck before he knew whether the power line had been de-energized. Neither the driver nor the Operations Lead recognized that this was not a safe practice or realized the potential for electrocution. Electrical Utilities personnel de-energized and repaired the power line after the truck was moved away.

If the bed of your truck makes contact with an overhead power line, attempt to lower the bed or move the vehicle to break contact. If you cannot do either of these things, remain in

the vehicle until electrical personnel indicate that it is safe to exit. If you must get out because of a fire, jump clear as far as possible with both feet together, ensuring that you do not make contact with the vehicle and the ground at the same time. Shuffle away or hop with both feet together. If you step, you could become a conductor because your feet will move from higher electrical potential to lower potential as the electrical energy dissipates radially while you move away from the source.

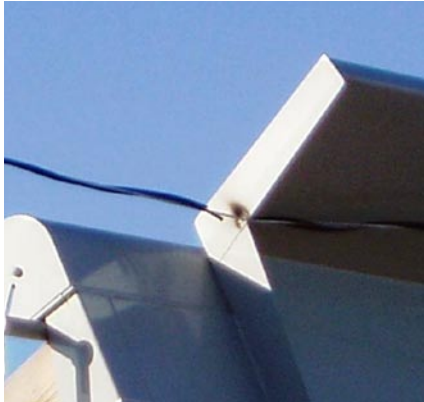
power line. Figure 1-2 shows a closeup of the contact point and burn mark left by the arc when the line was severed.

Figure 1-2. Severed power lines held in place by support cable

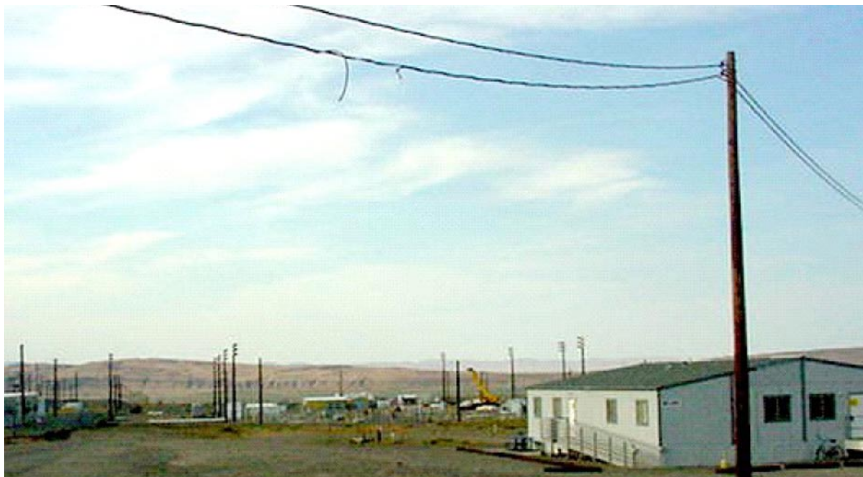
Figure 1-3. Cut power line running diagonally across the road bed

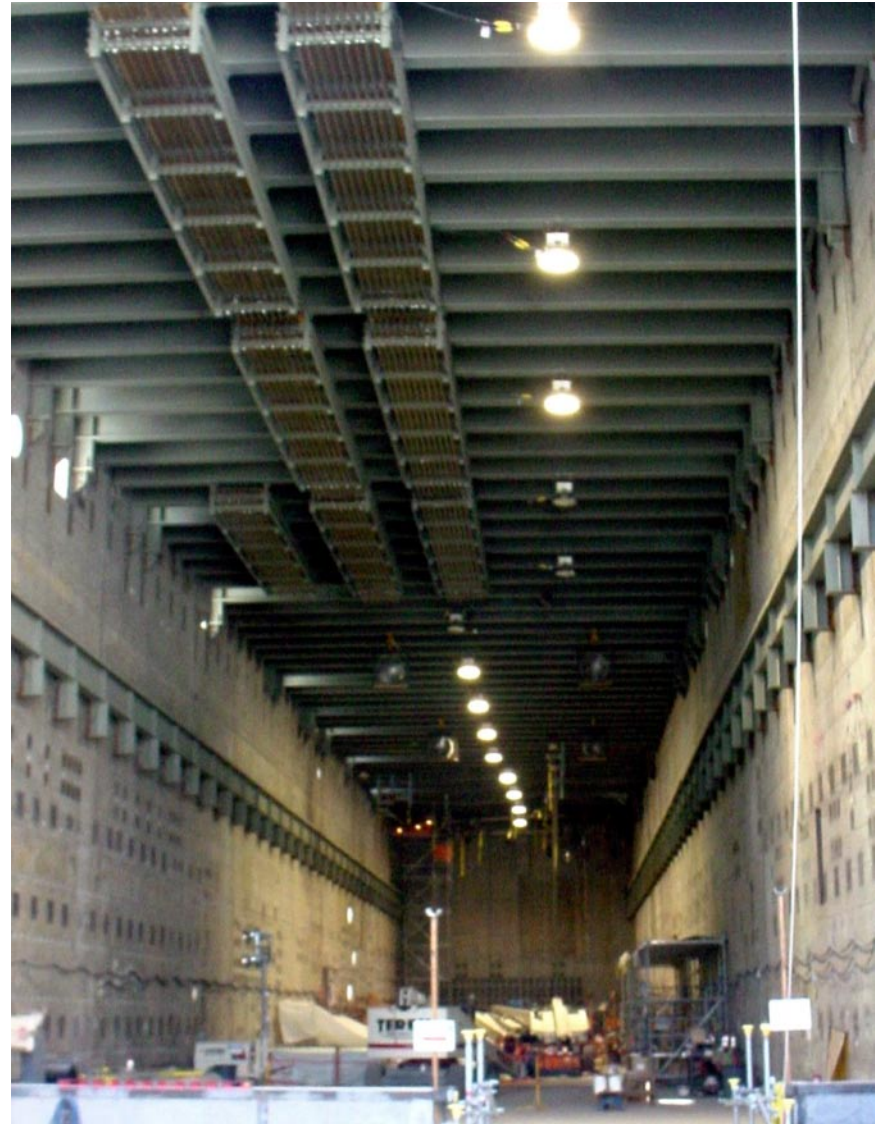
The floodlight was one of a series that are attached to the ceiling beams (Figure 2-1) 45 feet above the floor of the facility. The 480-volt floodlight was manufactured by Hubbell and rated for 1,000 watts.

Figure 2-1. Facility lighting

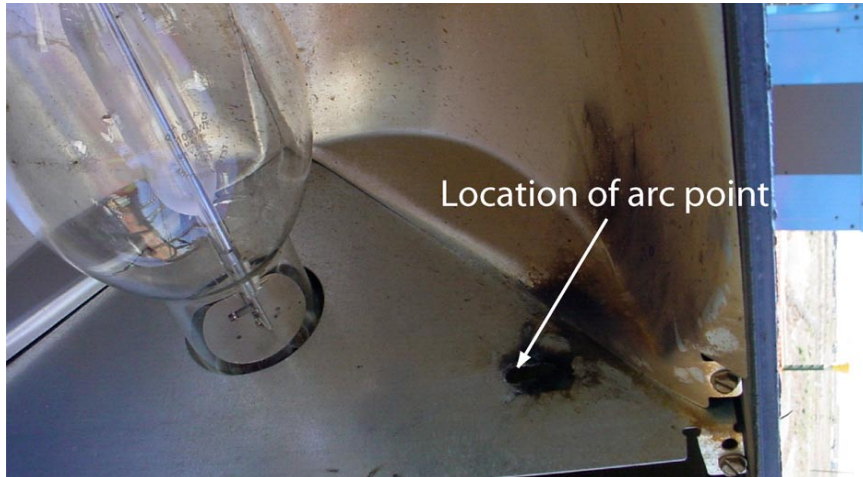
Electricians modified the light units by attaching two leads to the back of them, so they could fasten the units to the ceiling beams and interconnect the power cords. However, they did not consult with the manufacturer about making this modification. The electricians found that the support bracket did not provide enough room for the connections, so they made the connections inside the lamp fixture instead.

The label on the back of the unit specified the use of supply wire rated to 90°C (194°F). The electricians used wiring and wire nuts that were properly rated; however, the components inside the fixture are rated for 150°C (302°F). One of the lower-rated wire nuts inside the lamp melted, and the wire grounded to the bulb reflector, resulting in an arc (Figure 2-2) that blew out the lamp lens. Figure 2-3 shows the floodlight after the lens broke. Inspectors later found other floodlights with discolored wire nuts and brittle wire insulation.

Figure 2-2. Arc point

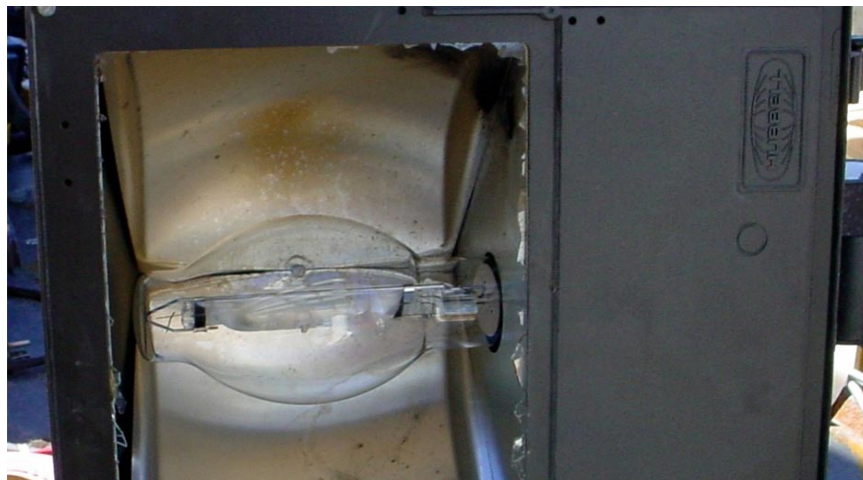
On September 6, 2005, at the Office of River Protection at Hanford, an electrician found a floodlight with the lens glass broken. Broken glass from the lens could be seen on top of a tarp that covered a pit opening. No one witnessed this event, and no one was injured. (Not reported in ORPS)

Figure 2-3. Floodlight with broken lens

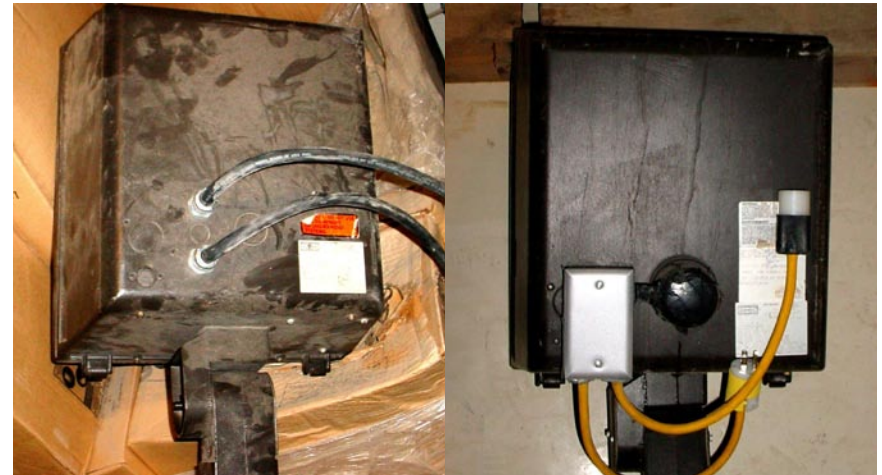
Figure 2-4. Back of previously modified (left) light unit and corrected modification (right)

The electricians should have attached a junction box to the outside of the floodlight and made the connections inside the junction box to prevent the wiring components from overheating. Figure 2-4 shows the original modification and the corrected modification.

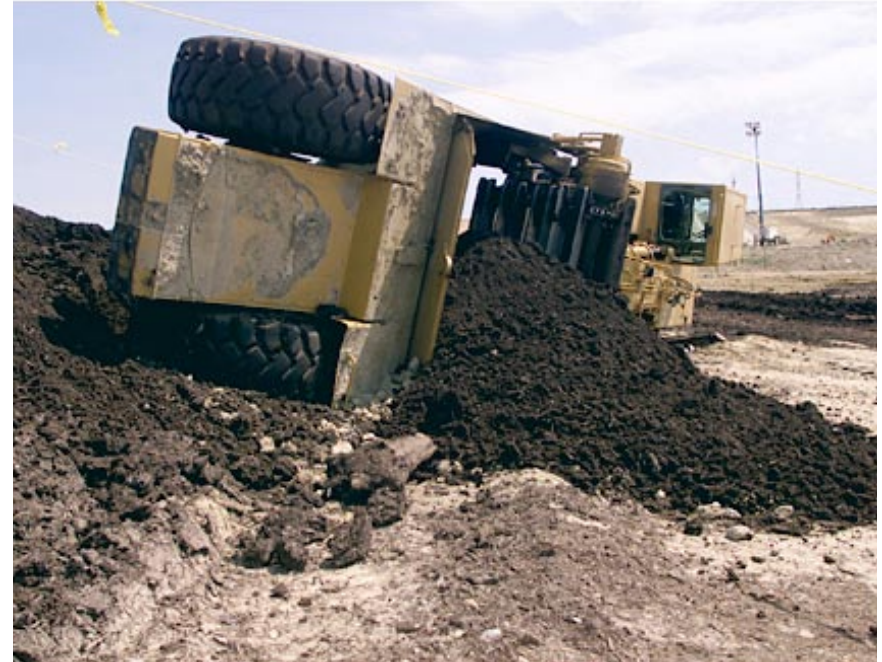
The scraper operator had been spreading compost from a long, rectangular stockpile of compost material (about 14 feet high) that had an 80-foot-wide entrance ramp and a 40-foot-wide exit ramp. Because of the soft nature of the compost, the rubber-tired, belly-pan scraper was pushed up the stockpile by a bulldozer until it reached the downward slope, then the operator left the stockpile via the exit ramp to spread the compost. When the operator was about 6 feet from the edge of the exit ramp, the right rear corner of the scraper began to slide sideways down the side of the ramp, and he braced himself for the inevitable rollover. After the scraper came to rest on its right side, the operator turned off the engine, removed his seatbelt, and safely climbed out of the scraper and down to the ground. Figure 3-1 shows the scraper following the rollover.

Investigators determined that the hazards associated with using this type of scraper on a large compost pile were not analyzed. The work authorization document identified hazards associated with stockpiles consisting of soil, stone, and rock materials, but did not take into account that the stockpile being spread was compost and a scraper was going to be driven across the top of

Figure 3-1. Scraper following rollover

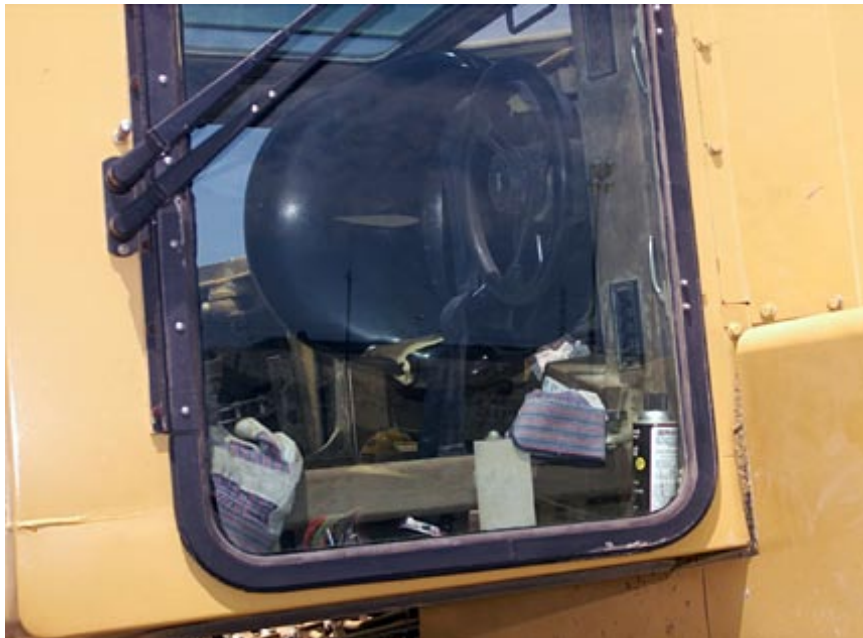
Figure 3-2. Scraper cab, post accident

required by the work order, and was protected from sustaining a head injury. By following site procedures that require drivers to “buckle up” and by choosing to wear a hardhat, the scraper operator walked away from the accident uninjured.

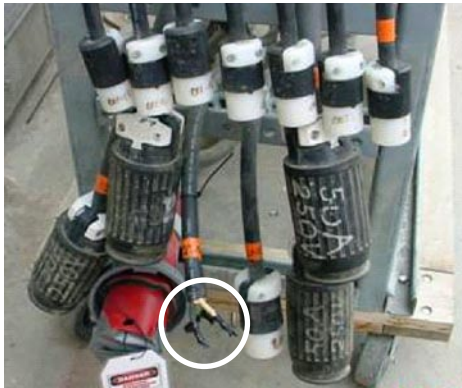
On September 29, 2005, at the River Protection Project Waste Treatment Plant, an electrician removed a plug to install a missing weather-protection cap, and the bare ends of an energized 240-volt power cord came together, causing an electrical arc. The electrician, who was not injured, had deviated from work instructions for de-energizing the circuit. (ORPS Report EM-RP--BNRP-RPPWTP-2005-0026)

The electrician was assigned to test power cords for assured grounding and to install missing weather-protection cord caps on the pigtails of a mini load center (Figure 4-1). The electrician was not given written work instructions, but was orally instructed to remove electrical power to the load center by disconnecting the 480-volt power cord (red plug in Figure 4-1) supplying the load center before he began to work. Instead, the electrician decided to keep the load center energized and open the circuit breaker for the specific cord he planned to work on. However, he opened the wrong circuit breaker so the cord he intended to work on remained energized.

Figure 4-1. Pigtails on the back of the mini load center and the exposed wires that arced (circled)

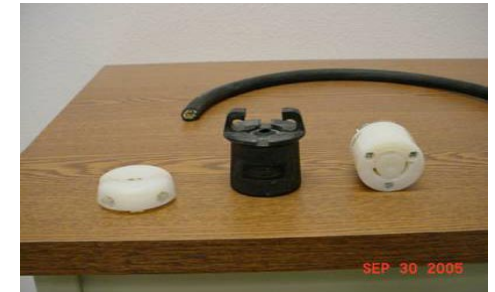
Figure 4-2. Plug attachment clip, cap cover, and plug (left to right)

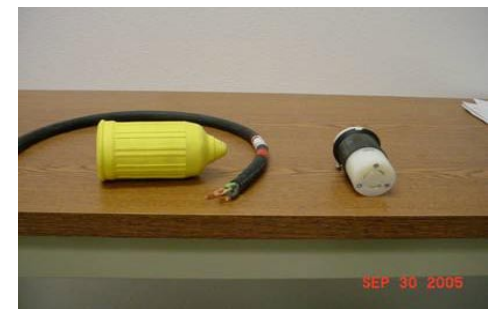
Figure 4-3. Weather protection cord cap (yellow) next to assembled plug
