Operating Experience Summary

U.S. Department of Energy
Office of Environment, Safety and Health

OE Summary 2005-15
December 2, 2005

Shared Neutral Circuits Pose a Danger if Not Properly Identified During Safety Checks

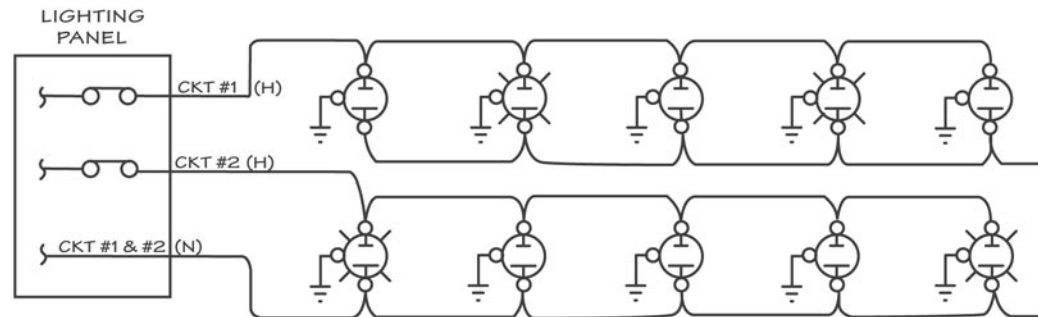
Figure 1-1. A typical two-light circuit with common neutral

during normal circuit operations as shown in Figure 1-1. If the common neutral is disconnected (broken), as shown in Figure 1-2, an unsafe condition occurs because line voltage appears on the broken lead. A worker who touches the broken neutral could receive a severe electrical shock.

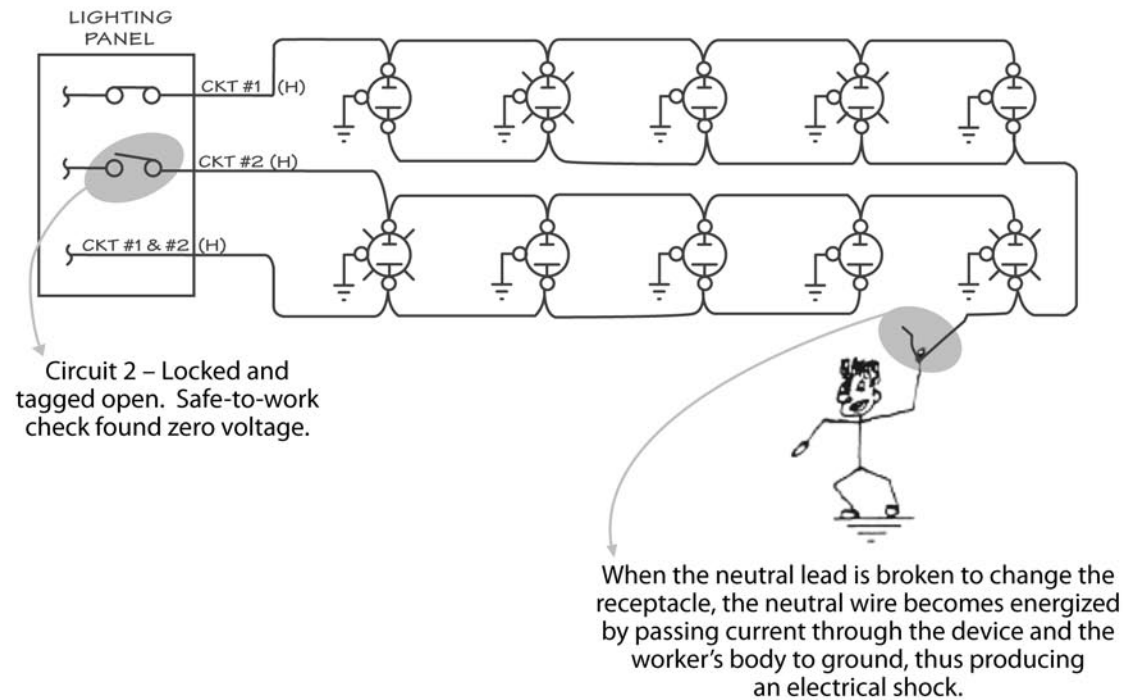
Figure 1-2. Example of unsafe condition when common neutral is broken

Because voltage can only appear on a common neutral after the wire is broken, normal zero-energy checks will not show the presence of electrical energy. The only positive way to prevent potential electrical shock is to open all circuits that share the common neutral wire. The present edition of the National Electrical Code (NEC) allows single-pole circuit breakers to be physically tied together so that all circuits that share the neutral can be de-energized simultaneously. Information and guidance on multi-branch circuits can be found in Article 210.4 of the NEC Code (NFPA 70).

- Treat the neutral as energized even though the circuit is locked out at the source panel. NOTE: PPE should be used because of this assumption.
- Maintain the continuity of the neutral by breaking only the single white wire connecting the device being worked on. Many common neutral circuits use wire nut or pigtail-type connections. If you only break the single lead to the device from the connection, the neutral is maintained back to the source and prevents voltage on the neutral wire connecting the device. If the neutral is wired through the device and not connected using a pigtail, then a common neutral should be suspected.

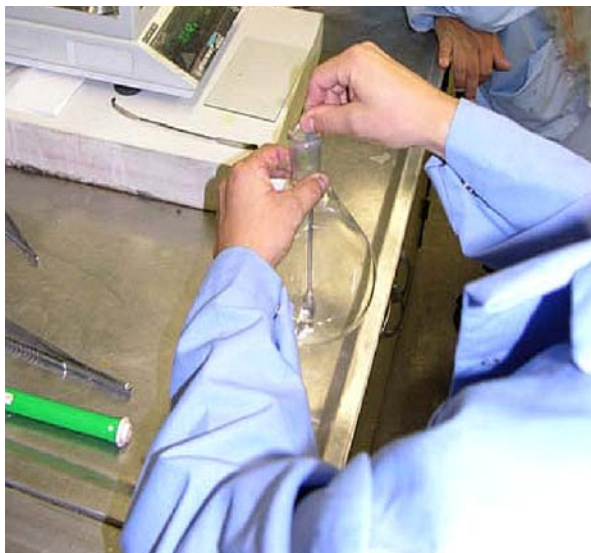
Figure 2-1. Re-enactment of the scene

Finally, on the 27th, the material was dry. The researcher wanted to remove the material from the round-bottomed glass flask it had been created in and place it into a smaller container for weighing. He used a small metal spatula to scrape the material out of the flask. Figure 2-1 shows a re-enactment of the researcher's actions just before the material exploded.

Investigators determined that the root cause of the event was that the synthesis procedure was ambiguous and failed to disclose the potential for synthesizing a sensitive byproduct. However, the researcher had changed some of the parameters of the experiment without analyzing those changes. For example, the experiment described drying the material under vacuum

Accident investigators recommended that the Laboratory re-evaluate its use of broad-scope integrated work documents and develop a mechanism for ensuring that any activity under this type of work document is adequately screened for potential hazards before work begins. They also recommended that the Laboratory re-emphasize the importance of applying ISM principles while working and that the facility be upgraded to provide better analytical capabilities.

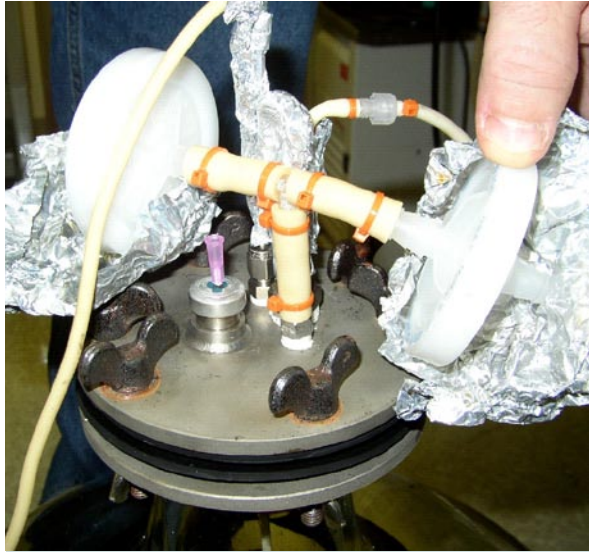
Figure 2-2. The vent in the head plate

Researchers were introducing nitrogen gas into the carboy, which held 30 liters of a culture medium. They knew that the potential existed for excess pressure to build up, but did not consult a subject matter expert. Instead, they decided to insert a 1½-inch needle into a rubber septum in the carboy head plate to act as a redundant vent for the 2-inch flat membrane filters. Figure 2-2 illustrates this configuration.

PNNL's internal oversight organization investigated the accident and determined that the membrane filters became clogged with condensation and the redundant vent was inadequate

to reduce the pressure. Because no written procedure existed for this activity, the hazardous situation caused by pressure building up within the carboy was insufficiently addressed.

- Walked down similar laboratories to identify other potential hazards that may have been overlooked.
- Evaluated the need for subject matter expert review of potentially hazardous laboratory work.
- Developed and disseminated a PNNL lessons-learned document on the event.
