OPERATING EXPERIENCE SUMMARY

U.S. Department of Energy
Office of Environment, Safety and Health
OE Summary 2005-01
January 10, 2005

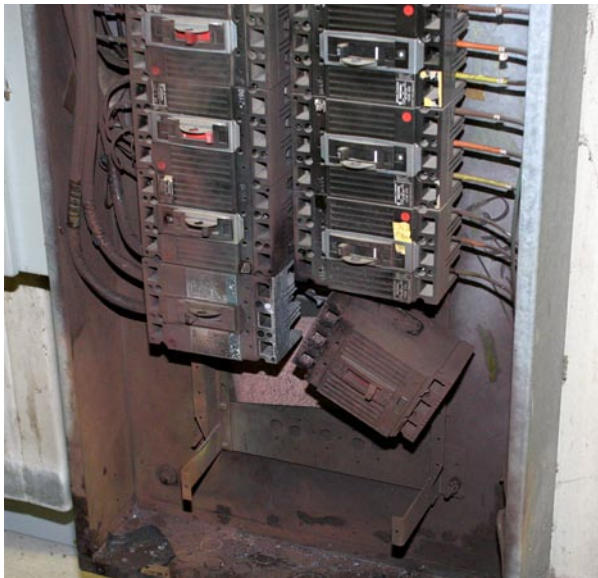
On the day of the accident, a SLAC field supervisor gave the electrician a circuit breaker and directed him to install it in the 480-volt electrical panel. The supervisor did not obtain an approved permit to conduct electrical hot work before making the assignment. The electrician wore a short-sleeved cotton/polyester shirt, leather gloves over Voltage (V)-rated gloves, safety glasses, and a hardhat. A rubber insulating mat was placed on the floor in front of the panel. The electrician removed the deadfront panel cover to begin the work. A laborer, who was assigned only to pull wire, acted as the electrician's safety backup. The electrician knelt on the mat in front of the panel to install the circuit breaker into position 12 of the panel (Figure 3-1).

Figure 3-1. Arc-damaged circuit breaker in panel position 12 hanging by the phase C connection

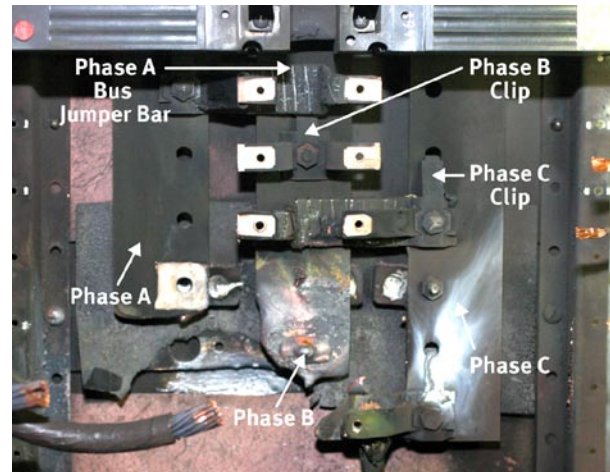
The circuit breaker panel has three vertical buses with phase A on the left, phase B in the center, and phase C on the right. The line-side connection to each circuit breaker is made by a connection attached to the phase by a clip. Insulated jumper bars cross over the B phase to connect the circuit breaker to the A and C phases. Figure 3-2 shows the circuit breaker panel after removal of the damaged circuit breaker, the adjacent circuit breaker, and the two circuit breakers above.

Figure 3-2. Circuit breaker panel with melted and damaged buses, jumper bars, and phase clips

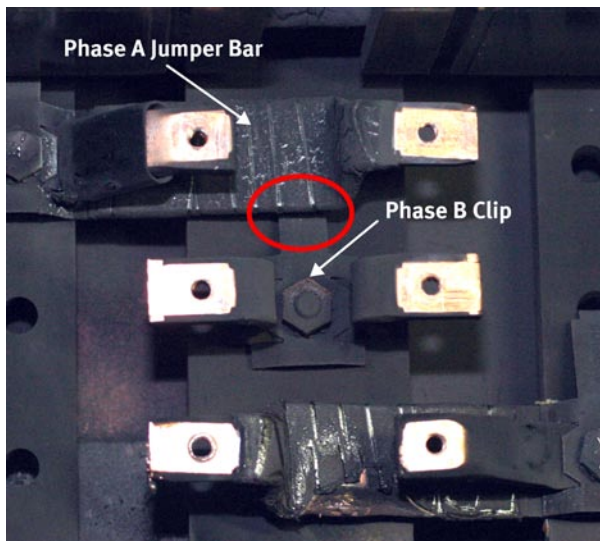
The Board also believes that when the electrician applied additional force to engage the screw with the phase A jumper bar (which is supported in a cantilever fashion above the center B phase), the jumper bar deflected toward the B phase and compressed the B phase stabilizing clip (Figure 3-3).

Figure 3-3. Close up of jumper bar and clip with the believed location of the fault circled in red

The compression of the rubber insulation increased the electric field stress, causing the insulation to fail and initiate an arc flash behind the incident circuit breaker.

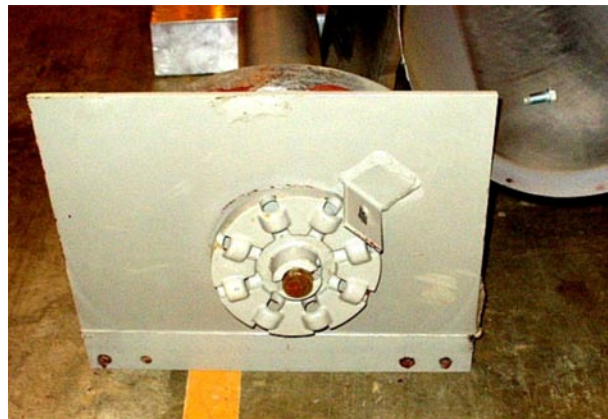
On October 1, 2004, a worker at Rocky Flats was injured while assisting with the removal of a truck dock rollup door. The motor and torsion bar assembly were being lowered to the floor by a forklift when energy stored in the torsion assembly suddenly released, rotating a 16-inch-square mounting bracket on the end of the assembly. The worker who was injured was guiding the assembly away from the wall when he was struck twice in the arm by the rotating bracket (Figure 4-1). He was taken to a local hospital and received 20 stitches in his arm. (ORPS Report RFO--KHELL-371OPS-2004-0024)

Figure 4-1. Mounting bracket
