OPERATING EXPERIENCE SUMMARY

U.S. Department of Energy
Office of Environment, Safety and Health
OE Summary 2005-02
January 24, 2005

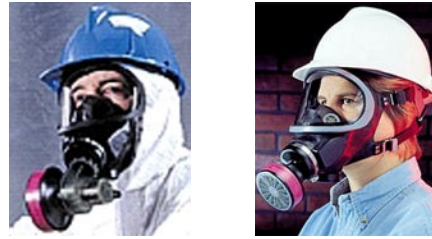
The attendant on duty in the Issue Room had completed the required issuer training but had not previously issued a PAPR. Although two attendants usually staff the Issue Room, the other staff members were elsewhere, leaving only the one attendant. The attendant verified the RCT's PAPR and respirator qualifications and issued what he believed was the correct full-face respirator (an MSA Optimair[®] MM2K), blower, cable, battery pack, and compatible HEPA filter to the employee. However, the attendant later learned that he had inadvertently issued an MSA P100 Ultra Filter[®] instead of an MSA Optifilter XL[®] Filter, which is the National Institute for Occupational Safety and Health (NIOSH)-approved filter for the MSA Optimair[®] MM2K PAPR.

The P100 Ultra Filter has a smaller diameter threaded connector than the Optifilter XL. However, the employee managed to assemble the PAPR and filter issued by the attendant. Figures 1a and 1b illustrate that although the filters have a similar appearance, their orientation is different.

Figures 1a and 1b. MSA Optifilter (left) and Ultra Filter (right)

Corrective actions are still underway. They include revising issuer training to provide more specific guidance on issuing PAPRs and filters, developing visual aids for Issue Rooms, and providing refresher training on this event to all qualified issuers. Managers and supervisors will also receive training on the potential for inexperienced issuers to make errors when selecting equipment, and both issuers and RCTs will receive reinforcing training on the need to stop work if in doubt about proper respirator assembly.

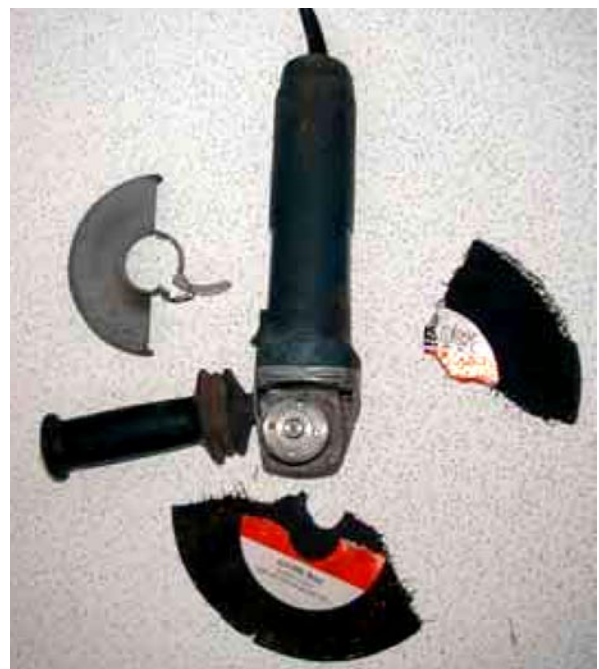
In October 2004, the Occupational Safety and Health Service of the New Zealand Department of Labour issued an [Accident Alert](#) describing the death of a welder who was using a portable angle grinder with a 9-inch wheel on an excavator bucket when the wheel disintegrated and pieces penetrated his chest and abdomen (Figure 2-1).

Figure 2-1. Disintegrated grinding wheel

An initial investigation revealed that the grinder and wheel were incompatible and that the grinder was not fitted with a guard. The Alert emphasized that grinders and abrasive wheels should always be used in accordance with the manufacturer's instructions and offered the following tips:

- Always ensure the maximum speed (the no-load rpm) marked on the abrasive wheel is greater than the rated speed of the grinder.
- Do not use grinding wheels that are larger than the maximum recommended size or worn-down wheels from other grinders.
- Never use grinding wheel power tools without the wheel guard attached to the tool and positioned for maximum safety.
- Store and handle abrasive wheels with care and inspect them for chips or cracks before installing. Do not use a wheel that may be damaged.

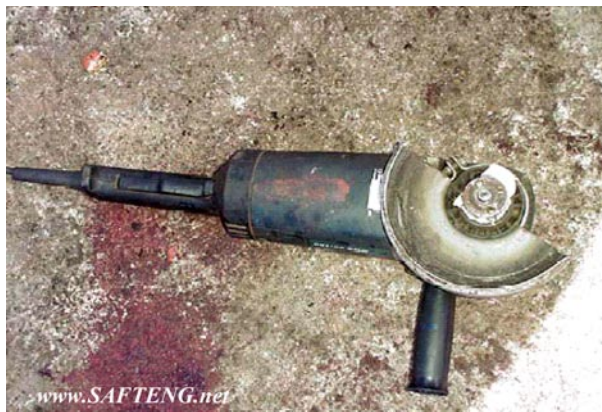
In December 2004, a worker in Brazil was seriously injured when the grinding disc on his angle grinder disintegrated (Figure 2-2) and pieces struck his legs, resulting in heavy loss of blood. The worker ultimately suffered amputation of his right leg and damage to his left leg. Investigators determined that the grinding wheel was too large for the grinder.

Figure 2-2. Grinder missing the disk

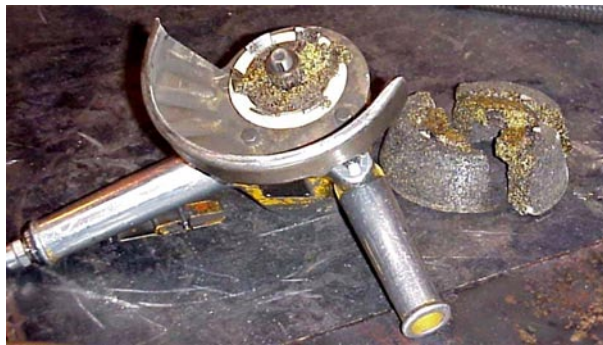
OE Weekly Summary 1999-05 reported a similar event that occurred on January 26, 1999, at the Hanford Site. A pipefitter was grinding slag from the flame-cut edge of a 3/8-inch-thick metal plate when the grinding wheel disintegrated. The guard protected the pipefitter and deflected the broken pieces away and down to the floor. The largest piece traveled approximately 15 feet and struck a metal garbage can, penetrating one side of the can and propelling it approximately 15 feet. Other fragments were distributed over an area within a 12-foot radius. Figure 2-3 shows the grinder and pieces of the cup stone. There were no injuries. (ORPS Report RL--PHMC-FSS-1999-0006)

Figure 2-3. Damaged grinder and cup stone

The pipefitter stopped work and notified his immediate supervisor. The facility manager directed all grinding operations to stop until personnel had inspected all grinding wheels for visible damage and verified that no wheels were mounted in grinders with a greater speed rating.

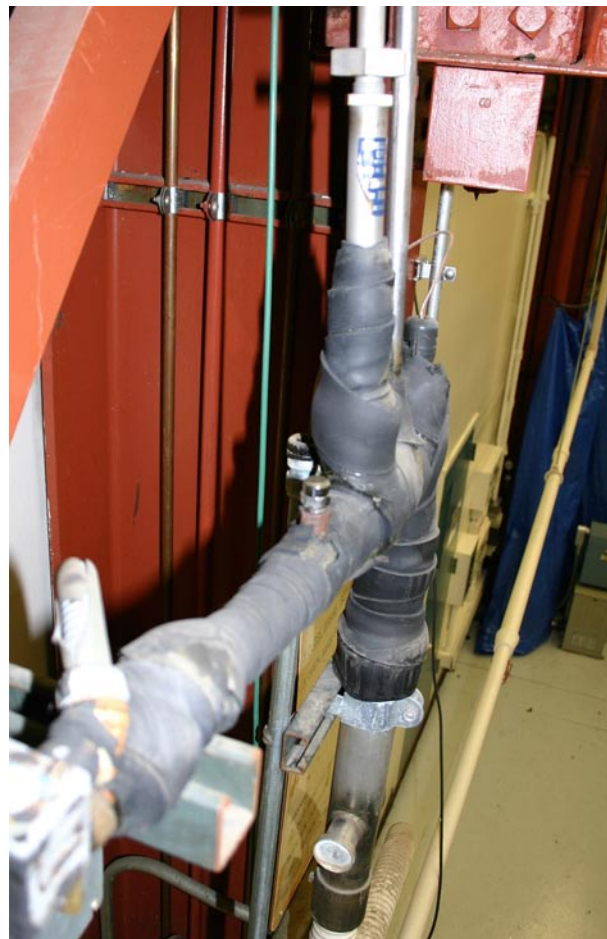
- Design engineers were unable to find the original design documents and drawings for the old tank when planning the tank replacement project. As a result, facility personnel did not know the exact settings to use for the new tank. After the leak was found, original drawings were finally located. The drawings showed that the old system was designed to operate at 35 psig with a final delivery relief valve pressure of 50 psig.
- The pressure setting for relief valves (illustrated in Figure 3-1) on the liquid line coming into the building was 150 psig.

Figure 3-1. Pressure relief valve

However, several other smaller relief valves inside the building, which were untagged and difficult to find and read, were set at 50 psig, the same as the operating pressure. This, in effect, created a series of small distributed gas leaks that made it difficult to detect any single leak until liquid finally flowed from one of them.

1. Facility personnel should thoroughly research proposed changes to any pressure system, even if they seem to be insignificant. It is especially important to locate the original documentation, inspect the entire existing system, and compare it to the as-built drawings, noting the original design intent.

2. Design engineers should always conduct a system design review before replacing components with those of different specifications, especially when replacing an aging system where identical components may not be available and compatibility issues may exist between replaced and new components. This is particularly important when installing new cryogenic delivery systems.

3. The responsible environment, safety, and health team should review pressure systems to identify and address safety and health concerns.
4. Facility personnel should perform a systems test to ensure that operating parameters remain within the design limits.

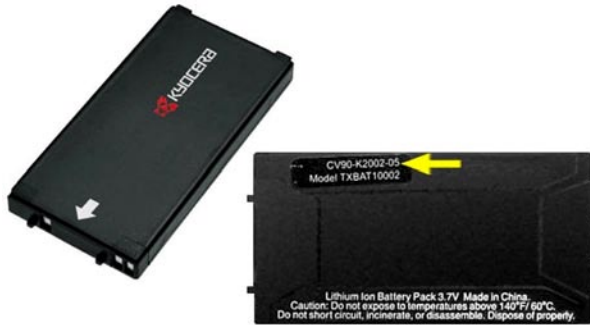
Hazard: The recalled batteries can short-circuit and erupt with force or emit excessive heat, posing a burn hazard to consumers.

Figure 4-1. An identified defective Smartphone battery

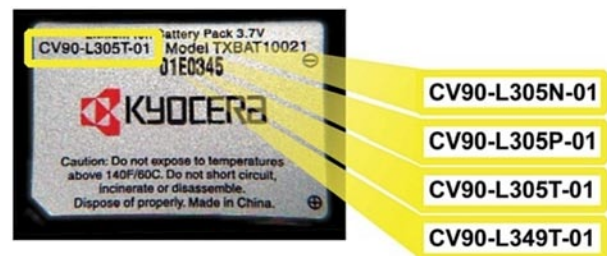
Hazard: Some of the cell phone batteries supplied by the battery manufacturer may be counterfeit. This can cause the batteries to short-circuit, overheat, and pose a burn hazard to consumers.

Figure 4-2. Slider series product codes

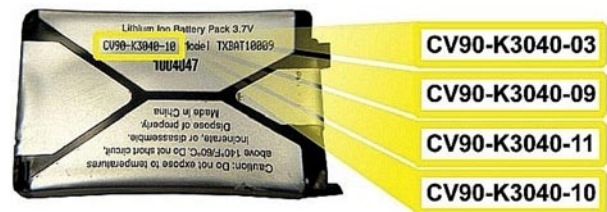
Figure 4-3. 3200/K400 series product codes

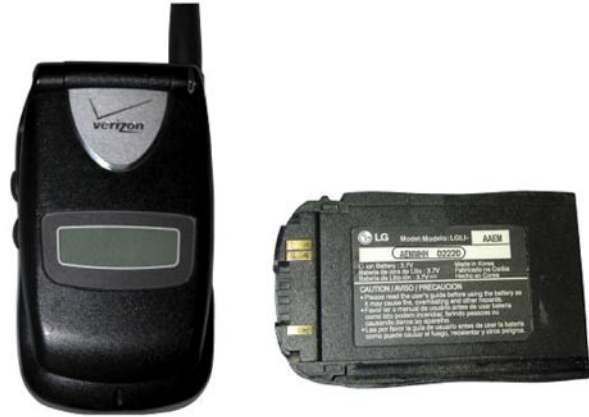
Hazard: Some LG-branded TM-510 batteries may be counterfeit and susceptible to overcharging, especially if used with a non-LG charger. LG Infocomm U.S.A., Inc. states that these are counterfeit LG-branded batteries that do not contain a safety device in the circuitry to prevent overcharging. In turn, the counterfeit batteries can overheat, posing a fire and burn hazard to users.

Figure 4-4. Verizon product codes
