OPERATING EXPERIENCE SUMMARY

U.S. Department of Energy
Office of Environment, Safety and Health
OE Summary 2005-04
February 22, 2005

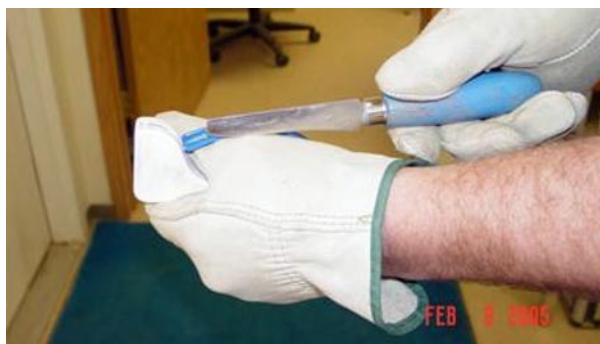
Figure 1-2. How the worker used the sharpener

The worker's knife was about 3 $\frac{3}{8}$ -inches long and very sharp. He held the sharpener upside down and pulled the knife through the sharpener (Figure 1-2), towards himself and through and over his left thumb, leaving a hairline cut in the thumb.

Proper use of this sharpening tool is important for the user's safety and the manufacturer's instructions for correct use were included with the tool. Figure 1-3 demonstrates how the sharpening tool should have been held and used in accordance with the manufacturer's instructions.

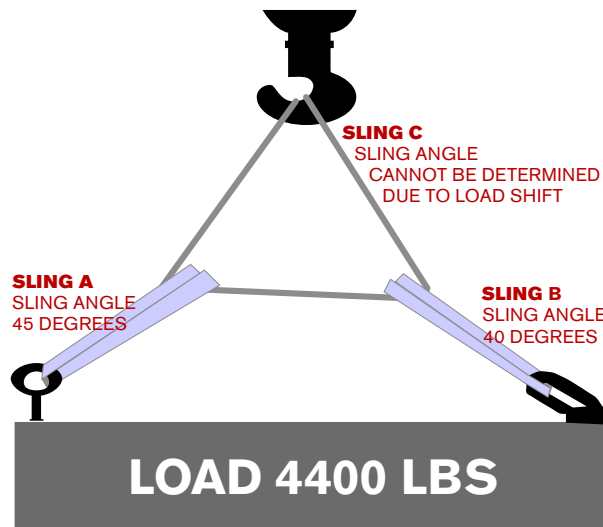
Figure 3-1. Rigging diagram

The rigger folded two 6-foot, 6,400-pound-capacity endless slings in half (shown in the figure as slings A and B), believing that doing so increased their weight capacity, but in actuality, it *decreased* their capacity. He folded sling A around the eyebolt and sling B around the swivel hoist ring. In this configuration, neither sling was long enough to reach the hook, so the operator joined them to the hook using sling C. This put slings A and B at angles of 40 and 45 degrees, which increased the stress on them by up to 1½ times. This additional stress meant that the slings were effectively sharing a 6,800-pound load, while their 6,400-pound weight capacity had been reduced.

Because the load's center of gravity was not in line with the lifting hook, sling C offered no load stability and could have allowed the load to shift or slide through it, even if slings A and B had not failed.

The load could have been lifted safely using a special lifting fixture designed for moving the block. The following corrective actions were taken.

- Revising facility hoisting procedures to include engineering oversight of all lifts and guidance on using special lifting devices for moving irregularly shaped loads such as the steel blocks.
- Comparing facility hoisting procedures to the SLAC hoisting and rigging policy.
- Revising hoisting and rigging training to include a refresher training course and hands-on-rigging practice.

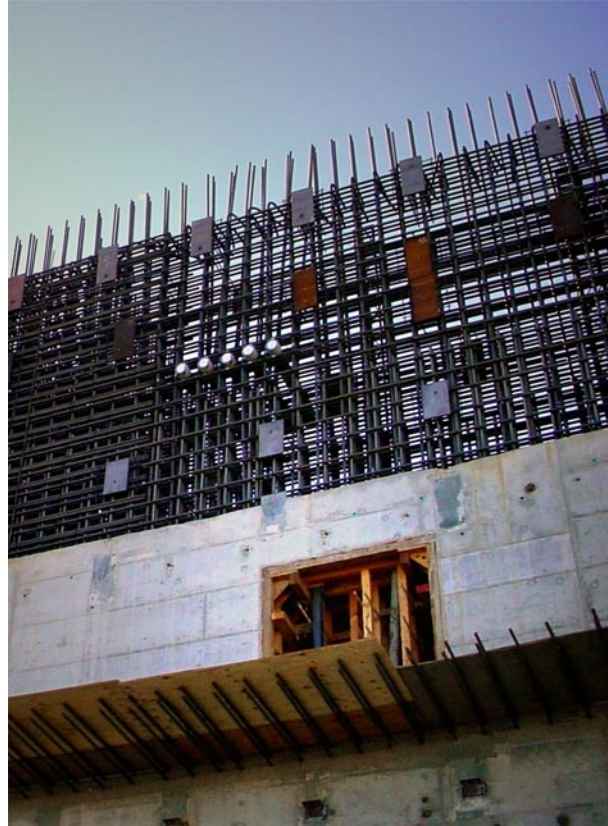
Figure 4-1. Rebar wall

On January 25, 2005, at the River Protection Waste Treatment Plant construction project, an electrician slipped and fell about 3 feet from a height of 55 feet before his fall protection equipment (a harness and double lanyard) caught him. Because he correctly maintained tie-off points above his body, he was not injured. The electrician was descending a rebar wall like the one shown in Figure 4-1 when his foot slipped and he fell. He continued his descent down the wall and reported the incident to his supervisor. (ORPS Report RP--BNRP-RPPWTP-2005-0002)
