OPERATING EXPERIENCE SUMMARY

U.S. Department of Energy
Office of Environment, Safety and Health
OE Summary 2005-05
March 7, 2005

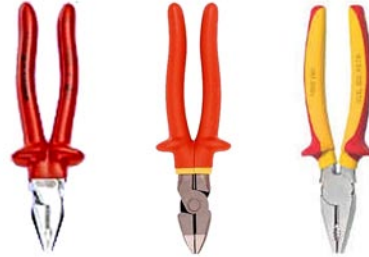
Figure 1-3. Insulated lineman's pliers

Tools rated for electricians are made and sold by many manufacturers. The screwdriver shown in Figure 1-2, for example, is insulated to the head to prevent workers from inadvertently contacting energized components with the metal shaft. Electrically rated lineman's pliers (see Figure 1-3) have handles coated with insulation and are designed to withstand certain levels of voltage (e.g., 1000 volts). The Plastisol-coated pliers the worker was using at the time of the incident were not electrically rated.

Never assume that a tool is insulated and acceptable for working on energized equipment or systems simply because it appears to have a nonconductive or plastic coating on its handles. Workers should understand that insulated tools must meet specific standards, but using them provides only a partial barrier in protecting workers from electrical hazards. Insulated gloves and other protective equipment should always be used with insulated tools.

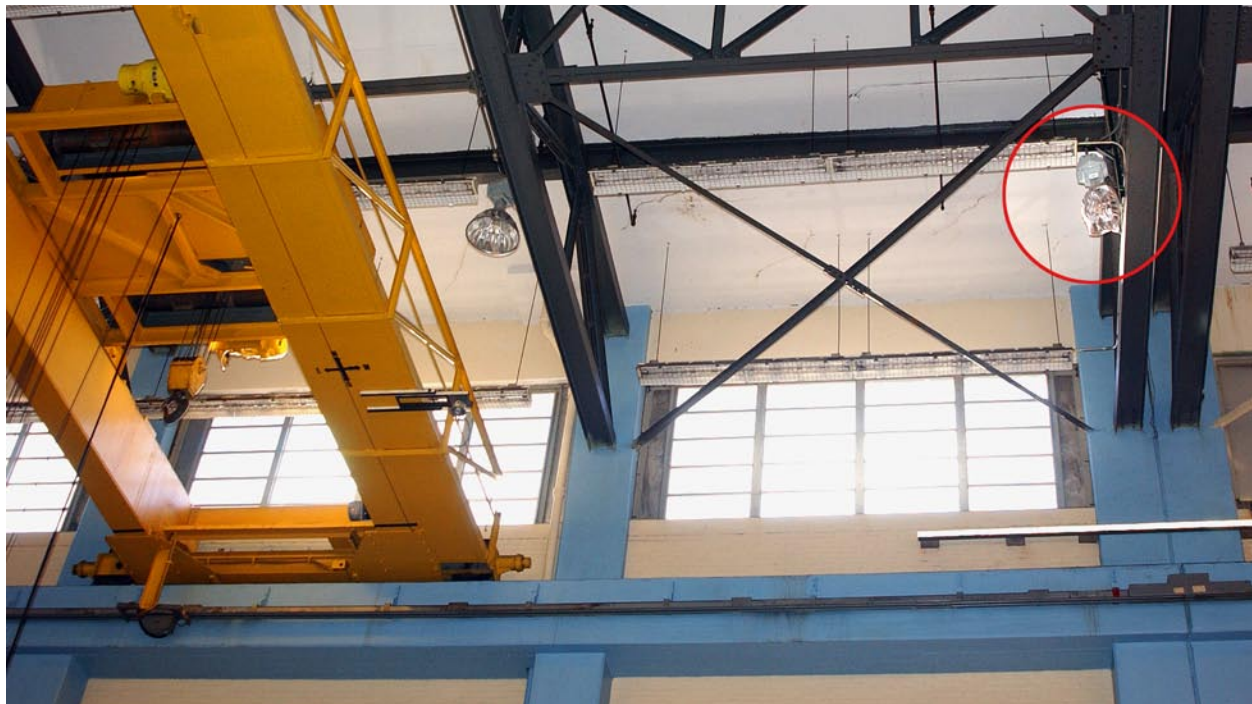
Figure 2-1. Broken light fixture

On December 27, 2004, at the Y-12 National Security Complex, the trolley of a moving overhead crane struck a light fixture causing the lens to detach and fall 35 feet to the floor (the broken fixture is shown in Figure 2-1). The fixture was one of 16 that had recently been replaced, and the ballasts were approximately 4 inches longer than those in the original fixtures. The 4-inch change affected the vertical length of the fixture, and consequently, the clearance requirement for the crane traveling beneath it. No injuries resulted, and the only damage was to the fixture. (ORPS Report ORYS-YSO-BWXT-Y12SITE-2004-0023)

After installation, the new fixtures hung down into the travel path of the crane, but installers did not consider the change in length either during or after the installation. Following the incident, investigators found additional fixtures, which were not replacements, also were hanging down into the crane's travel path. Following an inspection, the fixture hit by the crane, as well as 10 other fixtures, were raised to the proper height, and inspectors verified that the necessary clearance had been taken into account.

In all of these events important facts related to the work space had not been ascertained before operating the cranes. Environments in which overhead cranes are operated are not static, and one should never presume that the workspace remains in the same condition in which it was left. A complete check of a crane's planned travel path is warranted before work begins. Additionally, any changes to the workspace in which an overhead crane is installed must be accomplished with a full awareness that these changes may have an impact on the crane's field of motion. Any resulting encumbrance to the field of motion must be corrected.

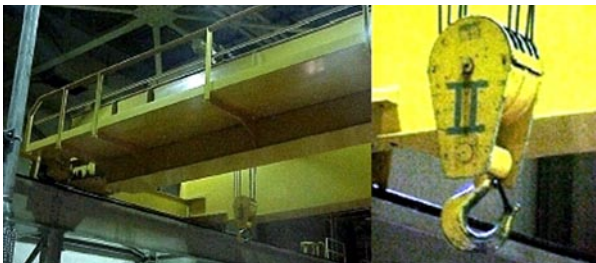
Figure 2-2. Overhead crane and crane hook

On April 29, 2003, at the Thomas Jefferson National Accelerator, an overhead crane was being used to replace lighting in the Test Lab high bay (ORO--SURA-TJNAF-2003-0001). The crane hook contacted an equipment cabinet and damaged two conduits, one of which contained a 120-volt power circuit, creating a near miss situation. The crane and crane hook are shown in Figure 2-2.

Causal analysis revealed that workers had not evaluated the location of the crane hook before the operation began. They had been using the same crane for a period of weeks without incident, and they had consistently found the crane in the same configuration in which they had left it. Because of complacency, they did not check the position of the crane hook.

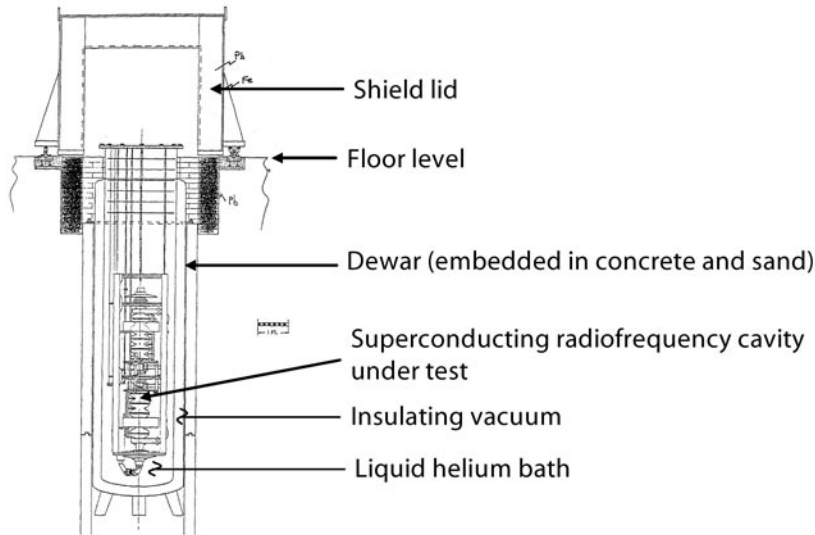
Figure 4-1. Dewar shield

On May 5, 2004, at the Thomas Jefferson National Accelerator Facility's Vertical Test Area, a worker preparing to run a test in a dewar (schematic shown in Figure 4-1) noticed that a metal plate had been attached to a safety interlock switch actuator in an effort to ensure the switch operated when the lid was closed. Two dewars in the facility were found to have been modified in this way. (ORPS Report ORTJ-TJNA-SURA-TJNAF-2004-0003)

The actuator contains a pair of switches and is attached to the inside of the shield lid. When the lid is closed, the switches send a signal that the safety interlock system must detect before allowing the high-power radiofrequency amplifier to operate.

The physicist who made the unauthorized interlock modification told investigators that he had made the modification to the two dewars about 6 months earlier to force the switches to function properly. He should have informed the Safety Systems Group of the intermittent

- The facility reported the event to the Noncompliance Tracking System, where the DOE Office of Enforcement could track it to closure.
- Facility management briefed personnel on the event and on the need to maintain configuration control of safety interlocks.
- The safety systems group replaced all switches and tested the interlocking functions.
- Maintenance plans and procedures were revised to ensure that lids and switches are operating as designed and that Safety Systems Group personnel inspect and recertify facility equipment after maintenance has been performed on it.
- Vertical Test Area personnel are required to notify the Safety Systems Group whenever safety-significant equipment is found damaged or nonfunctioning.
- Shield interlock switches were reconfigured to make them more reliable and less likely to become misaligned.
