OPERATING EXPERIENCE SUMMARY

U.S. Department of Energy
Office of Environment, Safety and Health
OE Summary 2005-06
March 21, 2005

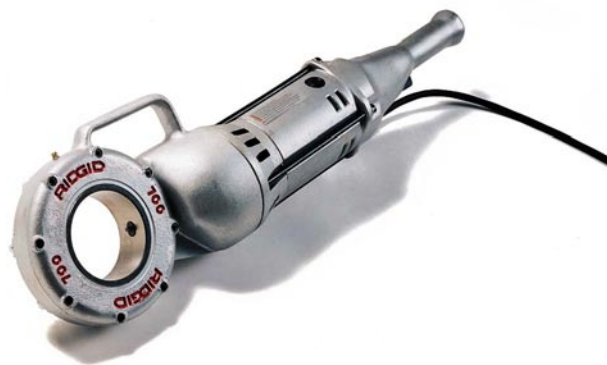
Figure 1-1. Portable power driver

To make adjustments to the blades, workers turn 8-inch-long screw jacks built into the test stand. The worker, who was wearing gloves at the time of the accident, used a Ridgid® Model 700 Portable Power Driver (Figure 1-1) while standing on a 5-foot stepladder to reach the screw jacks. As the worker was using the power drive, the handle broke away, causing the main body of the tool to rotate counterclockwise, pinning the operator's right thumb. A raised section on the body of the tool created a pinch point that severed the tip of the worker's right thumb and exposed the bone.

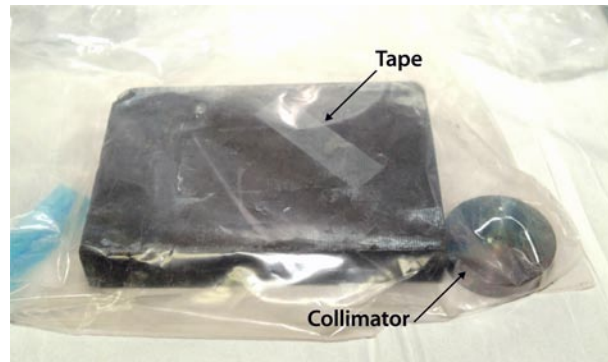
A health and safety technician monitored the workbench area for contamination. A direct survey of the graphite block indicated 2,000,000 dpm/100 cm² beta-gamma. Figure 2-2 shows the contaminated graphite block and the collimator in a plastic bag to contain the spill. A survey of the workbench showed 500,000 dpm/100 cm² beta-gamma and a swipe survey of the tongs showed 50 dpm. The researcher and technician did not have any contamination on their clothing, and whole body scans were negative.

Figure 2-2. Graphite block with tape to fix the cobalt-57 powder and the collimator that held the source

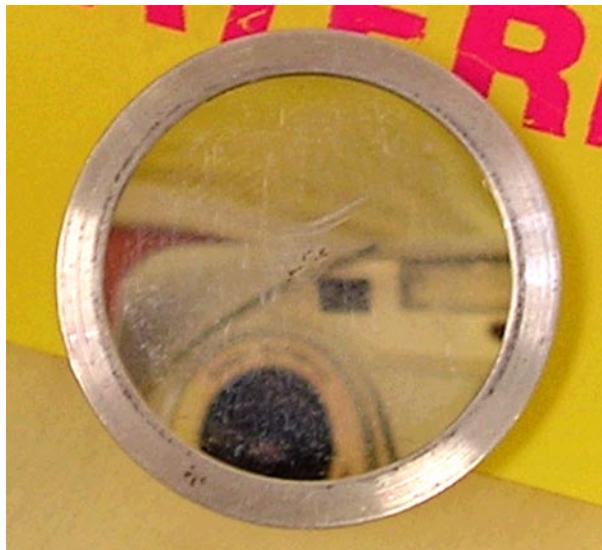
Figure 2-3. Magnified photo of source showing scratches on the face

an annual calibration of a high-purity germanium (HPGe) detector, which is used for gamma spectrometry measurements of soil surfaces. While setting up the calibration, he inadvertently placed the sealed source into the source jig (calibration holder) incorrectly with the active surface facing toward the back of the jig. Removing the source from the jig requires inserting a metal rod through a drilled hole in the jig and pushing it against a metal backing plate behind the source to push it out. However, with the source reversed in the jig, the backing plate damaged the thin (0.254 mm) Mylar cover on the source, allowing the cesium salts to leak out. Figure 2-4 shows the wooden jig.

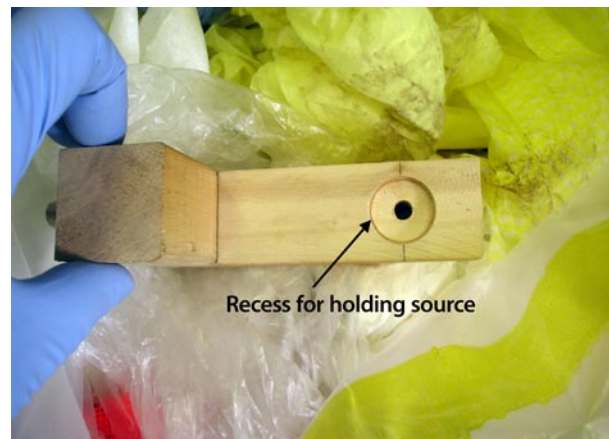
Figure 2-4. Jig for holding the source showing hole in center for source removal

- Design of the source jig and methods used to remove the source from the jig were not evaluated.
- Contamination monitoring was not required for handling and using sealed sources; therefore, the damage to the source was not detected during the calibration process.

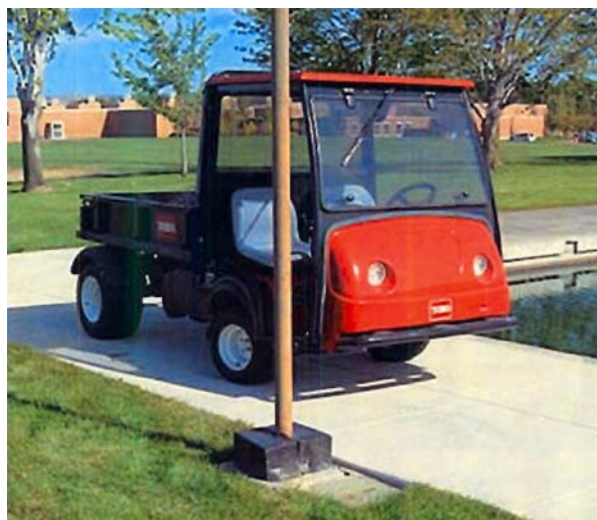
When the accident occurred, both the factory-installed seat belts and the hip restraints were missing from the vehicle. Two glass latching side doors had also been removed for comfort during warm weather and because of post-delivery concerns about potential carbon monoxide buildup in the cab if the vehicle was idling for any length of time. Figure 4-2 shows the vehicle at the accident scene.

Figure 4-2. Toro Workman 3200 following accident

The Board concluded that this was a preventable accident. They determined that the direct cause of the accident was the lack of a seat belt and hip restraint to prevent the passenger from falling out of the vehicle. In addition, removing the cab doors after the vehicle was placed in service also removed the remaining safety barrier and allowed the worker to slide out of the vehicle.

- Conduct a comprehensive hazard analysis of the work performed by site grounds personnel to ensure that all hazards are identified and that controls are developed to mitigate them.
- Train both supervisors and workers on the importance of routine safety behaviors and the use of safety equipment (e.g., seat belts) and on the need to ensure that those operating utility vehicles are aware of vehicle safety features and any specific hazards.
- Require grounds staff to participate in a comprehensive review of the operating manuals for all grounds-related equipment before using it.
- Update procedures to require operators to familiarize themselves with vehicle/equipment manufacturers' instructions before initial use of new equipment.

- Require operators to review new equipment information regardless of experience with previous model.
- Revise the procurement and inspection process to require a safety review of the procurement specifications and a validation that manufacturer safety features are installed.
- Ensure that vehicle custodians verify that safety equipment that should be present on the vehicle is in fact installed.
