# OPERATING EXPERIENCE SUMMARY

**U.S. Department of Energy**  
**Office of Environment, Safety and Health**  
OE Summary 2005-07  
April 11, 2005

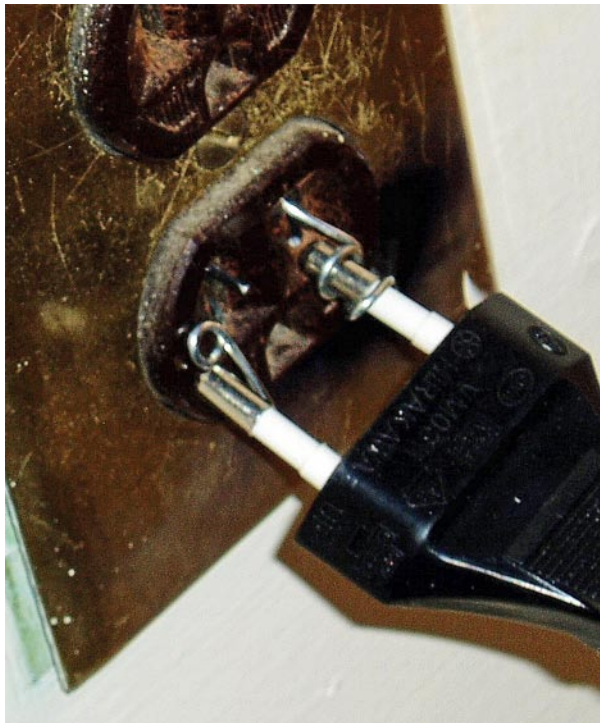
Investigators noticed that a computer laptop was plugged into the electrical wall receptacle. The laptop's power cord had European-style round pins, each of which had a paper clip twisted around it (Figure 2-1). The paper clips had been inserted into the receptacle to gain conductivity to run the laptop. As the custodian moved the bed while changing the sheets, one of the paper clips contacted the receptacle's grounded metal faceplate, causing a short and electrical spark.

**Figure 2-1. Modified plug**

The organization responsible for residence housing inspected all residence buildings for evidence of altered power cords or receptacles. The Laboratory issued a memorandum to all onsite residents informing them that power cords and receptacles are not to be modified. It also provided locations where approved adapters could be purchased. The memorandum will be included in welcome packets for onsite visitors as well.

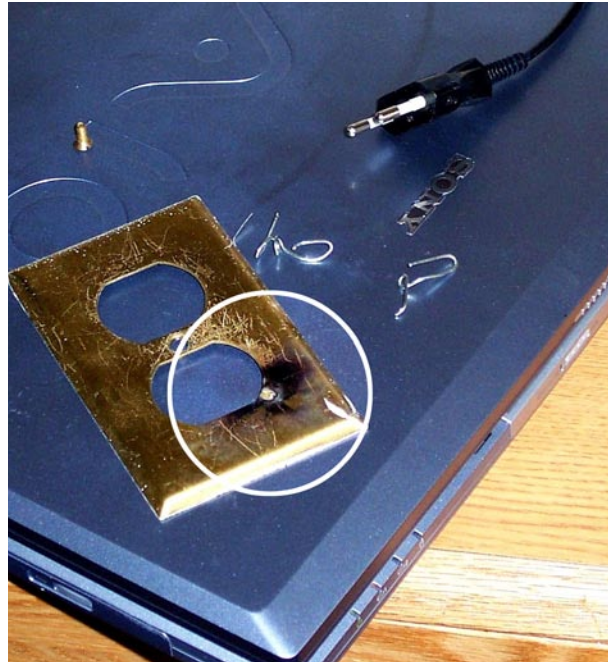
Fire and electrical experts examined the receptacle closely and found spark burns and smoke on the receptacle faceplate (Figure 2-2) and soot from the flash on the wooden headboard post. The circuit breaker did not trip, but was tested and found to be properly functioning.

**Figure 2-2. Laptop, plug, bent paper clips, and receptacle faceplate with burn marks (circled)**

Electrical experts determined that the breaker failed to trip because this was a high-resistance short rather than a direct short. The short condition did not exist for enough time and did not draw enough amps to trip the breaker, but had the power to potentially injure someone and cause property damage.

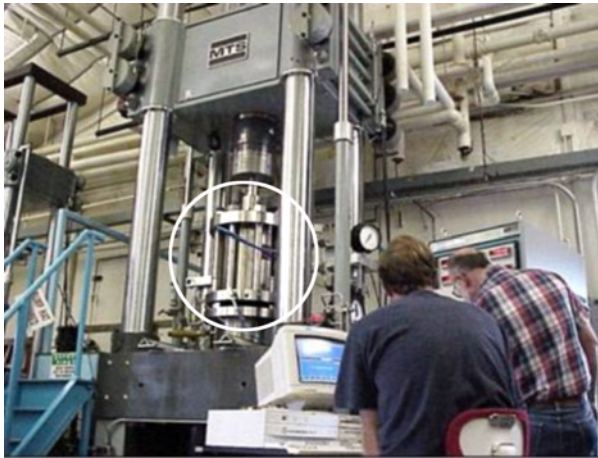
*Figure 3-2. Assembled pressure vessel (circled) in the loading frame*

Because the work plan specified ambient pressure only, the technologist engaged only 2 of the 10 tie rods to ensure proper alignment of all pressure vessel components. Encouraged by the results of his successful troubleshooting, the technologist decided to check the load cell at elevated pressure and began to pressurize the hydraulic oil, thus deviating from the work plan. At approximately 45,000 psi the threads stripped on one of the two tie rods, allowing the upper plate and upper vessel plate to separate from the vessel shell, damaging the threads on other tie rods (Figure 3-3) and causing a rapid depressurization of the oil.

The calibration testing on the load cell was not covered under a formal test procedure. This lack of formalization contributed to the occurrence and resulted in a stop-work order by the facility manager until additional process controls are established (e.g., a procedure for conducting calibrations and a pre-pressurization checklist).

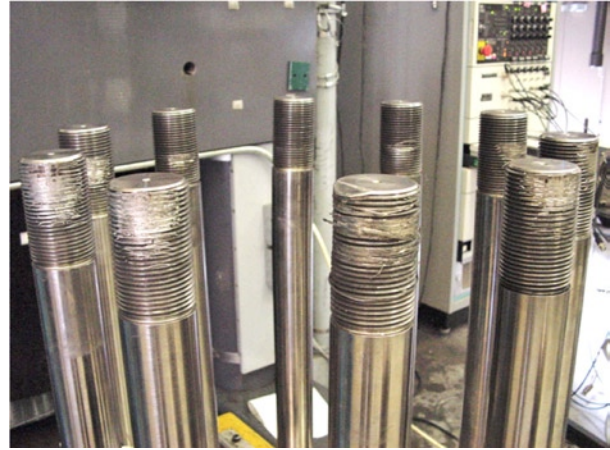
*Figure 3-3. Stripped threads on tie rod ends*

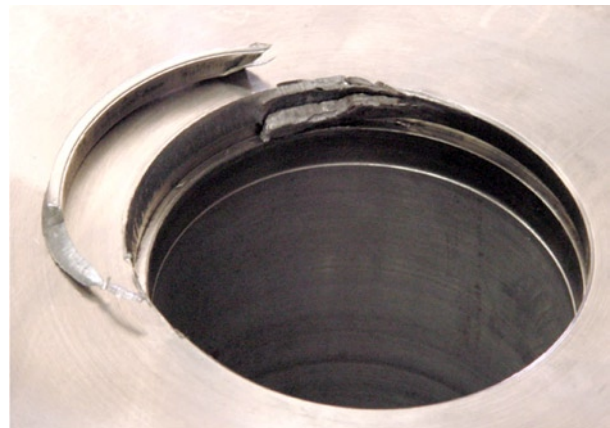
When the upper vessel plate lifted off the shell, it rotated and broke a piece of metal free from the o-ring seal groove at the inner bore near the top of the shell (Figure 3-4).

*Figure 3-4. Metal fragment from o-ring groove*

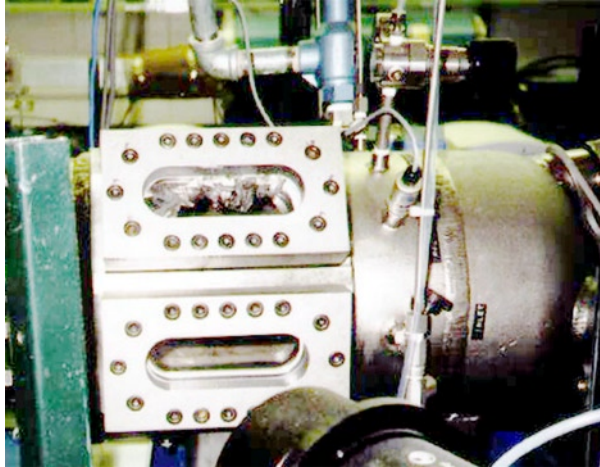
The importance of ensuring pressure vessel integrity prior to pressurization is illustrated in an event that occurred at Argonne National Laboratory-East in 1999. A researcher and technician were pressurizing a stainless steel pressure vessel used to examine the characteristics of diesel fuel aerosols when one of three glass viewing ports (Figure 3-5) failed at 800 psi. (ORPS Report CH-AA-ANLE-ANLEES-1999-0001)

**Figure 3-5. Vessel and failed upper viewing port**

When the viewing port failed, projectiles of glass chipped a masonry-block wall, shattered fluorescent lamps, severely damaged an overhead ventilation duct, and injured the technician.

The technician and researcher had just reinstalled the viewing port (quartz window) and were pressurizing the vessel to 900 psi with nitrogen when the incident occurred. Investigators determined that the technician and researcher were both aware of a readily visible flaw (1-inch crack) in the viewing port glass at the time of installation, but proceeded with the pressurization.

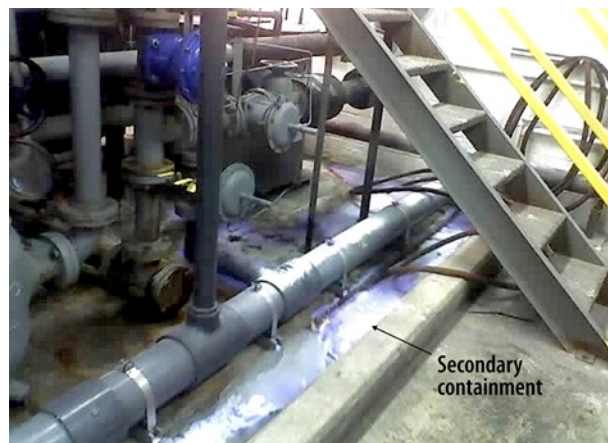
Investigators determined that the direct cause of this event was a plugged ventilation line. They believe that the root cause was most likely acid crystals that formed in the line and plugged it, causing acid to siphon from the bulk acid

**Figure 4-1. Secondary containment with neutralization results**

storage tank to the dilute sulfuric acid mix tank and eventually overflow into the secondary containment. Although there are no preventive maintenance records for the ventilation line, it has been in service for about 18 years without a failure.

- The tank's fill line was incorrectly marked at 29 inches instead of 27 inches, which would allow the tank to be overfilled by as much as 9 gallons.
- The utility operators were not familiar with the building's airflow patterns or the potential source of the leak.

Corrective actions included cleaning out the vent line, establishing a 6-month preventive maintenance schedule for the line, marking the tank at the correct level of 27 inches, and evaluating the ventilation in the area of the tank.
