Operating Experience Summary

U.S. Department of Energy
Office of Environment, Safety and Health
OE Summary 2005-13
September 6, 2005

1. TRANSFORMER ENERGIZED WITH PROTECTIVE GROUNDS STILL INSTALLED

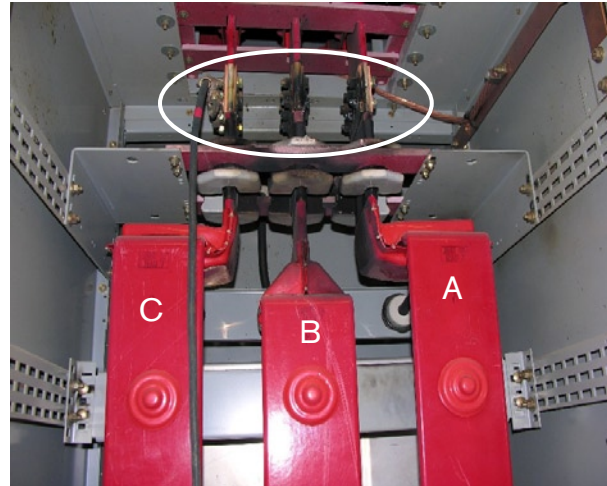
When the electricians completed the installation, the Clearance was removed. The electricians verified removal of two sets of personnel protective grounds; however, they overlooked the remaining set of grounds located inside a closed switchgear cabinet. Figure 1-1 shows the inside of the cabinet and the grounding attachment point. Figure 1-2 shows a closeup of the remaining ground, still connected to the "C" phase.

Figure 1-1. Grounding attachment point (circled)

These events underscore the importance of maintaining positive control over the use of personnel protective grounds. Organizations responsible for installation and maintenance of electrical distribution equipment must ensure that a process is in place for tagging and tracking these grounding devices. Never

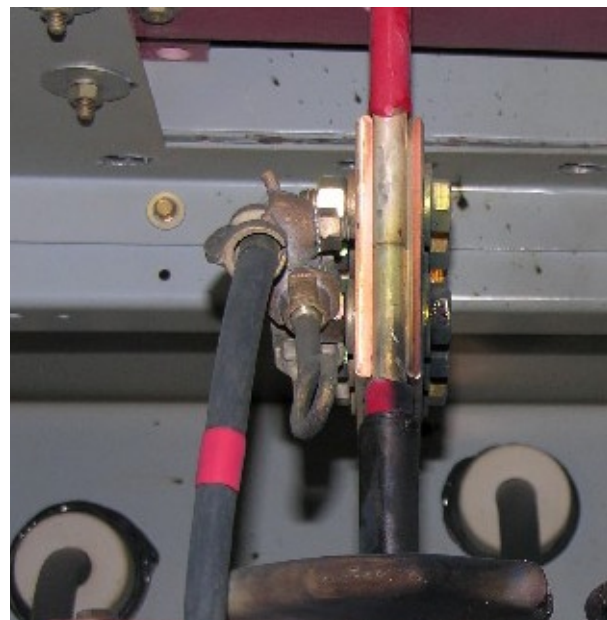
Figure 1-2. Protective ground clamped to phase "C"

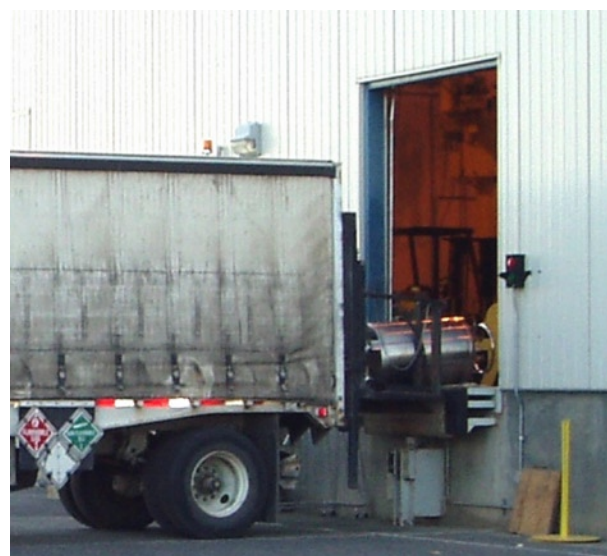
Figure 2-1. Truck at loading dock with fallen Dewar

Investigators believe that the ramp flexed under the load of the 700-pound Dewar, causing the Dewar to tip to the side, and that once the Dewar started to fall, there was no way to stop it. Fortunately, the Dewar fell in a way that it did not hit anyone. The teamster and operator placed the work area in a safe condition and strapped the Dewar to the truck rail and ramp until a rigging crew could right the cylinder and move it into the facility. Figure 2-2 shows the Dewar strapped in place.

Investigators determined that the apparent cause of this event was that neither management nor the work teams considered that

the high center of gravity and the design of the wheel base would create a tipping hazard when the Dewar was pushed or pulled on an incline. Contributing factors included flexing of the ramp and using diamond plate, which may have affected the ability to safely steer the Dewar. Also, the truck bed was lower than the dock and was not aligned parallel to the dock edge.

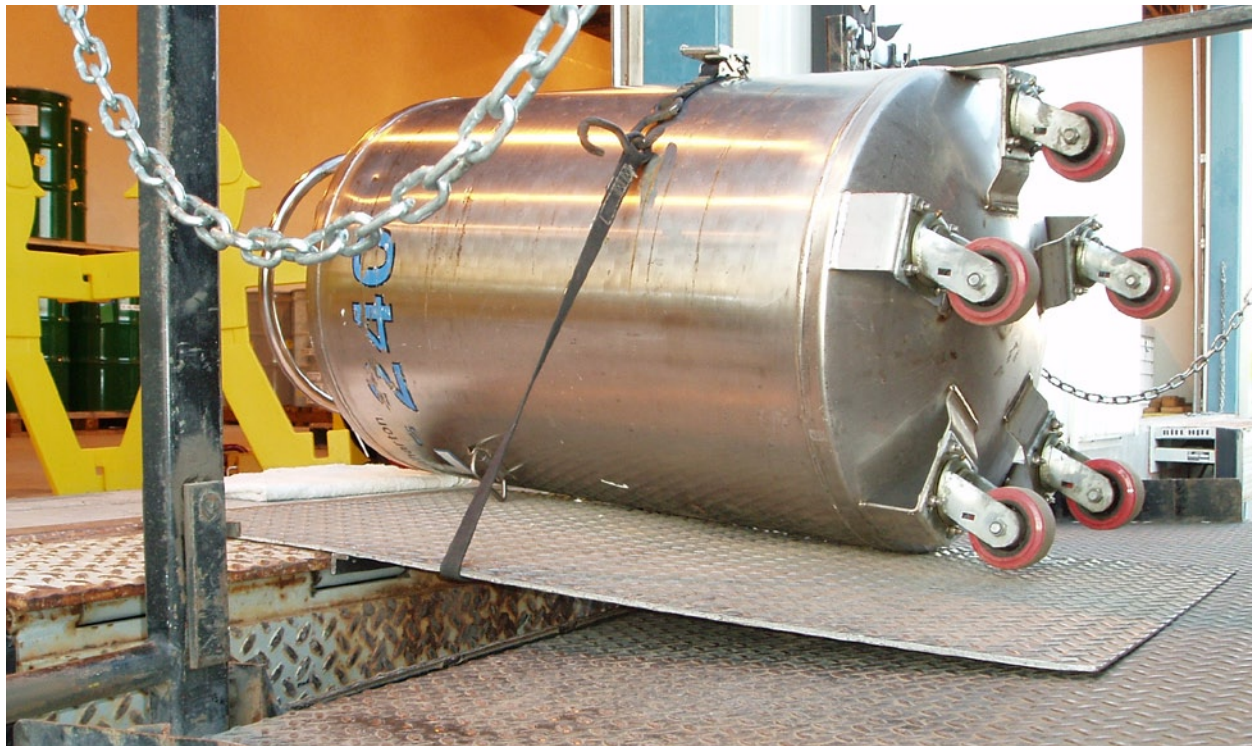
Figure 2-2. Dewar strapped to truck rail and ramp

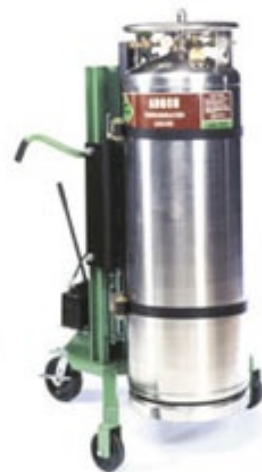
which immediately stopped the cart. Forward momentum of the liquid nitrogen shifted the center of gravity of the cylinder outside the stability triangle of the cart, causing the Dewar and cart to tip over and fall to the floor. The technician pushing the cart unsuccessfully attempted to counterbalance the falling Dewar by holding onto the cart handles. As a result, he landed on top of the Dewar when it hit the floor. Industrial Safety and Fire Department personnel righted the cylinder and moved it outside to vent the remaining nitrogen to atmosphere.

Causal factors included the uneven floor surface, which had never been leveled during earlier renovations, and inadequate training on the new cart used to lift and transport the Dewar. The manufacturer's operating instructions for handling cryogenic cylinders recommend lowering the cylinder as close to the floor as practical to reduce the chances of an accident during transport. Training needs for this new equipment were never formalized. Also, an engineering analysis of the stability of the cart was never performed. Figure 2-3 shows a similarly configured three-wheeled cart carrying a Dewar.

Figure 2-3. Three-wheeled cart and cryogenic cylinder

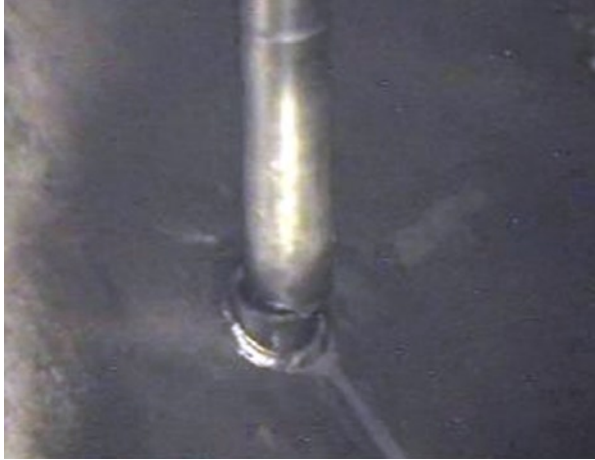
The clarification cell is a stainless-steel-lined space measuring 60 meters long, 20 meters wide, and 20 meters high. The camera inspection was initiated because of calculated discrepancies in the nuclear material balance and indications of leakage into one of the sumps within the cell. Investigators determined that the dissolver solution had been leaking into the cell for many months, possibly since July 2004. It is believed the pipe, which provides feed to an accountability vessel (tank), suffered a major break on or around January 15, 2005, based on a rapid increase in sump level and rising temperature. Figure 4-2 shows the failed feed pipe to the accountability vessel.

Figure 4-2. Failed pipe nozzle on tank head

Investigators believe the pipe failed because of fatigue stresses induced by excessive movement of the vessel. Operators had seen problems with vessel vibration as evidenced in their shift logs and video footage showing significant movement of the vessel during agitation and emptying cycles.

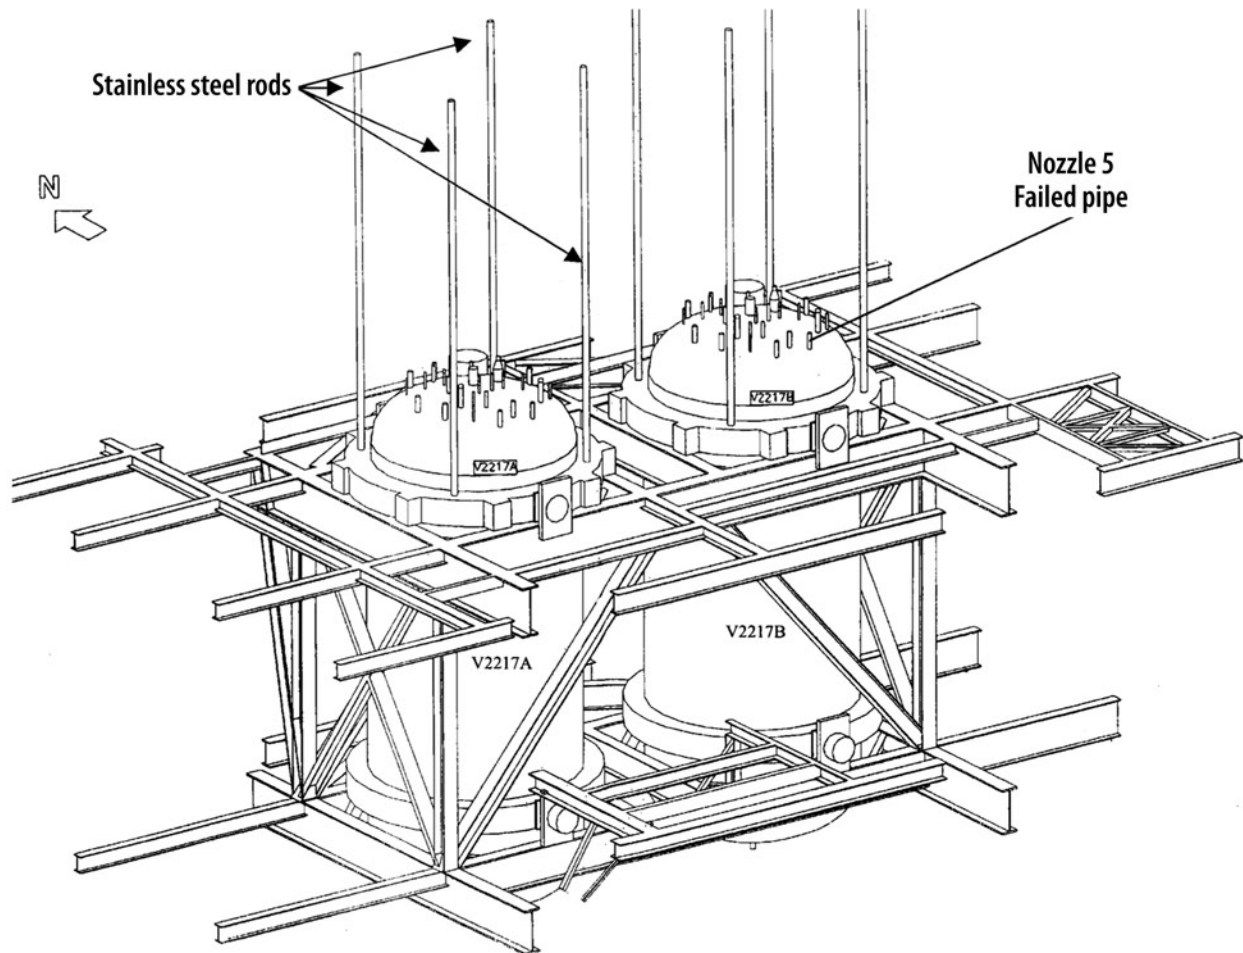
The accountancy vessels are suspended from the cell roof to allow weighing of the vessel and contents and determining material balance. To achieve this, the vessels are supported by four rods that pass through the roof to a weigh mechanism. The vessels are normally operated suspended, except for brief periods to establish a datum or for calibration, at which time they are lowered to rest on a steel frame in the cell (Figure 4-3).

The original design of the accountancy vessels provided for seismic restraints to prevent lateral movement and induced stresses from pumping devices. However, the installed configuration was modified and did not include the restraint blocks. The Board of Inquiry has no evidence that the design was reviewed to consider fatigue stresses following modification that eliminated the restraints.

Figure 4-3. Accountancy vessel showing suspension rods and support frame
