Operating Experience Summary

U.S. Department of Energy
Office of Environment, Safety and Health
OE Summary 2005-15
December 2, 2005

1. SHARED NEUTRAL CIRCUITS POSE A DANGER IF NOT PROPERLY IDENTIFIED DURING SAFETY CHECKS

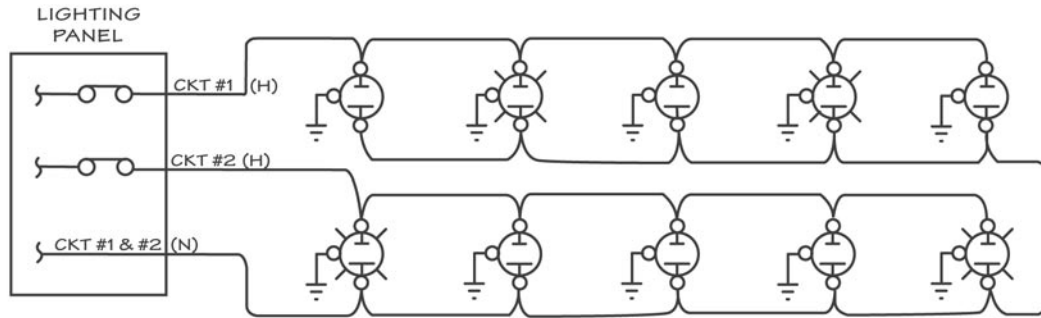
Figure 1-1. A typical two-light circuit with common neutral

The common or shared neutral is used to save wire, to permit the use of smaller diameter conduit, and to reduce the voltage drop in lighting and receptacle circuits. Common neutrals are typically used on 120/240-volt, single-phase systems and on 208Y/120-volt and 277Y/480-volt, three-phase systems. The common neutral wire carries the unbalanced load current during normal circuit operations as shown in Figure 1-1. If the common neutral is disconnected (broken), as shown in Figure 1-2, an unsafe condition occurs because line voltage appears on the broken lead. A worker who touches the broken neutral could receive a severe electrical shock.

Common Neutral carries the difference in current (unbalance) between Circuit 1 and 2

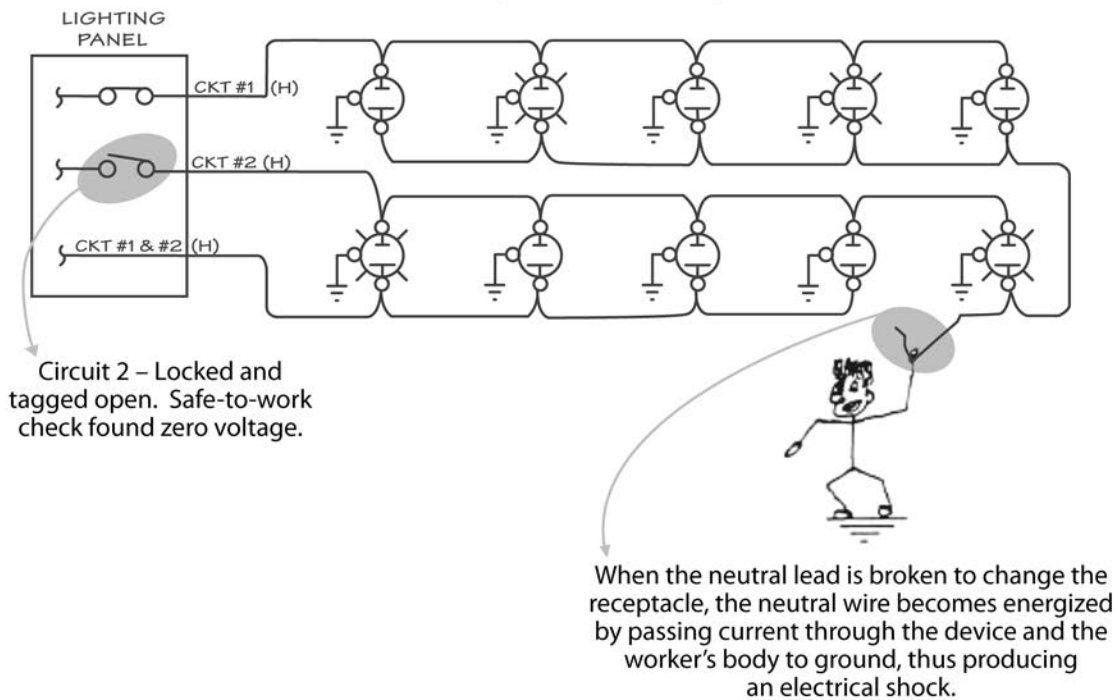
Figure 1-2. Example of unsafe condition when common neutral is broken

Because voltage can only appear on a common neutral after the wire is broken, normal zero-energy checks will not show the presence of electrical energy. The only positive way to prevent potential electrical shock is to open all circuits that share the common neutral wire. The present edition of the National Electrical Code (NEC) allows single-pole circuit breakers to be physically tied together so that all circuits that share the neutral can be de-energized simultaneously. Information and guidance on multi-branch circuits can be found in Article 210.4 of the NEC Code (NFPA 70).

Typical Common Neutral Conditions
When Receptacle Is to Be Changed

- Ensure panelboard directories indicate which circuits are used in multiwire applications and identify common neutrals with all associated circuit numbers.
- Use permanent wire markers on neutrals at all accessible device or junction boxes to indicate which circuits are associated with the neutral conductor.
- Consider using two (or three) pole protective devices for multiwire circuits where simultaneous tripping of multiple circuits would not create an additional safety hazard or other undesirable condition. This would prevent using circuit breakers that are not adjacent (i.e., circuit 1 and 7) to eliminate confusion

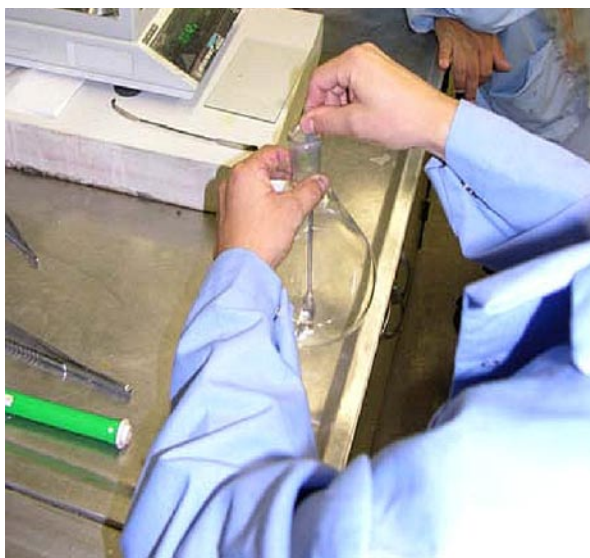
Figure 2-1. Re-enactment of the scene

Finally, on the 27th, the material was dry. The researcher wanted to remove the material from the round-bottomed glass flask it had been created in and place it into a smaller container for weighing. He used a small metal spatula to scrape the material out of the flask. Figure 2-1 shows a re-enactment of the researcher's actions just before the material exploded.

Investigators determined that the root cause of the event was that the synthesis procedure was ambiguous and failed to disclose the potential for synthesizing a sensitive byproduct. However, the researcher had changed some of the parameters of the experiment without analyzing those changes. For example, the experiment described drying the material under vacuum with pure nitrogen gas. The researcher used a stream of air instead, believing that the change would not affect the experiment's outcome.

A contributing cause was that the Laboratory's integrated work document for hazardous chemical operations at this facility was very broad and loosely implemented because the approval time for more specific integrated work documents had become somewhat lengthy. The broader document helped personnel bypass the process. The broad-scope integrated work document authorizes general chemistry operations and includes a list of 25 activities, among which is "non-energetic materials synthesis." It did not include a detailed description of the activities involved or a cross-reference to another document that included such a description. The Laboratory permitted personnel to attach an established procedure to the integrated work document if it met seven specified criteria, but it did not have a mechanism for verifying that procedures were evaluated to these seven criteria.

Accident investigators recommended that the Laboratory re-evaluate its use of broad-scope integrated work documents and develop a mechanism for ensuring that any activity

under this type of work document is adequately screened for potential hazards before work begins. They also recommended that the Laboratory re-emphasize the importance of applying ISM principles while working and that the facility be upgraded to provide better analytical capabilities.

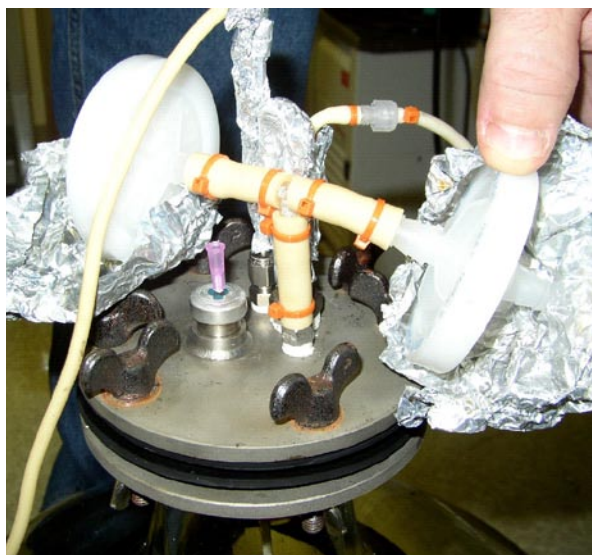
Figure 2-2. *The vent in the head plate*

Researchers were introducing nitrogen gas into the carboy, which held 30 liters of a culture medium. They knew that the potential existed for excess pressure to build up, but did not consult a subject matter expert. Instead, they decided to insert a 1½-inch needle into a rubber septum in the carboy head plate to act as a redundant vent for the 2-inch flat membrane filters. Figure 2-2 illustrates this configuration. PNNL's internal oversight organization investigated the accident and determined that the membrane filters became clogged with condensation and the redundant vent was inadequate to reduce the pressure. Because

no written procedure existed for this activity, the hazardous situation caused by pressure building up within the carboy was insufficiently addressed.

- Walked down similar laboratories to identify other potential hazards that may have been overlooked.
- Evaluated the need for subject matter expert review of potentially hazardous laboratory work.
- Developed and disseminated a PNNL lessons-learned document on the event.
