Operating Experience Summary

U.S. Department of Energy
Office of Environment, Safety and Health
OE Summary 2006-07
June 16, 2006

Risk-Taking and Shortcuts Result in Welder Fatality at BP Pipeline

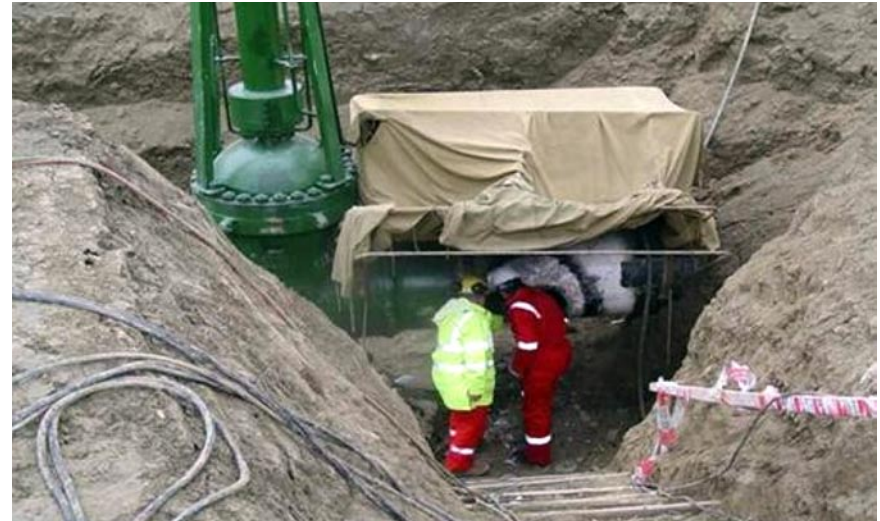
An experienced work crew had welded a 30-inch gate valve into a run of pipeline. The pipeline had been buried 9 months earlier, but was excavated to allow the pipe to be cut and the valve to be welded in place. Figure 1-1 shows the large gate valve and section of pipe in the excavation. After the gate valve was installed, radiographic inspections showed weld defects.

Figure 1-1. Gate valve (green) and pipe section under tarp where fire occurred

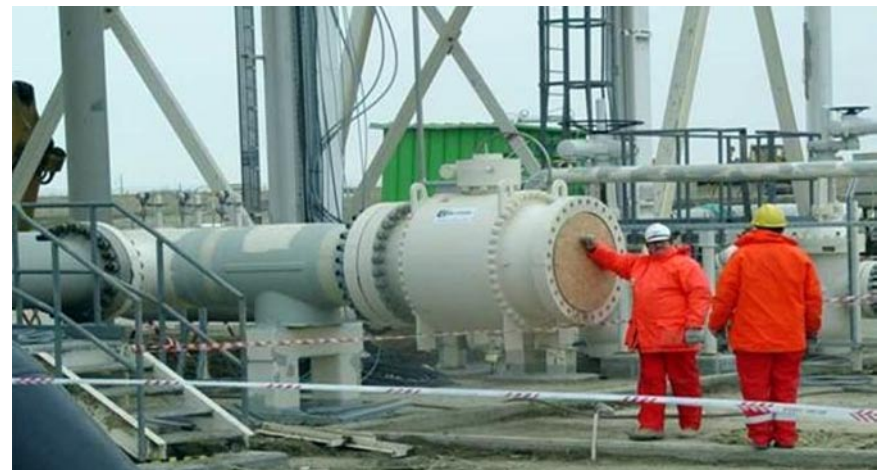
The welder entered the pipe feet first through a large above-ground ball valve. Figure 1-2 shows the ball valve and entrance point. The welder had a rope and welding cable tied to his body

Figure 1-2. The ball valve and point of entry into the 30-inch pipeline

and carried a small pen light for illumination. He had to travel about 13 feet horizontally in the pipe before the pipe dropped below grade at a 45-degree angle for 21 feet. He then entered a 10-foot section of horizontal pipe to access the valve and weld location.

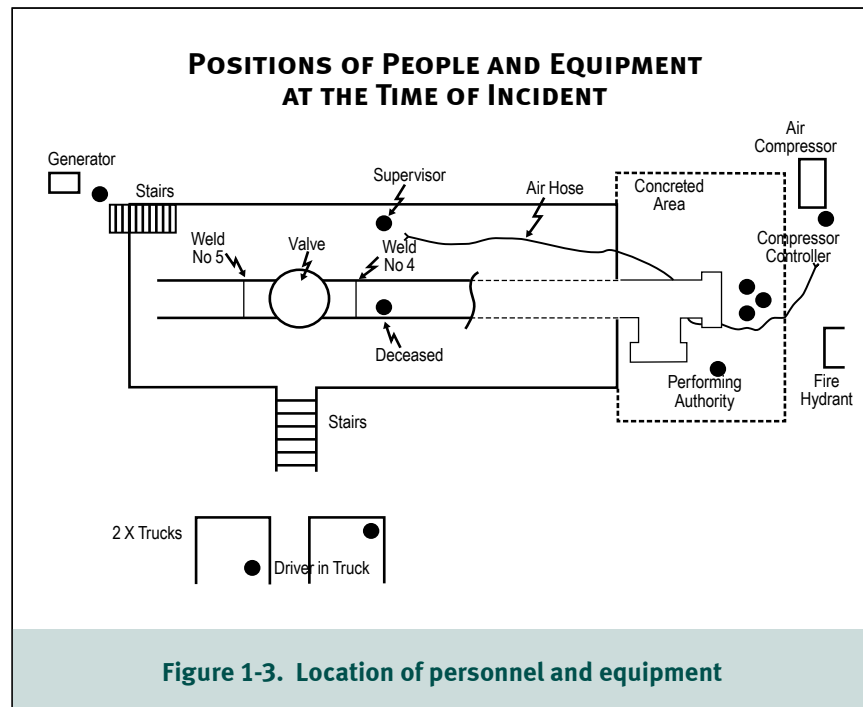
The welder had completed about 20 cm of the weld when the work crew heard him call out that he was burning. The crew attempted to pull the welder from the pipe, but the rope and welding cable became disconnected from the welder and pulled free. The crew heard no further sounds from inside the pipe as they saw smoke pouring from its open end. Rescuers later confirmed that the welder had died. Figure 1-3 shows the location of workers at the time of the accident.

Figure 1-3. Location of personnel and equipment

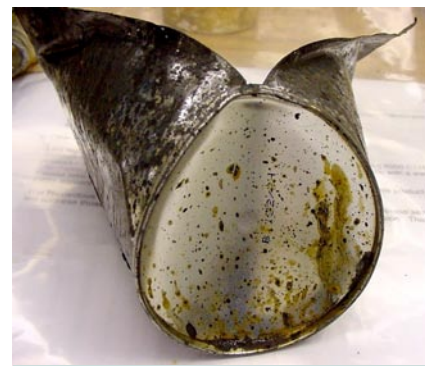
On April 11, 2006, at the Oak Ridge National Laboratory, one of two aerosol cans of graphite lubricant ruptured inside a flammable material storage cabinet. Researchers working nearby discovered the can and notified their laboratory space manager. Fortunately, this event occurred late in the evening, and no one was injured. (ORPS Report SC-ORO--ORNL-X10EAST-2006-0002)

The manufacturer of the graphite product, Acheson Colloids, Inc., stated that there are two possible scenarios that would result in a can rupture: ambient temperatures at or above 120°F; and propellant leaking from the can and reacting with other substances. The temperature in the room was estimated to be 65°F. Investigators noted, however, that the can was rusted on its bottom edge (Figure 2-1). They also determined that the product's shelf life of 2 years (as stated on the manufacturer's [Product Data Sheet](#)) had been considerably exceeded, as the can was purchased in 1994. Figure 2-2 shows the internal corrosion and the failure points on the can.

Figure 2-1. Bottom of aerosol can

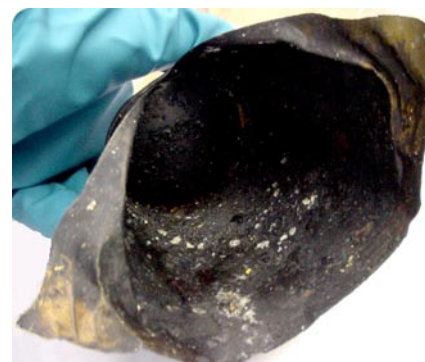
Figure 2-2. Internal corrosion

- Wherever possible, substitute chemicals that are less hazardous, toxic, or volatile. (In the case of the graphite lubricant, for example, the product is also available in a non-aerosol brush-on form.)

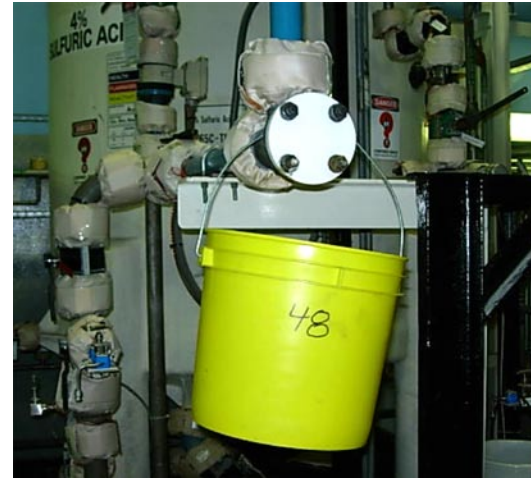
The work involved installing a metal blind flange cover over an existing Teflon® flange to reduce the potential for leakage. Figure 3-1 shows the flange. A shift operations manager prepared the TAF, which included instructions for boundary isolation and for draining the piping system. A technical reviewer walked down the TAF. Both the preparer and reviewer referred to a Piping and Instrument Diagram (P&ID) while performing their tasks.

Figure 3-1. Blind flange with catch bucket

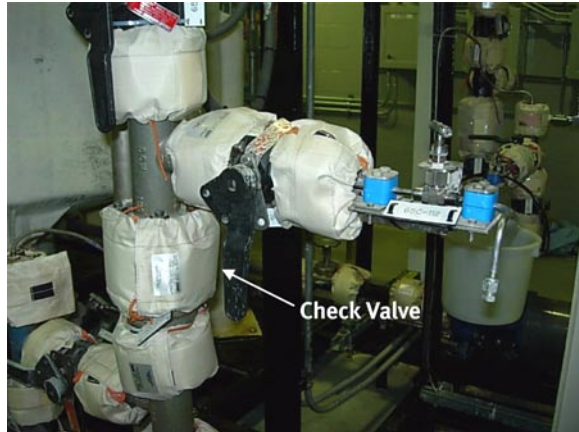
During the critique, investigators learned that there was a pump discharge check valve in the piping. The check valve, which allows flow in only one direction, caused liquid to be retained in the downstream piping. Figure 3-2 shows the check valve in a vertical run of pipe. In addition, there was approximately 27 feet of vertical head from where the blind flange was being worked on to where the line was vented.

Figure 3-2. Check valve hidden by flange guard

- Workers at ETF had installed flange guards throughout the piping systems to identify and control system leaks. The check valve was not visible in the field because it was hidden by the flange guard, and the valve label was also underneath the flange guard. This situation decreased the probability of identifying the check valve unless someone was specifically looking for it.

Action: A system walkdown will be conducted to verify that all check valve labels are visible.

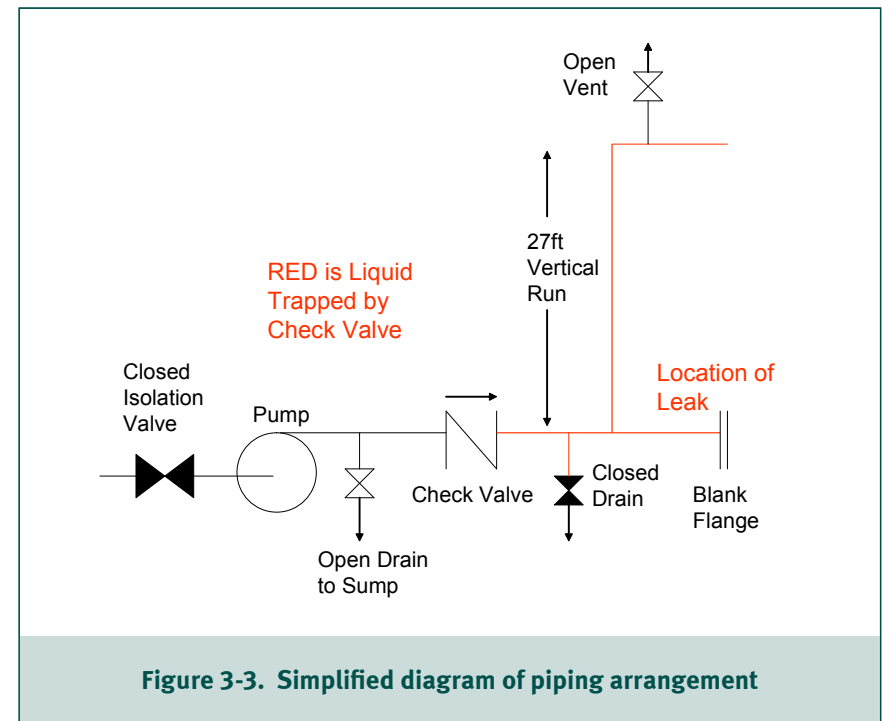
A simplified diagram of the piping arrangement is shown in Figure 3-3. The diagram shows the drain location selected

was on the wrong side of the check valve. Another valve, shown downstream of the check valve, could have been used to drain and depressurize the piping.

Because the TAF identified a drain valve that was located upstream of the check valve, the safe-to-work check did not effectively verify the safety and operational status of the system. The drain valve only drained liquid from a small portion of the piping associated with the pump discharge and recirculation line. This drained liquid was directed to a sump through a temporary hose. Operators had allowed the piping to drain to the sump for about 30 minutes before they noticed a small rise in the sump level. They assumed this level change was the drainage from all the piping covered by the TAF.

Figure 3-3. Simplified diagram of piping arrangement
