# OPERATING EXPERIENCE SUMMARY

U.S. Department of Energy  
Office of Health, Safety and Security  
OE Summary 2006-11  
October 6, 2006

## Inadequate Work Package Results in Water Hammer in Steam System

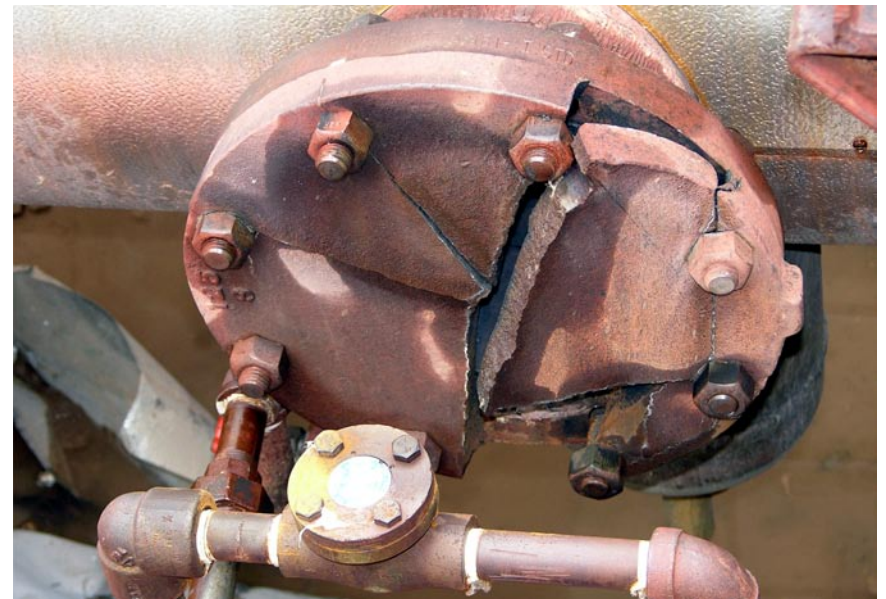
in other manholes. Steam plant recorders indicated that the duration of the steam release was approximately 5 minutes. The damaged blind flange and ruptured expansion joint are shown in Figures 1-1 and 1-2. Water (condensate) had accumulated in the steam piping upstream of the isolation valve; when the valve was opened, the condensate flashed, causing extremely high-pressure pulses in the steam piping.

Figure 1-1. Failed blind flange

A contributing factor was that the 1950s-era flange that failed was made of cast iron with a maximum pressure failure rating of 125 psi. LANL engineering standards require all steam system flanges to be steel with a maximum failure pressure of 150 psi. As a corrective action, LANL Utilities personnel are conducting a system-wide survey to identify and replace all nonconforming flanges.

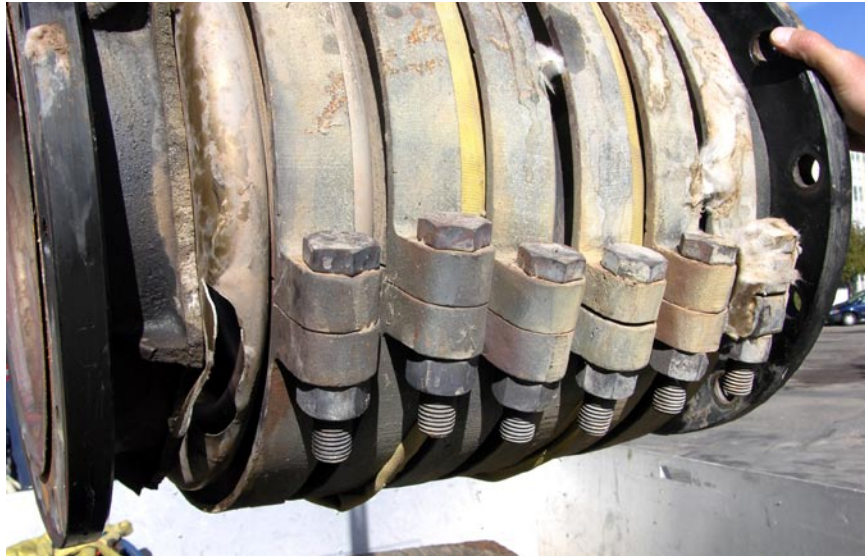
Investigators determined that the work package preparation was inadequate. The Integrated Work Document and Work Order were valid, but the procedure used to perform the work was a general “Steam Startup” procedure, which was not specifically tailored to the job the pipefitters performed. If the pipefitters had used a specific procedure, the condensate collected upstream of the isolation valve would have been drained off, and the water hammer would have been prevented.

**Figure 1-2. Ruptured expansion joint shown after removal**

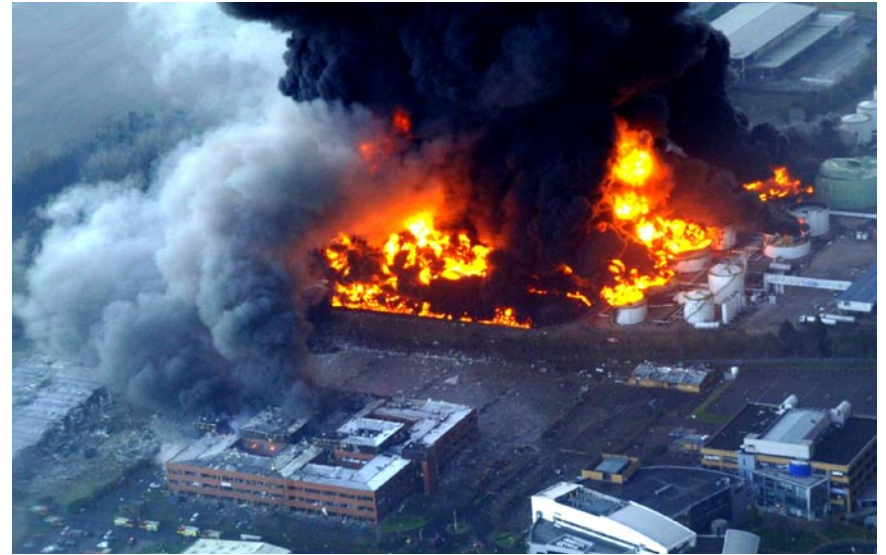
At about 6:00 a.m. on Sunday, December 11, 2005, at the Buncefield oil storage and transfer depot in Hemel Hempstead, England, gasoline spilling from an overfilled gasoline storage tank created a vapor cloud that ignited and caused a series of massive explosions. The explosions resulted in a fire (shown in Figure 3-1) that engulfed 20 storage tanks, caused injuries to 43 people, extensively damaged nearby buildings, destroyed the onsite pumping station (thereby hindering emergency response), and caused the release of large quantities of contaminated water and black smoke to the environment.

Figure 3-1. Fire in progress

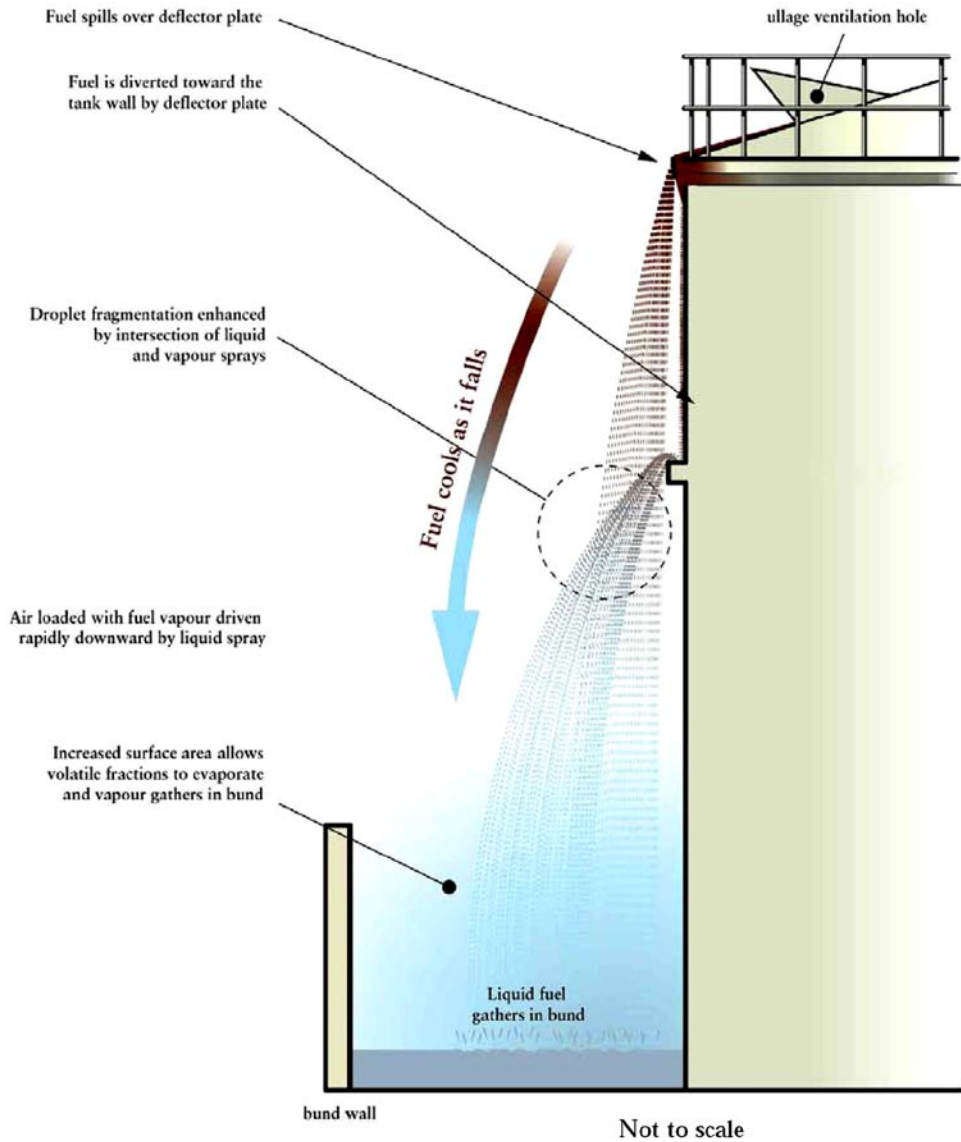
Figure 3-2 is a graphic rendering of the tank and the trajectory of the excess gasoline as it overflowed the tank. As the diagram shows, gasoline spilled out of the tank and onto a wind

girder, which redirected the stream outward from the tank, fragmenting it and creating more vapor, which ignited a little over a half-hour later.

Figure 3-2. Diagram of the fuel dispersion pattern (from the investigation report)

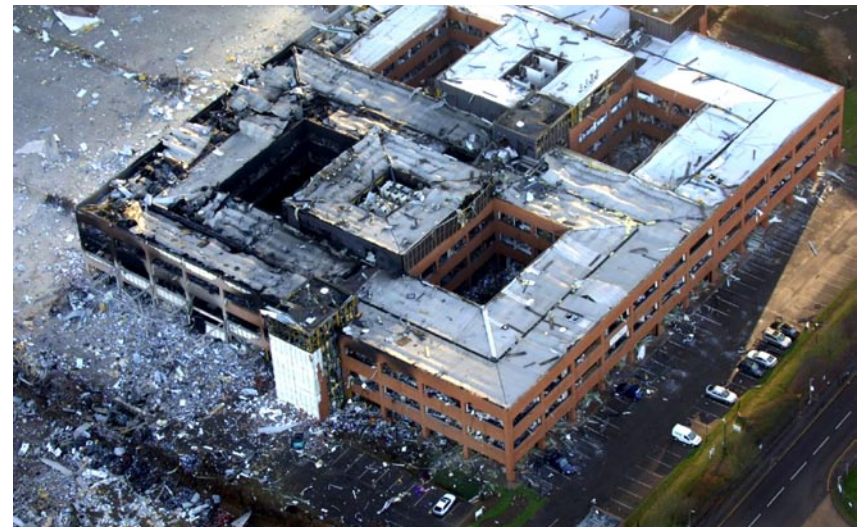
One significant finding that the investigation uncovered was that the worst credible fire scenario involved liquid fuel that could pool and catch fire — not a vapor cloud arising from spilled fuel, which is much more flammable than liquid fuel. Investigators also learned that although operators knew that the tank was being filled, no one noticed or questioned why the level indicator stopped rising. Another finding was that the storage facilities were located very close to other buildings. As a result, many of these buildings were severely damaged in the explosion (Figure 3-3).

Figure 3-3. Damage to an adjacent building
