# Operating Experience Summary

April 21, 2006

## ***PRELIMINARY FINDINGS ON FATAL EXPLOSION AT TEXAS REFINERY***

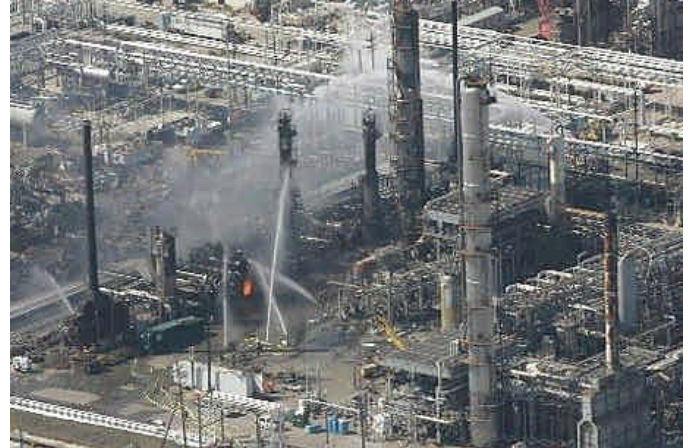
The accident occurred when operators started up a tower called a raffinate splitter. The tower and associated piping were over-filled and over-pressurized. This resulted in hydrocarbons flowing from the tower into a blowdown drum, which was vented to atmosphere through a tall stack. The blowdown drum filled completely with flammable liquid, and a geyser erupted out of the stack. A large flammable vapor cloud developed at ground level and drifted underneath the trailers housing the contract workers. Figure 1 shows firefighters spraying water on damaged refinery equipment located to the right of the temporary trailers.

*Figure 1. Damaged refinery equipment*

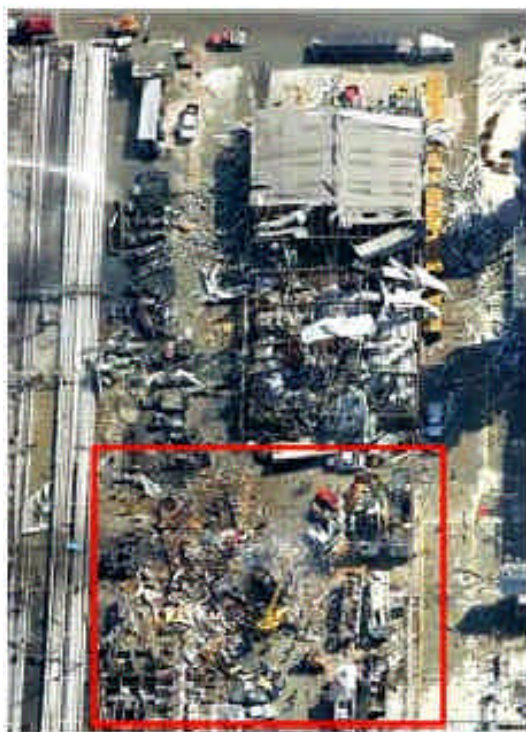
Figure 2 shows the extensive damage to the trailers, some of which were as close as 121 feet from the release. A total of 43 trailers were damaged by the blast pressure wave, and 13 of them were totally destroyed.

*Figure 2. Aerial view showing some of the destroyed temporary trailers (inside red box)*

**Key Safety Issue Number 1** – Occupied trailers were placed in an unsafe location near process equipment handling hazardous materials. This is important because all the fatalities occurred in these trailers.
