OPERATING EXPERIENCE SUMMARY

U.S. Department of Energy
Office of Health, Safety and Security
OE Summary 2008-02
March 14, 2008

Near Miss—Worker Falls Into Empty Effluent Tank When Ladder Shifts

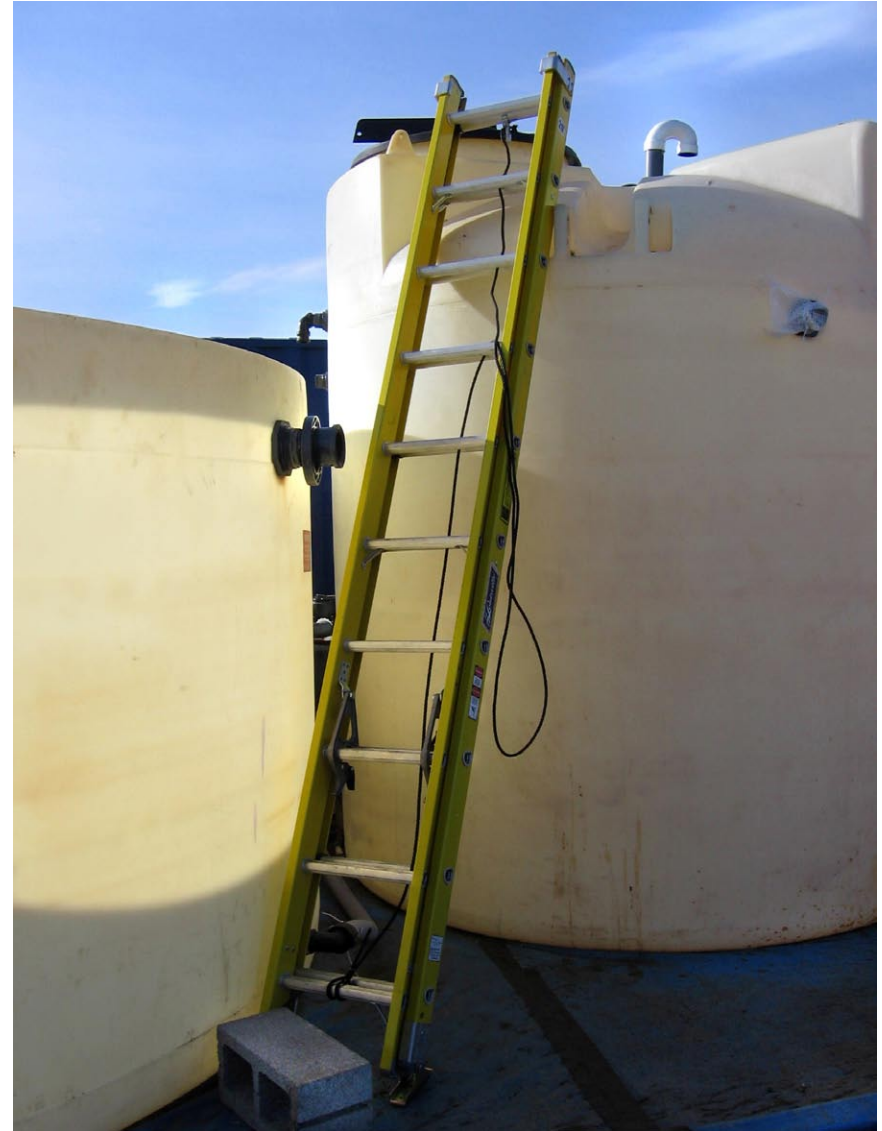
On November 11, 2007, at Hanford, a subcontractor worker installing bolts to secure a lid on a plastic waste-water tank fell more than 6 feet into an empty, adjacent tank when the extension ladder he was using shifted unexpectedly. Figure 1-1 shows the tank he was working on, with the ladder placed against it, and the empty tank (to the left). The worker hit the bottom of the tank head-first, and the ladder fell into the tank on top of him. The worker could have been seriously injured, but his only injury was a scalp abrasion. The worker was taken to the onsite first-aid station for evaluation and released to return to work. (ORPS Report EM-RL--PHMC-GPP-2007-0007)

The worker had installed three or four bolts that were directly in front of him on the tank lid and then reached to the left back side of the lid to install another bolt. He leaned to the side to tighten the bolt, shifting his center of gravity, and the ladder began to slide sideways. The worker tried to stop the ladder from moving, but it was top heavy from his weight, so it continued to slide. The worker fell into the adjacent effluent tank while still holding the ladder, and it fell on top of him. After a few moments, he pushed the ladder off, set it up inside the tank, and climbed to the top of the tank. An engineer, who heard him call for help, put a step ladder on the outside of the tank, helped the worker out of the tank, and took him to the first-aid station.

Figure 1-1. Tank and extension ladder
(the worker fell into the tank on the left)

Following their investigation of this fall event, investigators concluded that the worker did not follow the safety training he had received and did not follow safety plan requirements to tie off the ladder.

This event demonstrates the importance of securing ladders to prevent any unexpected movement or sliding across a smooth surface, as well as the importance of analyzing any potential hazards and developing actions to mitigate them.

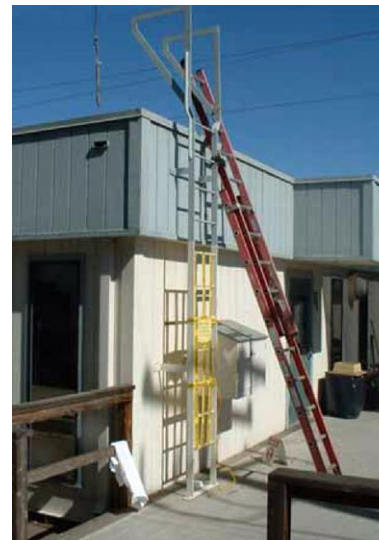
An article in OE Summary [2007-02](#) discussing a Type B investigation of a ladder fall injury at Lawrence Livermore National Laboratory that occurred on July 31, 2006, reported that an electrician was working alone to replace four air conditioning units on the roof of a building. He accessed the units from an exterior fixed ladder, missed a step, lost his balance, and fell approximately 5 feet to a deck below the ladder. Figure 1-2 shows the accident scene and the fixed ladder from which the electrician fell. The Accident Investigation Board concluded that the accident could have been prevented if the

Figure 1-2. Accident scene showing the fixed ladder and an extension ladder added post-accident for temporary roof access

worker had maintained three points of contact with the ladder (i.e., used his feet and hands in any combination of three). Had he followed this technique, he would have been able to recover from the missed step without falling. (ORPS Report NA--LSO-LLNL-LLNL-2006-0037)

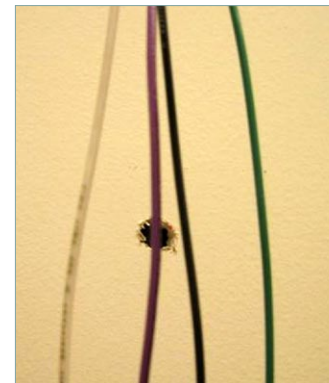
On November 8, 2007, at Pacific Northwest National Laboratory, a carpenter securing a storage cabinet to a sheetrock wall drilled into an energized electrical conduit providing 120-volt power to an electrical receptacle. There was no arc; the circuit breakers did not trip; and the worker did not receive an electrical shock. (ORPS Report SC--PNSO-PNNL-PNNLBOPER-2007-0012; final report issued December 19, 2007)

Seven storage cabinets had been placed along a wall in the corridor before being secured to the sheetrock, and the carpenter had already installed three of them successfully. One of the remaining cabinets was in front of the electrical receptacle, hiding it from view, so the carpenter did not see it before he began to drill. When he stopped to inspect the penetration, according to procedure, he saw what he thought was a galvanized sheet-metal wall stud and proceeded to drill a 1/8-inch pilot hole. Following the procedure, the carpenter stopped again to inspect his work and realized that what he thought was a metal stud was the conduit for the electrical receptacle. Figure 2-1 shows the penetration and the wires

Figure 2-1. Wall penetration and wires pulled from conduit post-event

To address situations such as those encountered in this event, the blind penetration procedure was revised to limit the depth of penetration to the thickness of the external surface of hollow cavities, or no more than 2 inches into solid materials, when using power tools. The procedure also was revised as follows:

When a hollow cavity must be penetrated beyond the thickness of the exterior surface for the purpose of verifying the absence of hazards (e.g., utilities,

asbestos), inspect the inside of the penetration by looking into the hole with a flashlight or boroscope or by probing with a nonconductive or insulated tool, such as a screwdriver or wooden handle punch. Stop work and notify your supervisor if this check reveals any potential hazards, such as asbestos-containing material, or any metallic material, such as a metal wall stud or conduit.

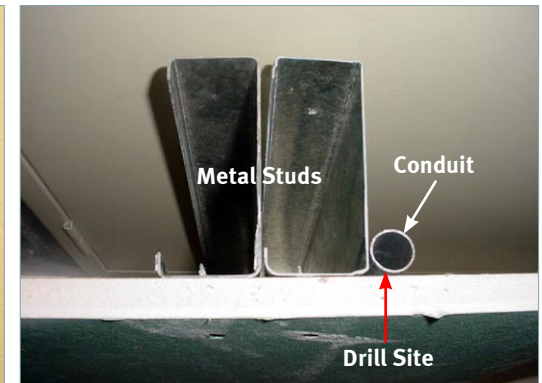
removed from the conduit for inspection after the event. Figure 2-2 shows the drill site, the metal studs, and the conduit.

Figure 2-2. Drill site, studs, and conduit
