# OPERATING EXPERIENCE SUMMARY

U.S. Department of Energy  
Office of Health, Safety and Security  
OE Summary 2008-03  
April 10, 2008

## Look Out Below – The Hazards of Falling Objects

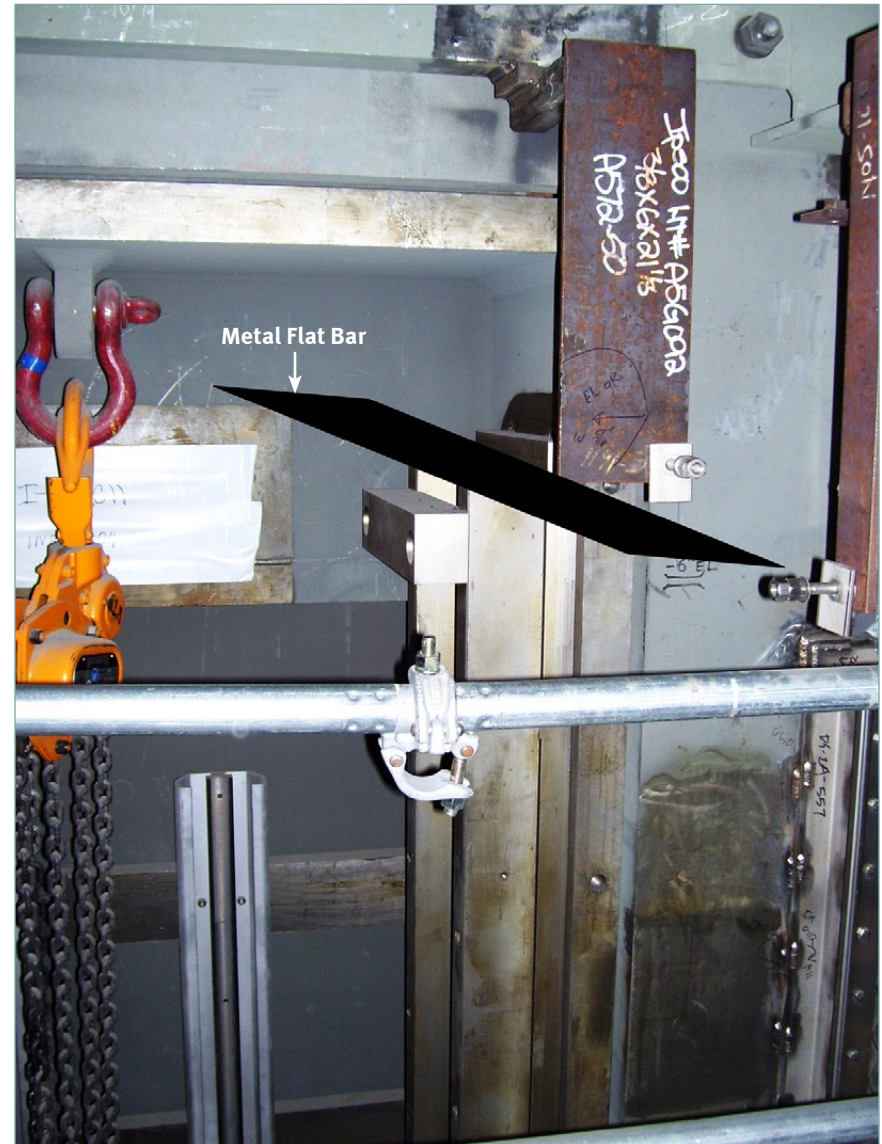
Workers had attached the flat bar to a stainless steel member of an elevator using magnets. (Figure 1-1 shows the scaffolding and the placement of the flat bar.) The laser sight also has a magnetic base, which is used to connect the instrument to the metal bar and hold it in place. When the crew member reached down and put the laser sight on the flat bar, the magnets holding the bar to the stainless steel member detached, and the bar fell. The worker was able to grasp the laser sight instrument and keep it from falling along with the bar. Figure 1-2 shows where the bar landed underneath the scaffolding and the location of the carpenter at the time of the incident.

Investigators determined that the surveyors failed to ensure that the flat bar was attached securely. However, they also determined that the work package documentation for both work groups was inadequate and did not provide for thorough job scoping and planning for any associated hazards. As a result of the work package deficiencies, signs for overhead work had not been posted before work began and no barrier tape or other restrictive measures were in place.

Figure 1-1. Illustration of metal piece placed on scaffolding

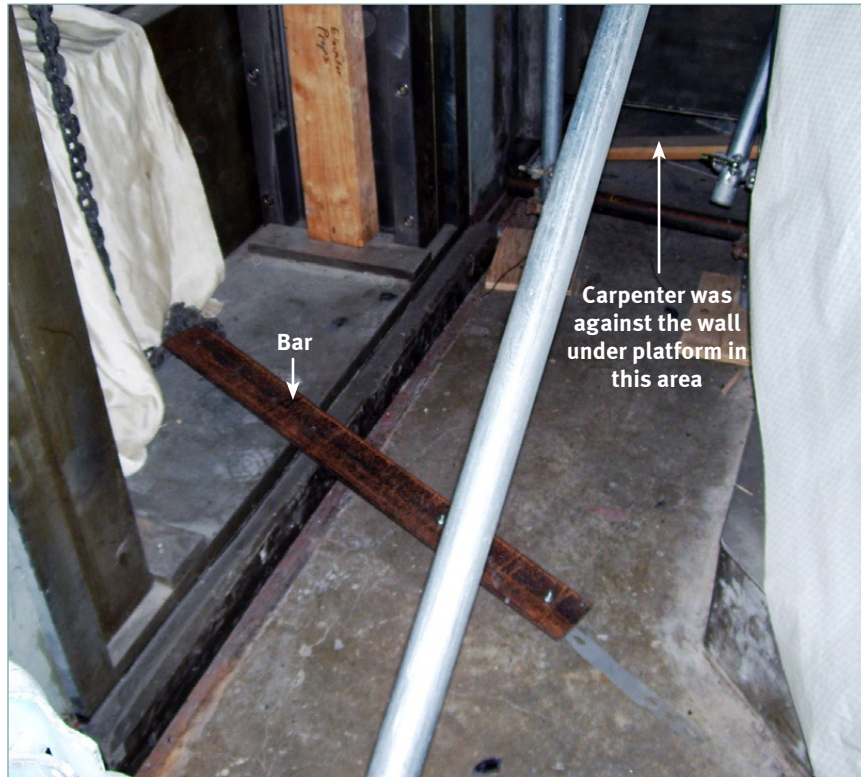
On November 7, 2007, at Hanford, a worker on a subcontractor survey crew dropped a metal flat bar for a laser sight instrument from a scaffolding platform. The bar, which weighed about 7 pounds, fell 17 feet and landed near a carpenter working directly below the survey crew. The carpenter was standing within 2 or 3 feet of where the bar landed and could have been seriously injured had it hit him. (ORPS Report EM-RP--BNRP-RPPWTP-2007-0020; final report issued December 19, 2007)

**Figure 1-2. Location of bar after falling and area where carpenter was standing**

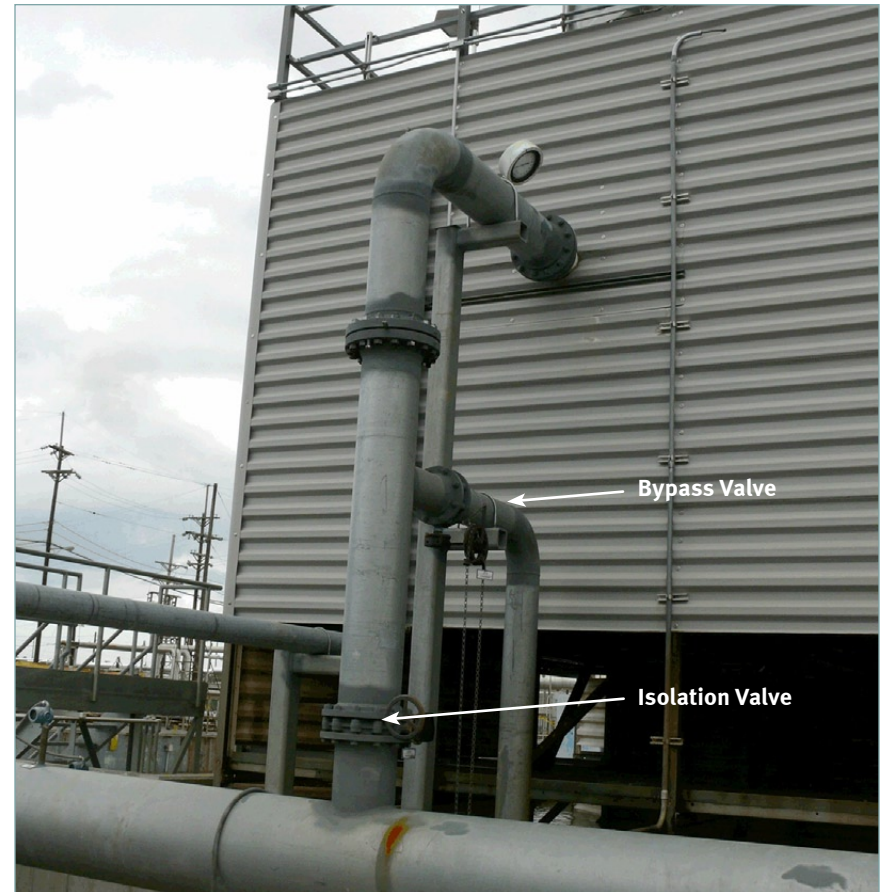
The actions of the on-coming operator resulted in the loss of Normal Cooling Water, which automatically isolated on low water level in the cooling tower basin. Control room operators followed the appropriate alarm response and abnormal operating procedures to shut down facility processes. Process water operators, responding to the cooling water system upset, found all four cooling water valves closed, which resulted in dead-heading the cooling water flow. The operators reopened the valves to restore normal flow.

The on-coming operator's good intentions were based on a concern that icing on the cooling tower could result in structural damage. However, she was thinking of older, wooden cooling towers rather than the newer, metal structures, and valve configuration on the newer tower is the opposite of configuration

**Figure 2-1. Cooling tower and piping arrangement**

on the old tower. This may have contributed to the operator's mistake of isolating cooling water flow and not opening the bypass valves (Figure 2-1). The operator did not have a procedure to follow and received no oral instructions from control room operators or the shift operations manager.

As a result of this event, refresher training on Conduct of Operations will be provided to the cooling tower operators to ensure that each of them has full knowledge and understanding of their associated tasks.
