OPERATING EXPERIENCE SUMMARY

U.S. Department of Energy
Office of Health, Safety and Security
OE Summary 2008-05
June 10, 2008

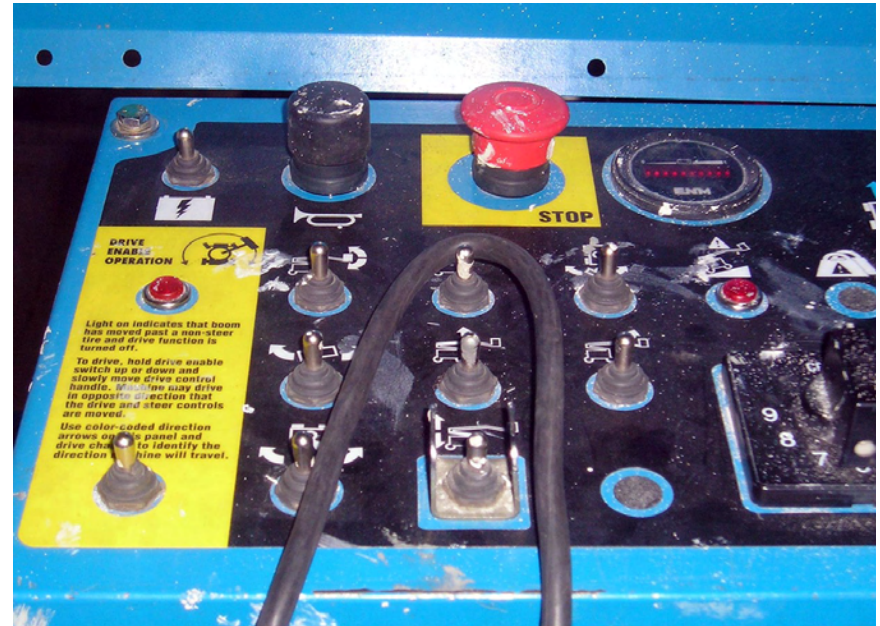
On April 23, 2008, at Hanford, a subcontractor painter working from a boom lift while cleaning pipe hangers with an electric grinder was caught between the lift and an overhead pipe when the cord of the grinder looped around a toggle switch on the control panel (Figure 1-1), causing the boom to rise. The painter was able to hit the stop switch and reach the controls to move the lift basket enough to free himself and lower the lift to the ground. He received contusions to his back, chest, and jaw; a slight cut on his chin; and scrapes on his hand, but this incident could have resulted in a life-threatening injury or a fatality.

The painter was working in tight quarters (i.e., pipe supports, piping, I-beam, and ceiling) and was wearing a respirator. When the foreman asked him to stop work, he put the grinder down, but was unaware that the cord had looped around the toggle switch. He began to lower himself to the ground, and when he engaged the foot pedal and pulled the stop switch to the “on” position, the lift moved unexpectedly. The worker’s left hand was pinned between the control panel guard and an I-beam; his head, neck, and back were pinned between the control panel guard and a 2-inch-diameter pipe. The worker had not removed his respirator, and investigators believe that may have impaired his ability to see the control panel as he began his descent. Figure 1-2 shows the filter on the painter’s respirator, which was crushed in the accident. Figure 1-3 shows a re-enactment of the event, with the worker’s back against the pipe and his chest and head pressed into the control panel.

Figure 1-1. Cord looped over the toggle switch (re-enactment)

Investigators determined that the cord wrapping around the toggle control resulted in unexpected movement when power was provided and that there were not sufficient guards on the control panel. However, several barriers were in place that helped prevent a more serious event, including a “stop” button at the base of the lift that the spotter engaged, a similar button on the control panel that the painter engaged, and a slow setting on the operating speed of the lift. The manufacturer includes some toggle-switch guards on boom manlifts, but not all toggle switches are guarded. The contractor will add toggle-switch guards to all of the toggle switches (see Figure 1-1). Control panel covers that can be lowered during work tasks to protect the control panel will also be added to all lifts.

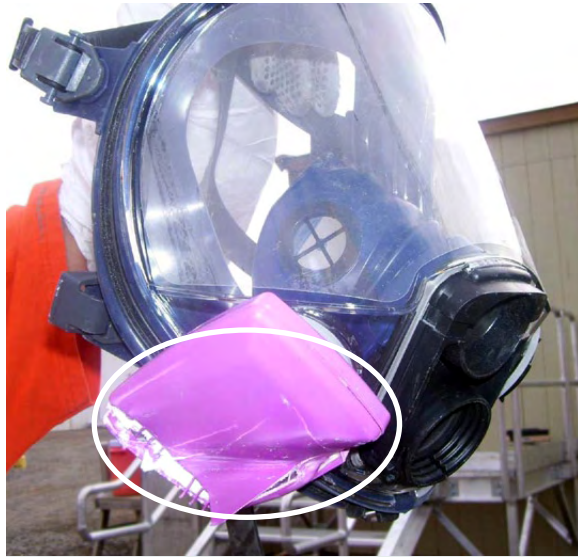
Figure 1-2. Damage to pink filter on painter's respirator

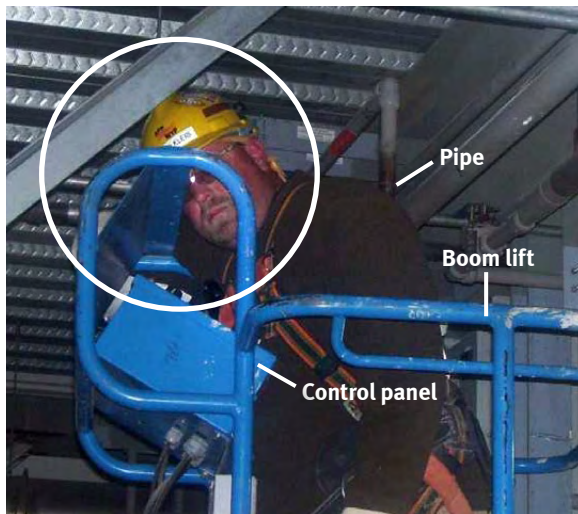
Figure 1-3. Re-enactment of the accident

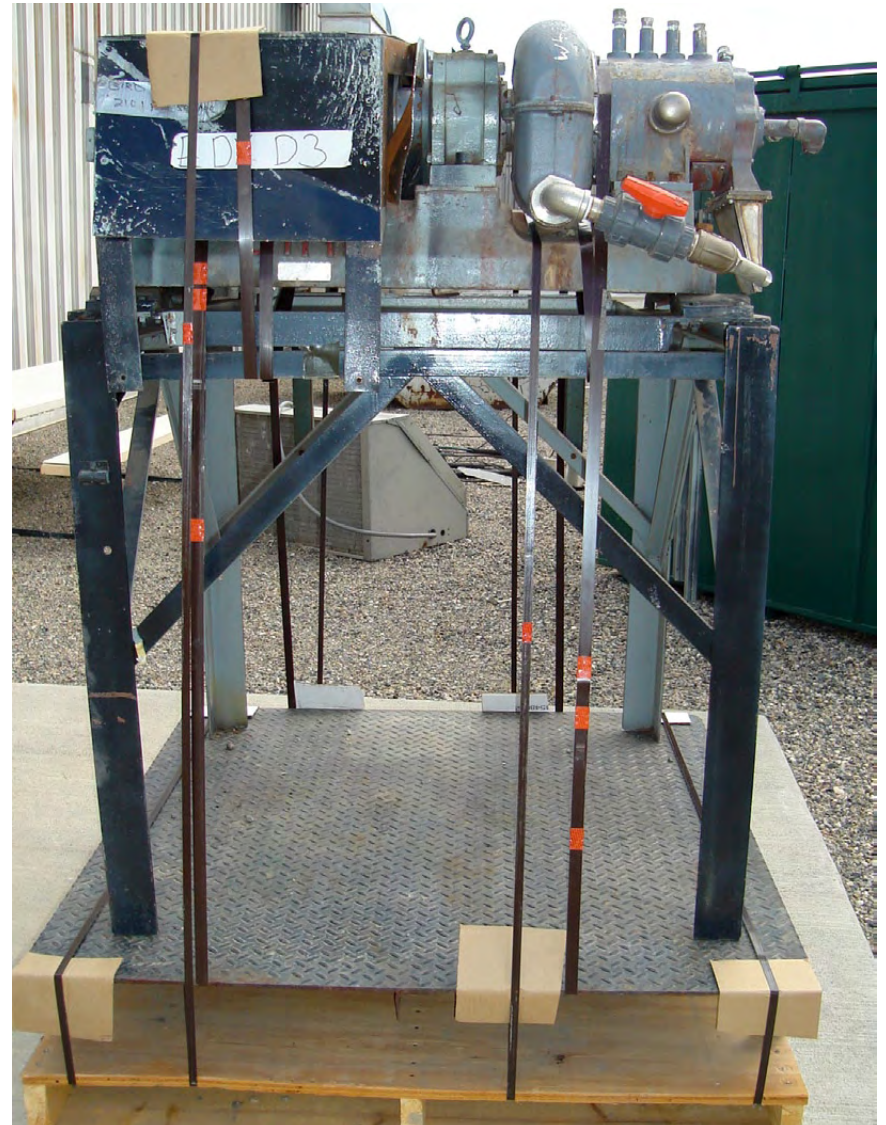
On April 17, 2008, at the Hanford Site, a pump assembly loaded on a Fluor Hanford Transportation Services flatbed semi-trailer fell off the bed of the truck and landed on the ground. The pump assembly (Figure 2-1), which weighed 1,260 pounds, was being transported to an excess yard when the near-miss event occurred. No personnel were within the vicinity of the dropped load. (ORPS Report EM-RL--PHMC-FSS-2008-0004; final report issued May 28, 2008)

A storekeeper used a forklift to load the pump assembly, which was sitting on a diamond plate metal skid, onto the flatbed trailer, and the driver secured the metal skid to the trailer with a 4-inch strap rated at 12,000 pounds. The two workers believed that the pump assembly, which had been on the metal skid for approximately 19 years, was welded to the skid and painted in place. However, the two pieces were never physically attached to each other.

Figure 2-1. The pump assembly shown banded back together on the metal skid after the incident

Investigators determined that no one involved in the shipment of the pump assembly recognized and communicated the need for special handling to stabilize the equipment and prevent damage. Because no one knew the exact weight of the load, the fact that it was top heavy, and that the skid and pump assembly were not attached to each other, the equipment was not properly secured in accordance with Federal Motor Carrier Safety Regulations, which require at least two straps.

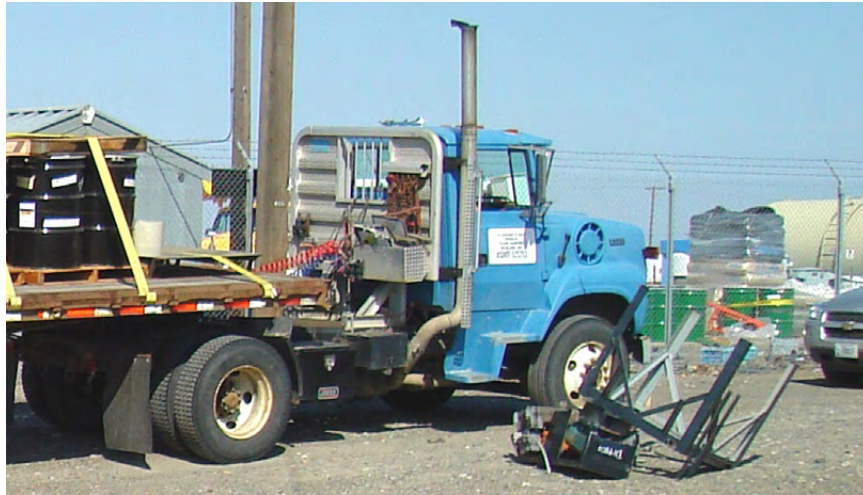
The loaded tractor-trailer had been driven approximately 200 feet from the loading area onto a graveled buffer area when the driver encountered a slight slope and a depression in the ground, and the pump assembly tipped over and slid off the trailer onto the ground (Figure 2-2).

Figure 2-2. Tractor-trailer and fallen pump assembly

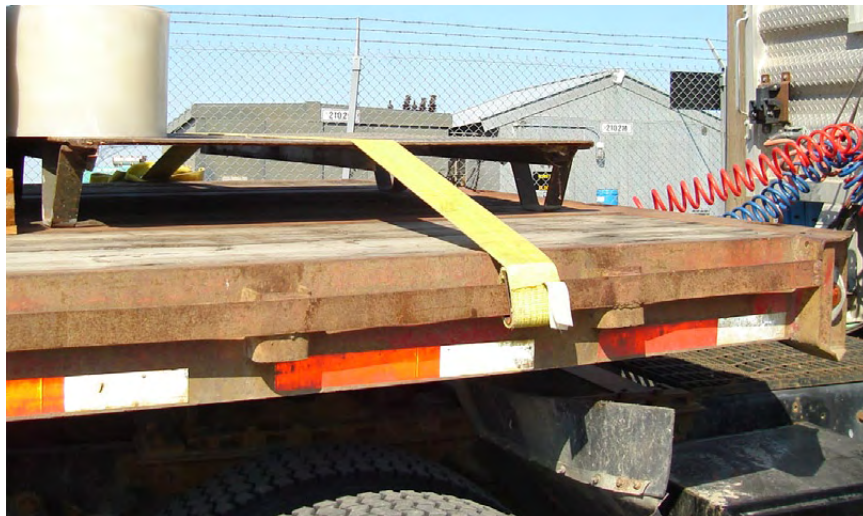
The metal skid remained secured to the truck (Figure 2-3), but the pump assembly was damaged in the fall. All loading and unloading operations and all movement of material using tractor-trailers were stopped pending a review of the event with Fluor Hanford drivers, identification of methods for safely hauling unstable materials, and approval to resume work from Senior Management.

Figure 2-3. Metal skid held down by yellow strap

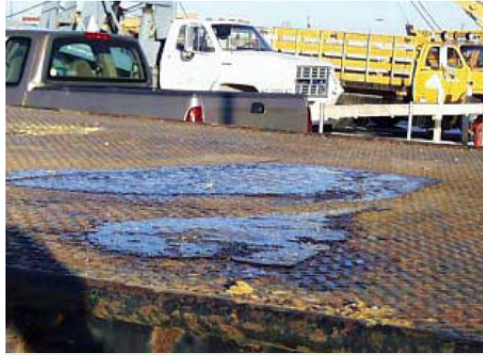
The initial investigation determined that the flatbed had been recently oiled and it had rained that morning, which contributed to the flatbed surface being considerably more slippery than normal. Although the driver was traveling at a low speed, the lack of tie-down straps, combined with the slippery deck and the sharp corner, caused the box to slide off. A similar event occurred at the Laboratory on January 6, 2003, when an unsecured multiple-ton crane counterweight slid off a flatbed truck because of ice on the metal bed (Figure 2-4). (ORPS Report EM-ID--BBWI-CFA-2003-0001)

Figure 2-4. Ice on metal bed of trailer

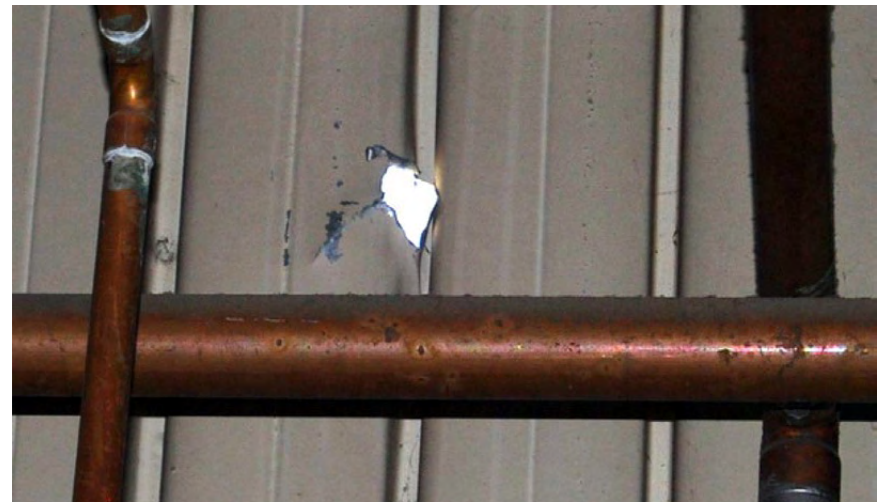
On September 13, 2007, at the Stanford Linear Accelerator Center (SLAC), a subcontractor welder was performing a hot tap into a carbon steel pipe when the heat from the acetylene torch ignited residual vapor trapped inside attached polyvinylchloride (PVC) piping and caused an explosion. The force of the explosion threw shrapnel at least 60 feet outward, and one piece was found 100 feet from the scene. Although pieces of the pipe punctured a sheet metal wall (Figure 3-1), the two workers closest to the explosion were protected by an alcove wall that separated them from the pipe. Four other workers standing about 25 feet away suffered temporary hearing loss from the concussion of the explosion. Following the explosion, the facility manager evacuated the accelerator tunnel below the work area as a precaution, and the area was barricaded. (ORPS Report SC--SSO-SU-SLAC-2007-0011; final report issued October 26, 2007)

Figure 3-1. Shrapnel penetration

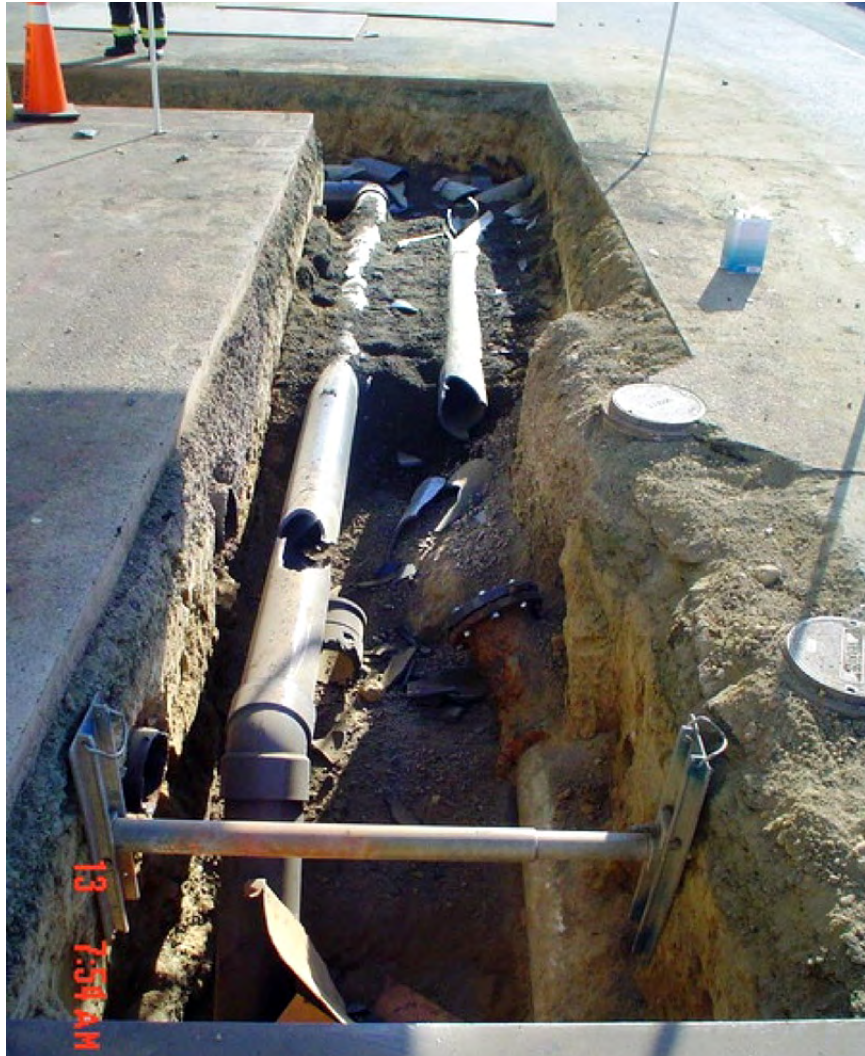
Subcontractor workers had used PVC cement and primer when installing new PVC piping that connected to a steel pipe, which extended into the alcove. The workers then blanked off (i.e., capped) the new pipe to prepare it for pressure testing. On the following day, the welder began to cut a hole in the steel pipe section to install a “threadlet” for pressure testing, and the vapor that had been trapped inside the blanked pipe ignited from the heat of the torch, rapidly increasing the pressure in the pipe and resulting in the explosion. Figure 3-2 shows the hole in the PVC piping after the explosion.

Figure 3-2. Hole in PVC pipe following the explosion

Importantly, the pressure gauge was not installed during preassembly work, which resulted in the need for the welder to cut into the new steel pipe after it had been attached to the PVC piping. In addition, the cement fumes were not allowed to dissipate to the atmosphere after the piping was assembled and before the new pipe sections were blanked off. The need to install the pressure tap constituted a change in job scope, which should have led to a re-evaluation of the hazards, but the potential for an explosion was never discussed. Also, the lack of a pressure test plan and a sequence of tasks that included installing the pressure gauge before capping the pipe, left it to the welder to decide how to proceed.
