# OPERATING EXPERIENCE SUMMARY

U.S. Department of Energy  
Office of Health, Safety and Security  
OE Summary 2008-06  
July 18, 2008

## Hoisting Cable On Leased Truck Breaks

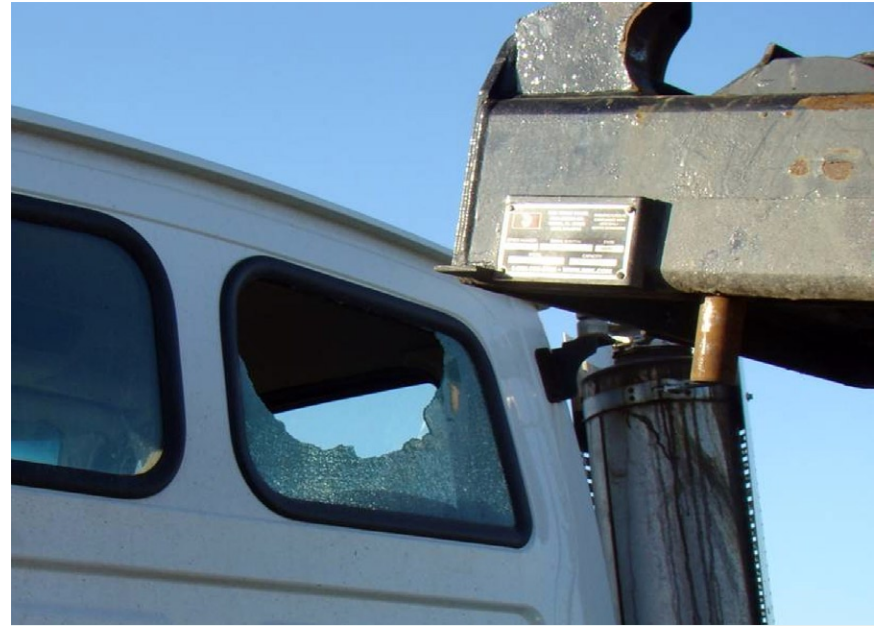
As the waste container came to rest against the container stops, the teamster heard a loud bang at the rear of the truck and realized that the cable had broken. The hydraulic rams had continued to apply pressure to the hoist system in excess of cable tensile strength after the container reached the end of the deck, causing the cable to break. Figure 1-2 shows the empty container after it slid off the rails; Figure 1-3 shows the broken cable underneath the truck rails.

**Figure 1-1. Passenger side rear window damage**

As result of this event, the hydraulic pressure setting will be verified during initial onsite inspections. Rear cab protection is also being added to shuttle hoist trucks to ensure that the driver is protected if a similar event should occur. A site lessons learned bulletin (Identifier RCCC-08-009) on this event is available at <http://www.washingtonclosure.com/about/safety/docs/RCCC-08-009.pdf>. The textbox on the following page shows the recommended actions from the bulletin.

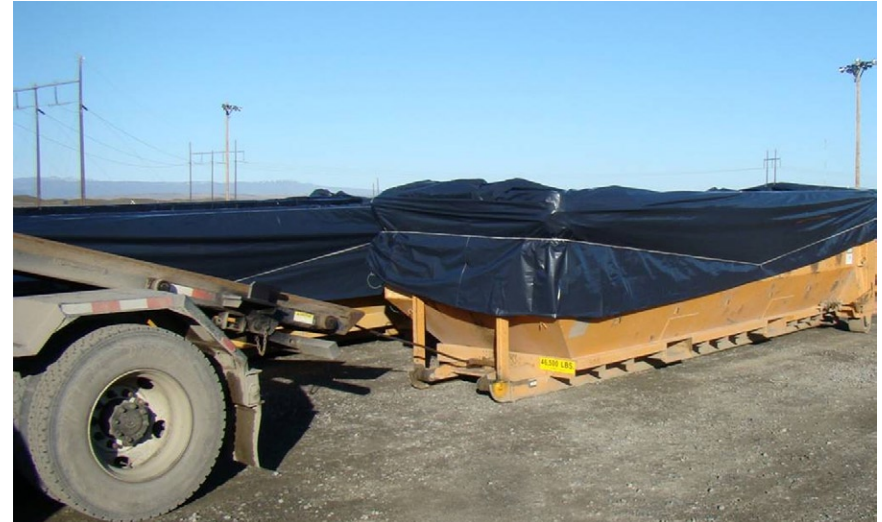
Figure 1-2. Empty container after sliding off rails

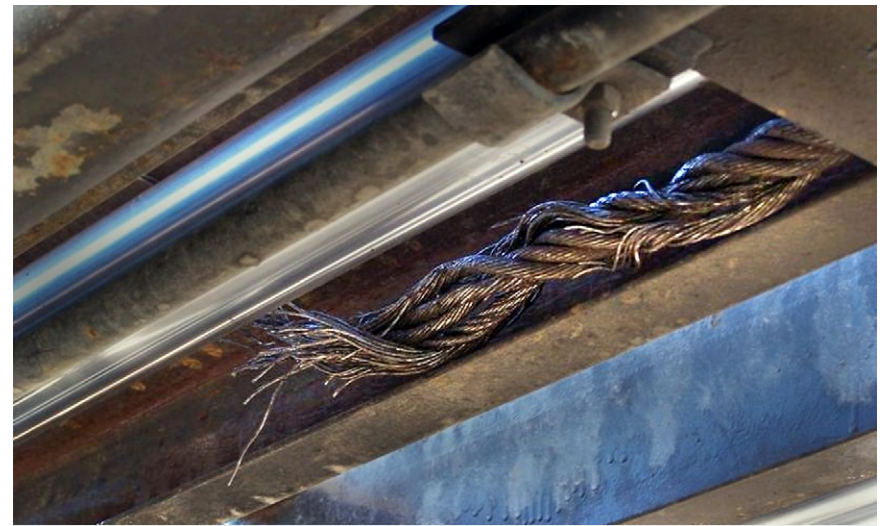
The rented truck had been on site less than 48 hours before this event occurred, and mechanics had inspected it upon receipt. A post-event mechanical inspection determined that the pressure relief valve on the shuttle truck was set to allow a maximum pump pressure of more than 3,000 psi. However, the manufacturer recommends a pump pressure of only 1,850 psi, and the valve is set at that value before shipment. An inspection of other shuttle trucks on site indicated that their hydraulic pressure relief valves were in compliance with manufacturer-recommended settings.

Investigators learned that the truck was operated the previous day, apparently also at 3,000 psi. However, on the day of the event, the operator ran the hydraulics for some time with the waste container on the stops, allowing sufficient pressure to build up in the hydraulics to break the cable. Investigators also spoke with the rental vendor and contacted the manufacturer. Both believed that this was an isolated incident and that it was likely that the pressure relief valve was set improperly before the shuttle truck was delivered to the Hanford site.

Figure 1-3. Broken cable underneath the truck rails

- Because the pressure relief valve is also a safety system, any incoming shuttle truck should have the pressure settings checked and compared to the service manual before acceptance or prior to field service. A pressure setting check should also be included in annual (periodic) inspections.
- If not addressed in the service manual, the manufacturer should be contacted before setting or resetting any pressure relief valves to confirm if field readjustment is allowed and to confirm the correct setting.
- A rear window shield should be installed to provide an increased level of protection for the driver in case of cable failure.
