OPERATING EXPERIENCE SUMMARY

U.S. Department of Energy
Office of Health, Safety and Security
OE Summary 2008-07
August 7, 2008

Industry Tower Crane Collapses Lead to Savannah River Site Crane Shutdown

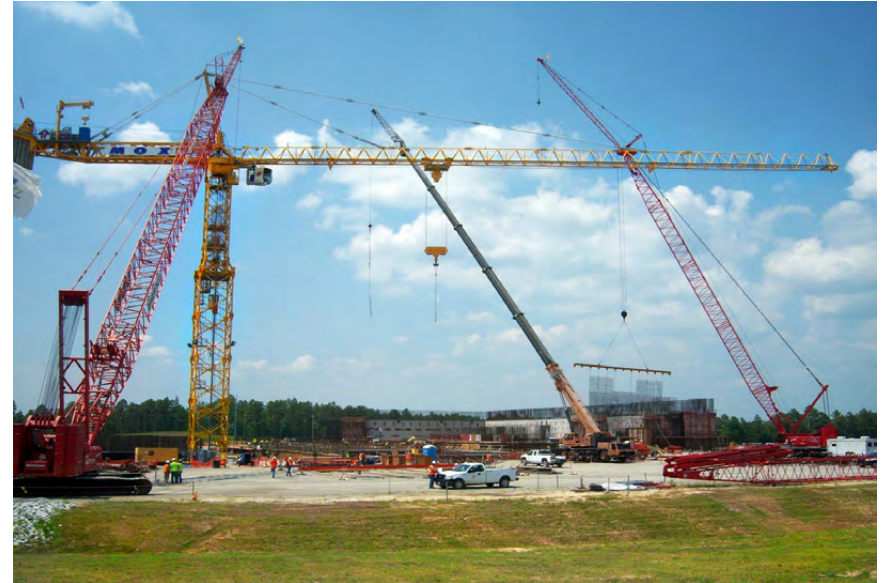
On June 4, 2008, at the Savannah River Site (SRS), a crane operator noticed cracks in the protective coating on two legs of the turntable supports of a tower crane while performing a routine, daily inspection. SRS uses the tower crane and three track cranes for a Mixed Oxide Fuel Fabrication Facility (MOX) project. Figure 1-1 shows the tower crane (yellow) and two of the track cranes (red). The operator notified his supervisor and the crane was shut down immediately, pending further investigation. (ORPS Report NA--SRSO-MOXS-MOX-2008-0004)

Figure 1-1. SRS cranes at MOX Project (yellow tower crane was shut down)

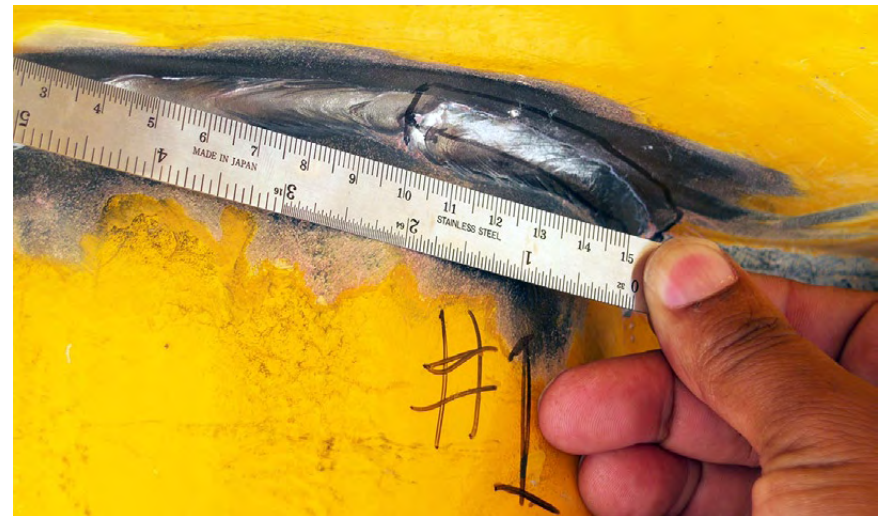
Magnetic particle inspection revealed hairline cracks on two of the four turntable supports (Figure 1-2). Since the cracks were not in a load-bearing component, the manufacturer stated that the crane was safe to operate. However, because of the numerous reports of tower crane accidents across the country, management decided, as a precautionary measure, to use the crane only on a limited basis until repairs are made by MOX personnel and factory representatives following an already scheduled annual crane inspection.

Figure 1-2. Cracks on turntable of SRS tower crane

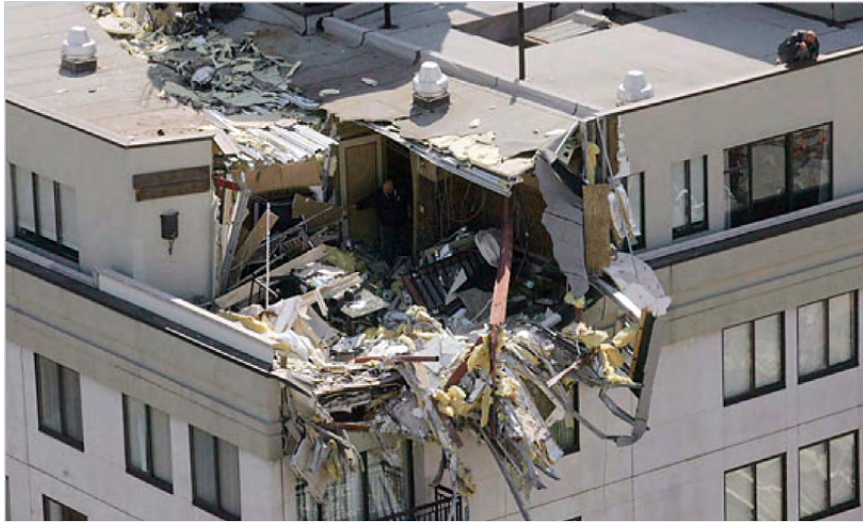
Figure 1-3. Penthouse demolished by May 30, 2008, crane collapse

Another recent crane accident occurred in New York City on May 30, 2008, when the working arm of a crane detached from the tower, fell, and killed two people. Figures 1-3 and 1-4 show the aftermath of that accident. Additional information about this accident is available at a New York Times blog. (<http://cityroom.blogs.nytimes.com/2008/05/30/crane-collapses-on-upper-east-side/>)

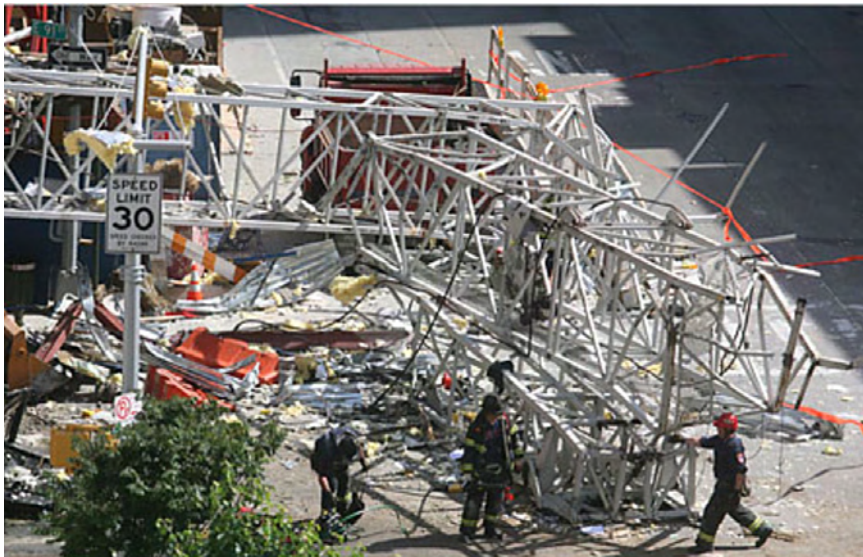
Figure 1-4. Crane on ground following May 30, 2008, accident

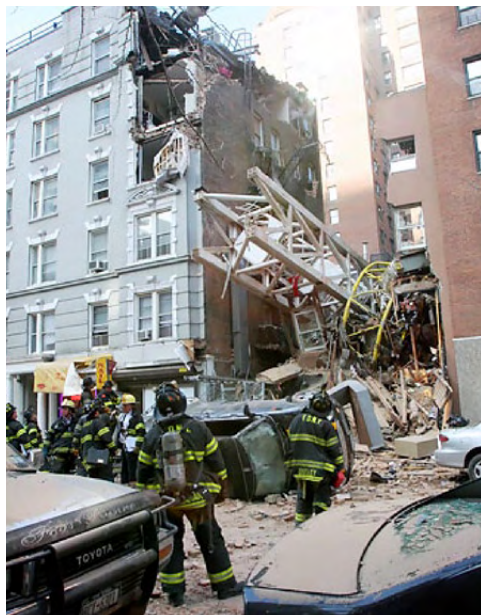
An earlier crane collapse in New York City on March 15, 2008, resulted in 7 deaths and injuries to 24 others, including people in the vicinity of the accident and 11 first responders. Figure 1-5 shows a section of the collapsed crane protruding from the building. The crane collapsed while workers were extending the height of the tower.

Figure 1-5. Collapsed crane protruding from building after March 15, 2008, accident
