# OPERATING EXPERIENCE SUMMARY

U.S. Department of Energy  
Office of Health, Safety and Security  
OE Summary 2008-08  
September 4, 2008

## Plutonium Spill at Boulder NIST Facility

## Unsafe Liftgate Operation Results in Worker Injuries

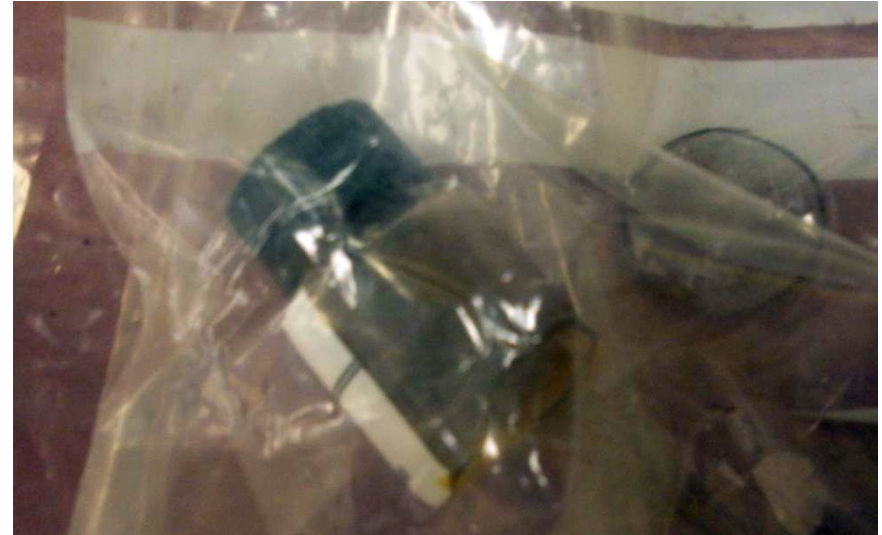
The small plutonium sample (smaller than a dime in size) was being used in a research project to develop improved radiation detectors for use by nuclear inspectors outside NIST and contained about 0.25 gram of plutonium. A few days before the accident, the guest researcher tapped the source bottle on a marble laboratory bench in an attempt to “settle the powder” inside the bottle in one location, which may have damaged the bottle. The bottle later broke when it was accidentally knocked against either the lead shield “bricks” or the detector (Figure 1-2).

The guest researcher, who was working alone in the laboratory and who had received no previous training in handling the sample, was not wearing gloves; and, although he noticed that the bottle was cracked, he continued to handle it. When the bottle broke, spilling the plutonium, he was unaware of the course of action that needed to be taken. He spread

**Figure 1-1. Broken glass container inside multiple plastic bags (broken bottom in upper right-hand corner)**

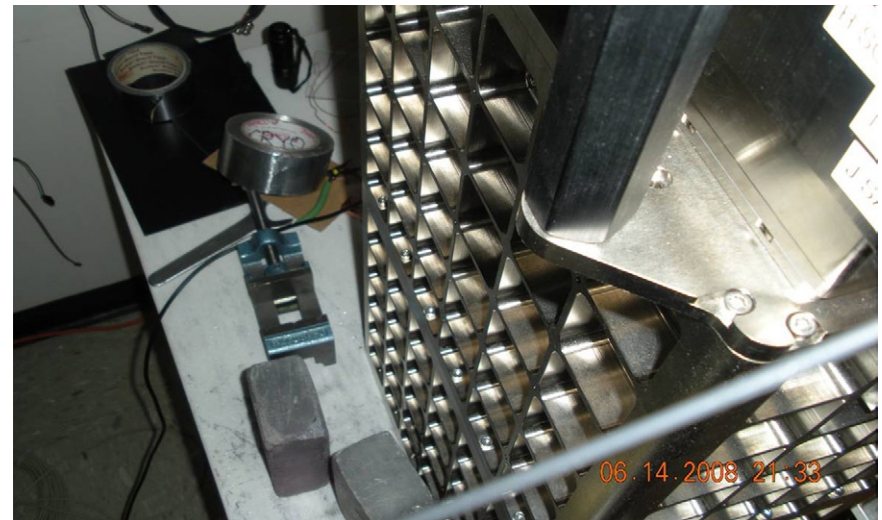
**Figure 1-2. Area between detector and electronics rack (note lead bricks)**

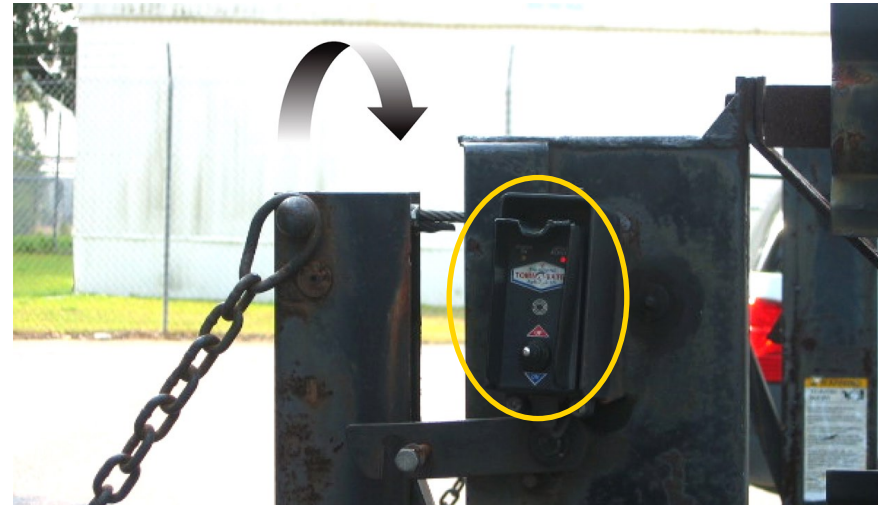
The worker offloaded a refrigerator being transported to the SCCB trailer warehouse and was putting a pallet jack back inside the delivery truck. He was holding the pallet jack with his left hand, operating the liftgate control switch (Figure 2-1) with his right hand, and riding on the liftgate.

**Figure 2-1. Control switch (circled) on right side of the delivery truck (arrow shows the scissor-like movement of the mechanism)**

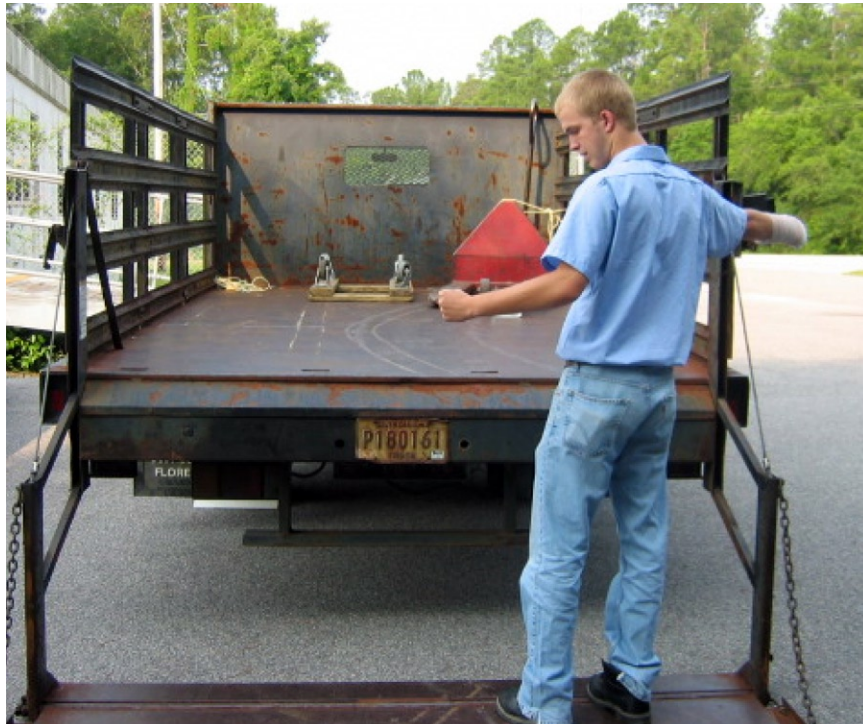
forearm (a few inches from the wrist) was pinched between the two sections of the liftgate (Figure 2-2).

Investigators determined that the cause of the accident was inattention to the task. The worker was not watching his surroundings; the load (pallet jack) was not properly secured; and the worker placed his arm in an area where it would be in a pinch point. The manufacturer of the liftgate (Tommy Gate®) warns that their lifts are industrial products for material handling only and are not to be used as a personnel lift, so the worker should not have been riding on the lift gate.

**Figure 2-2. Injured worker reenacts the accident, showing how he was positioned on the lift while operating the control switch (note worker's bandaged arm)**
