OPERATING EXPERIENCE SUMMARY

U.S. Department of Energy
Office of Health, Safety and Security
OE Summary 2008-09
October 8, 2008

Chemical Safety Board Completes Investigation of Danvers Explosion

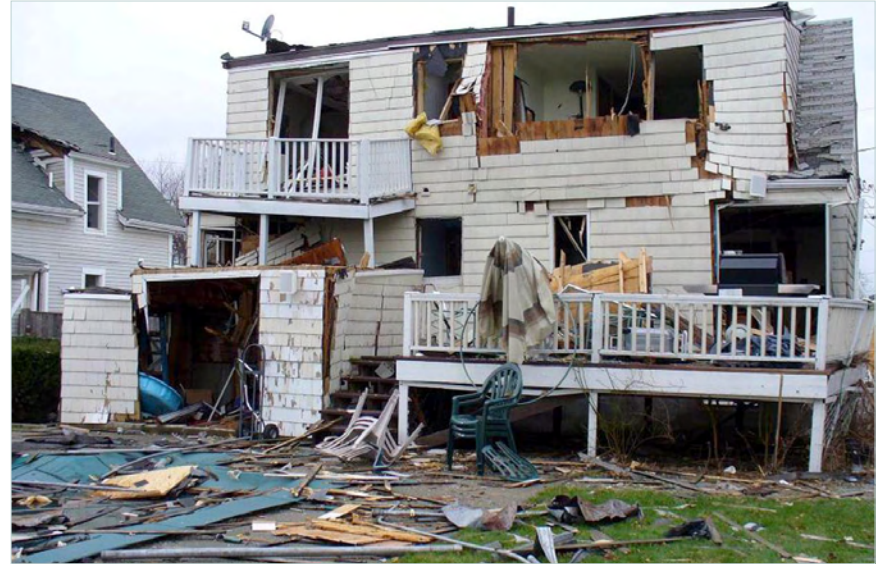
Figure 1-1. Nearby home destroyed in CAI explosion

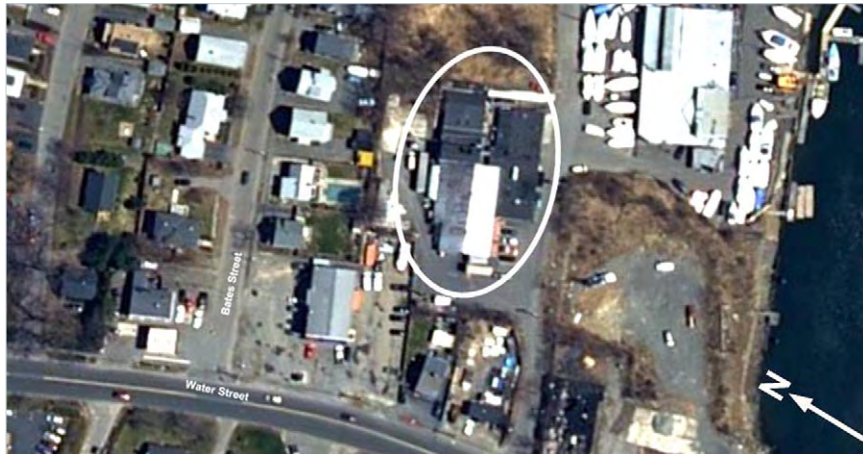
Figure 1-2. Area surrounding CAI before the explosion (plant circled)

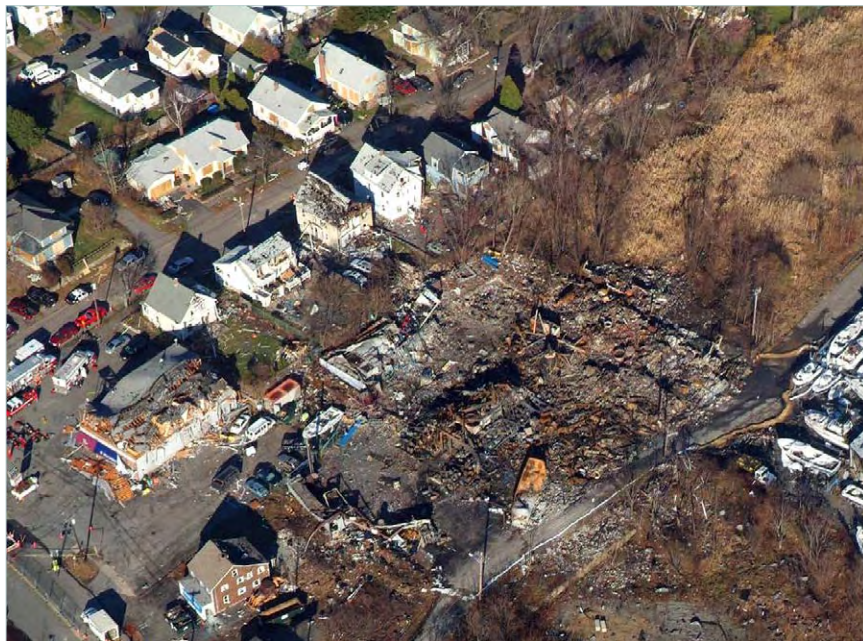
The CSB investigators concluded that the open steam valve would have caused the liquid to boil. As long as the steam valve remained open, the boiling mixture continued to release many hundreds of pounds of flammable vapor into the unventilated production area. Because the mix tank was not vented to the building's exterior, uncontrolled tank heating caused the mixture to rapidly vaporize and release enough vapor into the production area to fuel the explosion. They determined that an unknown ignition source ignited the flammable atmosphere, causing the explosion, and that thousands of gallons of flammable liquids stored inside the building and some 51,000 pounds of industrial-grade nitrocellulose material stored nearby were ignited. The resulting fire burned for over 17 hours. Figure 1-2 shows the area surrounding the CAI facility before the accident; Figure 1-3 shows the same area following the explosion.

Figure 1-2. Aftermath of explosion

- CAI management did not conduct a process hazards analysis or similar systematic review to ensure that the flammable liquids processes were safely designed and operated.
- CAI heated Class I flammable liquids in unsealed tanks inside a closed building.
- CAI did not install or use automated process controls, alarms, or safeguards when heating flammable liquids in process equipment inside a closed building.
- CAI did not maintain adequate building ventilation during all flammable liquids process operations.
- CAI management did not use written procedures or checklists to ensure that flammable liquids manufacturing processes were operated safely.

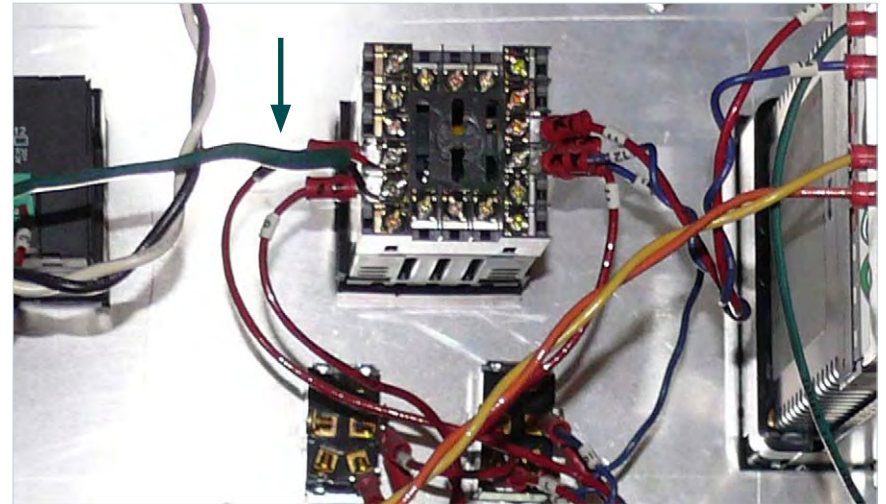
After the incident, an electrician tested both the oven and the control unit and determined that the control unit had been miswired. Incoming 240-volt power and the thermocouple leads were both landed on the thermocouple terminals in the controller. Figure 2-1 shows the over-temperature controller and the green power supply wires, which are attached to the same terminals as the thermocouple wires. The electrician determined that the researcher encountered 118 volts when he touched the wires.

Figure 2-1. Closeup of controller showing power supply wires (green) attached to same terminals as the thermocouple wires (red)

Corrective actions included revising the electrical safety procedure to require electrical worker qualification for all staff members performing maintenance, modification or component replacement and repair of electrical equipment. In addition, an inspection checklist that includes performing post-maintenance testing will be developed for staff use.

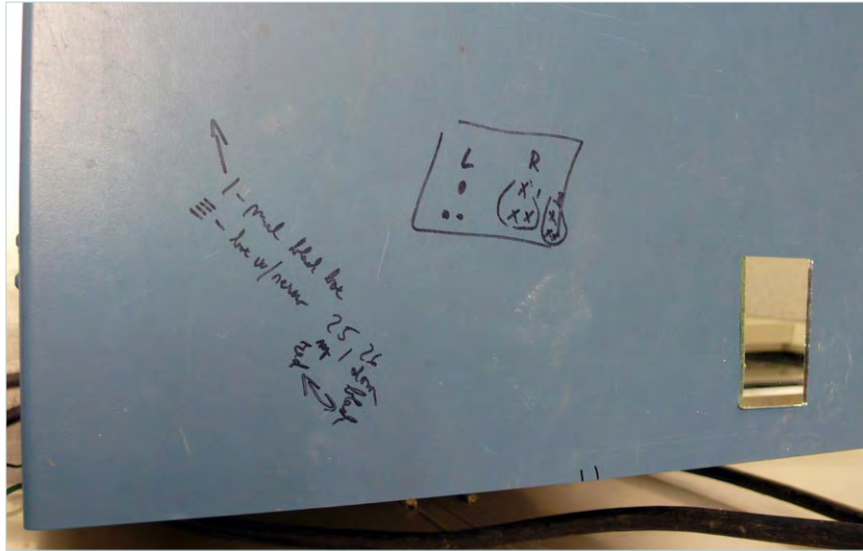
The controller had last been replaced in 2006 based on a wiring diagram made by a third researcher. Figure 2-2 shows the diagram (drawn on the controller unit). The researcher told investigators that he was certain that he had rewired the controller correctly, but they determined that the wiring diagram did not include enough detail to successfully perform the task.

Although it was not required by procedure, a key step missing in the replacement process was a post-maintenance function test to ensure that work was properly performed. Had such a test been performed on the over-temperature controller, the miswiring would have been discovered and corrected.

Figure 2-2. Wiring diagram drawn on controller unit
