OPERATING EXPERIENCE SUMMARY

U.S. Department of Energy
Office of Health, Safety and Security
OE Summary 2008-12
December 31, 2008

NRC Identifies Problems with Concrete Placement

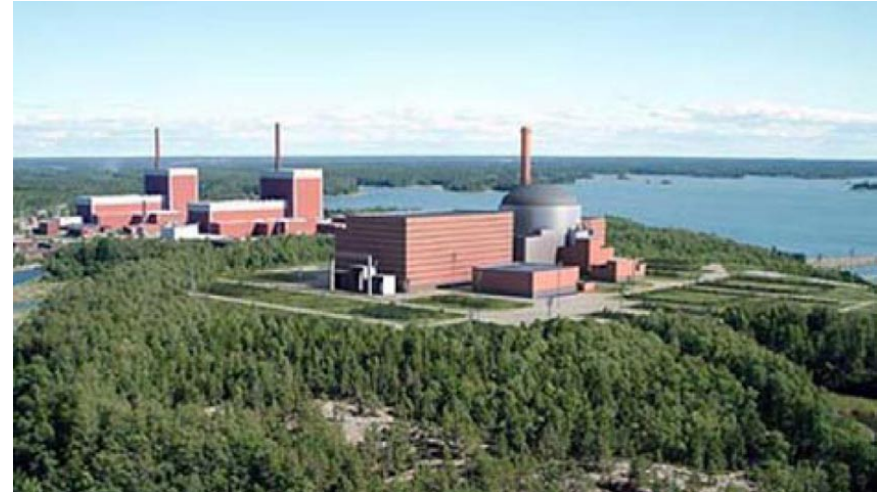
A July 10, 2006, investigation report issued at the Olkiluoto 3 Nuclear Power Plant in western Finland (Figure 1-1) identified several contributing factors that resulted in plant construction delays. During placement of the reactor building concrete basemat, Teollisuuden Voima Oy (TVO), the licensee, detected inconsistencies in concrete from different truckloads and confirmed that plasticizer caused the variation. Additional problems involved water-cement ratios outside of design requirements and changes in the composition of the concrete made by the contractor without TVO's knowledge. Testing on the concrete indicated that the concrete met minimum standards. An investigation of site operations found that

Figure 1-1. Olkiluoto 3 Nuclear Power Plant (foreground) as it will appear when completed in 2012

the delays were also caused by lack of communication and defined responsibilities and by poor quality control. Although the concrete was ultimately found to be acceptable, the construction delays had a negative impact on public confidence.

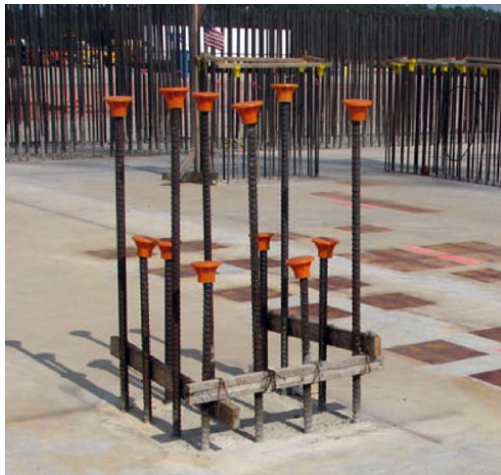
In September 2007, an NRC inspector observed problems with concrete placement at the Mixed Oxide (MOX) Fuel Fabrication Facility (MFFF) construction site (Figure 1-2) at the Savannah River Site. Based on the rejection of five truckloads of concrete by Shaw AREVA MOX Services (the applicant) because concrete slumps were outside the design value, the concrete batch plant, which was operated by a contractor, was inspected. The NRC inspector determined that chemical plasticizer and water in excess of both the manufacturer's recommendation and the design specification were being added to the design mix at the plant. The addition was made without

procedural guidance and was not documented. In response to the NRC report, the applicant assumed responsibility for concrete testing at the batch plant, provided immediate quality assurance coverage of all batching operations, ensured that batch plant procedures were written or revised as necessary, and consulted independent experts for recommendations for improvement.

In January 2008, at the MFFF construction site, a concrete reinforcement steel bar fractured near a bend location because of work-hardening during the bending process. An NRC inspection in February 2008 identified problems with bent rebar, primarily in the foundation of the facility. NRC inspections of the reinforcing steel vendor revealed five non-conformances: (1) inadequate surveillance of rebar fabrication; (2) inadequate audits of sub-suppliers; (3) failure to verify adequacy of design in the dedication of commercial grade items; (4) failure to write a corrective action process condition

report for a significant condition adverse to quality; and (5) failure to properly disposition a code deficiency. An inspection of the MFFF yielded no findings. The applicant had already issued more than 80 condition reports addressing problems with vendor parts and had increased oversight of vendor activities.

Figure 1-2. Concrete mat and rebar installation during construction of MFFF

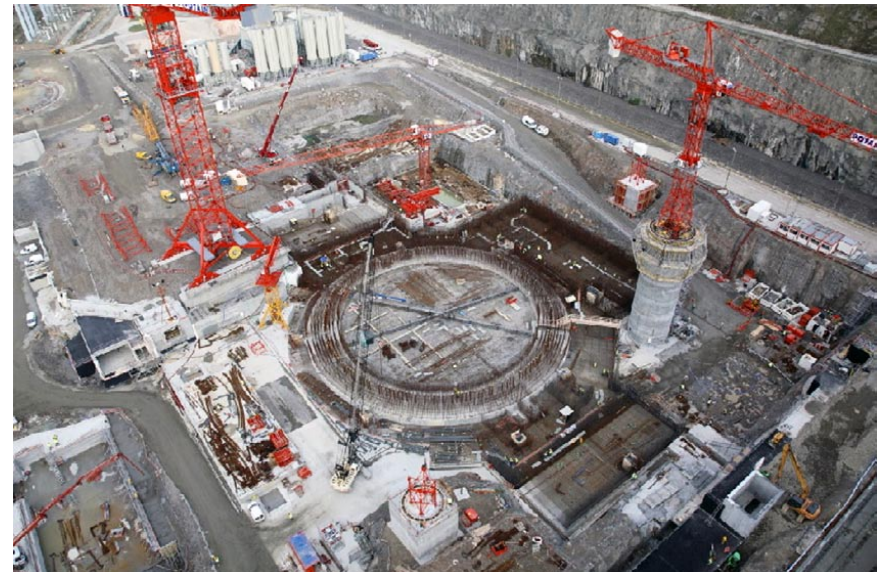
In March 2008, an inspection by the Autorite de Surete Nucleaire (ASN) revealed several problems with reinforcement steel bars and concrete placement for the basemat of the fuel storage buildings at the Electricite de France (EDF) Flamanville 3 European Pressurized Reactor construction site (Figure 1-3). The inspection revealed improperly spliced and tied rebar and reinforcing steel placement that did not conform to approved procedures and design requirements. Despite these deficiencies, the concrete contractor had initiated concrete placement. ASN was able to verify that corrective actions had been taken before concrete had actually been placed in the area.

Figure 1-3. Flamanville 3 construction site and circular basemat for reactor containment

In another case at the Flamanville 3 site, the concrete reinforcement and placement did not follow construction specifications and drawings. A review of site conformance records indicated that some aspects of the work were flagged as potential nonconformances, with specific notations, but follow-up actions were not tracked. Accordingly, ASN requested the licensee to provide additional information, including assurances that prior concrete placements were free of design-requirement inconsistencies with regard to the issue of improperly spliced and tied rebar and nonconforming reinforcing steel placement. Where implementation did not match the construction specifications and drawings, ASN asked the licensee to document and validate the alternate methods and explain the reasons for failing to follow approved construction procedures. ASN also requested information about the causes leading to the failure, so deficiencies identified in field records could be tracked and closed.

On May 21, 2008, EDF informed ASN about the lack of stirrups in the reinforcement steel of the basemat of the safeguard auxiliary buildings. Beyond the technical nonconformance, ASN considered the main issue to be the licensee's quality management system. A preliminary analysis of the root causes indicated that the nonconformance had not been corrected before concrete placement, even though both the subcontractors and the licensee had identified the lack of stirrups in time to do so. Consequently, ASN stopped concrete placement of all buildings relevant to safety until the licensee provided detailed plans that identified managerial and organizational enhancements to support improved oversight of field activities and facilitate field task tracking. In addition, the licensee was required to submit a technical analysis of the nonconformance and proposed correction.

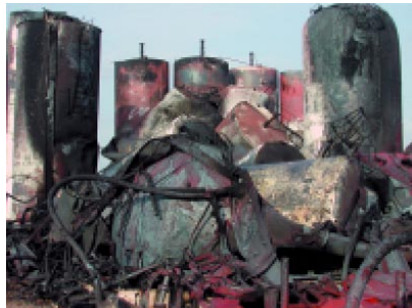
The fire, which began as a small fire on an outdoor worktable located between two warehouses, quickly grew to a flaming pool of liquid 65 to 80 feet wide and engulfed two semi-trailers full of empty drums. The flames also surrounded a 6,000-gallon tank wagon that contained synthetic motor oil, heating the oil and igniting flammable vapors vented from the tank. The intense heat ultimately resulted in the tank melting into several puddles of aluminum. Flames also surrounded several 2,000-gallon blending tanks, which collapsed and spilled their contents into the fire (Figure 2-1). Pipelines from nearby storage tanks also ruptured (Figure 2-2).

All of these burning fluids flowed toward the tank farm through a cracked and broken dike wall and ignited the storage tanks. Eventually the fire spread to other warehouses at the plant, breaching metal walls and consuming all the remaining fuel at the site.

Figure 2-2. Melted storage tanks post-fire
