OPERATING EXPERIENCE SUMMARY

**U.S. Department of Energy
Office of Environment, Safety and Health**

OE Summary 2004-01

January 12, 2004

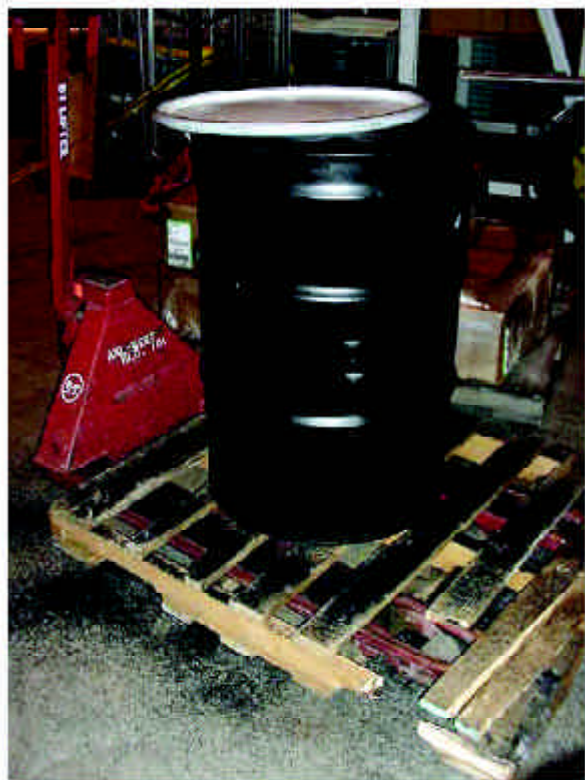
Figure 1-1. Drum containing activated charcoal

On January 9, 2004, at the Argonne National Laboratory – West receiving warehouse, the lid on a sealed drum (Figure 1-1) unexpectedly popped up while a material handling worker was opening the drum. The drum, which contained loose activated charcoal, had been received from a California manufacturer. The internal pressure was sufficient to raise the lid about 2 inches and disperse the granular charcoal in a 4-foot-diameter circle when the worker loosened the retaining ring on the drum lid. The worker was not injured and only a few ounces of material were released. (ORPS Report CH-AA-ANLW-ANLW-2004-0002)

check. Based on his knowledge of previous shipments by this vendor, the worker believed that the drum contained activated charcoal in bags, rather than in bulk form without secondary packaging; however, the worker did not verify the contents before he attempted to open the drum.

Investigators suspect that the pressure in the drum resulted from the drum being loaded at sea level and being opened at an elevation of approximately 5,100 feet.

- Train material handlers and drum users on the possibility of drum pressurization from changes in altitude or environmental conditions (e.g., temperature).
- Treat all sealed drums, including new drums, as if they are pressurized until vented and proven otherwise.
- Provide instructions for safely venting drums that may be pressurized below the point at which they would bulge or otherwise deform.
- Use drum lid-restraining devices and harnesses.
- Develop drum handling procedures that address the need to vent new drums before use and describe a safe method for doing so.

These events underscore the importance of recognizing the hazards that a pressurized drum presents to workers. Material handlers and drum users should approach, handle, and open all sealed drums as if they are pressurized. Lid-restraining safety devices should be used routinely when opening closed drums. Personnel need to be aware that in addition to pressurization produced by chemical reactions within filled drums, empty drums can also become sufficiently pressurized to cause injury without any visible indications such as deformation or bulging.

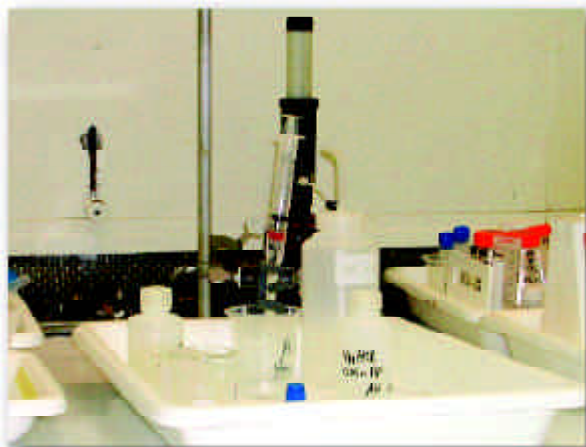
Figure 3-1. Syringe and column

The worker had inserted a syringe into a slip-fit seal and attached it to a resin column in a custom-made arrangement to move the acid solution through the column (see Figure 3-1). He attached the empty syringe to the top of the column with a rubber ring to provide air pressure. Apparently, the seal was not adequately seated, and when he depressed the syringe plunger, acid sprayed out around the plastic seal and entered his eyes over the top of his safety glasses.

Investigators determined that the PPE and fume hood did not provide an adequate level of protection for the hazards associated with the work being performed. They also determined that the hazard control plan was too generic in nature to provide adequate details regarding specific hazards and the

necessary controls. The plan made no mention of the custom-made apparatus, relying on the worker's knowledge and expertise. The worker apparently did not question whether there might be additional hazards that should be considered before using the apparatus.

- Managers and supervisors must ensure workers are equipped with proper PPE.
- The level of training provided to workers must be sufficient to enable them to recognize when controls and assistance are required.
- Workers can help protect themselves by performing their own hazard analysis and asking, "What can happen to me when performing this task?"
