OPERATING EXPERIENCE SUMMARY

U.S. Department of Energy
Office of Environment, Safety and Health
OE Summary 2004-02
January 26, 2004

1. GAS LINE PUNCTURED DURING UNSCHEDULED EXCAVATION WORK

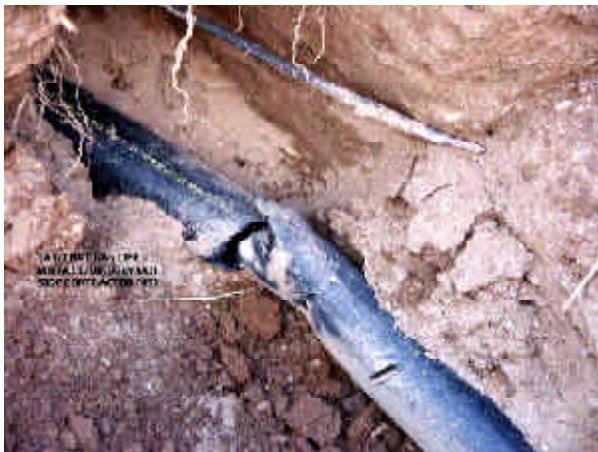
On November 4, 2003, at the Los Alamos National Laboratory (LANL), a backhoe operator began excavating a trench for electrical lines and punctured a pressurized (80 psi) natural gas line (Figure 1-1). As the tine of the backhoe bucket penetrated the line, a co-worker heard a hissing sound and directed the backhoe operator to stop work. Emergency responders evacuated the area, turned off the gas, and checked for gas concentrations. The leaking gas did not ignite, and there were no injuries. (ORPS Report ALO-LA-LANL-ADOADMIN-2003-0005; final report filed December 22, 2003; SELLS Identifier LANL-ADOADMIN-2003-0010)

Figure 1-1. Cut gas line

When the backhoe operator began digging the trench, he apparently was unaware that the utility locator markings had deteriorated since a

crew marked them a month earlier. Work planners intended to have the gas line re-marked before scheduling work on the trench. The operator did not realize that performing additional unplanned and unscheduled work posed a hazard, and did not discuss his intention to excavate the trench with anyone.

Investigators determined that work controls were inadequate to ensure that only authorized work was performed and that situations where tasks were completed ahead of time were addressed. Corrective actions for this event included counseling the worker; reviewing the event and excavation requirements with subcontractor construction workers; and incorporating a discussion on safety issues, controls, and the designated work boundary for each task into the subcontractor's plan of the day meeting. In addition, a planned Integrated Work Management Process developed by the LANL Health, Safety, and Radiation Protection Group was quickly implemented, and subcontractors received training on its requirements.

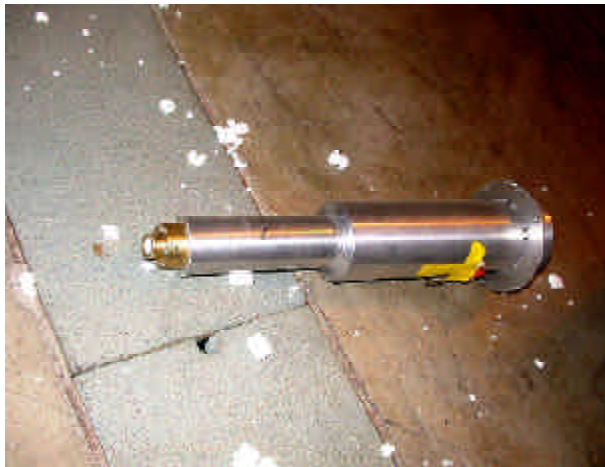
On September 18, 2003, at the Nevada Site Office North Las Vegas facility, an experimentation support engineer increased the pressure to an experimental pressure vessel from 1,000 psig to 1,100 psig, and eight socket-head cap screws connecting an electrical terminator housing to the chamber failed. The terminator was propelled about 60 feet (Figure 3-1), damaging a flammable storage cabinet (Figure 3-2), fire protection equipment, and a roll-up door. No one was injured, but the engineer and a principal investigator stood within 5 feet of the vessel, and two maintenance mechanics stood outside the roll-up door about 10 feet away (Figure 3-3). Had they been in the path of the component, they could have

Figure 3-1. The terminator assembly was forcibly ejected

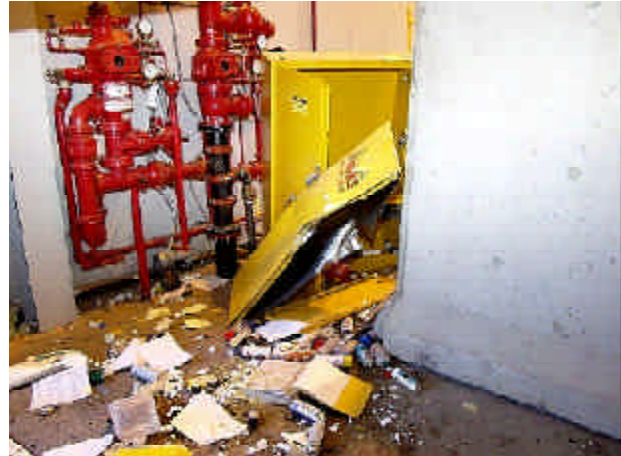
Figure 3-2. The damage to the flammable materials storage cabinet

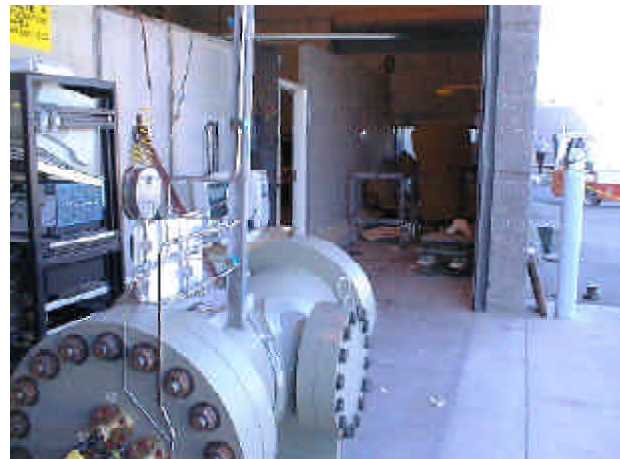
Figure 3-3. The projectile path from the vessel to the rollup door

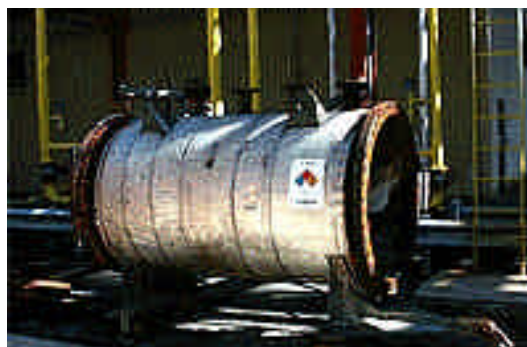
Near misses and adverse events are often precursors to more severe accidents, like the one that occurred on March 13, 2001, at BP Amoco Polymers (now Solvay Advanced Polymers LLC) in Augusta, Georgia. Three people were killed when they opened a process vessel (Figure 3-4) containing hot plastic, unaware that the vessel was pressurized at about 80 psi. One worker, who had performed this type of work for over 10 years, was killed when the 2,000-pound, partially unbolted cover struck him (Figure 3-5). The hot plastic that killed the other two workers was propelled with great force throughout the room, causing some nearby tubing to break. Hot fluid from the tubing ignited, resulting in a fire and second explosion minutes later. The U.S. Chemical Safety and Hazard Investigation Board investigated the accident. Their detailed report is

Figure 3-4. The opened process vessel

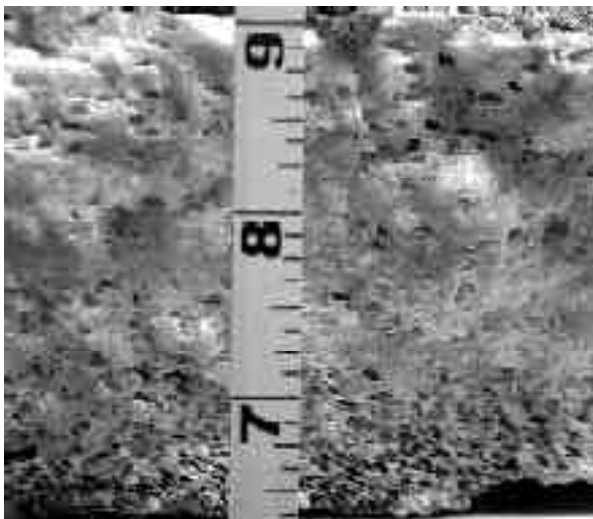
Once in the pipes, the plastic solidified as it cooled (Figure 3-6). A hardened layer of plastic 3 to 5 inches thick also formed around the entire inner wall of the tank. However, the core of the plastic mass remained hot and molten, and probably continued to decompose over several hours, generating gases that pressurized the vessel. Before attempting to open the polymer catch tank, the workers may have relied on a pressure gauge and a transmitter on the vent piping from the vessel to ascertain whether it was under pressure. However, any reading from the pressure gauge would likely have been unreliable because plastic had entered the vent line and solidified (Figure 3-7). The workers also knew that the process was shut down, which may have led them to believe they could safely open the vessel.

Figure 3-6. Hardened polymer taken from the perimeter of the catch tank

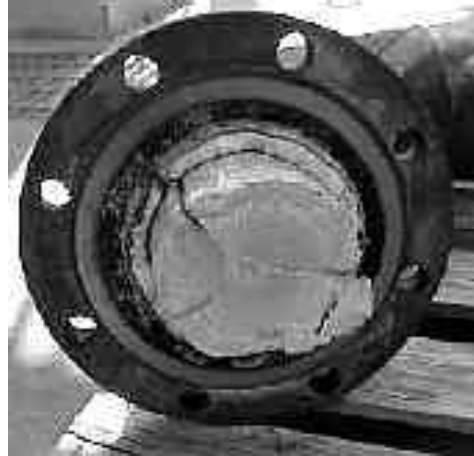
Figure 3-7. The vent pipes were plugged with hardened material
