OPERATING EXPERIENCE SUMMARY

U.S. Department of Energy
Office of Environment, Safety and Health
OE Summary 2004-06
March 22, 2004

1. AZTEC BATTERY CHARGERS MAY APPLY VOLTAGE TO METAL CASES

3. LACK OF GROUND FAULT PROTECTION LEADS TO FAILURE OF HEAT TRACE JUNCTION BOX

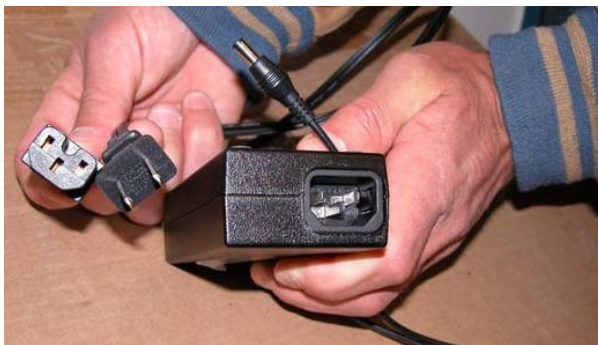
The AZTEC NiCad charger has a two-wire, two-prong-plug cord. The standalone cord is similar to a personal computer power cord, with a male plug on one end and a receptacle at the other that plugs into the unit (Figure 1-1). These chargers are often used to charge various general purpose batteries such as those used in the leakage tester. Figure 1-2 shows the AZTEC Model SA 45-3109 standalone battery charger the engineer used.

When the technician tested the charger, he expected a reading of 24 VDC across the charger output connector (i.e., the plug); instead, voltage measured 63 VAC. He installed a new charging unit, and the case to ground potential disappeared. Three additional faulty units were found in the facility, and all four were removed from service.

Figure 1-1. Charger plug and connector

The technician tested all four of the AZTEC chargers in the facility, substituting the three-wire power cord, which has a ground plug, for the two-prong plug. When he connected the charger to the leak tester, there was no AC component at the charger and no potential, either AC or DC, between the case and the ground. Investigators concluded that the two-wire, two-prong power cords created the voltage excursions. They destroyed all the cords with two-pronged plugs, and supervisors directed that only three-pronged plugs are to be used in the future.

To address this and any similar problems with the charger, a new Automated Job Hazards Analysis was written identifying the potential shock hazard when using the AZTEC chargers. The work package was also modified to include a step that directs the Instrument Technician to check the battery charger with a voltmeter before connecting it to the leakage tester. Additional information about this incident is available on the [Lessons-Learned](#) website (SELLS Identifier 2004-RL-HNF-0018).

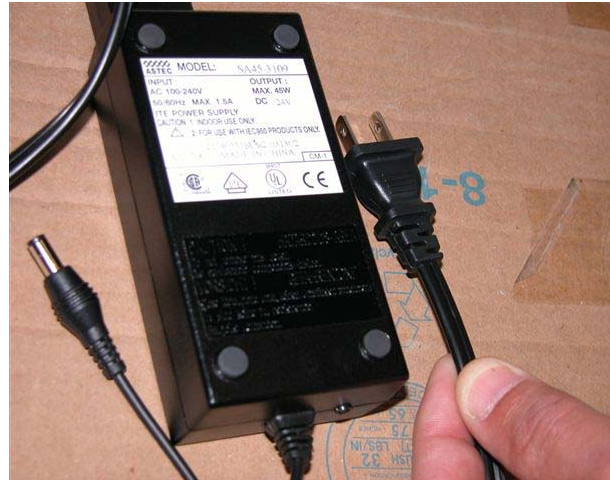
On April 6, 2004, at the Hanford Site, an engineer replacing batteries in a leakage tester felt a slight “hair-raising” sensation on his arm and asked an instrument technician to perform a voltage check to verify whether there was an electrical problem. The AZTEC battery charging unit he was using was plugged into 110 VAC and connected to the leak detector to charge newly replaced batteries. An instrument technician performed a voltage check on the metal case of the tester and found that the voltage measured 63 VAC across the case to the ground. Investigators determined that the AZTEC battery charger was the source of the voltage. (ORPS RL--PHMC-PFP-2004-0006)

Figure 1-2. Model SA 45-3109 Battery Charger

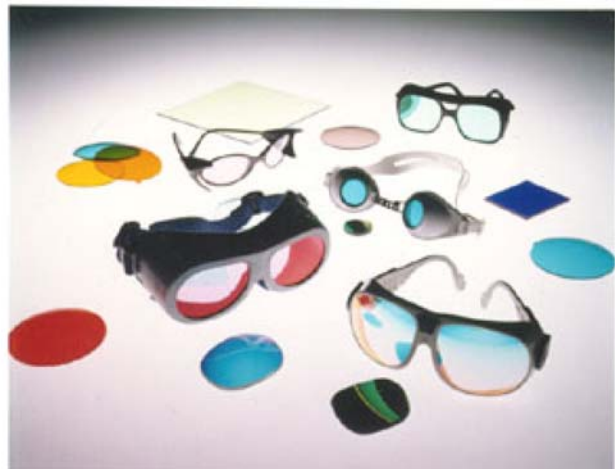
The student was not wearing protective eyewear (Figure 2-1), and the beam was reflected into both eyes, causing blurry vision and white spots. The student has regained 20/20 vision in one eye with corrective lenses, which he also wore before the

Figure 2-1. Protective eyewear

Even when accessible radiation levels are considered to be safe, it is a good practice for laser personnel to wear eye protection when lasers are in use. Prescription eyewear should also be provided for those who need it. This eyewear is issued to one individual user, based on a current prescription (no older than 1 year).

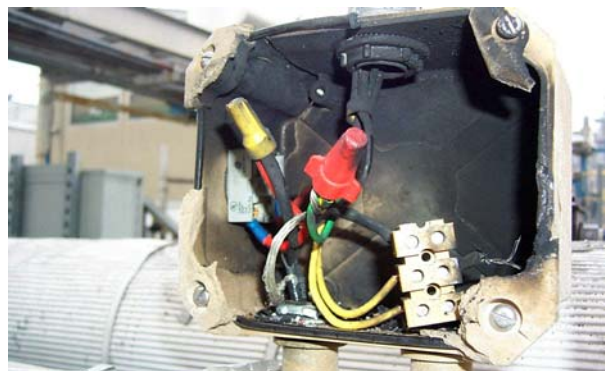
Figure 3-1 shows the junction box after the cover burst. When maintenance workers inspected the junction box and removed the piping insulation from the box to the power source, they determined that the heat trace had been installed

Figure 3-1. Junction box after the incident

correctly with aluminum tape over the heating cable running the length of the pipe. However, they saw one section of pipe where the heat trace had been burned.

Because they found no evidence of a short circuit, and the 20-amp circuit breaker did not trip, the maintenance workers believe that moisture entered the copper bus wire causing a ground fault in the heat trace line that spread the entire length of the heat trace, following the wiring to the next junction box. As the junction box overheated, the pressure of gases within the box caused it to burst and the electrical junction to

These events illustrate the necessity of ensuring that all heat trace systems are installed properly and in accordance with NEC requirements. The required ground fault protection should be provided for all heat trace systems and is essential when the systems will be used for moist or wet service.

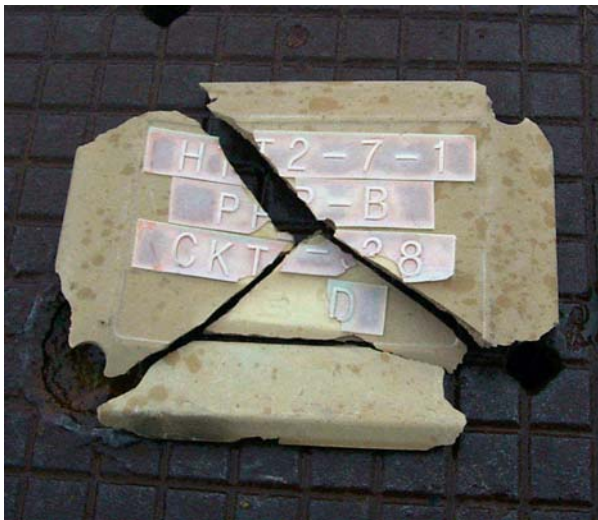
Figure 3-2. Shattered junction box cover

arc and fail. Figure 3-2 shows the pieces of the cover after workers retrieved them. Investigators determined that the most likely cause of the incident was the lack of ground fault protection for the heat trace. The system was installed in the mid-1980s under an electrical code that did not require ground fault protection. However, the current National Electrical Code® (NEC) requires ground fault protection, and newer maintenance manuals for the system recommend it when the power source will be exposed to moisture or water. Ground fault protectors will be installed on all heat trace systems currently in use at the site. More information and additional photographs on this event are available from the [Lessons-Learned](#) website (SELLS identifier Y-2004-OR-BJCBOP-0301).
