# OPERATING EXPERIENCE SUMMARY

**U.S. Department of Energy**  
**Office of Environment, Safety and Health**  
OE Summary 2004-08  
April 19, 2004

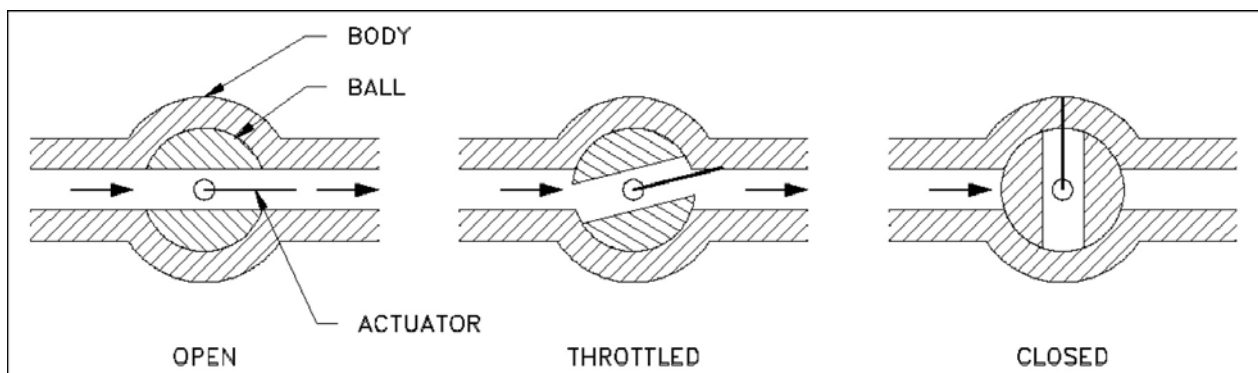
**Figure 1-1. Graphic of ball valve operation showing position of handle (actuator)**

The inlet valves to the ion exchange modules are ball valves, which typically rotate 90 degrees from full closed to full open. The valves installed in this system have an unusual configuration in that the valve handle is in-line with the pipe when the valve is closed. This is the opposite of normal convention, so when the operators looked at the valves, they appeared to be open.

The handle on the ball valves has a position indicator, but it must be viewed up close to be seen clearly. Investigators believe that the operators looked down at the valves from a catwalk and assumed the valves were in the open position based on normal valve convention. The operators involved in this event had not performed this operation in some time and were not familiar with the valve handle configuration on these modules.

DOE-HDBK-1018/2-93, *DOE Fundamentals Handbook, Mechanical Science, Volume 2 of 2*, states that most ball valves are equipped with stops that permit only a 90-degree rotation because that is all that is required to fully close or open the valve. The handle indicates valve position. When the handle lies along the axis of the valve, the valve is closed. Figure 1-1 is a graphic from the handbook showing ball valve operation with a normally configured operating handle. Some ball valve stems have a groove machined in the top face of the stem that indicates the flow path through the ball. Observation of the groove indicates the position of the port through the ball. The handbook can be accessed at <http://www.eh.doe.gov/techstds/standard/appframe.html>.

Although facility managers continue to review this event, the operating procedure for the ion exchange system will be revised to include a "Caution" that will ensure operators understand the valve operation and handle configuration. Also, operators will attend refresher training that will stress this issue.

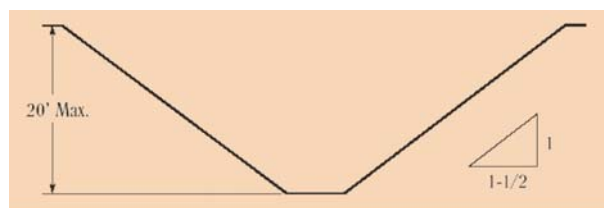
**Figure 2-1. A 1.5:1 slope (34 degrees)**

The trench was about 13 feet deep on one end and 7 feet deep on the other. The slope was estimated to be 1 foot horizontal for every 3 feet vertical (1:3), although Appendix B, *Sloping and Benching*, to OSHA standard 29 CFR 1926, Subpart P, states that the maximum allowable slope for Type C soil is 1.5 feet horizontal to 1 foot vertical (1.5:1). An onsite competent person had previously determined that the soil was Type C.

Table 1 shows the definition for each soil type, as defined in Appendix A to 29 CFR 1926, Subpart P. Table 2 lists the OSHA-required sloping for each type of soil. The allowable slope for Type C soil in trenches 5 feet and deeper is depicted in Figure 2-1. A representation of the 1:3 slope at the Stanford construction site is shown in Figure 2-2 for contrast.

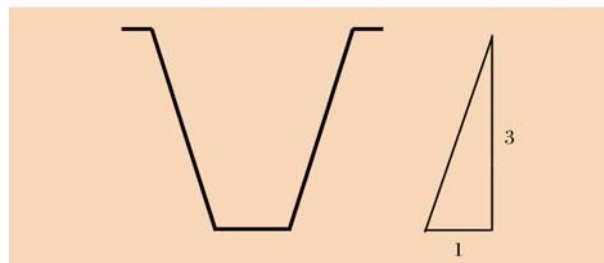
**Figure 2-2. A 1:3 slope**

On February 5, 2004, at the Stanford Linear Accelerator Center, a construction inspector spotted a subcontractor worker standing in an open trench that was inadequately shored and too steeply sloped. The spoil pile of dirt was also too close to the edge of the trench. The construction inspector stopped work and ordered an investigation. (ORPS Report OAK--SU-SLAC-2004-0001)

The safety plan recommended performing the work from above, and the subcontractor’s work plan stated that no workers were allowed in the trench. After the inspector stopped work, safety barriers were placed around the trench and a safety review ensued.

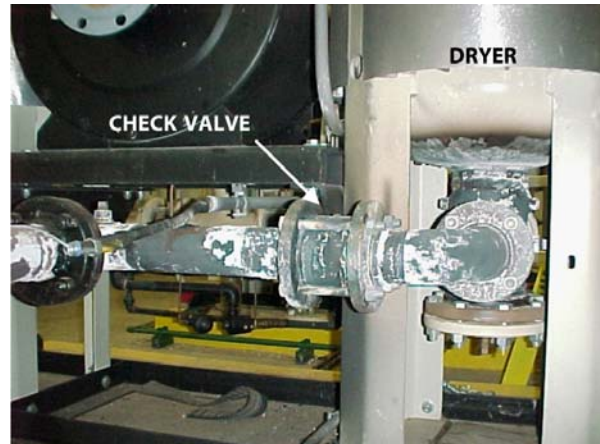
The fire, fueled by oil from the primary air compressor, started within the piping between a heater and the west drying tower of dryer No. 2 (Figure 3-1) during its desiccant regeneration cycle.

*Figure 3-1. Fire-damaged bottom of dryer and piping*

Investigators determined that an equipment problem was the direct cause of this event. Excessive oil traveled from the air compressor and accumulated downstream of the filter, receiver, and separator, which is designed to remove oil from the compressed air. Forced hot air (400°F to 425°F) was sufficient to ignite oil vapors in the piping near the downstream exit of the drying tower, resulting in a brief but hot fire. Investigators identified the following three contributing causes for this event.

1. A lack of procedure resulted in no preventive maintenance being prescribed or performed on the dryers or their associated filters during 3 years of operation. This allowed oil to buildup in the dryer filters, piping, and desiccant tower to go undetected.
2. Inattention to detail by utilities operators resulted in warning signs of problems not being investigated and resolved in a timely manner. These signs included excessive oil consumption by the compressor and dew point temperature alarms. In addition, the filter and separator differential pressure instrumentation never indicated a pressure drop.

- The separator element in the compressor and the filter in dryer No. 1 were replaced.
- Regular preventive maintenance has been established.
- Guidelines for preventing and dealing with utility system problems have been established and distributed to utilities supervisors and system engineers/owners.
- The route sheets for the utilities operators were revised to include the manufacturer’s requirements for system operation and inspection.
- Utilities personnel will lead a management assessment of the commissioning process for new and/or modified utility systems and facilities.

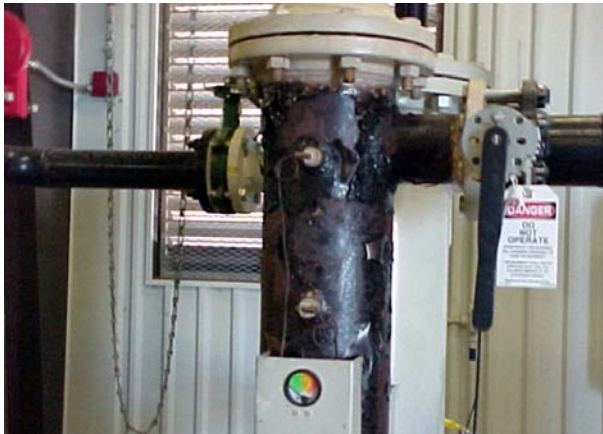
The fire burned from the lower portion of the tower in one direction and traveled through a check valve into the compressed air stream flowing from the east tower. The fire continued to burn through several gaskets in pipe joints and also traveled downstream into a particulate filter (Figure 3-2).

3. Defective or inadequate procedures for post-installation testing and commissioning of the equipment in the year 2000 failed to detect quality problems with system instrumentation. For example, on both dryers, the pressure differential gauge for the particulate filter was installed “backwards,” and an air saver temperature sensor was wired incorrectly. Although this sensor did not directly contribute to the accident, it indicates the ineffective startup testing.

**Figure 3-2. Fire-damaged filter housing**
