OPERATING EXPERIENCE SUMMARY

U.S. Department of Energy
Office of Environment, Safety and Health

OE Summary 2004-09

May 3, 2004

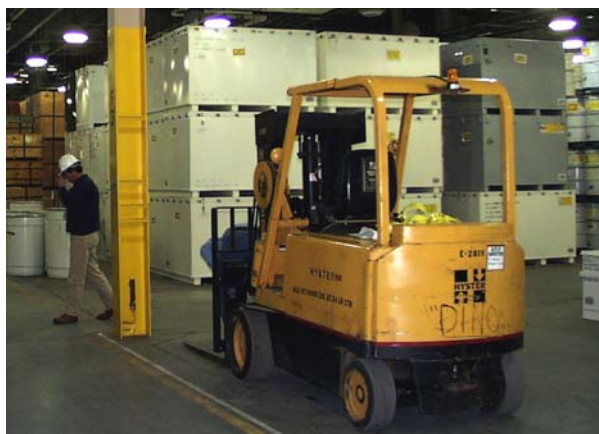
On February 26, 2004, at the Rocky Flats Environmental Technology Site, workers noticed two holes in a metal support column in a building material storage area. The holes were produced by the tines on a large powered industrial truck. Figure 1-1 shows the location of the damaged column. (ORPS Report RFO--KHL- WSTMGTOPS-2004-0005)

Figure 1-1. Location of damaged support column

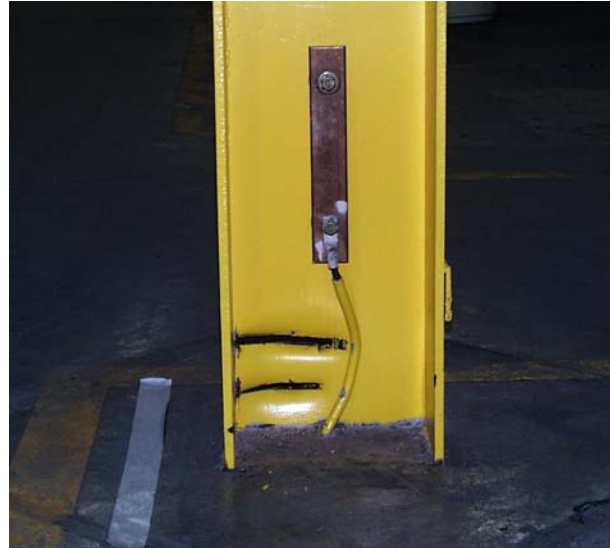
The column is located where the forklifts are parked for recharging. Engineers evaluated the damaged column and determined that there was a 12 percent reduction in the ability of the column to support load. The column will be reinforced. Figure 1-2 shows where the forklift tines penetrated the column. All operators of powered industrial trucks, spotters, and their foremen who work in the storage area were briefed on the incident.

Figure 1-2. Penetration damage from forklift tines

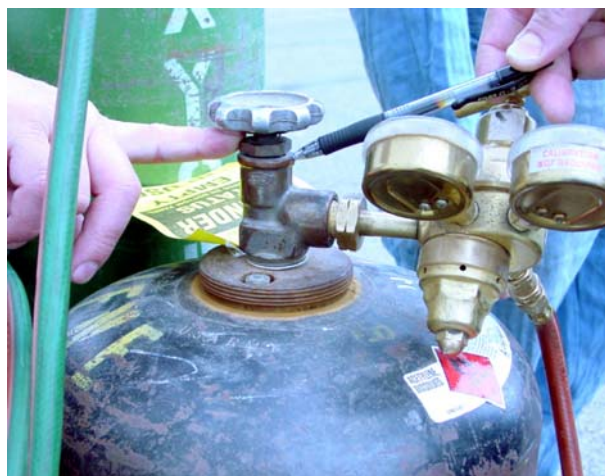
On April 6, 2004, at the Idaho National Engineering and Environmental Laboratory, a craft person observed a small flame near a valve on a cylinder containing acetylene gas. The craft person had just finished using a cart-mounted oxygen-acetylene torch and while closing the isolation valve on the acetylene bottle, felt heat through his glove. He saw a small 1-inch-long flame that appeared to originate from the valve stem and packing nut (see Figure 4-1). The craft person warned others to evacuate the area while he turned the valve handle again to verify the valve was shut. The flame did not immediately extinguish. Firefighters who responded to the incident saw no flames and did not detect any leaks using a flammable gas detector. (ORPS Report ID--BBWI-SMC-2004-0003; final report filed May 18, 2004)

Workers removed the cutting torch cart from the building, capped the acetylene cylinder, and returned the cylinder to the vendor for examination. They also checked other oxygen-acetylene torch systems at the site for leaks, identifying several that were leaking. One cylinder was leaking at the same location (the valve stem packing nut) as the one in the incident; another leaked at the regulator threads. Tightening the packing nut and regulator stopped both leaks. The gas bottle vendor stated that occasional leaks at the packing nut can be expected.

Because of this incident, the site compressed-gas handling procedure will be revised to incorporate a requirement to leak-test flammable gas bottles after installation or changeout. Investigators have not conclusively determined the ignition source. The most probable source is the high pressure (>15 psi) acetylene self-ignited as it escaped from the cylinder, which was at 100 psi. Auto-ignition of escaping acetylene is a known phenomenon and documented in the Material Safety Data Sheet for acetylene.

Figure 4-1. Fire originated between the isolation valve and packing nut
