# OPERATING EXPERIENCE SUMMARY

- *Five lead exposure events reported since the beginning of 2004..... 1*
- *Results of Type B Accident Investigation of worker head injury..... 3*
- *Fatality of lineman from induced voltage results in Type A Accident Investigation..... 5*
- *Ladder fall injuries continue to occur across the complex..... 8*

**U.S. Department of Energy**  
**Office of Environment, Safety and Health**  
OE Summary 2004-21  
November 1, 2004

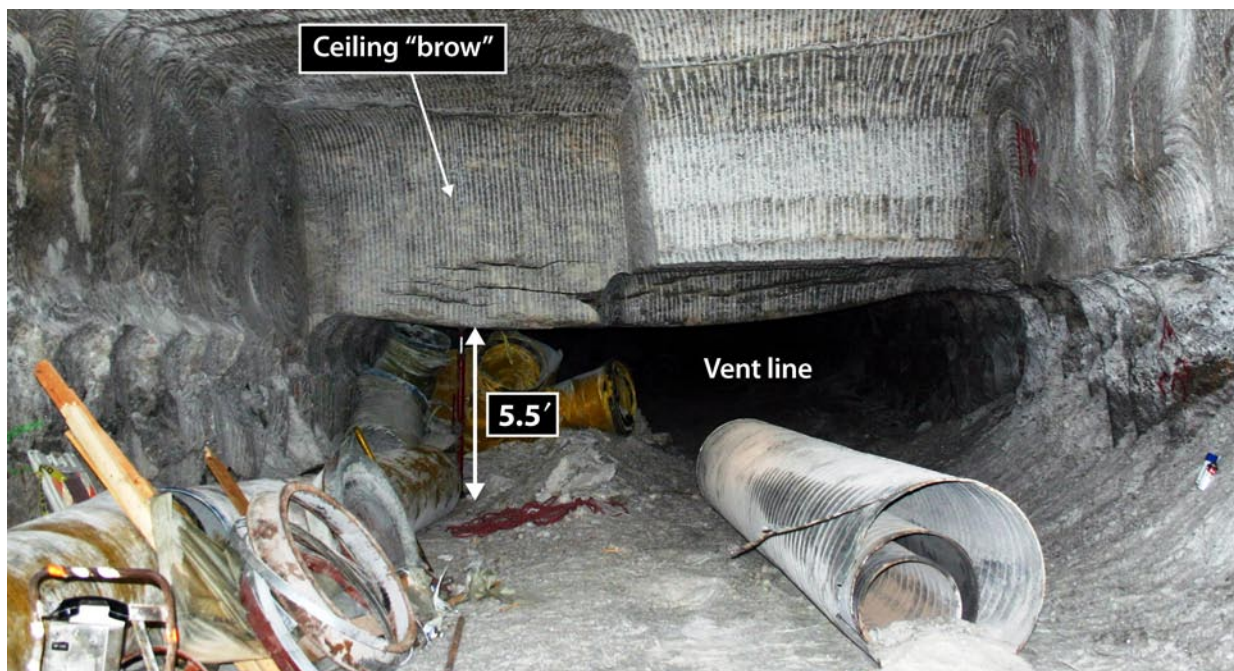
**Figure 2-1. Vent pipe in the drift**

The injured worker was part of a team that was tasked with cleaning out the drift (shown in Figure 2-1), which had been unused for 10 years. The work scope included removing stockpiled muck, ventilating the drift, evaluating and repairing roof beams, and retrieving abandoned materials and equipment.

The work package described hazards from rotating equipment, noise, and ground control, but did not mention moving the vent lines or the

equipment to use. Workers interviewed after the accident stated that they had experience in moving fiberglass vent lines, which are equipped with handles and weigh about 140 pounds, but not in moving metal vent lines, which weigh about 460 pounds.

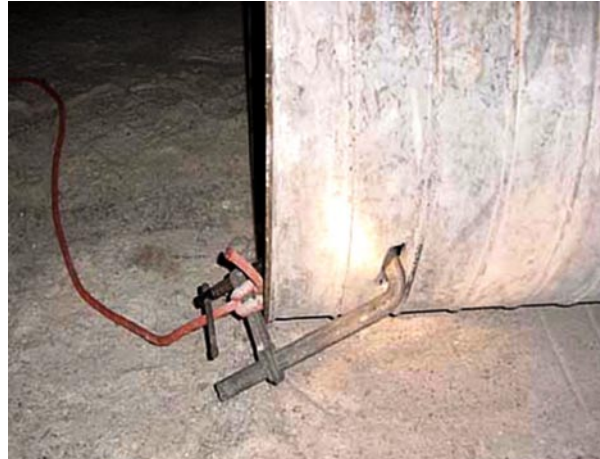
*Figure 2-2. C-clamp attached to vent line*

As the hauler pulled the vent line, one of the workers noticed that the clamp was tearing the line and called to the hauler operator to stop. The operator, however, was moving in reverse and did not see the worker. The 5½-pound C-clamp pulled out of the line with sufficient force to fracture the hard hat and safety glasses of the worker, who was 65 feet away, and to propel the clamp another 85 feet behind him.

The Board concluded that the root causes for this accident were that work planning for moving vent lines was less than adequate and that the workers proceeded to work without the proper tools, equipment, methods, and conditions needed to complete the job safely. Using the root and contributing causal analyses, the Board identified the following Judgments of Need

- Establish a program to provide a formal Person-In-Charge or equivalent to ensure that safe work practices accomplish work package objectives.
- Strengthen the integrated safety management program to identify the scope of work, analyze the hazards, plan, control, and conduct work safely, and effectively address improvement opportunities when developing work packages.
- Better communicate work scopes that involve multiple work groups.
- Focus management attention on identifying hazards and evaluating work performance at the activity level.
- Assess the effectiveness of hazard recognition and accident prevention training.
- Ensure that training requirements comply with 30 CFR 49.8, *Training for Mine Rescue Teams*, as prescribed by MSHA.

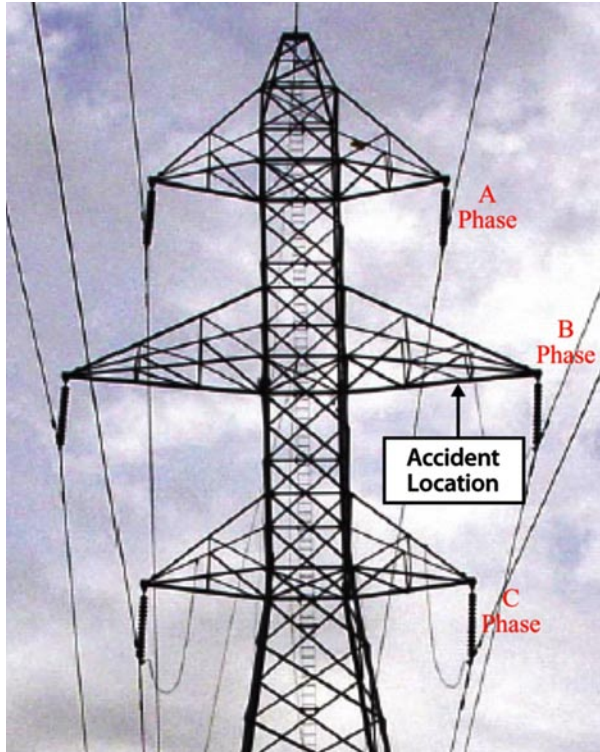
*Figure 3-1. Transmission tower involved in the accident*

The Board determined that removing the cold end of the protective ground while the "hot" end of the ground was still connected to the "A" phase conductor was the direct cause of the accident. This condition placed the apprentice lineman in series with a circuit that was energized by induction. The current on the ground cable was calculated at 1,400 milliamps, well above lethal levels (50 milliamps or greater).

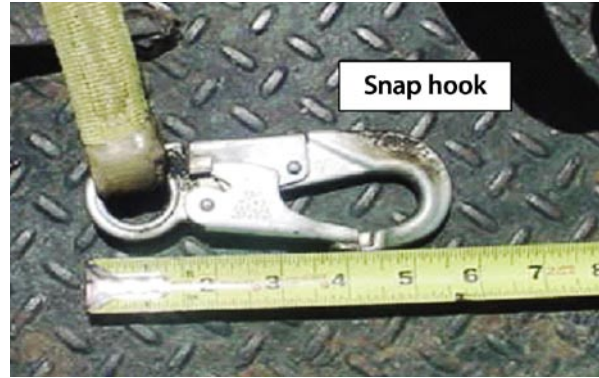
*Figure 3-2. Lanyard snap hook showing burn marks*

The apprentice proceeded to remove grounds without communicating with the journeyman, and he disregarded proper fall protection requirements by using the lanyard snap hook as a tool to remove the ground end.

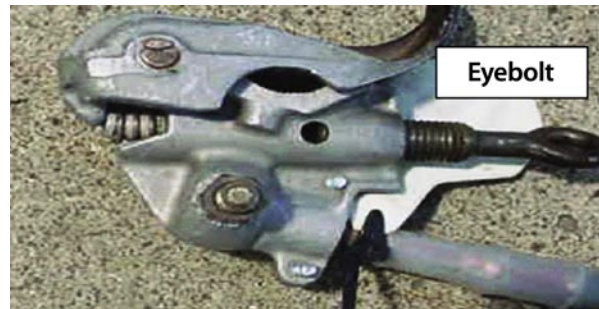
*Figure 3-3. "Cold-end" clamp of the ground cable that was attached to the tower*

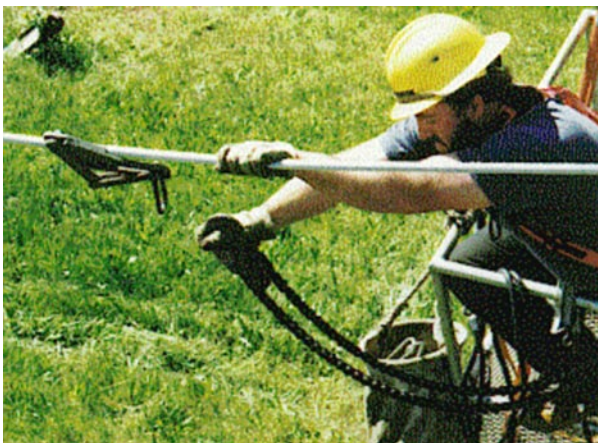
A similar event occurred on April 25, 1997, when a Bonneville Power Authority subcontract lineman was electrocuted when he came in direct contact with a de-energized 230-kV transmission line conductor that contained induced voltage. A 287-kV line operating at 300 kV ran parallel to the line on which the fatal accident occurred. Accident investigators determined that the conductor may have had an induced voltage of 4 kV from coupling with the energized line. When the lineman attached the ground to the conductor, over 125 milliamps flowed through his body. The accident occurred while the lineman was attempting to remove a gripper from the conductor while standing in a lift basket. A reenactment of the accident is shown in Figure 3-4.

Investigators found that the portable protective grounds were not properly secured at the ground clamp end and that the lineman's

*Figure 3-4. Reenactment of lineman removing gripper from conductor*

personal ground may not have been in place. They also found no evidence that the lineman had been trained on parallel line induction and other hazards associated with high-voltage transmission lines.
