# OPERATING EXPERIENCE SUMMARY

**U.S. Department of Energy**  
**Office of Environment, Safety and Health**  
OE Summary 2004-22  
November 15, 2004

### 1. REBAR CURTAIN COLLAPSE RESULTS IN NEAR-MISS EVENT

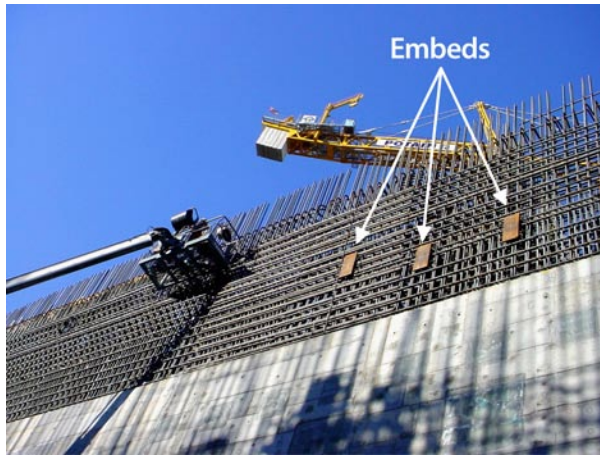
*Figure 1-1. Splice curtain*

The splice curtain consisted of 2 vertical bars of #5 size (0.625-inch diameter) and 18 rows of #11 size (1.41-inch diameter) horizontal bar pairs. Before the incident, ironworkers had positioned the splice curtain into place, secured enough horizontal bars to release the tower crane, and started work on a second curtain. The workers set the second curtain and took a short rest break. When they returned to work, they began repositioning the upper bars to correct a misalignment in the curtain by removing the tie wires to the #5 vertical bars. After the workers removed several of the ties, the weight from the #11 bars caused the lower portion of the splice curtain to fall to the ground.

Investigators determined that the crew foreman deviated from standard work practices. He directed the crew to tie off every fourth bar to expedite the work and had them change the tying direction from bottom-up to top-down. Both of these deviations led to the rebar curtain's collapsing.

Work stopped, and workers secured the area and notified BNI managers, who initiated an investigation. BNI management also ordered

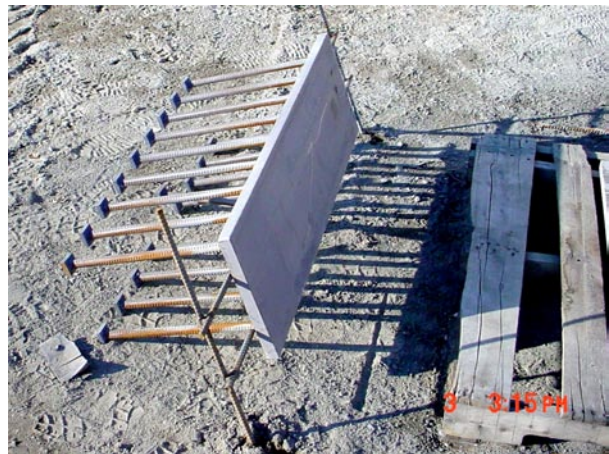
*Figure 1-2. Embed*

A similar near-miss event occurred at the WTP construction site 5 days later. On June 22, 2004, a 100-pound embed (Figure 1-2) fell approximately 45 feet as carpenters removed a concrete wall-form panel. The carpenters had removed the bolts securing an embed that was located just above the concrete placement level of a wall. As they pulled the form away from the wall, the embed slid down between the form and the wall and fell onto a scissor lift. No one was injured, but the embed landed about 8 feet from a carpenter who was standing on the opposite side of the scissor lift. (ORPS Report RP--BNRP-RPPWTP-2004-0010; final report filed August 5, 2004)

Workers secured the area and notified BNI management. The ensuing investigation revealed that the placement height of the concrete wall had changed from 56 feet to 50 feet; as a result, some embeds were positioned above the pour level and were not attached. No one checked to see that these embeds were secure. When the carpenters removed the bolts holding the embeds to the concrete form,

they did not realize that some embeds were unattached.

- Superintendents should discuss significant changes in work scope with crews, safety representatives, and field engineering to identify and analyze new hazards and to develop controls.
- Construction personnel should develop a multidisciplinary checklist of items that must be verified prior to stripping formwork, such as inspecting for loose items between the forms above the pour line.
- All personnel should be actively involved in identifying hazards that could arise from changed work environments or task conditions.
- Management should review and establish acceptable superintendent-to-craft ratios.

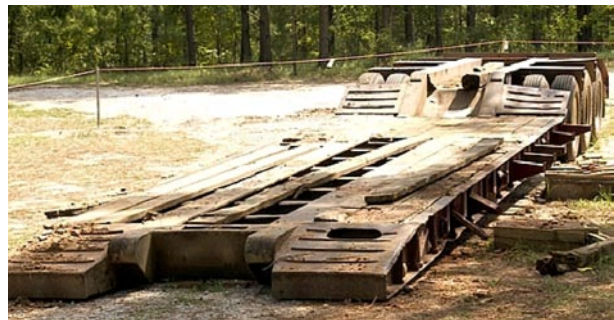
**Figure 2-1. Lowboy trailer after removing excavator**

Upon arrival at the Pond B Dam, the truck driver parked the lowboy trailer (Figure 2-1) near the excavator, and the teamster drove the excavator onto the lowboy. Although the teamster was not qualified to operate the excavator and had not been assigned to move it, he stated in a post-accident interview that he drove the excavator onto the lowboy as a courtesy to the truck driver.

The teamster stated that the truck driver told him that the outrigger plank on the driver's side of the lowboy was cocked and needed to be repositioned. The driver asked the teamster to use the excavator boom to pick up the tracks on that side so he could reposition the outrigger plank. The teamster raised the excavator boom and swung it about 90 degrees to the right so

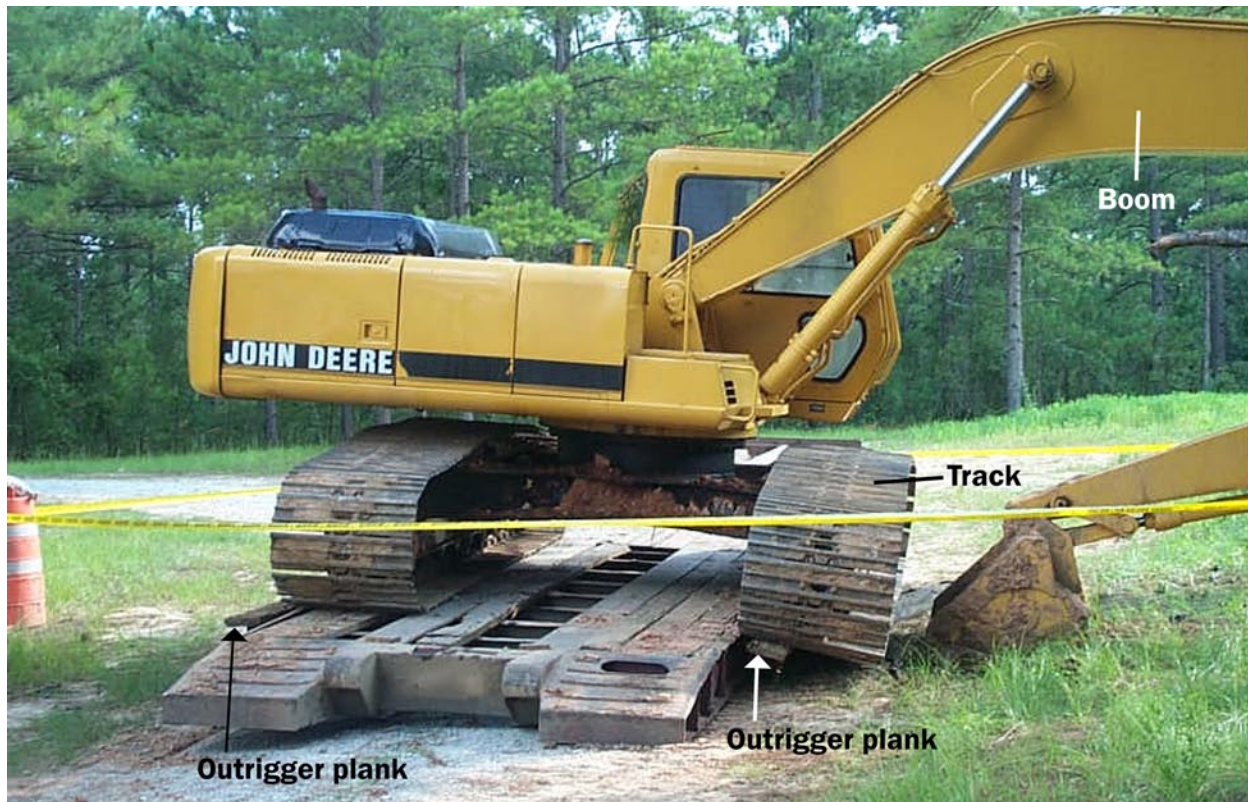
*Figure 2-2. The accident scene*

The teamster's foreman, upon arriving at the accident scene (Figure 2-2), determined that the truck driver needed an ambulance and called the excavating company's onsite office via cell phone. The onsite company office in turn contacted the Savannah River Site Emergency Duty Officer and informed him that an accident had occurred that required medical assistance.

- The driver was working under or near the excavator.
- The teamster was not qualified to operate the excavator.
- The subcontractor excavating company failed to exercise control over its employee and vendor.
- Stop-work authority was not effectively utilized.

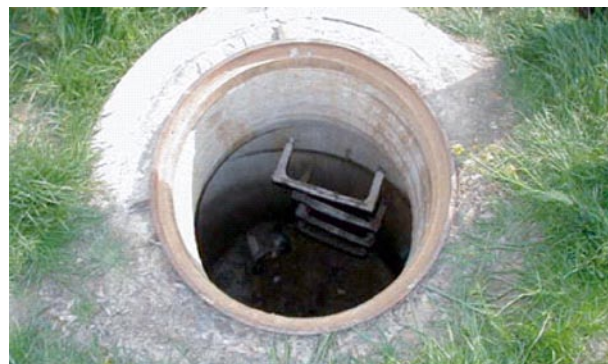
to a hospital. The engineer had opened the manhole cover with a pickaxe and used a metal wire hook in an attempt to retrieve the flow meter, which was attached to a built-in ladder rung about 3 feet below the manhole opening. The meter slipped off the hook and fell more than 7 feet to the bottom of the hole. The engineer’s response was automatic — and fatal. He quickly descended, picked up the fallen flow meter, placed it on the top rung, and began to ascend, but lost consciousness and collapsed. Figure 4-1 shows the manhole where the fatality occurred.

*Figure 4-1. Landfill manhole where fatality occurred*

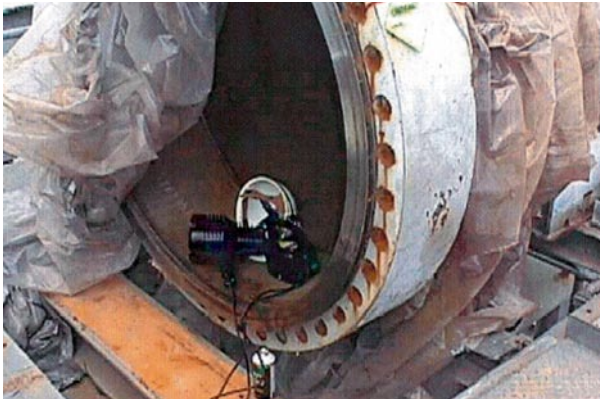
In March 1998, a worker at a Union Carbide plant was asphyxiated while inspecting the inside of a 48-inch-diameter pipe (Figure 4-2). The pipe, which contained nitrogen for moisture control, was not identified as a confined space.

*Figure 4-2. Pipe in which worker was asphyxiated*
