National Aeronautics and
Space Administration

Office of Inspector General
Washington, DC 20546-0001

September 5, 2008

SUBJECT: Final Memorandum on the Review of Rocket Segment Handling (Report No. IG-08-029; Assignment No. S-08-020-00)

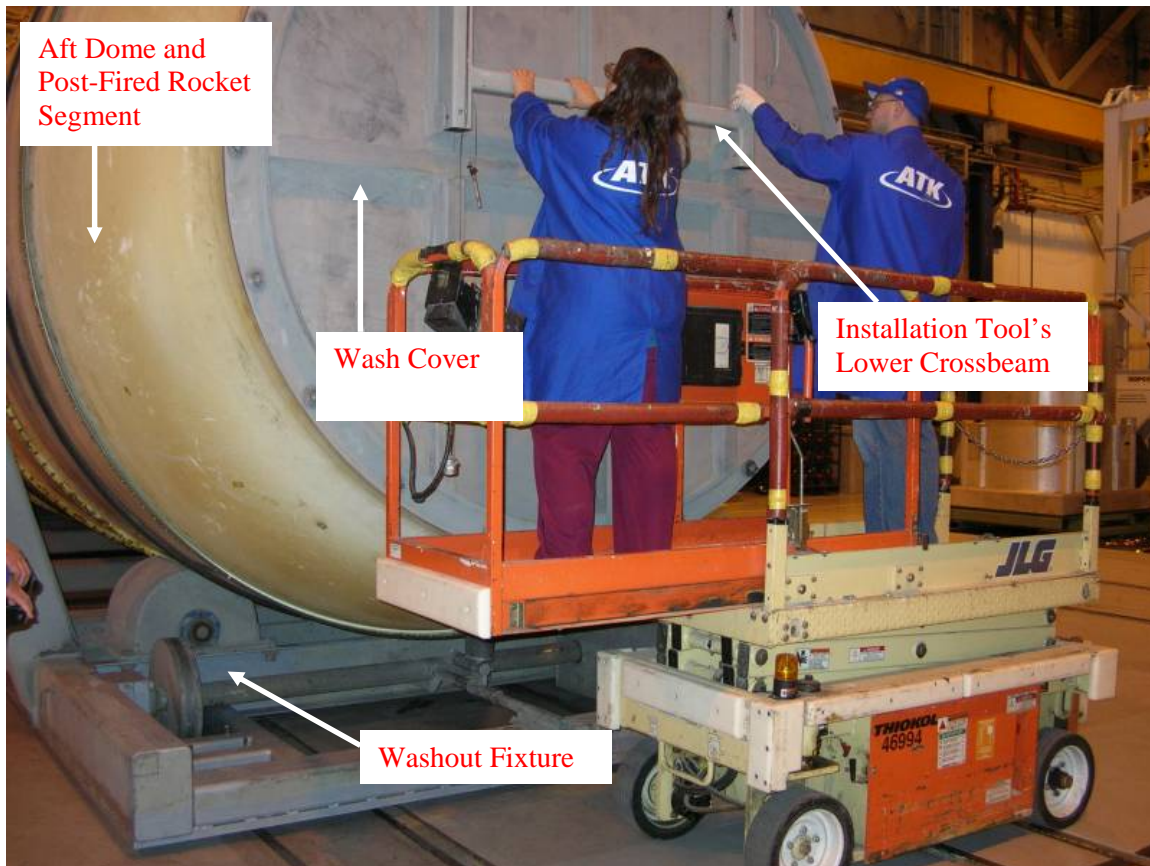
Figure 1. Wash Cover Installation

The complaint we received concerned a simple move on April 8, 2008, of an aft rocket segment, which is an early process stage of program critical hardware (a single part). The purpose of the move was to install a wash cover (see Figure 1). The wash cover is a stainless-steel plate weighing approximately 4,200 pounds and is used in the refurbishment of post-fired rocket segments. Once the wash cover is installed onto the segment, high-pressure water lines are attached and water is flushed through the rocket segment to remove any remnant thermal insulation debris.

The Director also instructed the move crew, in coordination with the handling and safety engineers, to reenact the steps involved in the move and to provide input on how the Clearfield Center could improve the process. Based on this input, ATK management issued a standard work instruction, Form FA-0043-100, "Aft Segment Wash Cover Installation Procedures," May 20, 2008, that provides details on the process for the installation and removal of the wash cover. At the time of the April 8 incident, ATK did not have a standard work instruction for mounting a wash cover onto a rocket segment.

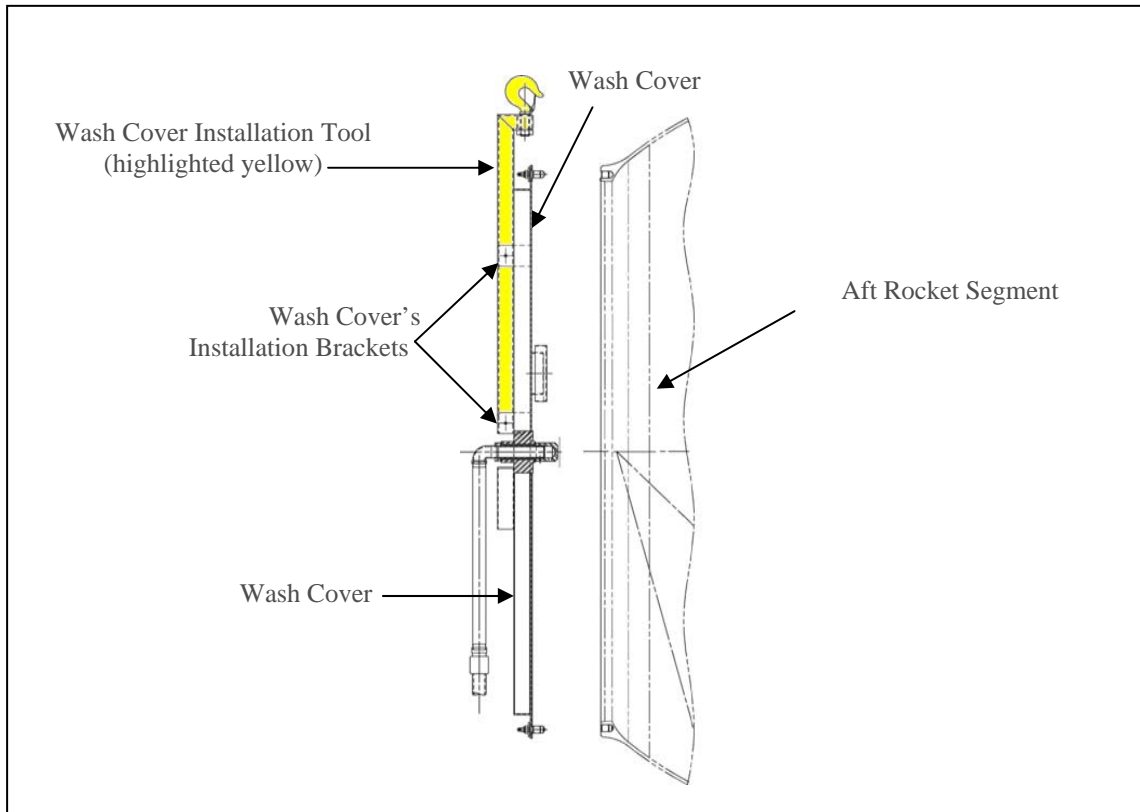
Figure 2. Diagram of Wash Cover Installation Components (Side View)

ATK uses an overhead bridge crane and a three-person move crew for the installation of a wash cover onto a rocket segment, in accordance with ATK Launch Services Group policy.³ See Figures 2 and 3 for side and front views of the installation components. Figure 4 is a close-up that shows the installation tool attached to the wash cover's installation bracket. Installation details from the policy include the following:

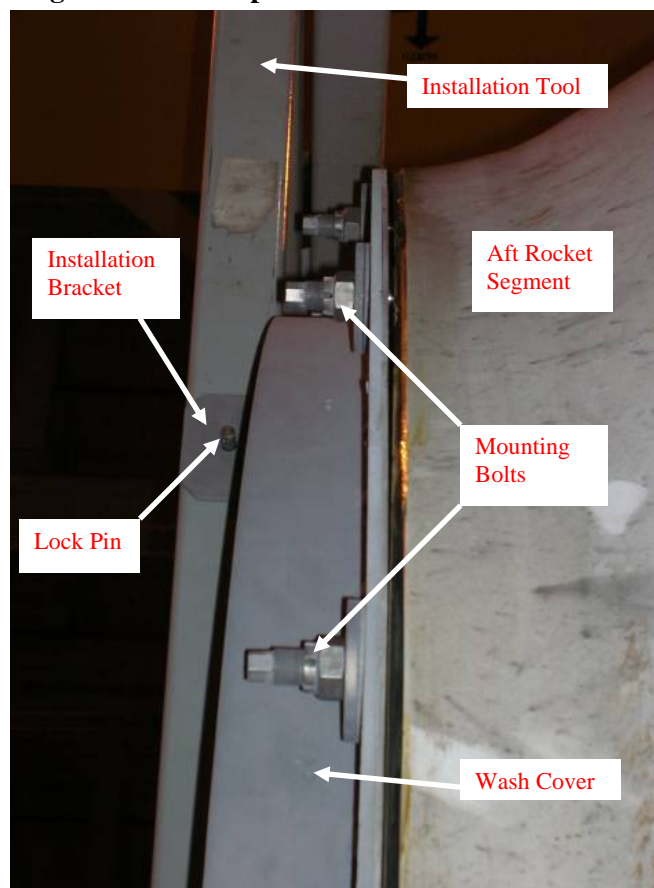
Figure 4. Close-Up View of Mounted Wash Cover

The move crew stopped the operation immediately when “an unusual condition or event” occurred. In this case, the unusual event occurred when the crane operator raised the installation tool. Because the tool had not been moved far enough away from the cover to clear the wash cover’s installation brackets, the lower crossbeam of the installation tool encountered one of the installation brackets. With the lower crossbeam wedged under the bracket, the installation tool was inappropriately poised to bear the combined weight of the cover and the rocket segment, potentially moving the entire assembly and exceeding design parameters of the installation tool, which is designed to accommodate only the weight of the cover. When move crew members observed what was occurring, they immediately halted operations and, after lowering the installation tool to relieve tension on the bracket and to remove any stress on the rocket segment, they notified the crew supervisor.
