# Historic Structure Report

Kaymoor Mine  
New River Gorge  
National River

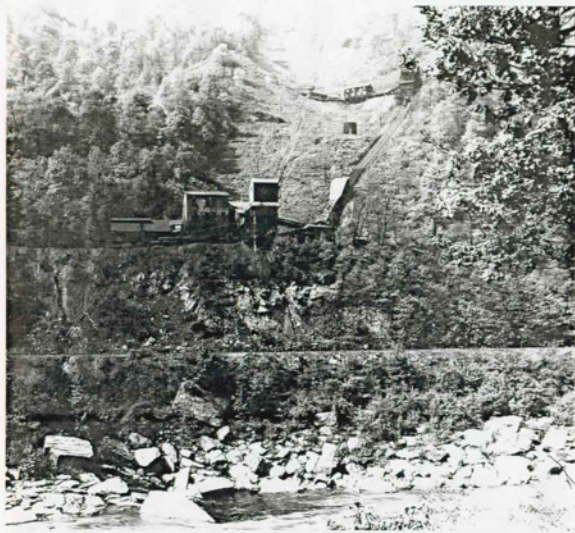
**Figure 6** The Kaymoor No. 1 Mining Complex, 1947, showing the New River, C&O mainline, tipple, conveyor, monitor tracks, headhouse, haulage, and cleared landscape. Photo courtesy of C&O Historical Society Collection, Alderson, WV.

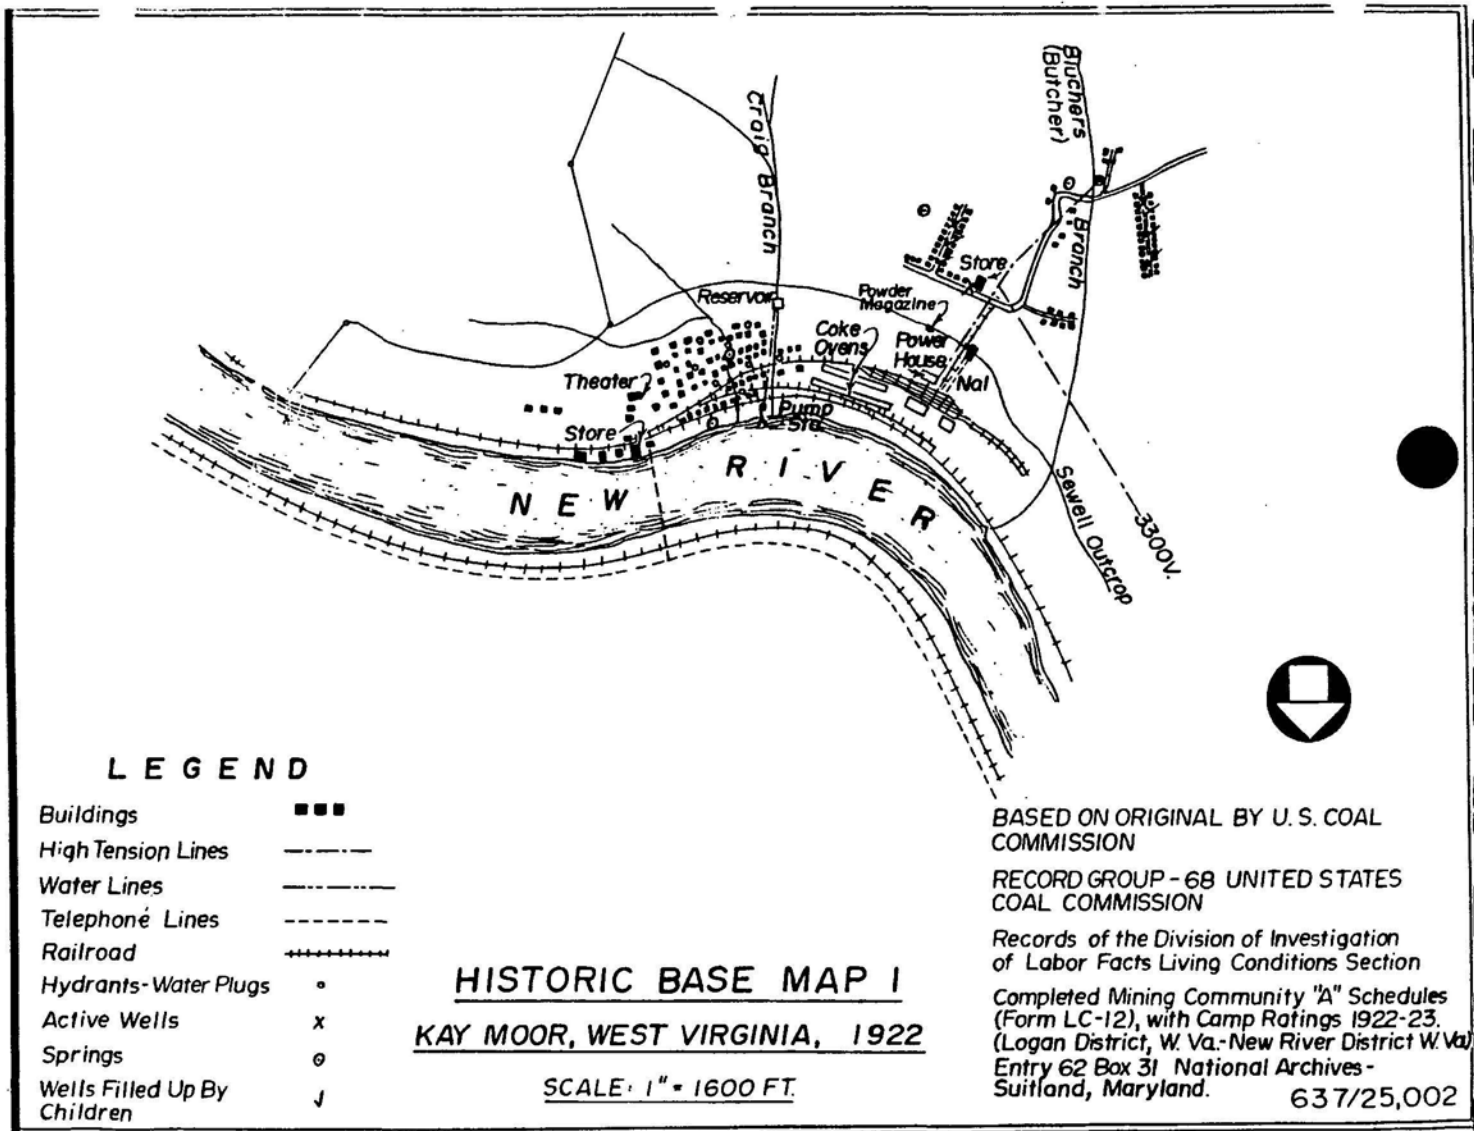
Figure 7 Historical Base Map, Kaymoor, West Virginia, 1922.

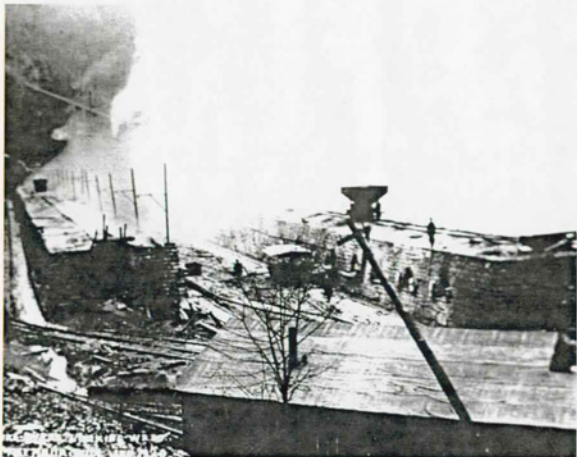
Figure 8 Kaymoor coke over batteries looking westward, January 1920. The lorry is carrying coal to the ovens at right as smoke from the ovens in black obscures the view. Photo courtesy of Wallace Bennet.

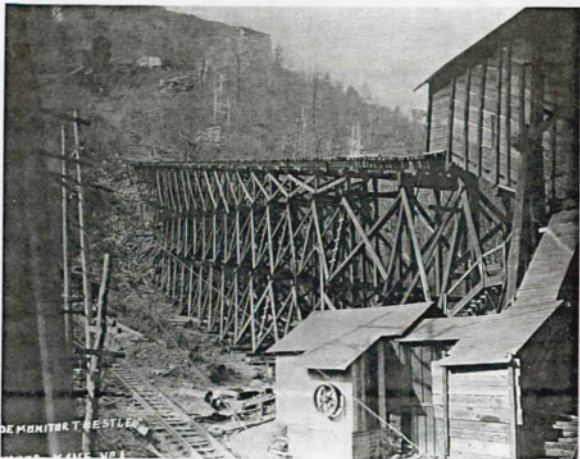
Figure 12 The monitor trestle supported the tracks that ran 1,000 feet from the headhouse (upper left) to the tippie in the right foreground. 1920. Photo by Clyde J. Simpson.

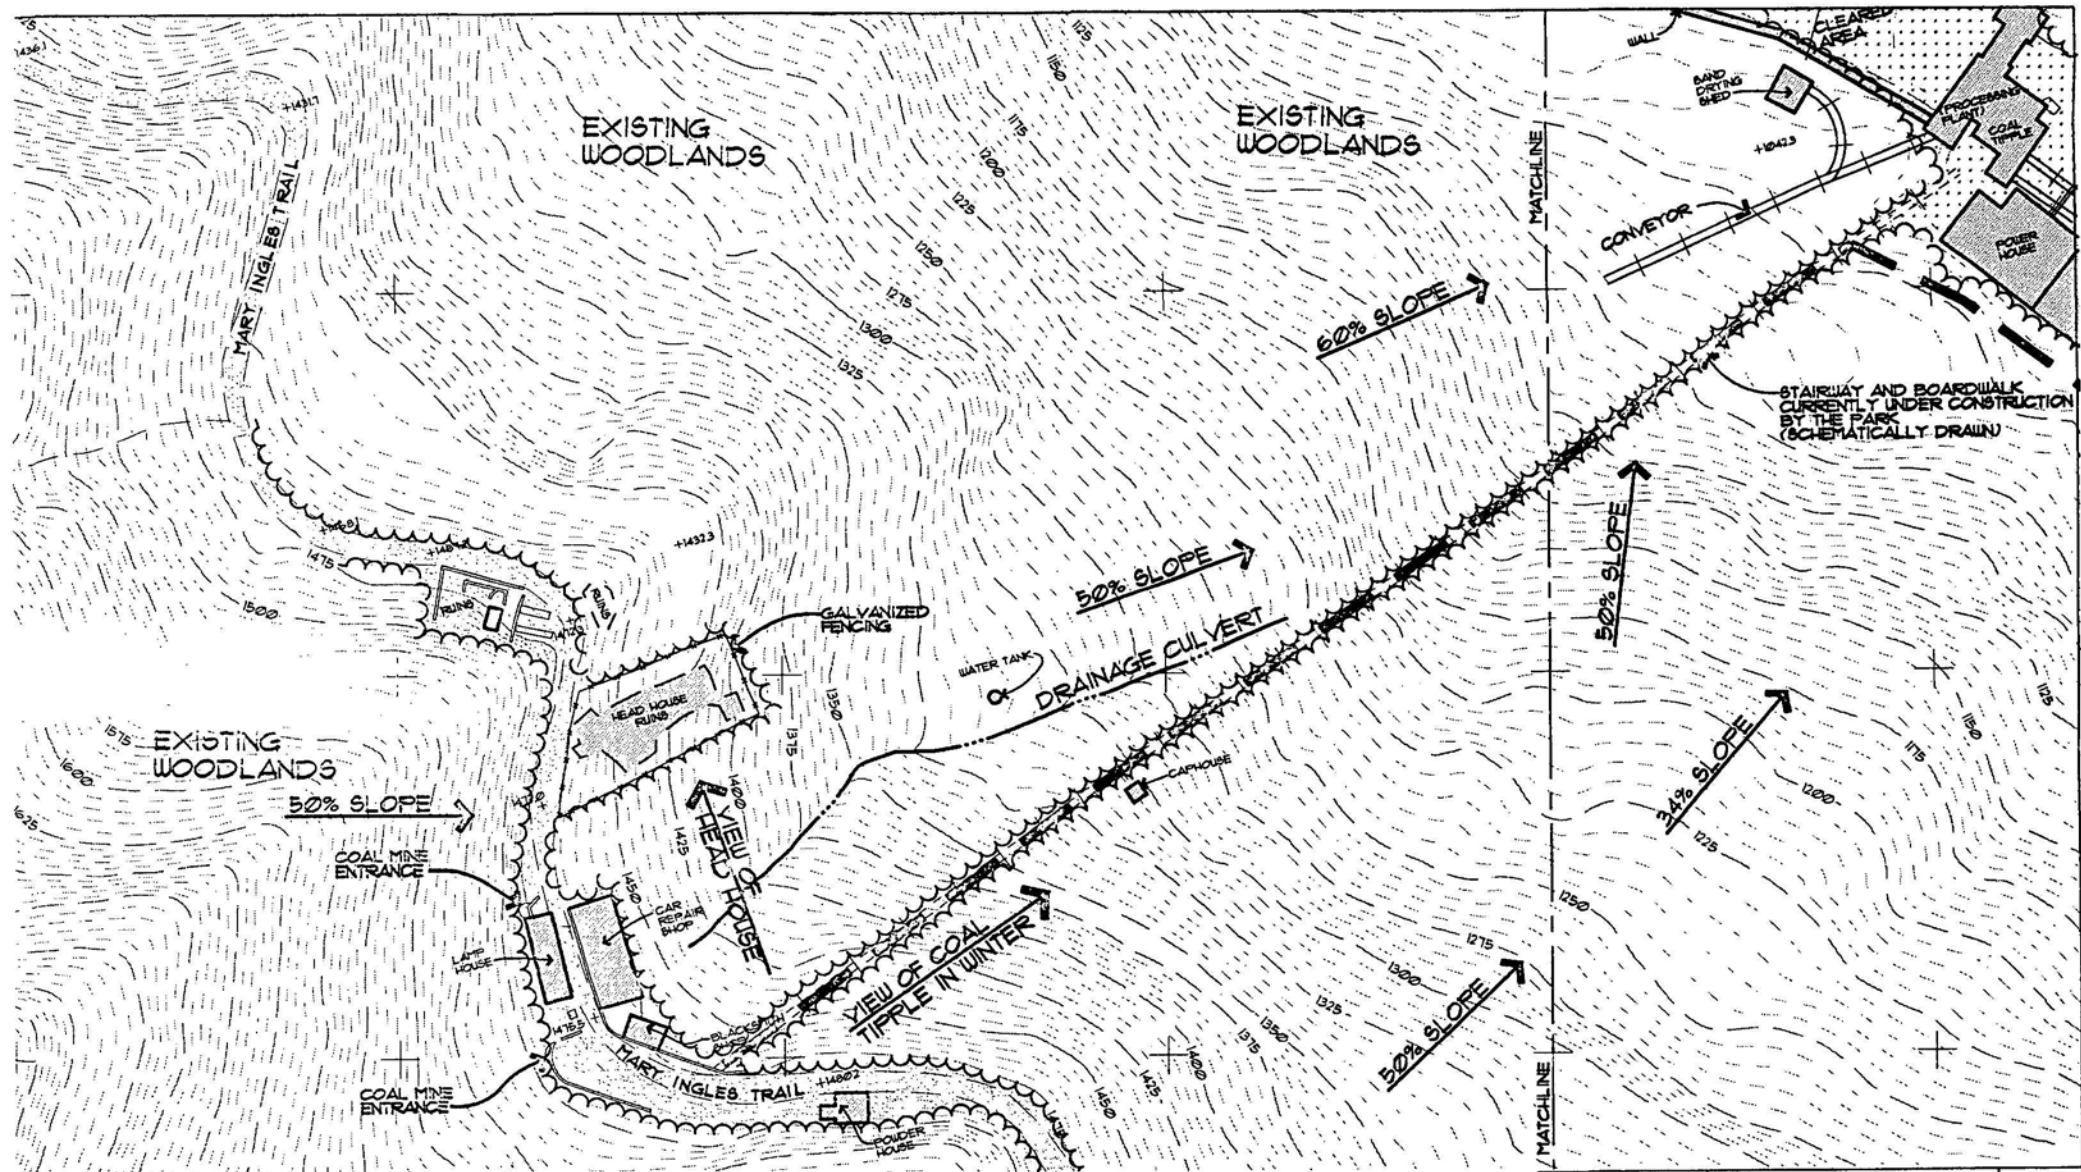
DESIGNED: K. VANCE	SUB SHEET NO.	TITLE OF SHEET <b>SITE ANALYSIS AND EXISTING CONDITIONS</b>	DRAWING NO. <b>637</b>
DRAWN: GREGG LEIDENCKER			<b>20,089</b>
DATE: 1/97		NEW RIVER GORGE NR	PKG. NO. 156
			SHEET 1 OF 1

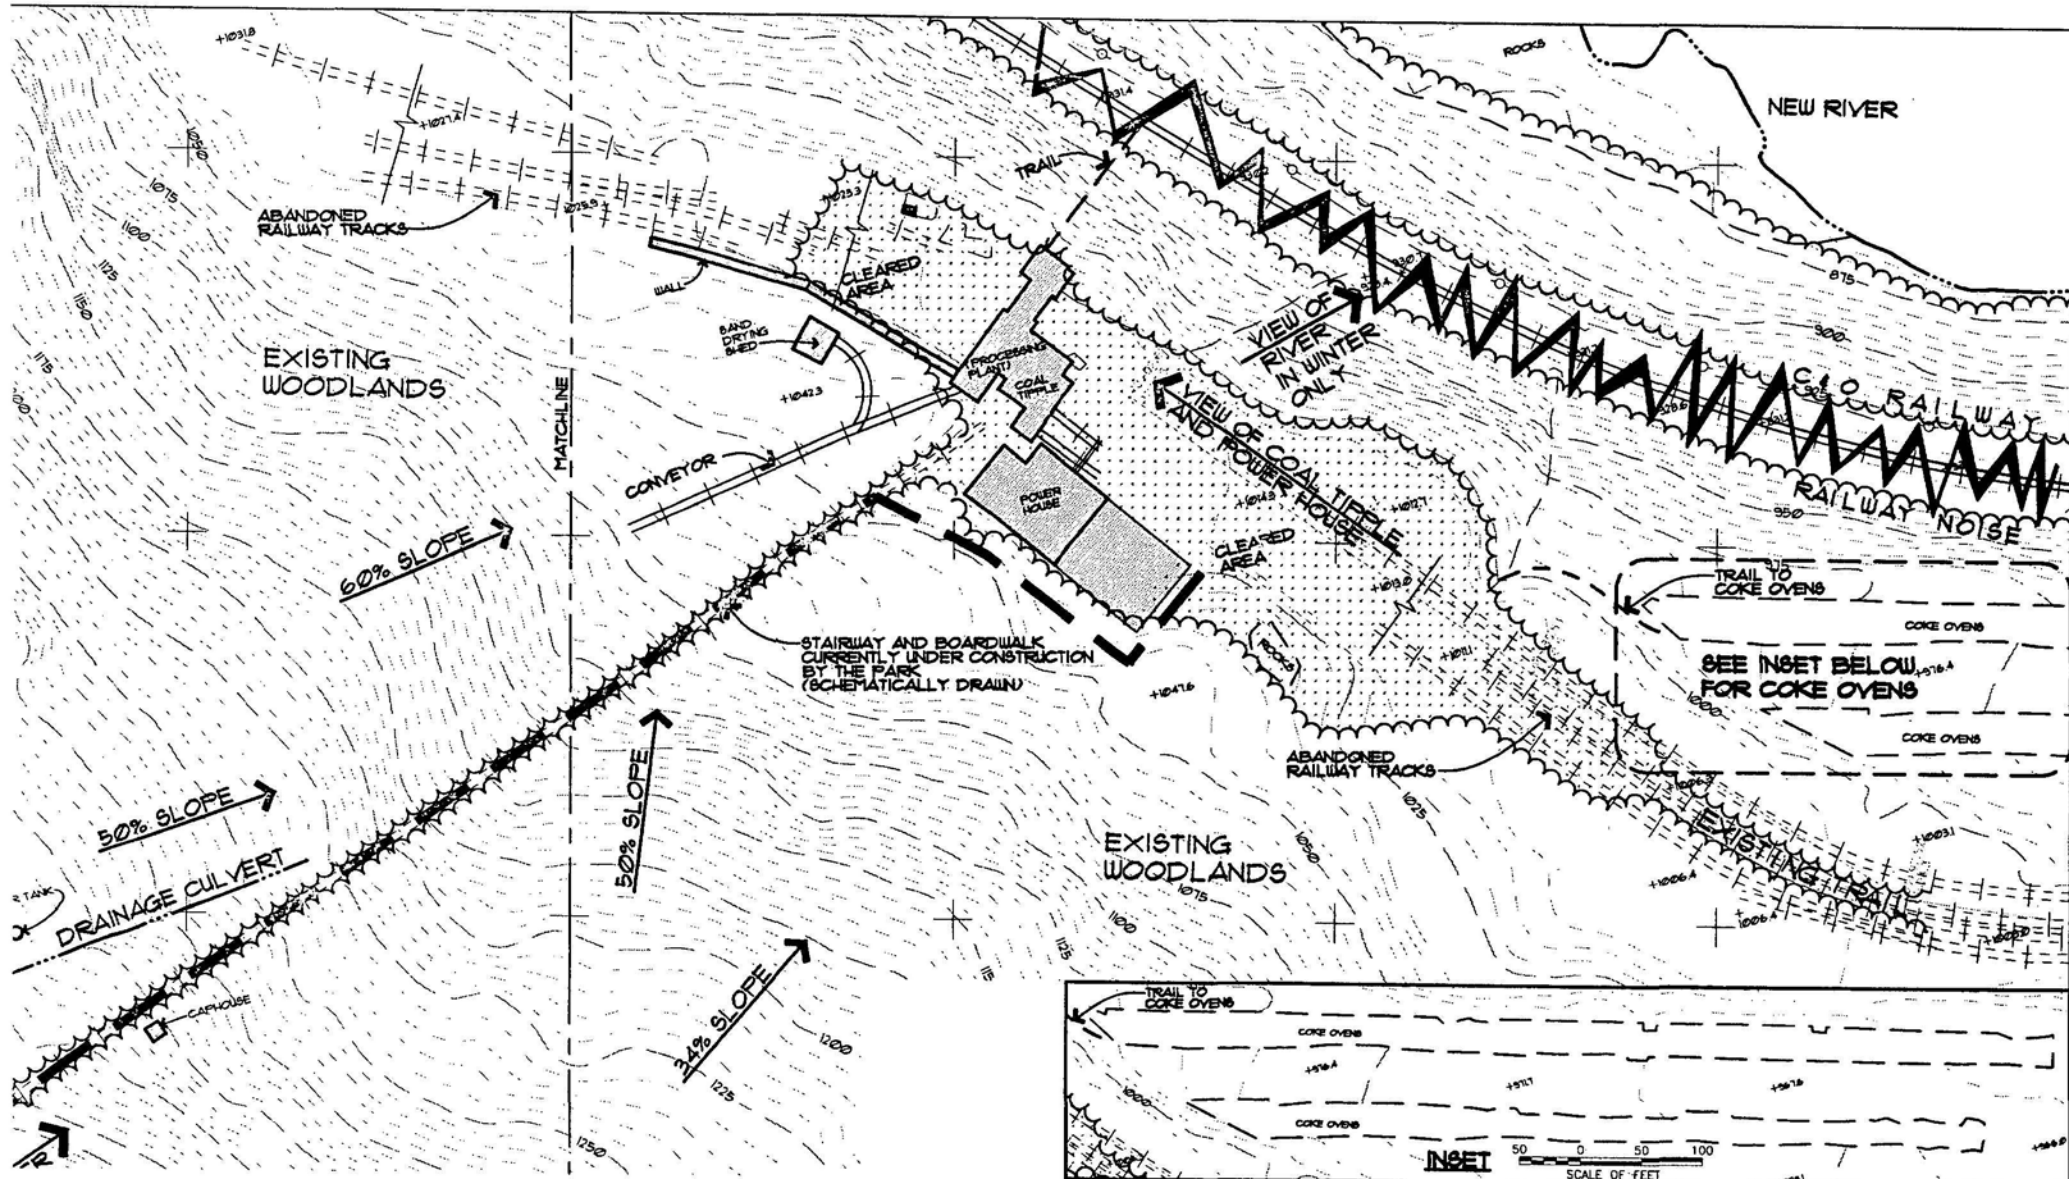
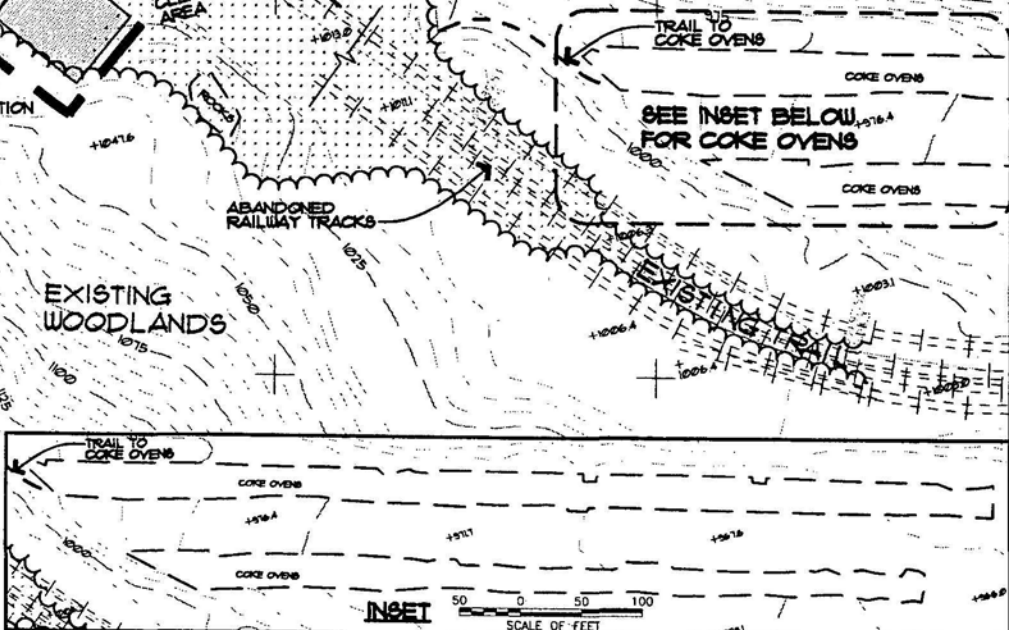
**NOTE**  
 • THIS SURVEY WAS DRAWN FROM AERIALS. A GROUND SURVEY WILL NEED TO BE COMPLETED IF MORE ACCURACY IS REQUIRED FOR FURTHER WORK.

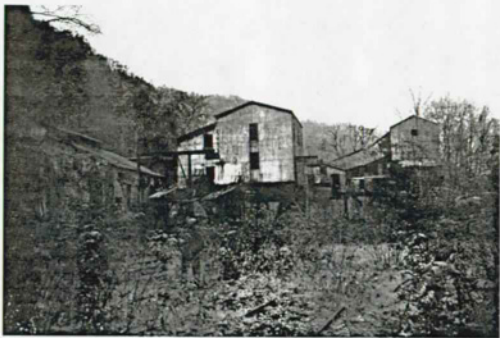
Figure 16 Coal Tiple Existing Condition Photograph. Coal tiple south elevation with powerhouse on the left.

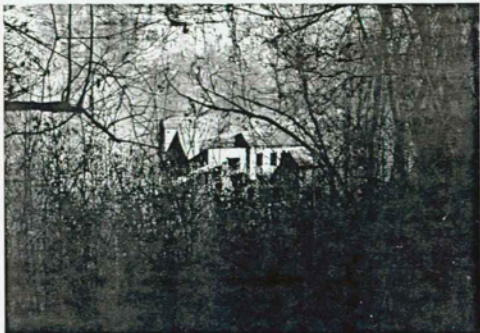
Figure 17 Coal Tipple west elevation. View from uphill on the haulage route.

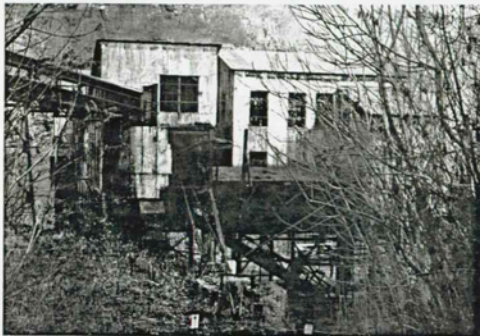
Figure 18 Coal Tipple Existing Condition Photo: West elevation. Rusted roof sheathing and broken windows. Note monitor conveyor at upper left.

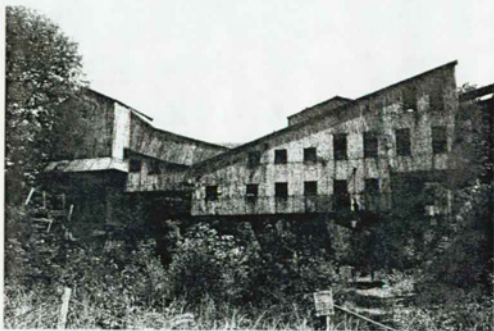
Figure 19 Coal Tipple Existing Condition Photograph: North elevation. July 1996. NPS photo.

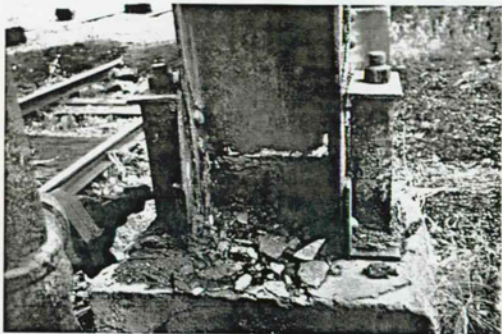
Figure 20 Coal Tipple Existing Condition Structural Detail: Column base showing severe rust and exfoliation of web and connection plates. November 1996. NPS photo.

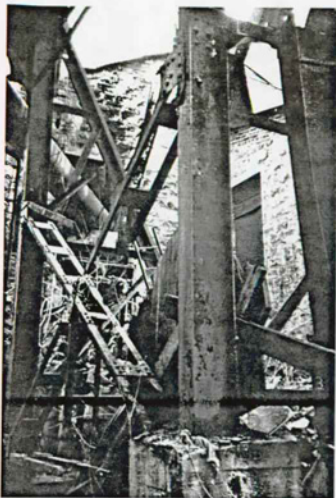
**Figure 21** Coal Tippie Existing Condition Structural Detail: Failed cross-bracing between columns 7A and 8A. Note powerhouse in background.

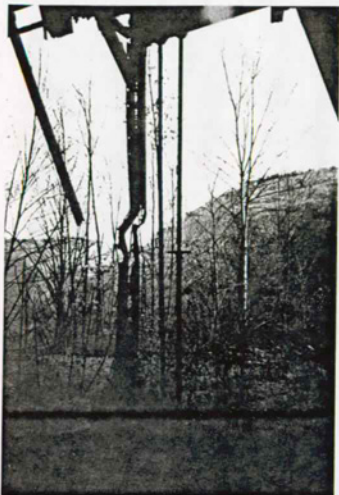
Figure 22 Coal Tippie Existing Condition Structural Detail: Column 4E column failure due to weak axis buckling and broken cross bracing. Two temporary pipe columns to the right. Nov. 1996. NPS photo.

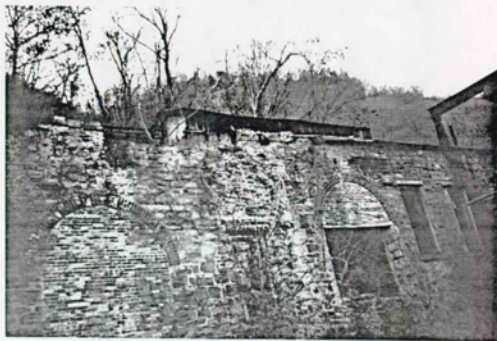
Figure 23 Powerhouse Existing Condition Photo: East elevation. Roof missing over boiler room (to left). November 1996. NPS photo.

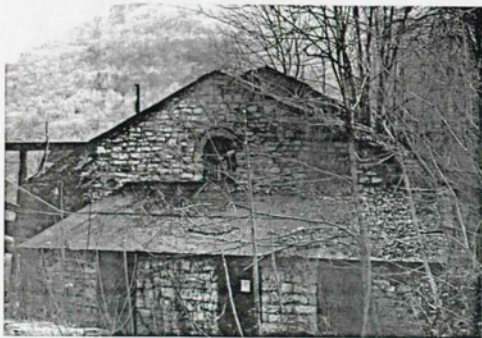
Figure 24 Powerhouse Existing Condition Photo: North elevation. Roof over generator room in the foreground. Nov. 1996. NPS photo.

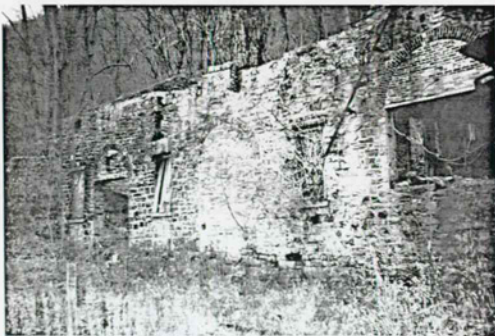
Figure 25 Powerhouse Existing Condition Photo: East elevation of boiler room. Note crumbling upper wall surfaces, brick infill, deteriorated wall base and sill at right. Nov. 1996. NPS photo.

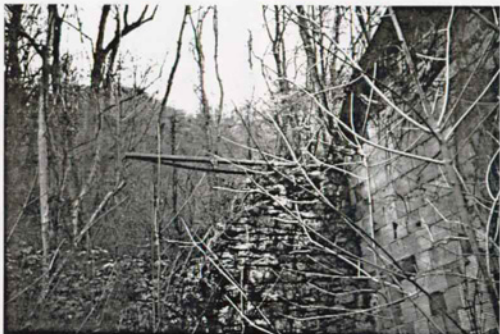
Figure 27 Powerhouse Existing Condition Photo: Structural detail. View from interior of boiler room. Notice lack of roof, missing sections of back wall, and vegetation growing inside the building. Nov. 1996. NPS photo.

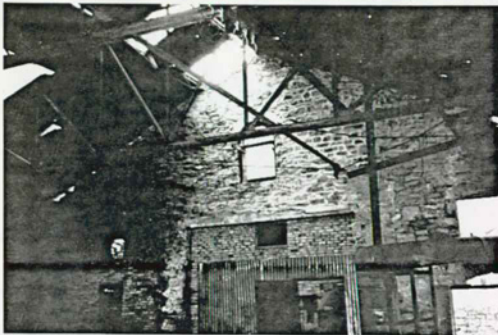
**Figure 28** Powerhouse Existing Condition Photo: Structural detail. Interior of compressor room. Roof damage visible, view towards north. Noted later brick infill at base of wall. Nov. 1996. NPS photo.

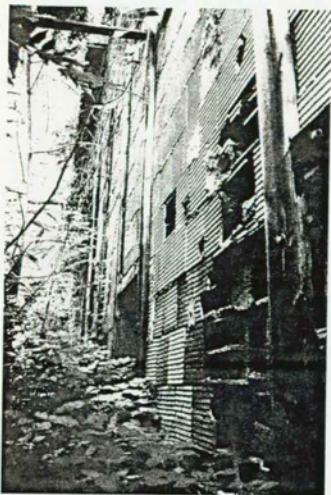
Figure 29 Powerhouse Existing Condition Photo: Structural detail. Hollow clay tile wall between compressor room and old boiler room looking towards building east. July 1996. NPS photo.

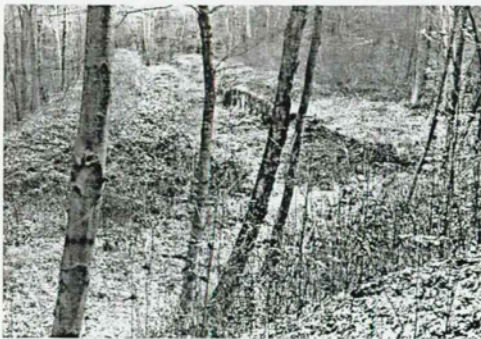
Figure 30 Coke Ovens Existing Condition Photo: Double battery of coke ovens. Vegetation partially cleared in between. July 1996. NPS photo.

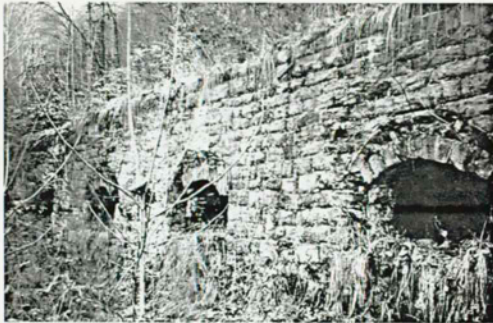
Figure 31 Coke Ovens Existing Condition Photo: Semicircular arched opening with fallen voussoirs. Vegetation and lack of historic oven doors is accelerating arch failure.

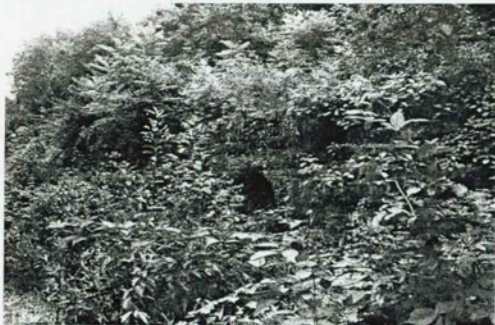
Figure 32 Coke Ovens Existing Condition Photo: Notice arched openings amidst the vegetation. July 1996. NPS photo.

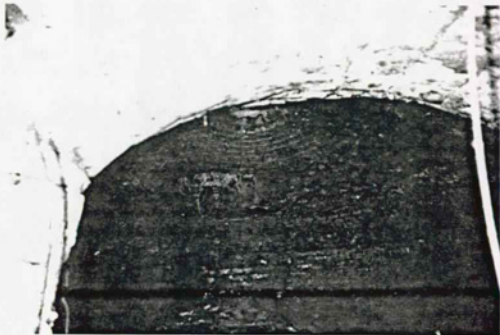
Figure 33 Coke Ovens Existing Condition Photo: Interior of oven, fire brick masonry in beehive dome construction. Notice opening at top of dome. Nov. 1996. NPS photo.

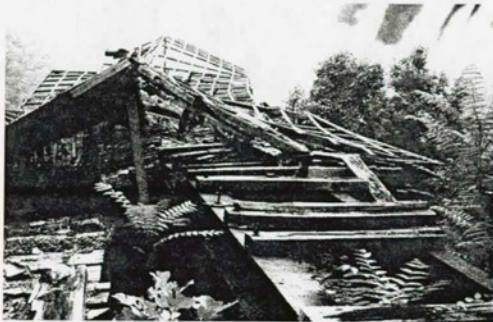
Figure 34 Headhouse Existing Condition Photo: Remains of 1990 stabilization efforts and reroofing.

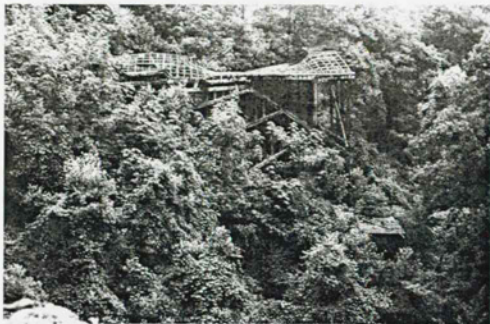
Figure 35 Headhouse existing condition photo: South elevation as viewed from haulage route/ steps. July 1996. NPS photo.

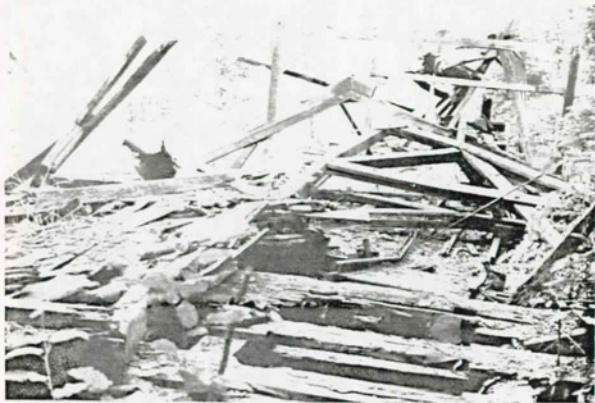
Figure 36 Headhouse Existing Condition Photo: Collapse of roof structure. View toward river. 1986. Photo courtesy of West Virginia University.

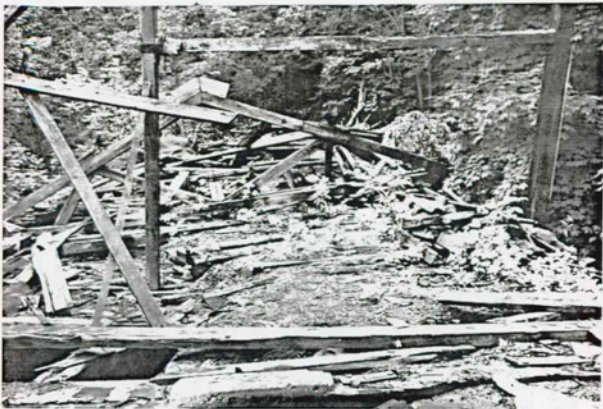
Figure 38 Headhouse Existing Condition Photo: Structural Detail. Collapse of roof structure. View toward mine opening. 1986. Photo courtesy of West Virginia University.

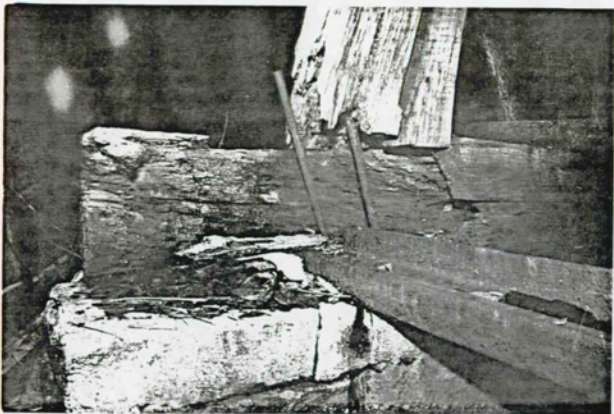
Figure 39 Headhouse Existing Condition Photo: Structural detail. Typical column/sill joint showing severe rotting of members. 1986. Photo courtesy of West Virginia University.

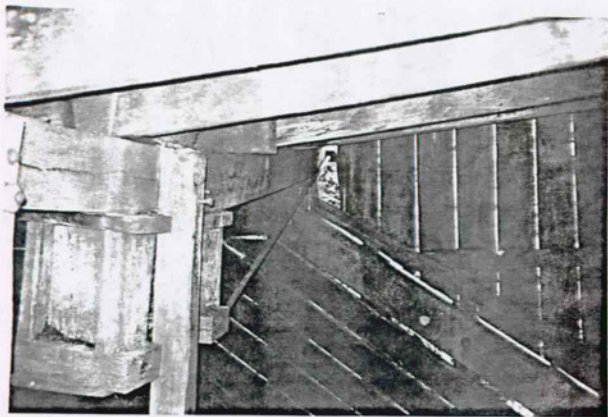
Figure 40 Headhouse Existing Condition Photo: Structural Detail. Failure of interior beam showing excessive deflections. 1986. Photo courtesy of West Virginia University.

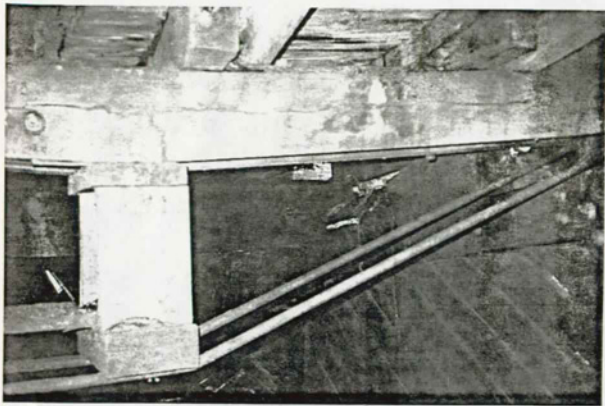
Figure 41 Headhouse Existing Condition Photo: Structural detail of sag rods and beam failure. 1986. Photo courtesy of West Virginia University.

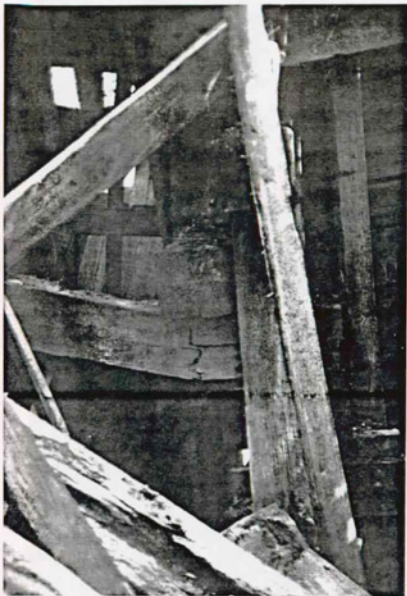
Figure 42 Headhouse Existing Condition Photo: Structural detail. Flexural failure of interior beam on Bent G. 1986. Photo courtesy of West Virginia University.

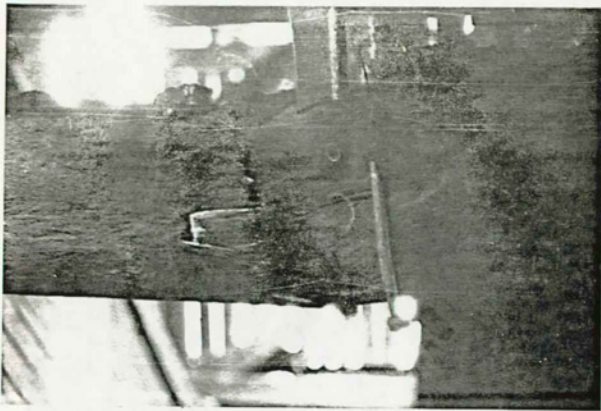
Figure 43 Headhouse Existing Condition Photo: Structural Detail. Flexural failure of interior beam on Bent E. 1986. Photo courtesy of West Virginia University.

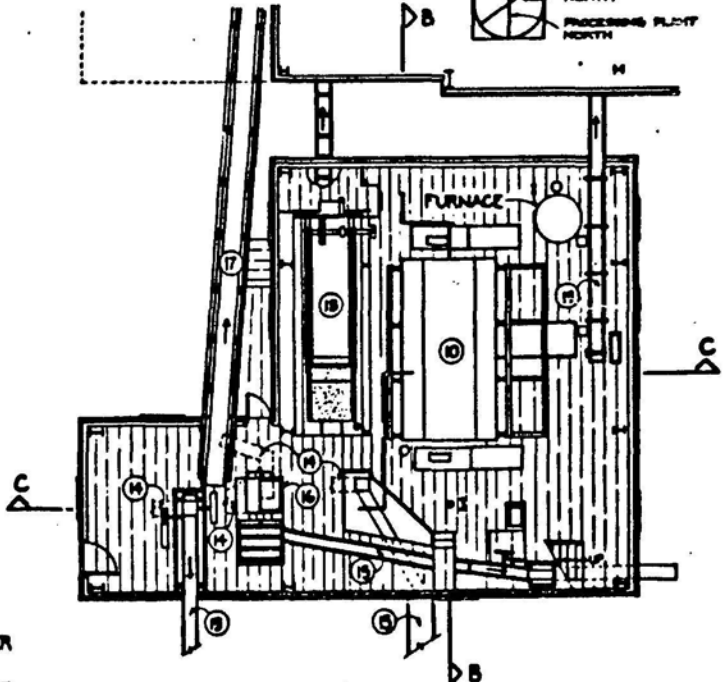
**COAL WASHING ROOM  
LOWER LEVEL**

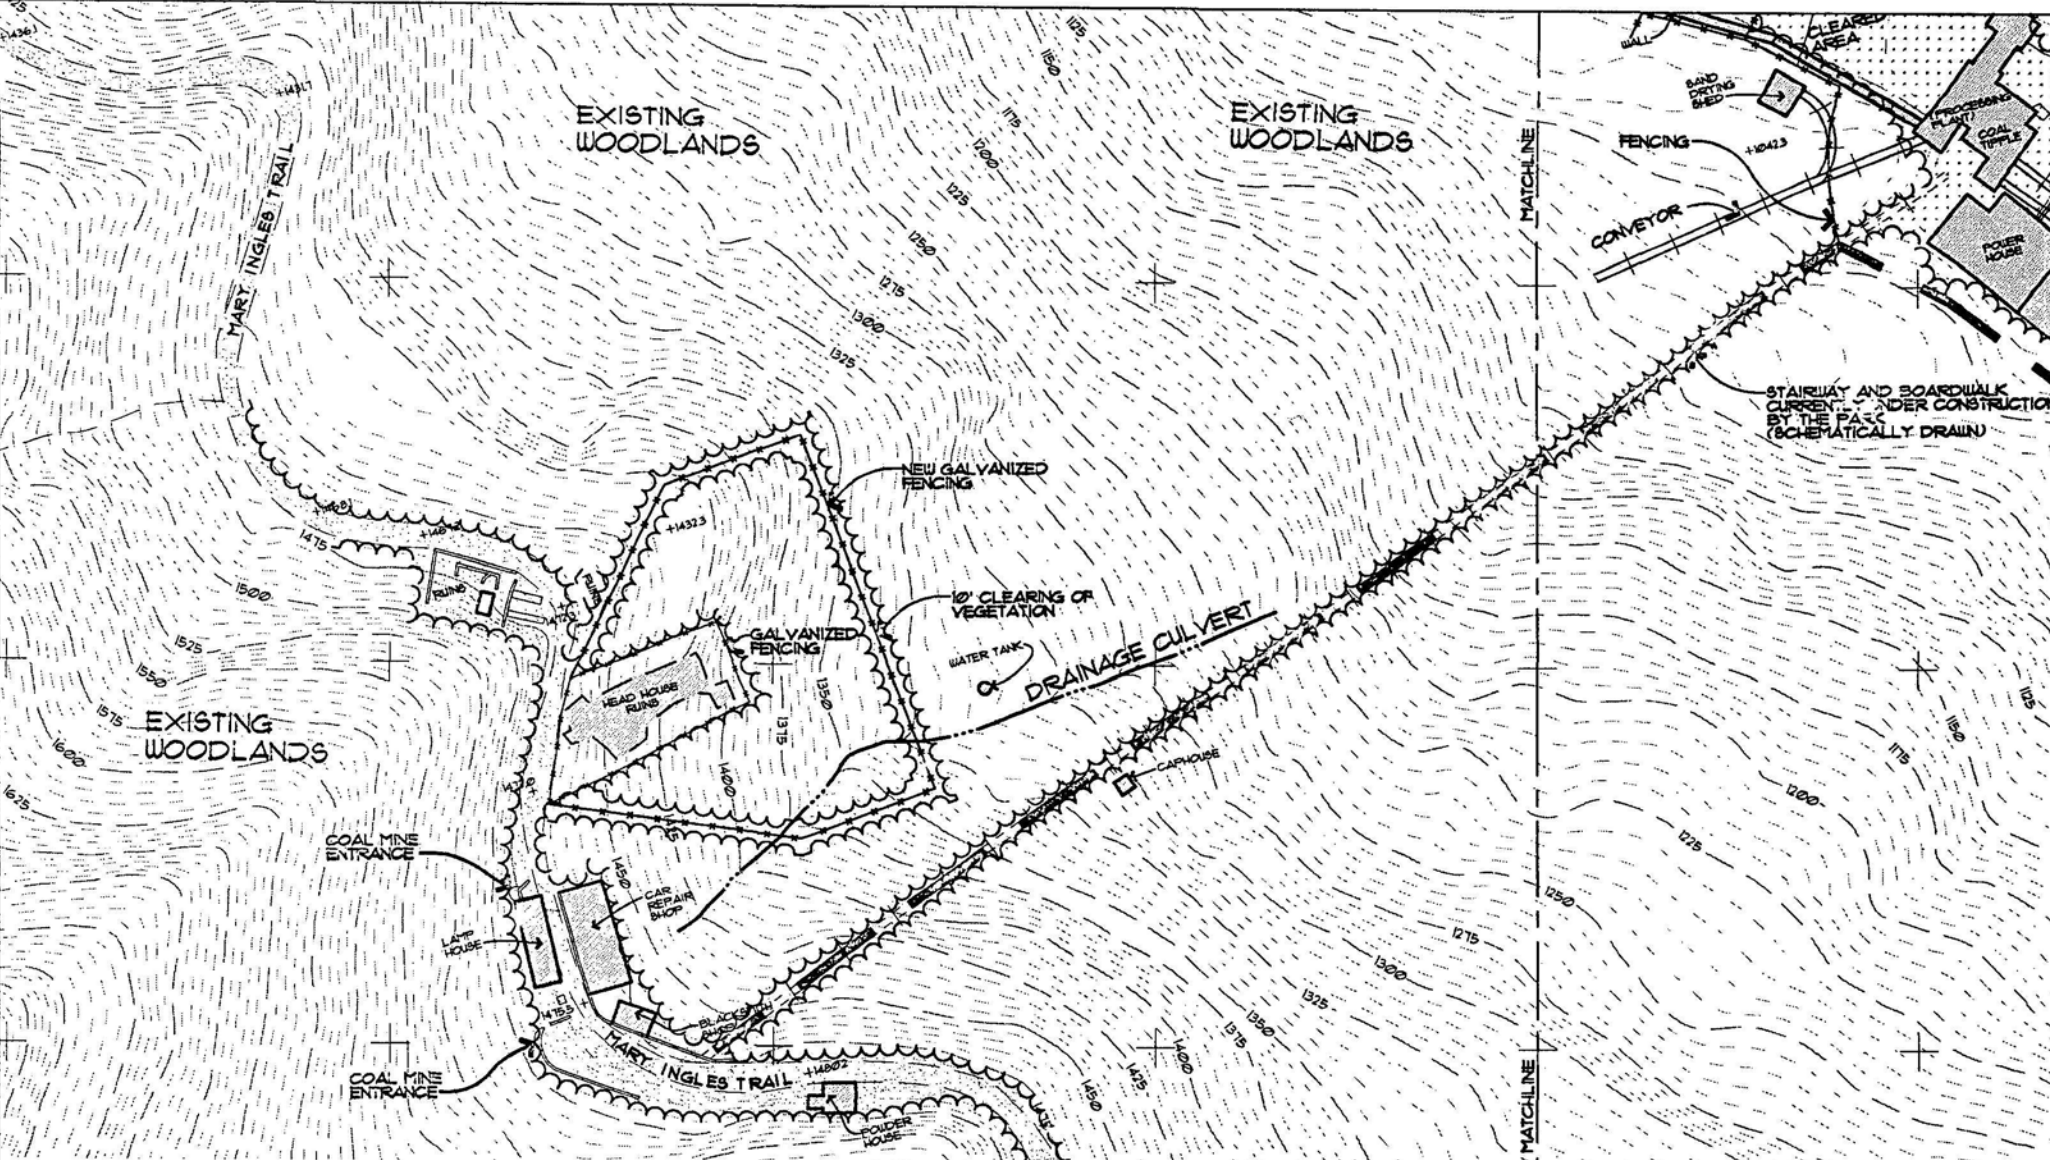
**NOTE**  
 WAYSIDE EXHIBITS AND WARNING SIGNS  
 WILL BE LOCATED BY PARK STAFF.

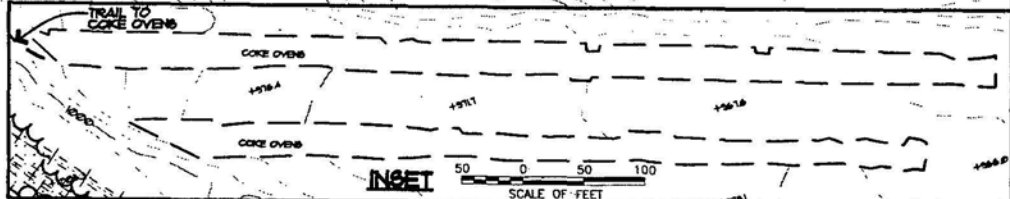
DESIGNED BY: K. VANCE (0000)	SUB SHEET NO.	TITLE OF SHEET SITE ANALYSIS AND EXISTING CONDITIONS	DRAWING NO. 637 20,089
TECH. REVIEW		NEW RIVER GORGE NR	PKG. NO. 158
DATE: 1/97			SHEET OF

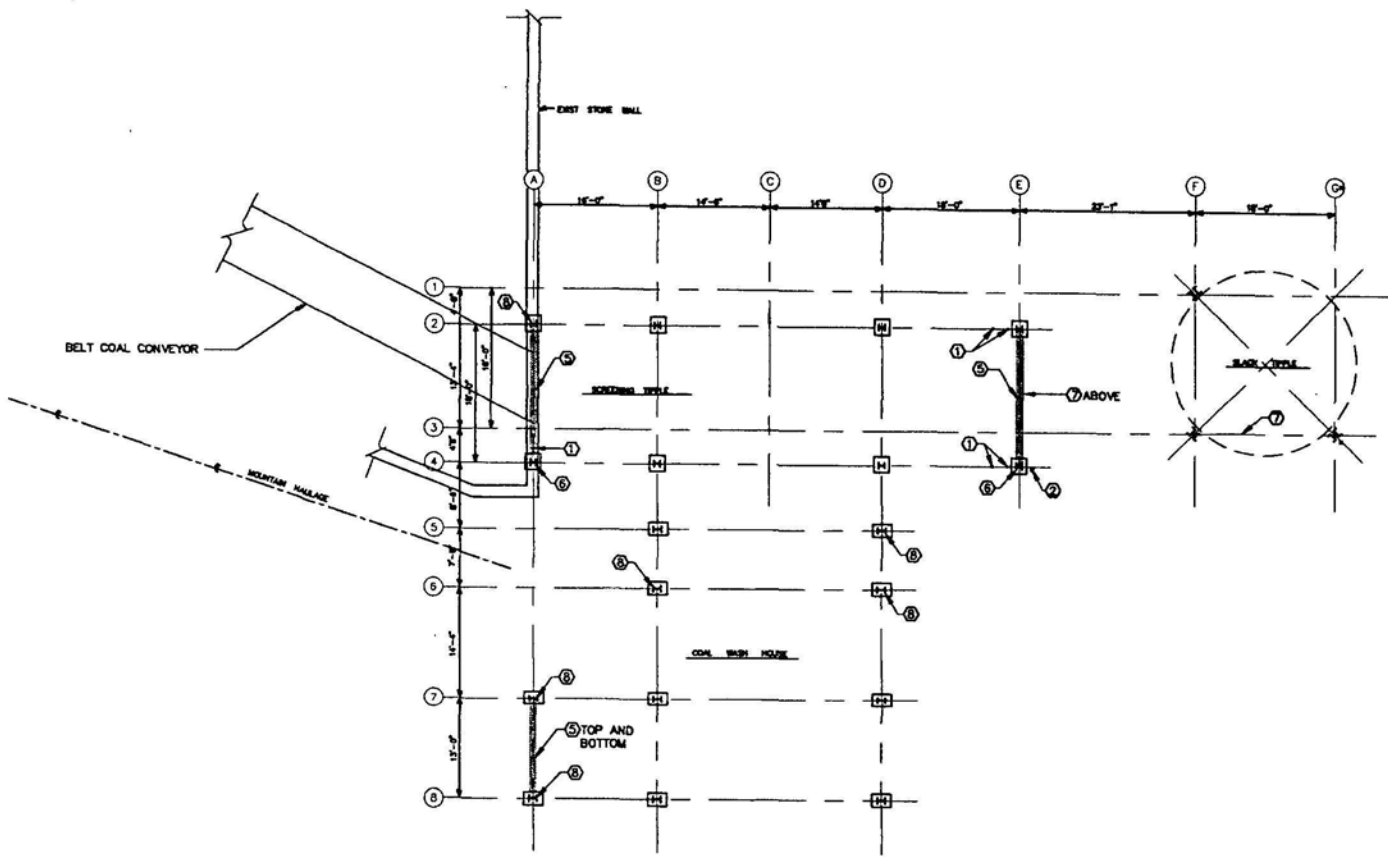
COAL TIPPLE PLAN  
SCALE (A)

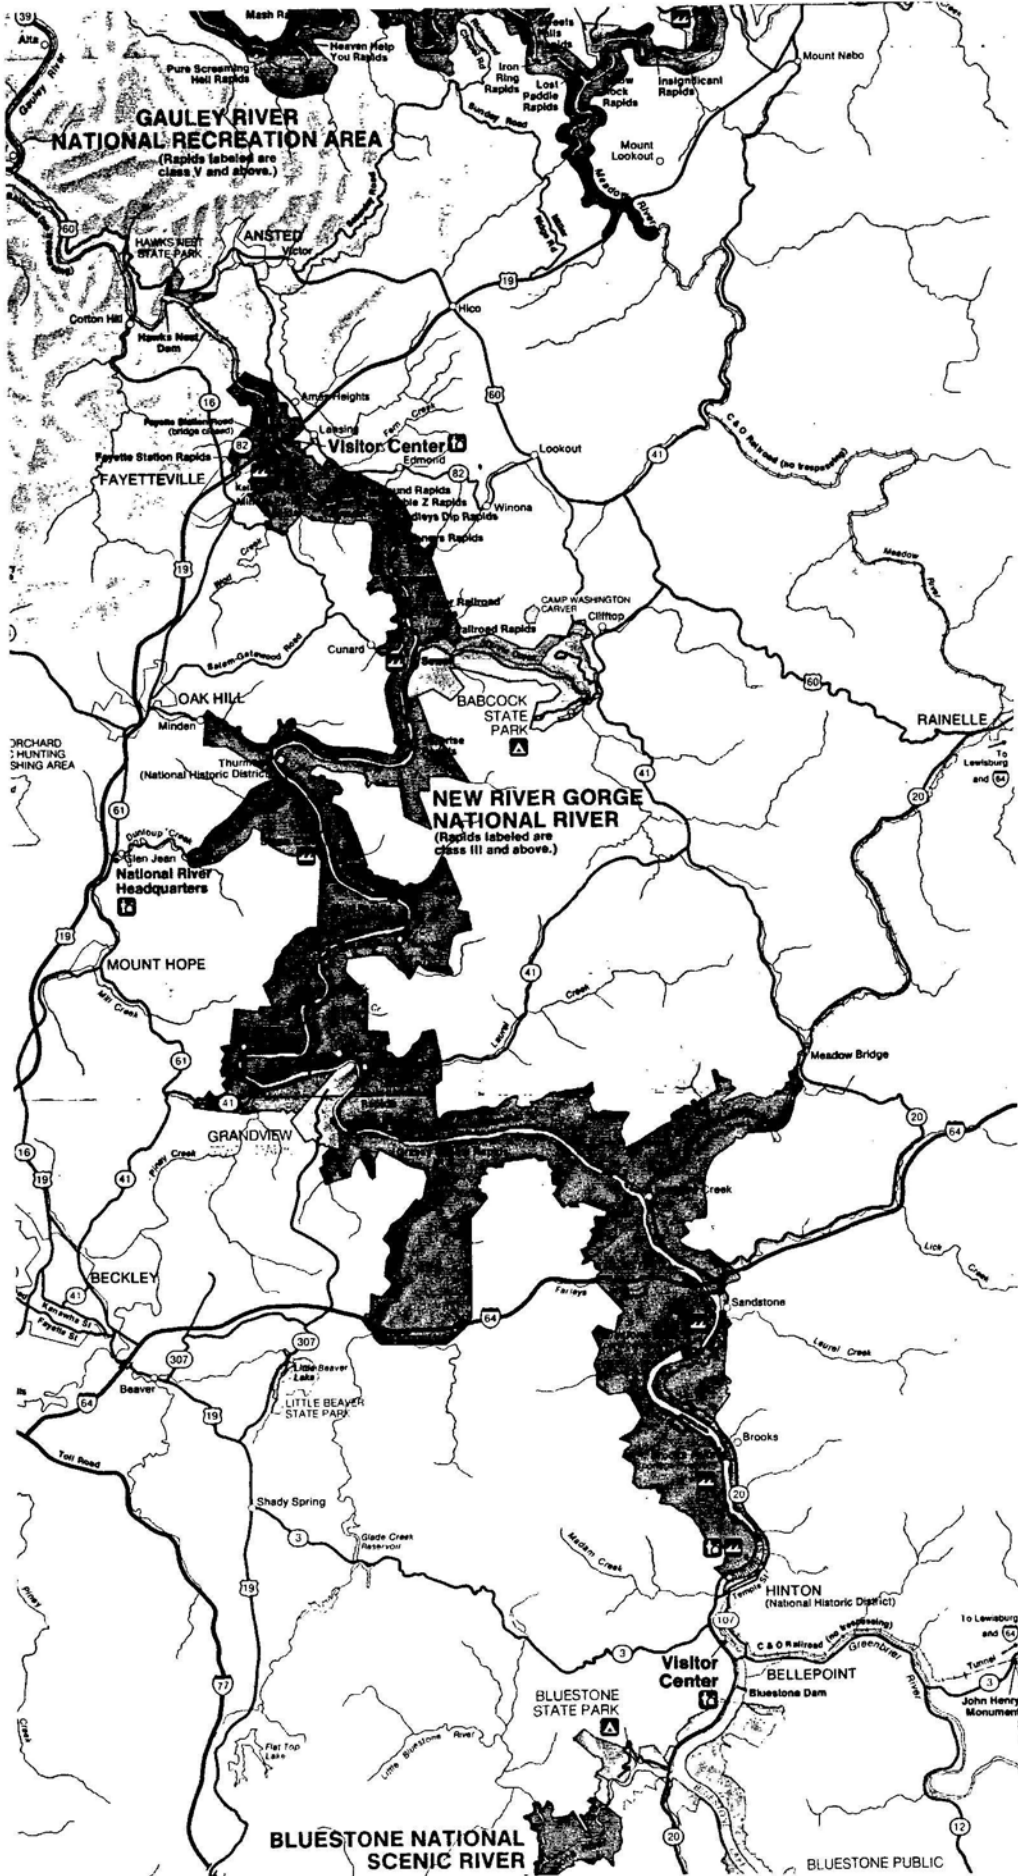
The National Park Service has prepared a Development Concept Plan (DCP) for the site. The Denver Service Center is preparing a Historic Structure Report(1997) for the Kaymoor site, focused on four structures, the Headhouse, Coal Tipple, Power House and Coke Ovens. The HSR will make recommendations concerning the condition of the resources and the method for implementing the DCP recommended treatment of stabilization for the site and structures. This value study is a component of the HSR effort.

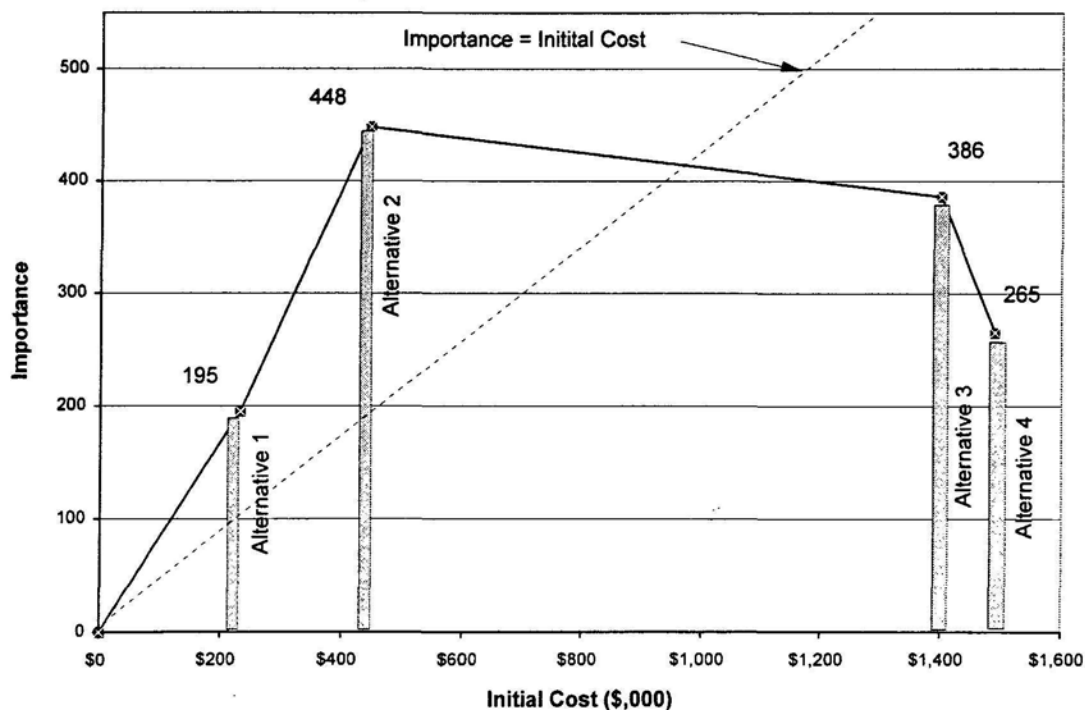
### Coal Tipple, Power House and Coke Ovens Importance versus Life-cycle Cost
