Ruins Stabilization in the Southwestern United States

Publications in Archeology 10

National Park Service

U. S. Department of the Interior
Washington 1974

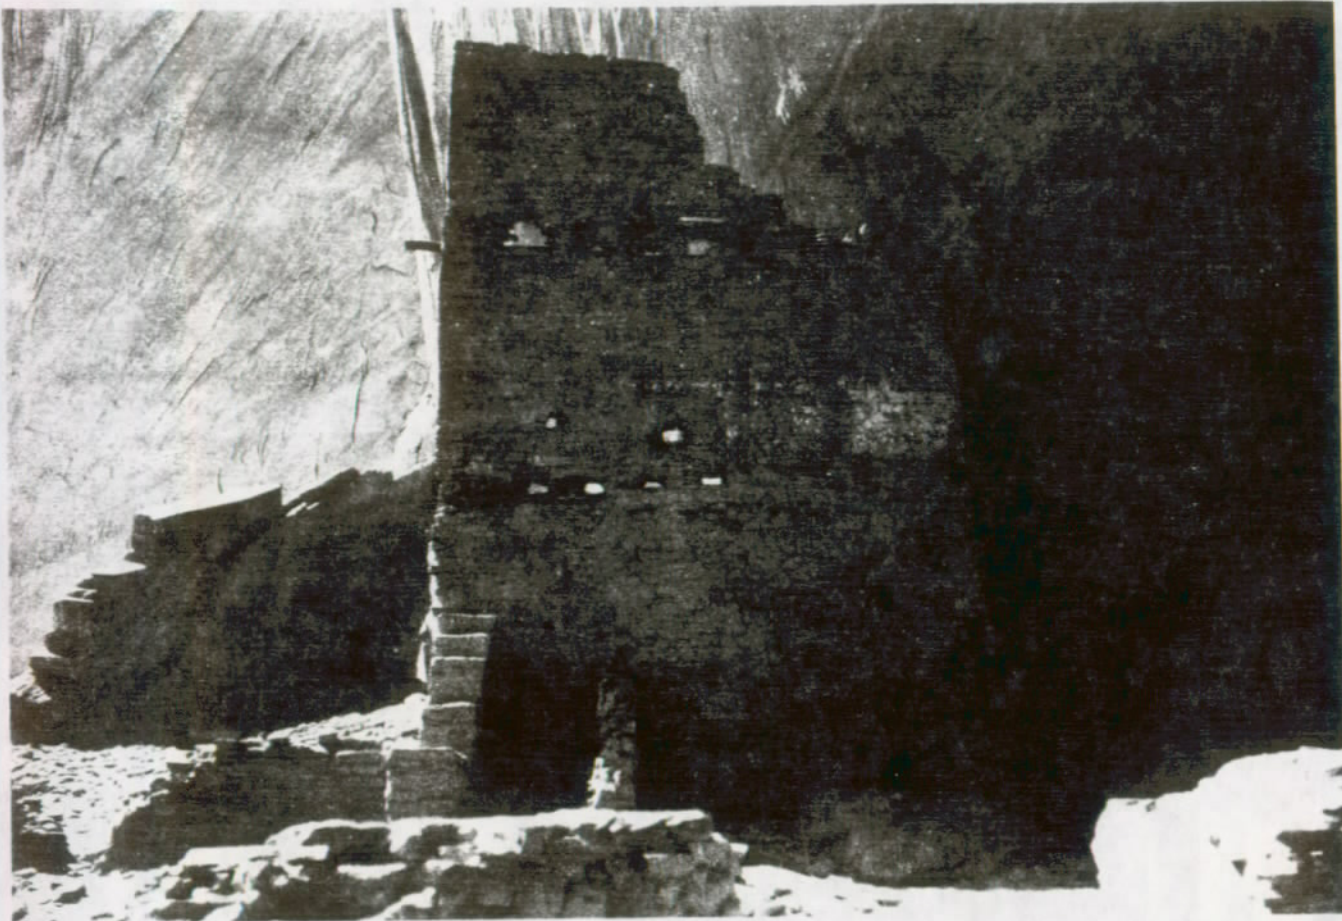
FIGURE 1. Settling caused by lack of foundations and unstable fill. Bond between stone and soil mortar is poor. Holes are caused by decay or theft of wood members. (Antelope House Ruin, Canyon de Chelly National Monument, Ariz.)

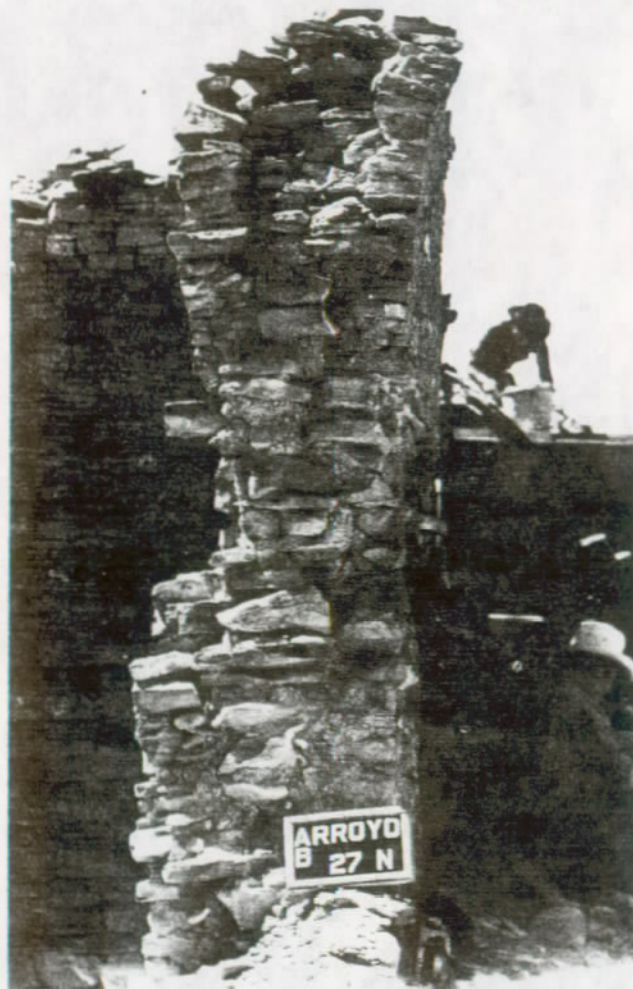
FIGURE 2. Aboriginal construction often left narrow strips at ceiling line. This wall is much wider at the top than in the center. (Room 27, north wall, Pueblo del Arroyo Ruin, Chaco Canyon National Monument, N. M.)

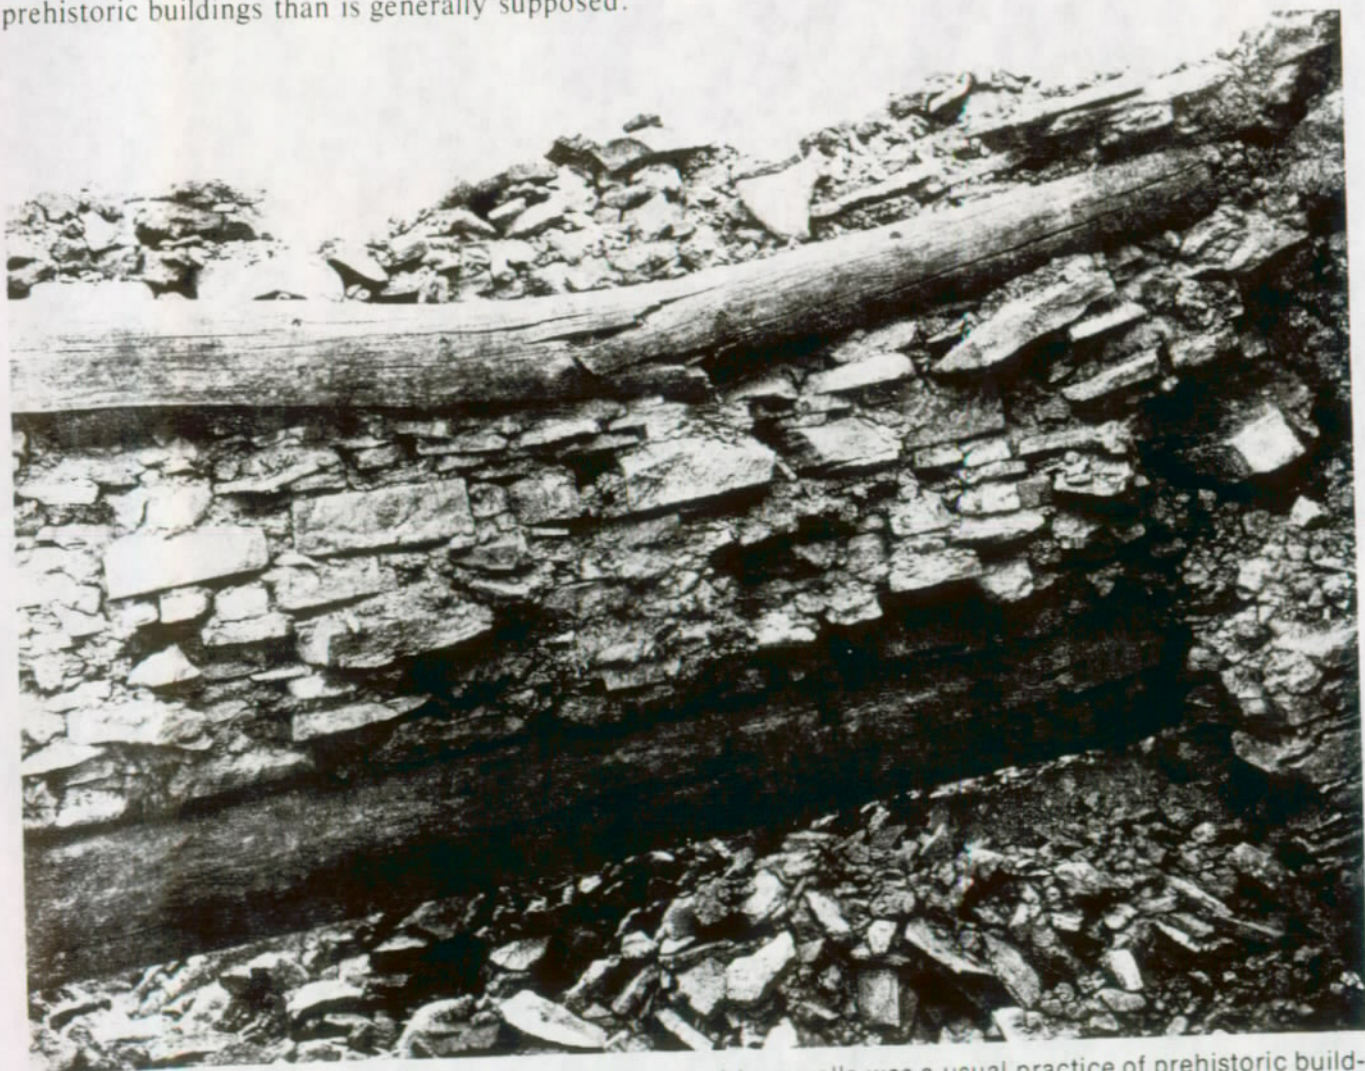
FIGURE 3. The inclusion of heavy timbers within cored-type walls was a usual practice of prehistoric builders. Collapse of walls from flood damage at Chetro Kettle exposed 300 logs similar to those above. (Chetro Kettle Ruin, Chaco Canyon National Monument, N. M.)

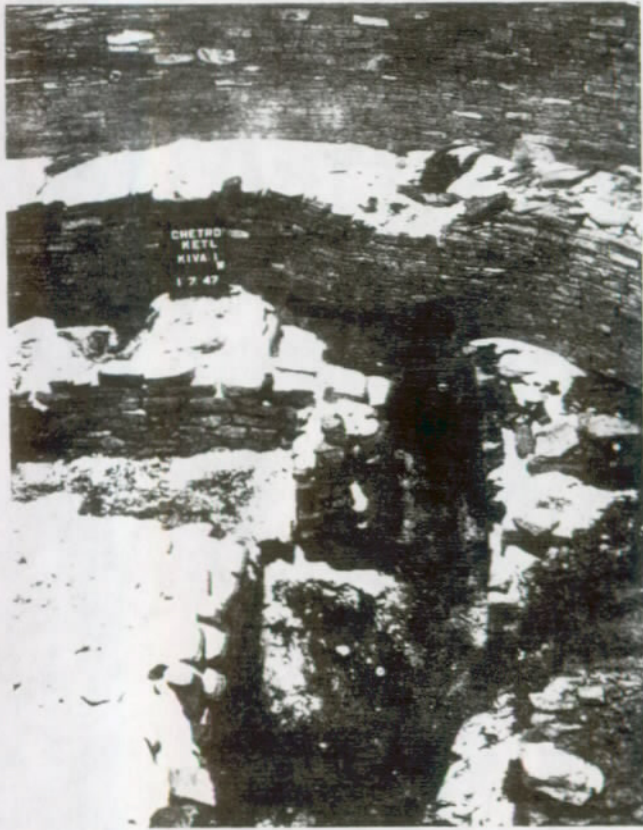
FIGURE 4. Excavation neither proceeds nor ends on a single plane and often leaves walls unsupported. (Kiva I, west perimeter, Chetro Kettle Ruin, Chaco Canyon National Monument, N. M.)

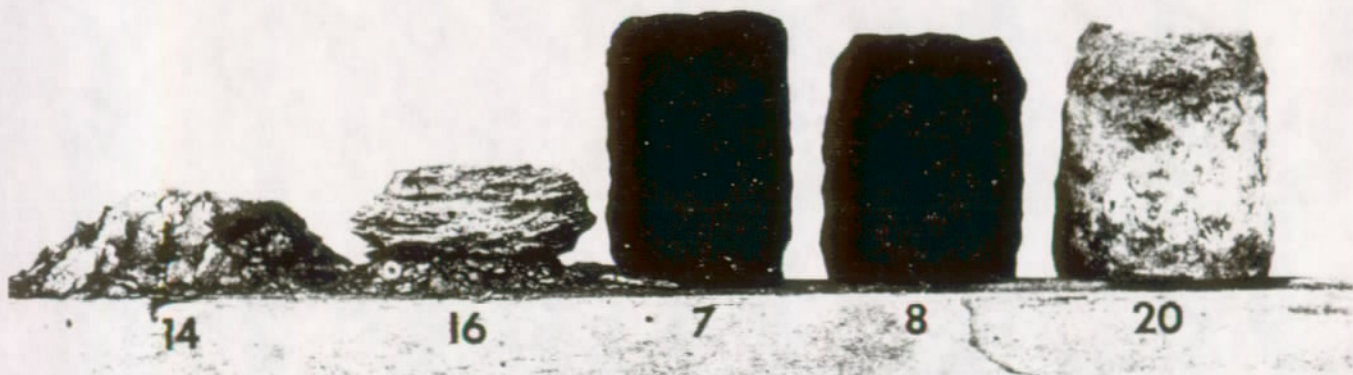
FIGURE 7. Selected cylinders subjected to freeze-thaw test. Nos. 14 and 16, with 10 and 12 percent cement by volume respectively, failed at the third cycle. Both were made up with equal parts clay and silt-loam. No. 20, with 15 percent cement by volume, is shown at the 12th cycle. Nos. 7 and 8, consisting of three parts clay, two parts silt-loam, and emulsified bitumen, were tested in conjunction with the soil-cement and are shown at the 15th cycle.

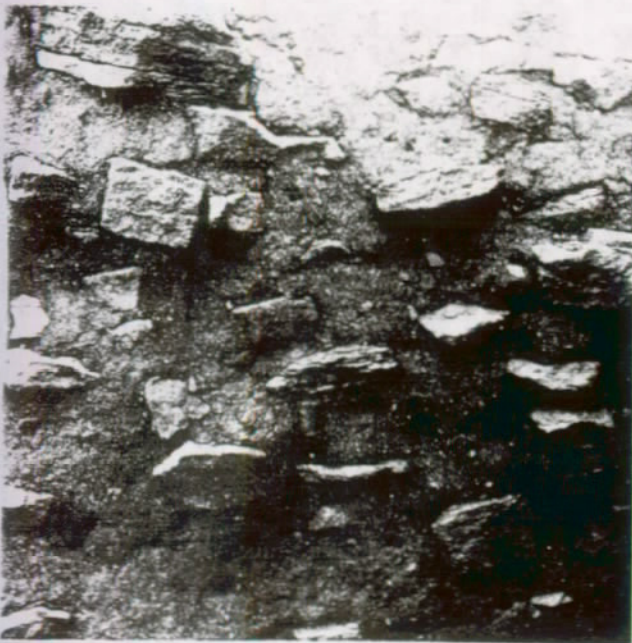
FIGURE 8. The use of heavy grouting to replace native soil between random stone; after 10 years exposure to the elements. (West Ruin, Aztec Ruins National Monument, N. M.)

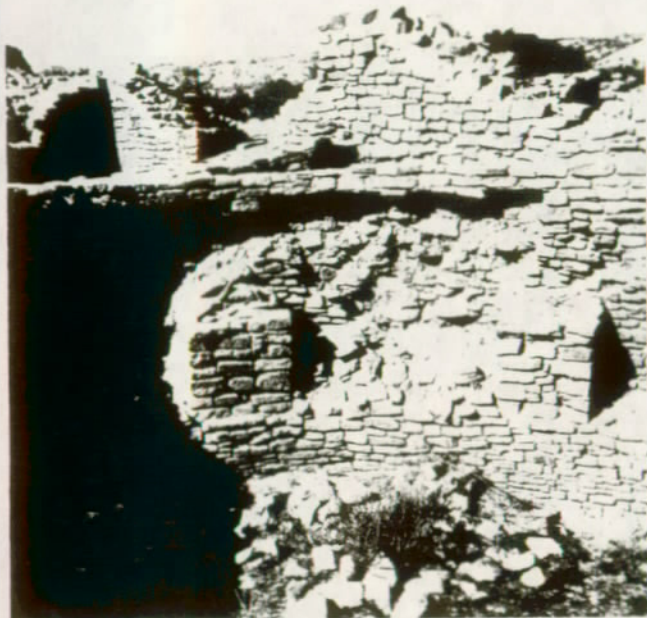
FIGURE 15. Damage caused by outward movement of moisture from fill behind kiva wall. The most severe disintegration is at the limit of capillary rise, just below the concrete capping. (Clan Kiva, West Ruin, Aztec Ruins National Monument, N. M.)

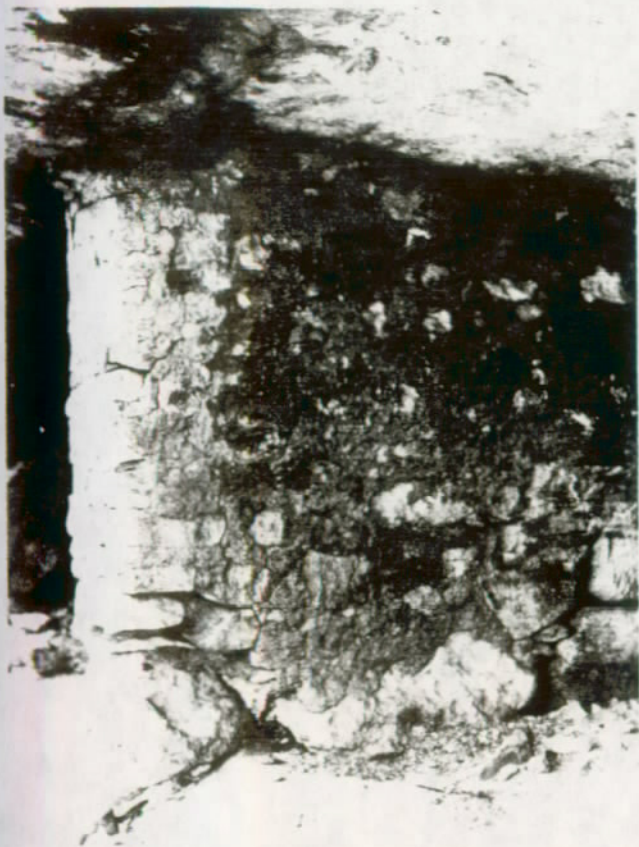
FIGURE 16. Damage as the result of rising moisture from melting snow. Note that decay is confined to the limit of capillary rise in the mortar column. (Cliff dwelling in Walnut Canyon National Monument, Ariz.)

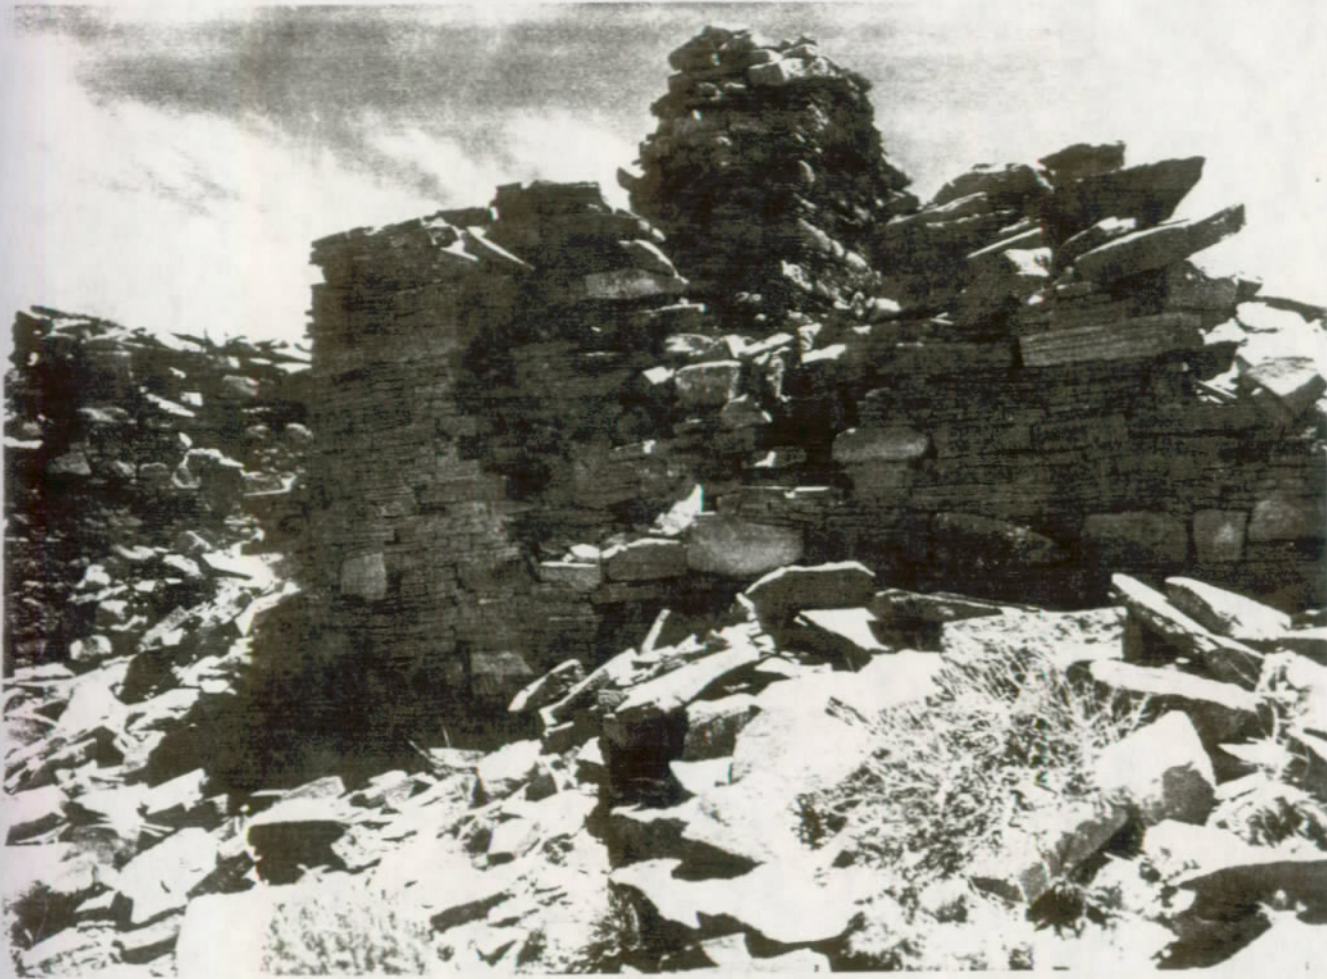
FIGURE 23. An example of soft, pecked and dimpled stone in random areas over wall surface. Replacement of the stone requires extreme care if the character of the wall is not to be changed. (Peñasco Blanco Ruin, Pecos Canyon National Monument, N. M.)

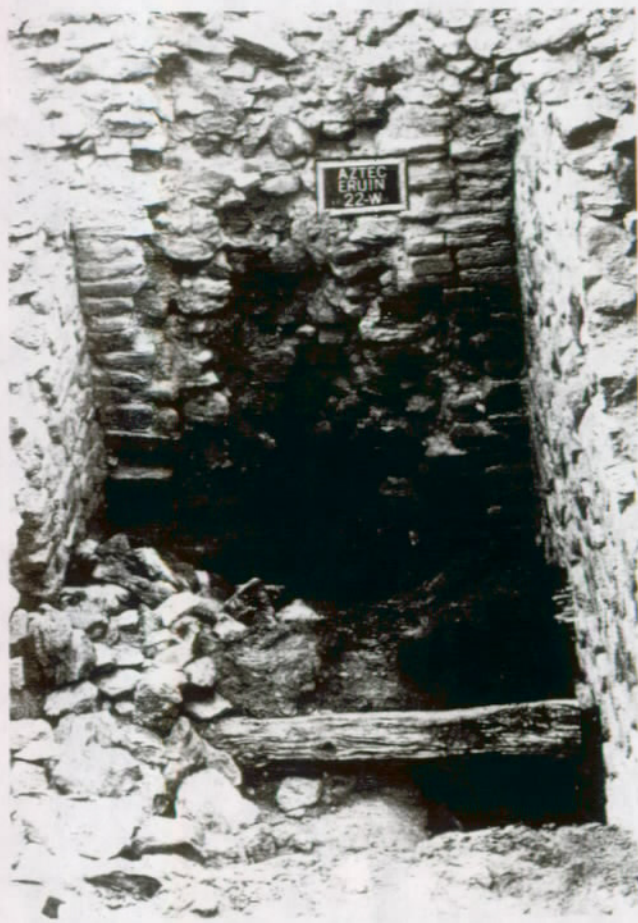
FIGURE 24. Wall break in a partially excavated site. A patch must be designed to prevent further flow of water and fill at the top, and some excavation will be required to base patch on sound masonry. (East Ruin, Aztec Ruins National Monument, N. M.)

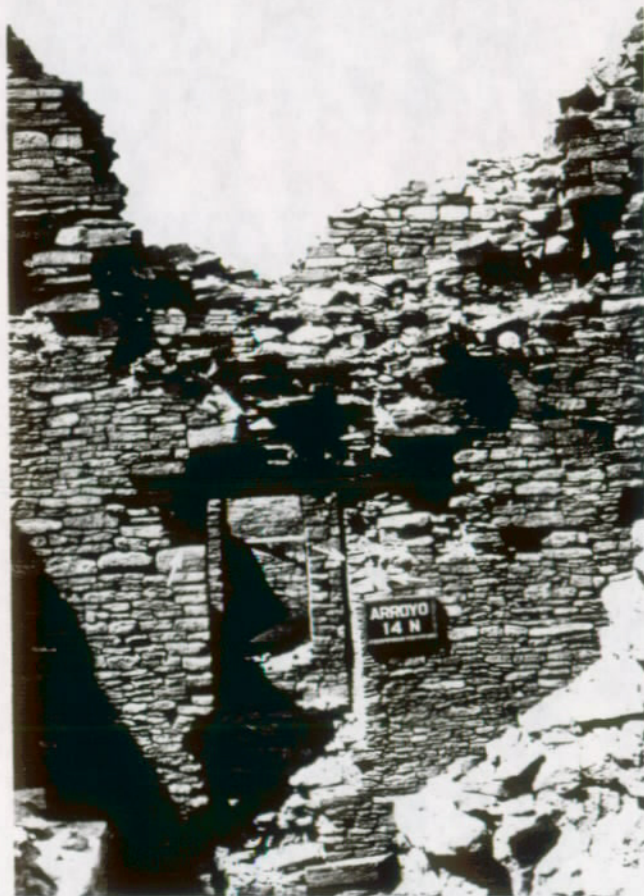
FIGURE 25. Repair at the position of the arrows will be based on a very small area in comparison with the total size of break. Every effort should be made to tie such patches securely to the existing wall. (Pueblo del Arroyo Ruin, Room 14, north wall, Chaco Canyon National Monument, N. M.)

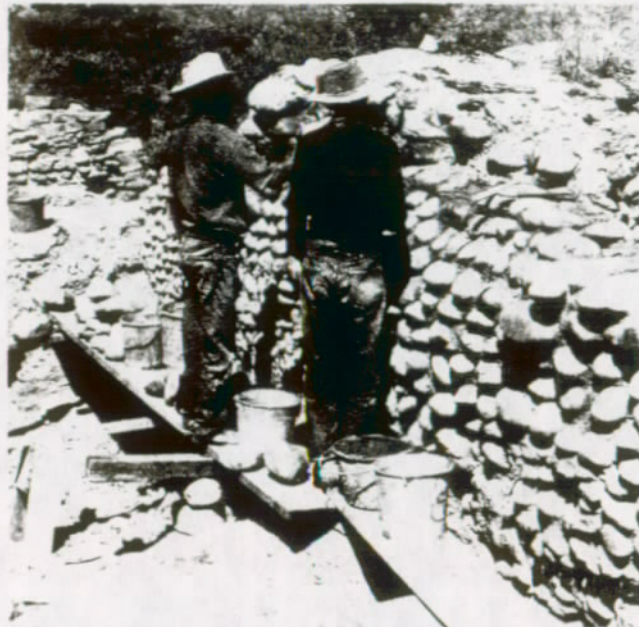
FIGURE 26. Deep grouting with soil-cement on the badly weathered face of this cobblestone wall will not change its appearance, but will halt the rapid rate of erosion. (East Ruin, Aztec Ruins National Monument, N. M.)

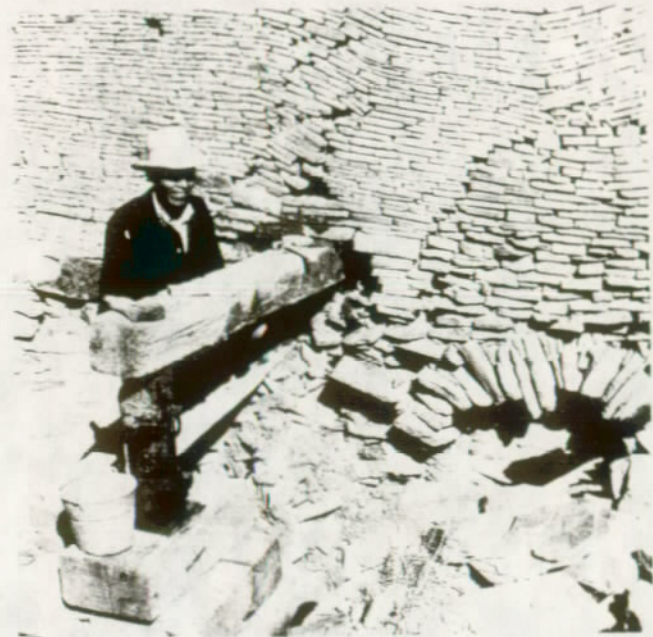
FIGURE 28. The temporary support of a heavy wall with timber. The arch at lower right was constructed in the 1920's as a repair measure. The first step in stabilization involved the placing of a beam through a hole adjacent to the arch. Not of aboriginal origin, the arch was subsequently removed. (Room 1, Chetro Kettle Ruin, Chaco Canyon National Monument, N. M.)

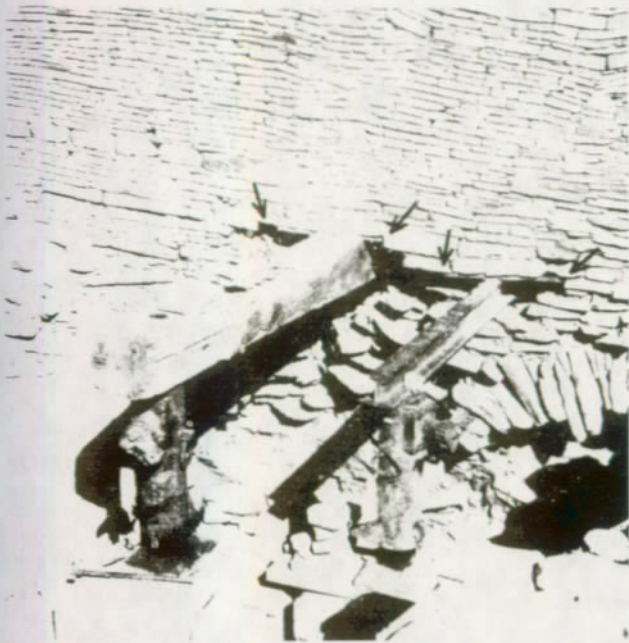
FIGURE 29. A second beam resting on jacks is placed through the wall depicted in figure 28. Arrows indicate extent of steel plates above the beam. The area of settling was reduced with upward pressure.

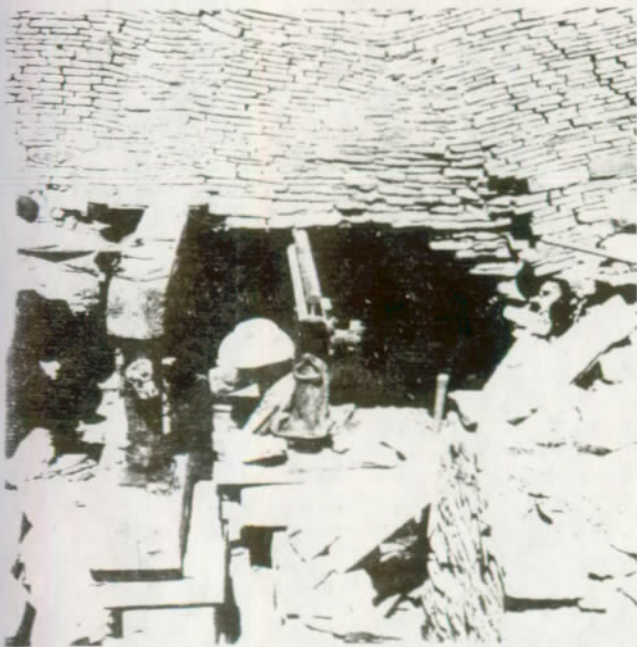
FIGURE 30. Jacks and beams provide support of wall depicted in figures 28 and 29 while arch section is removed. The break is filled with repair masonry.

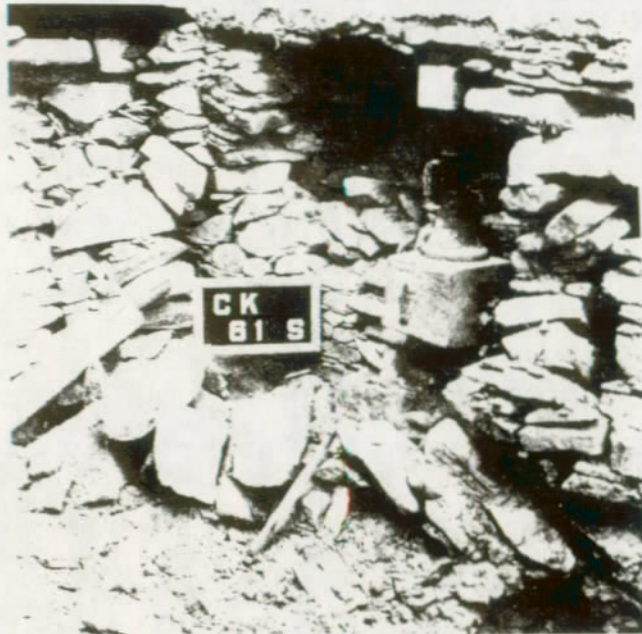
FIGURE 31. Placement of jack in line with shattered facing near the bottom of a 14-foot wall. The jack provided support while the broken area at the right was being replaced. (Chetro Kettle Ruin, Chaco Canyon National Monument, N. M.)

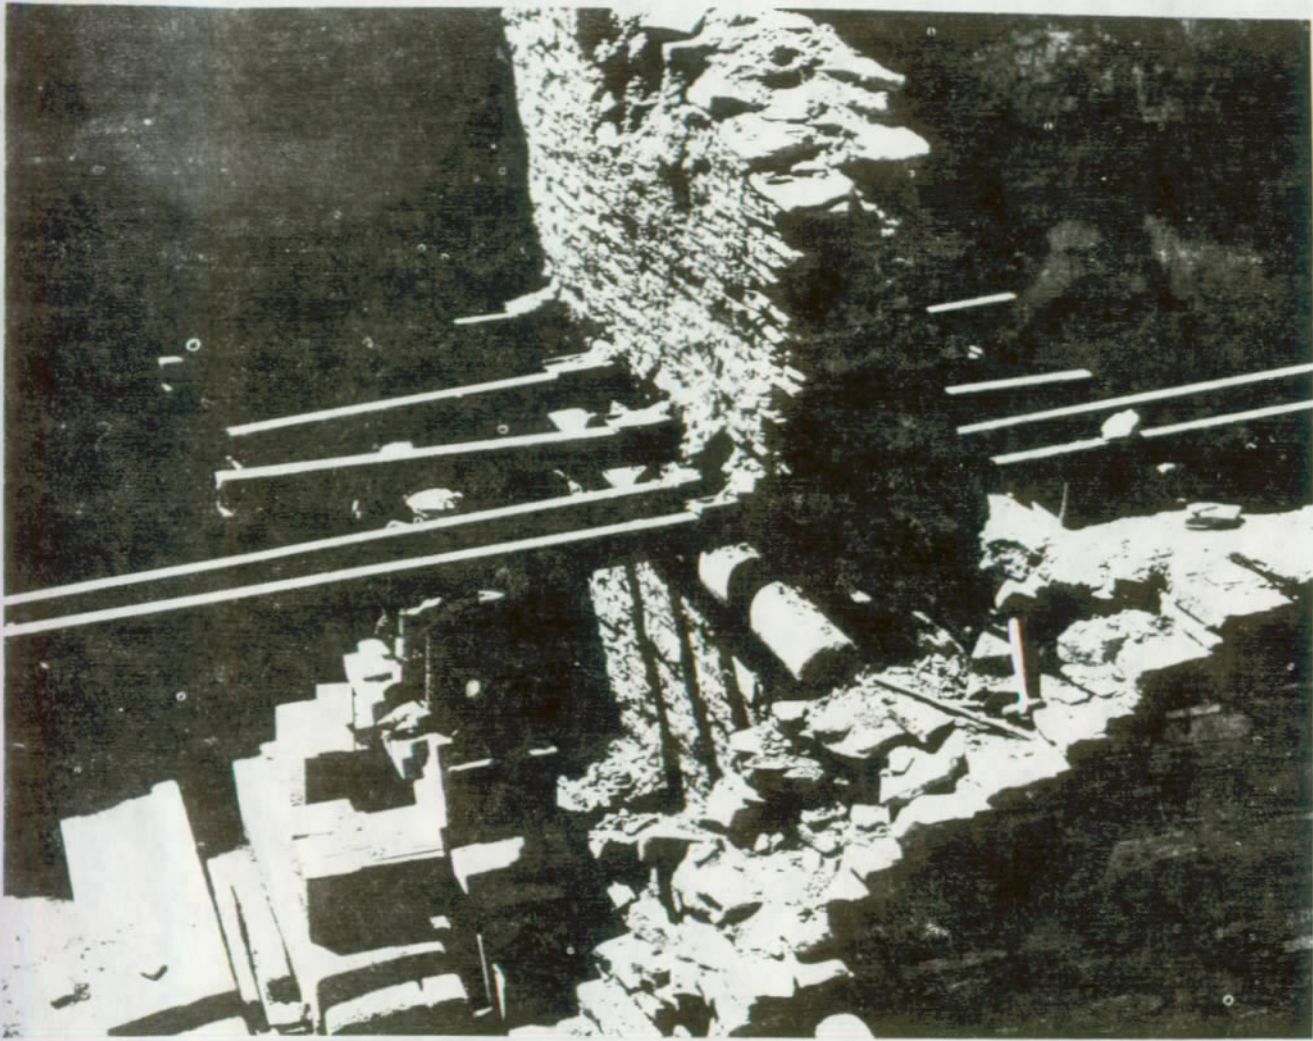
FIGURE 32. A temporary support. Six steel beams buttress the upper half of the wall while a decayed horizontal timber is replaced. The timber is partly removed here. With care, steel beams can be run through pole sockets or other natural openings without damage to the wall. (Chetro Kettle Ruin, Chaco Canyon National Monument, N. M.)

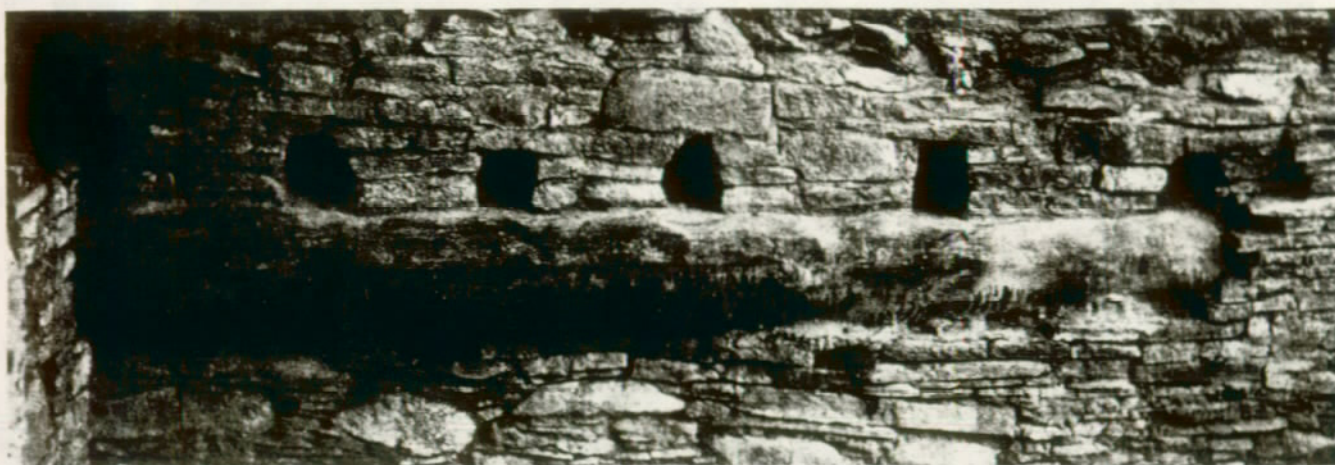
FIGURE 38. A horizontal cast log replaces the original timber which had rotted on the interior and in the embedded portions. (Chetro Kettle Ruin, Chaco Canyon National Monument, N.M.)

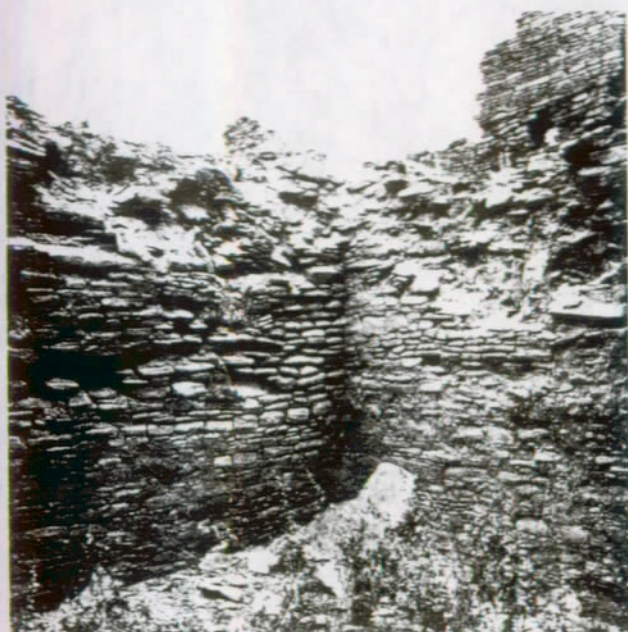
FIGURE 44. In many cases such as that depicted above it will be difficult to draw a distinction between general wall repairs and capping. This wall will have to be carried up to the level of the outside fill to prevent further washing over the top. Whatever type of mortar is used for such wall repairs, the top courses must be set in a cement mortar to provide as durable and waterproof a cap as possible. (Pueblo del Arroyo, Chaco Canyon National Monument, N.M.)

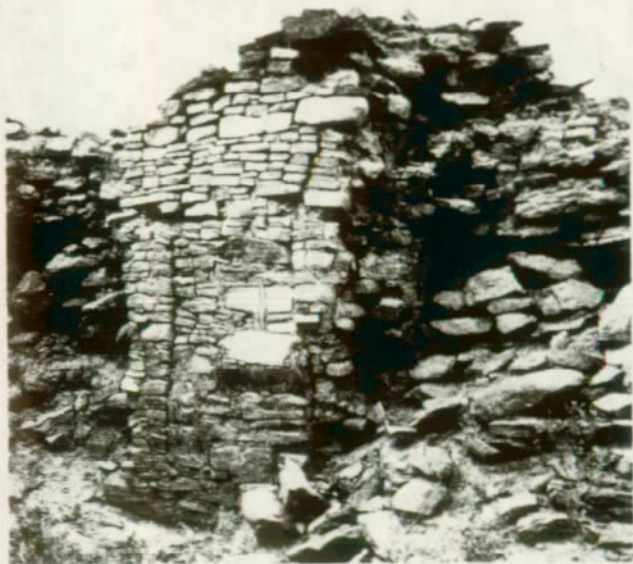
FIGURE 46. A good deal of repair masonry must be laid to fill breaks and support undercut areas in this wall at Pueblo del Arroyo. Some support must also be provided for the embedded timbers. Soil or masonry cement mortars may be used for the major part of this work. The upper courses however must be laid in concrete mortar as capping to halt further washing from the top. In this example, damage was started by surface water from adjacent, unexcavated fill and every effort should be made to prevent erosion.

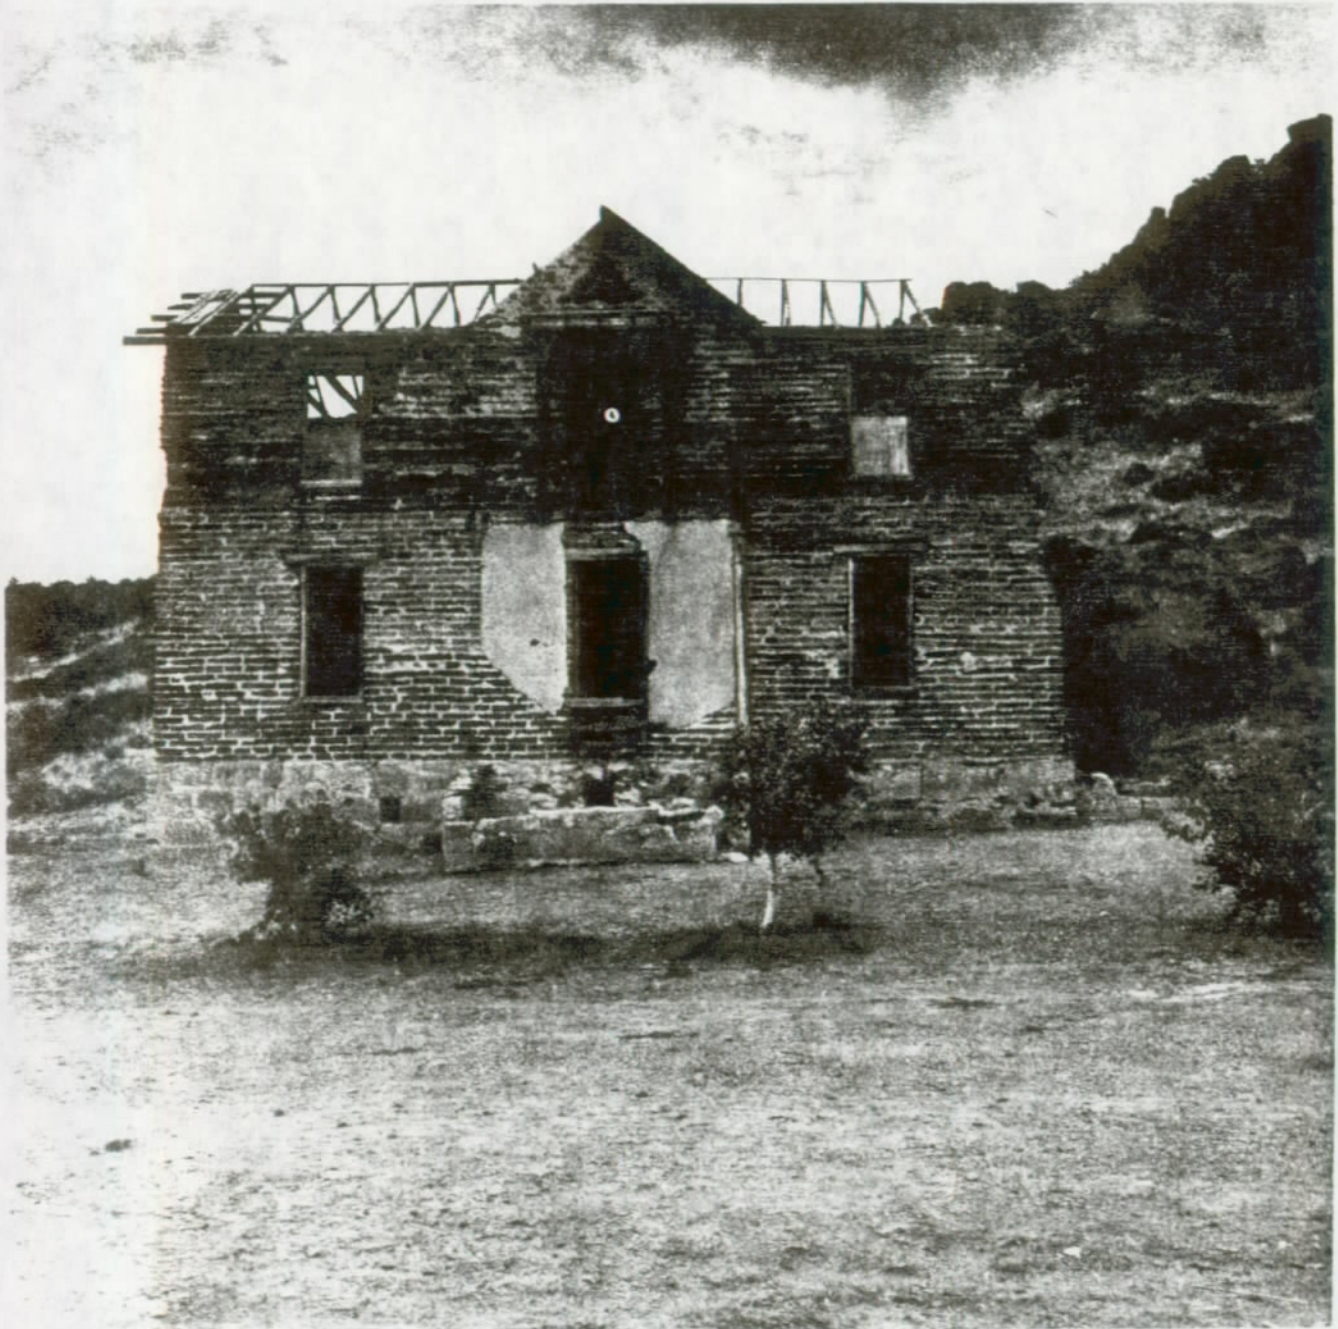
FIGURE 55 One of four 2-story adobe structures, designated HB-14, at Fort Davis National Historic Site. The building was probably used as a residence for important non-commissioned officers. Front view in 1964 before repairs were undertaken by the National Park Service.

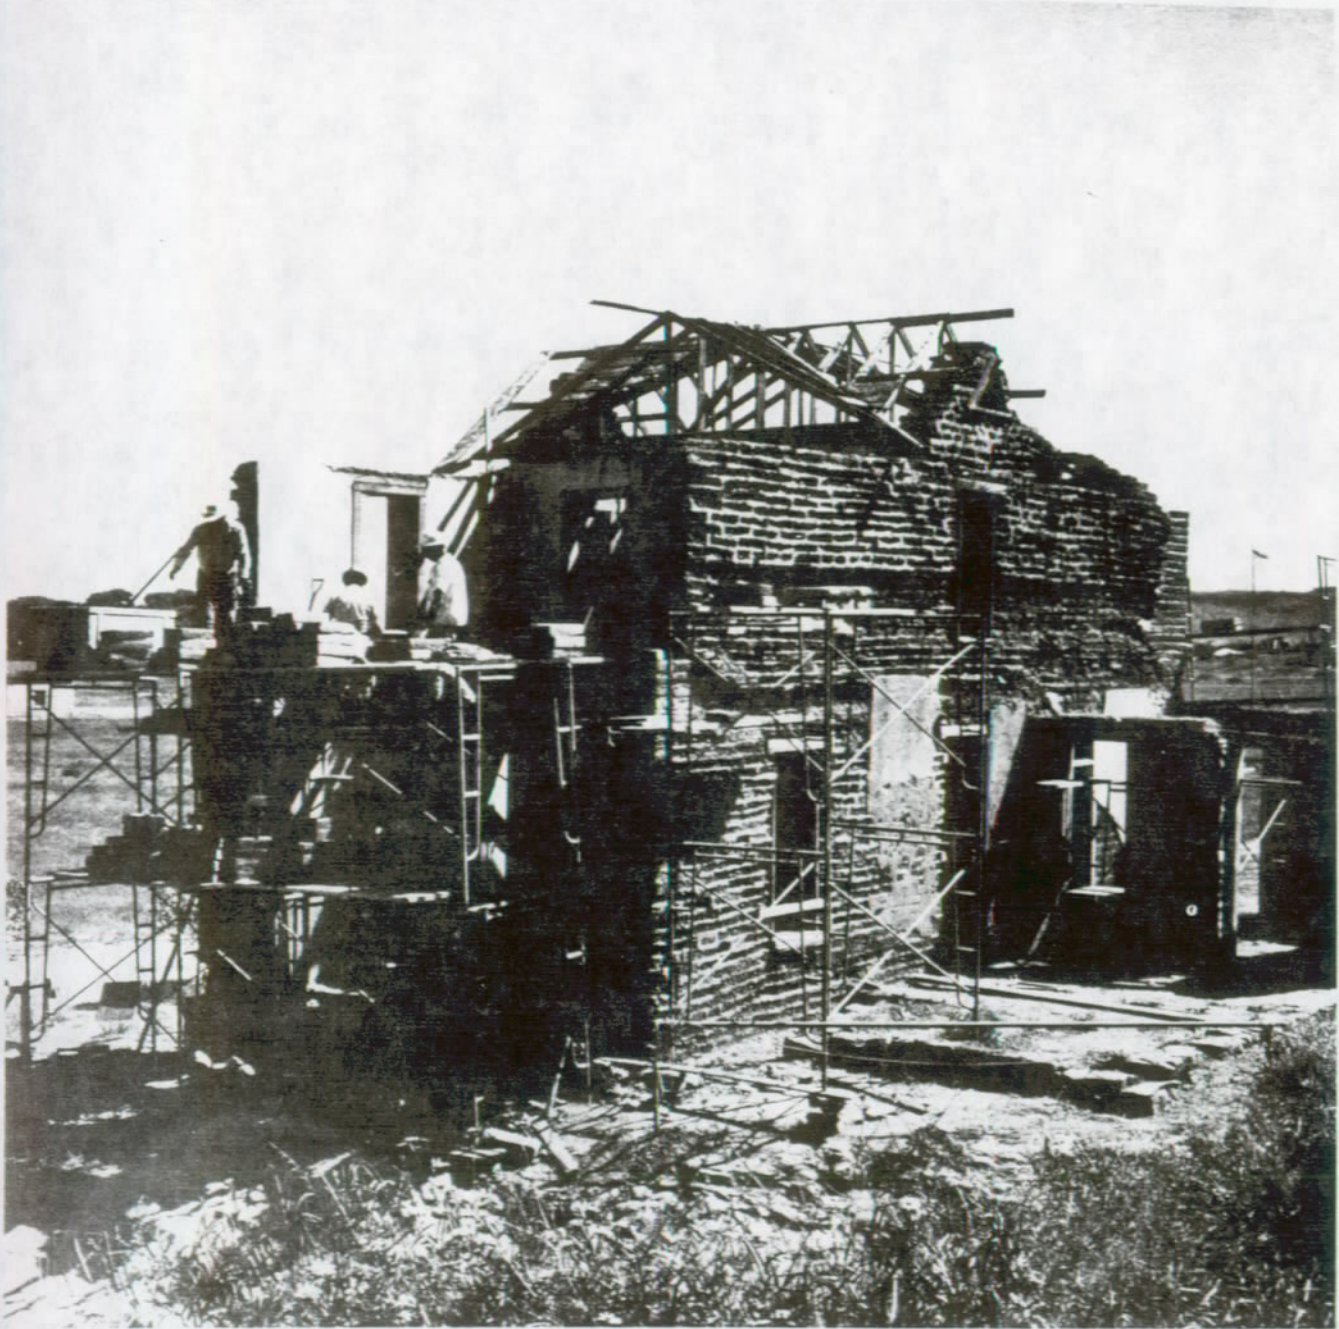
FIGURE 56. Stabilization and modified restoration in process at HB-14, shown in figure 55. Soil-cement adobes were used for repairing walls. A concealed integral bond beam was installed around the building between the first and second story levels. Concrete bearing beams were installed at roof line to support restored roof.

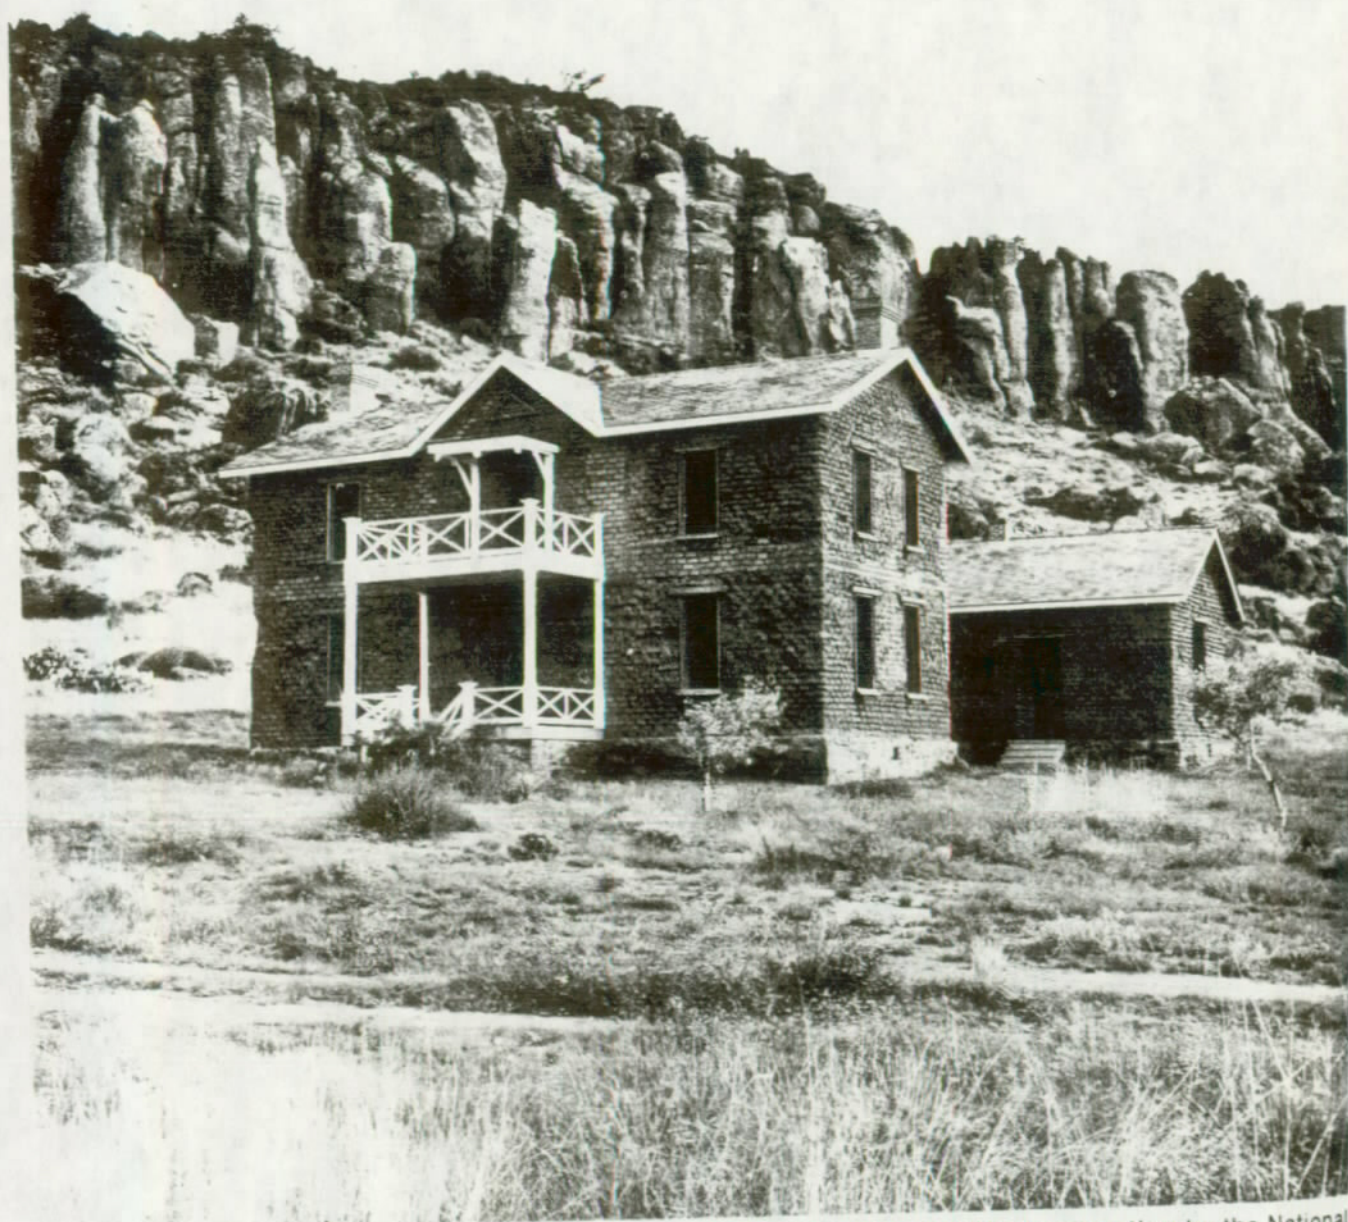
FIGURE 59. Building HB-15 and its outbuilding, a kitchen, following modified restoration by the National Park Service. Soil-cement adobes simulating original adobes were used as modular units of repair. Compare with figure 58.

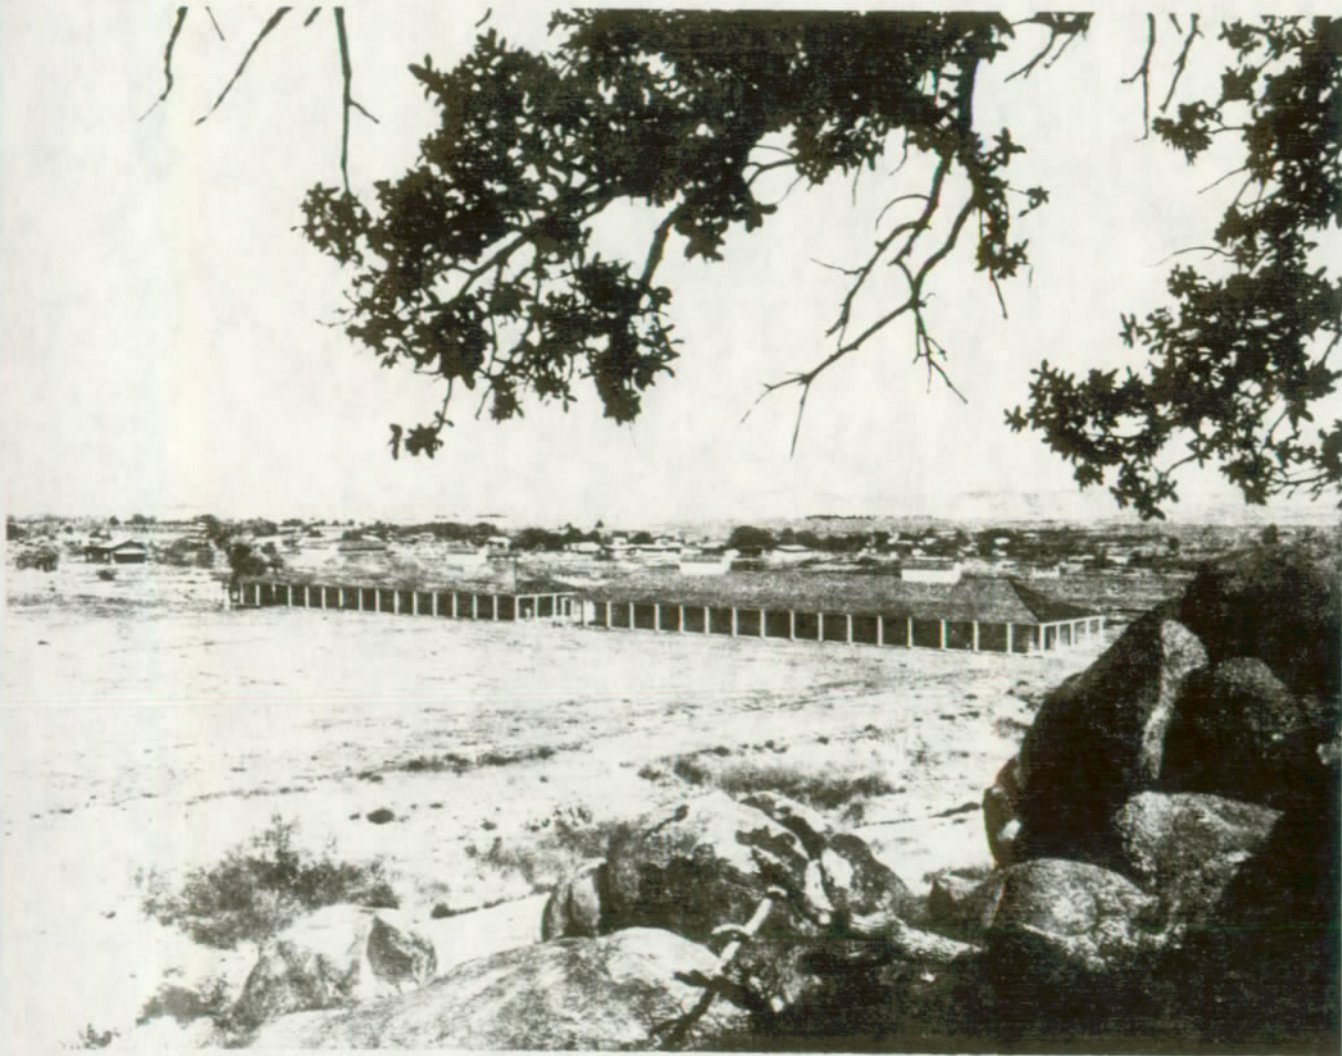
FIGURE 61. A view of the Fort Davis barracks after restoration. The ruinous shell seen in figure 60 was veneered with hand molded soil cement bricks, 4" x 4" x 12". They were made with one part portland cement (untinted), three parts unwashed sand, and three parts native soil. The bricks laid in masonry mortar with rough joints, set with spalls, were wire-brushed. Original walls were pared down where required to accommodate the veneer brick and to retain original wall dimensions and thickness. Bond beams were installed at roof line to support the restored, hipped, shingled roof. The soil cement brick walls were painted with white cement paint, although originally they were whitewashed. The building is used functionally today as the Visitor Center. Cost of the restoration: \$129,000 or \$12.90 per square foot.

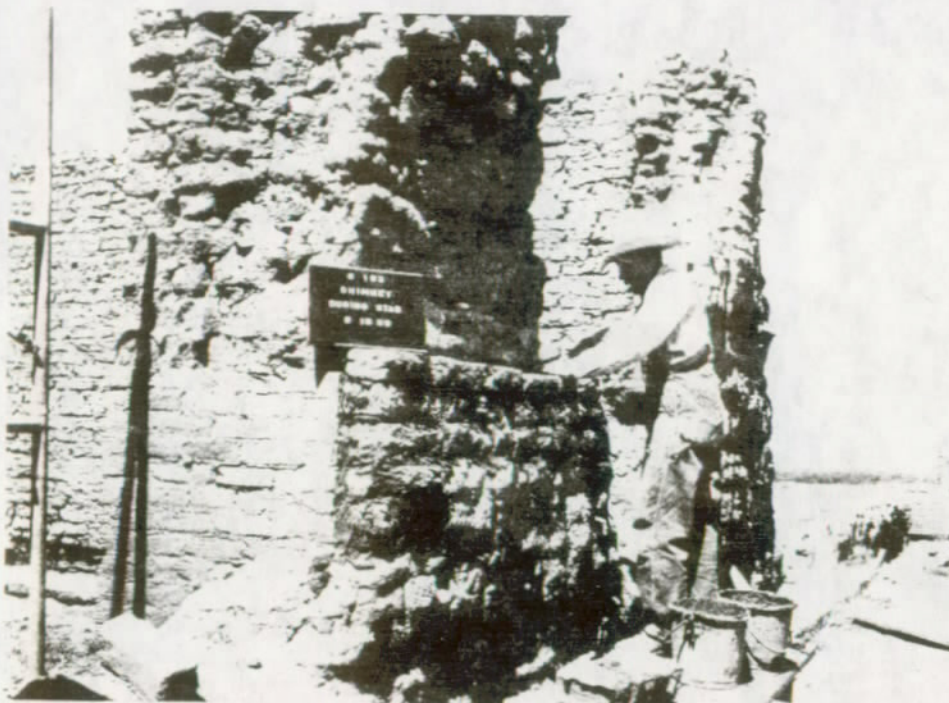
FIGURE 97. Building 6-160, Room 163, flue and chimney in east wall, during stabilization. Soil adobes are being laid to replace those that had fallen away. Fort Union National Monument.

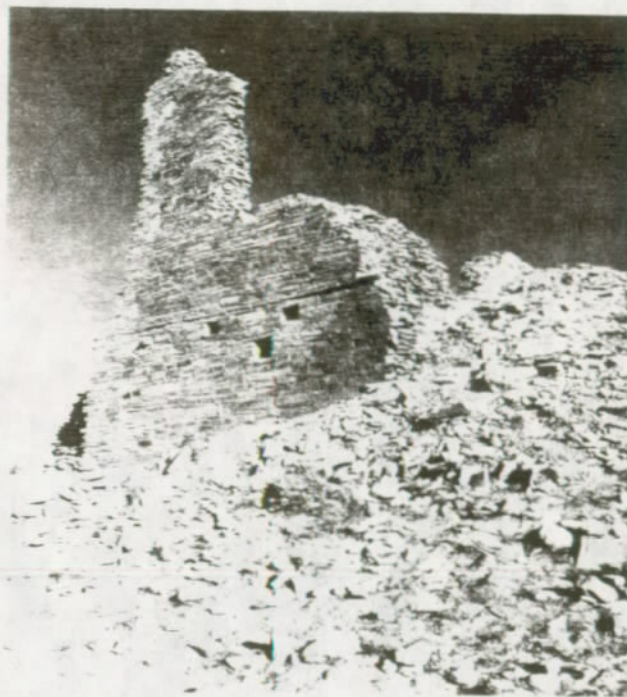
FIGURE 102. Hole at base, square openings (the two upper held beams, the lower was a ventilator) and insets repaired and wall stubs capped. Beam stub at left and two beam holes in line above (arrows) either represent reinforcing ties for kiva corner or supports for some sort of prehistoric scaffolding used in construction or a balcony.
